# Air Transportation Safety Investigation Report A1700243

## HARD LANDING

Jazz Aviation LP  
Bombardier DHC-8-402, C-GYJZ  
Toronto/Billy Bishop Toronto City Airport, Ontario  
09 November 2017

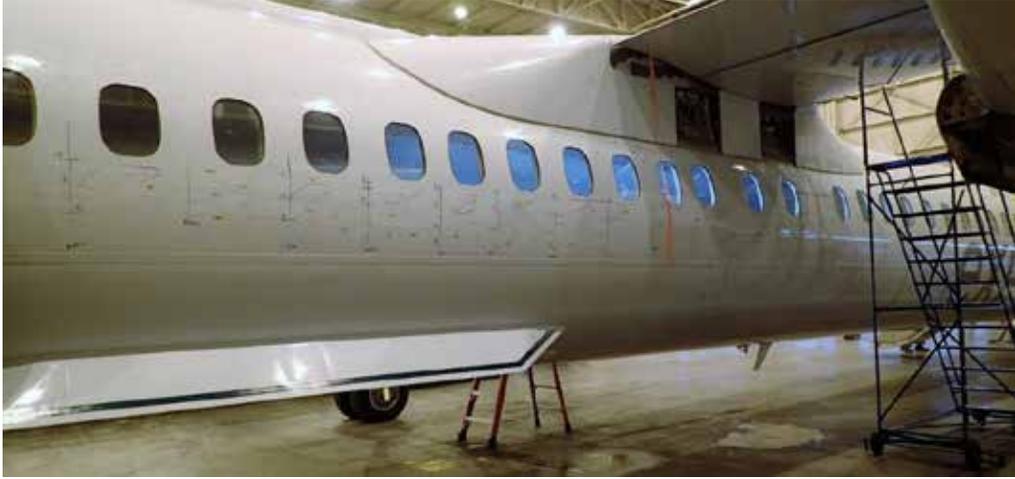
The inspection at CYUL found that the aircraft had sustained substantial damage, including buckling of the skin below the windows on the right fuselage (Figure 1). The landing conditions experienced by the right main landing gear during the second touchdown exceeded its ultimate design criteria, which resulted in failure of the orifice support tube during the in-stroke (Figure 2). Once the orifice support tube failed, shock strut damping was effectively lost, thereby generating significant bottoming loads.

Figure 1. Maintenance marks on the right-side fuselage showing areas of buckling

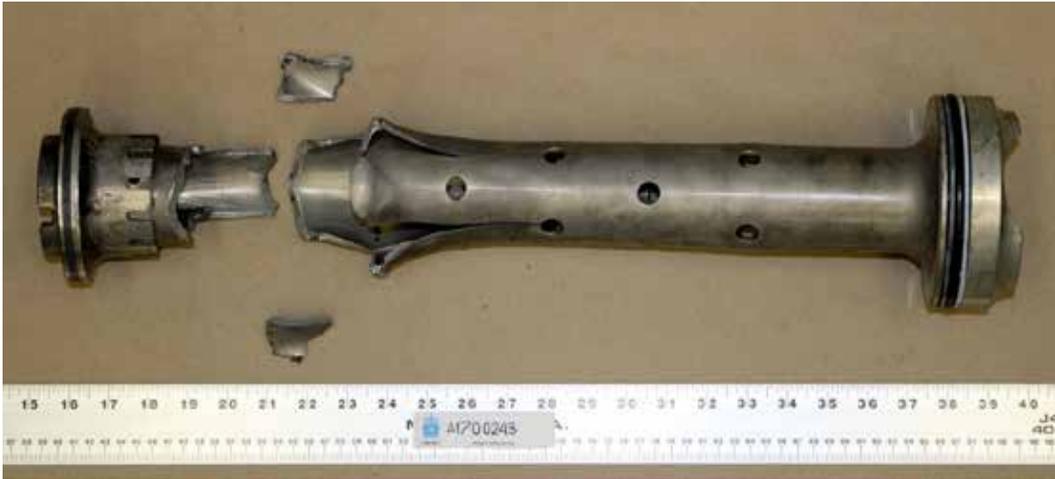
Figure 2. Orifice support tube

The calculated theoretical vertical load that would have been instantaneously generated when the landing gear bottomed out was at least 5.7g, which exceeded the design criteria for the landing gear.
