**FINAL REPORT**

**AIC 17-1004**

## **CONTROLLED FLIGHT INTO TERRAIN**

**P2-ISM**

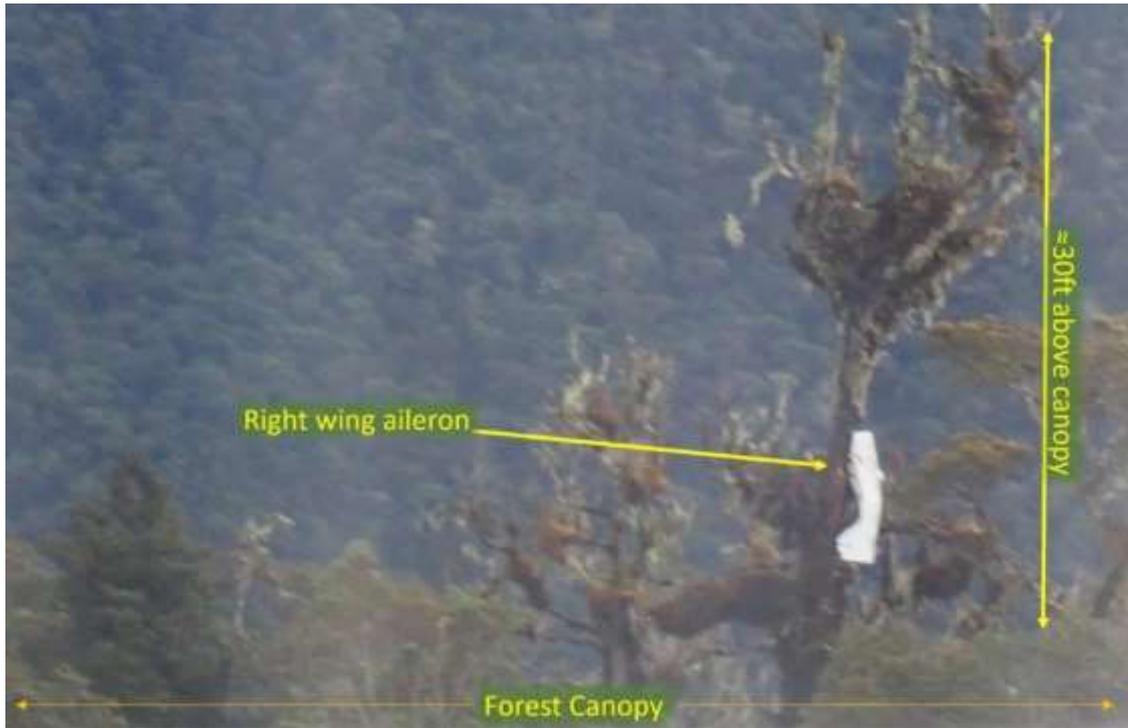
During the search for the aircraft, what appeared to be the right aileron was found hanging from a tree near the top of the heavily-timbered, densely-vegetated ridge.

Figure 2: P2-ISM right aileron hanging from a tree.

The right aileron separated from the wing during the initial impact with trees. It is likely that the aileron separated when the mass balance became caught in a tree branch when it initially clipped a tree on the ridge.

The aircraft was determined to be in a right wing low attitude at the initial point of impact with a tree. The aircraft's right aileron separated from the wing when it's mass balance impacted and was snagged by a tree protruding from the forest canopy at the top of the ridge. (see figure 2).

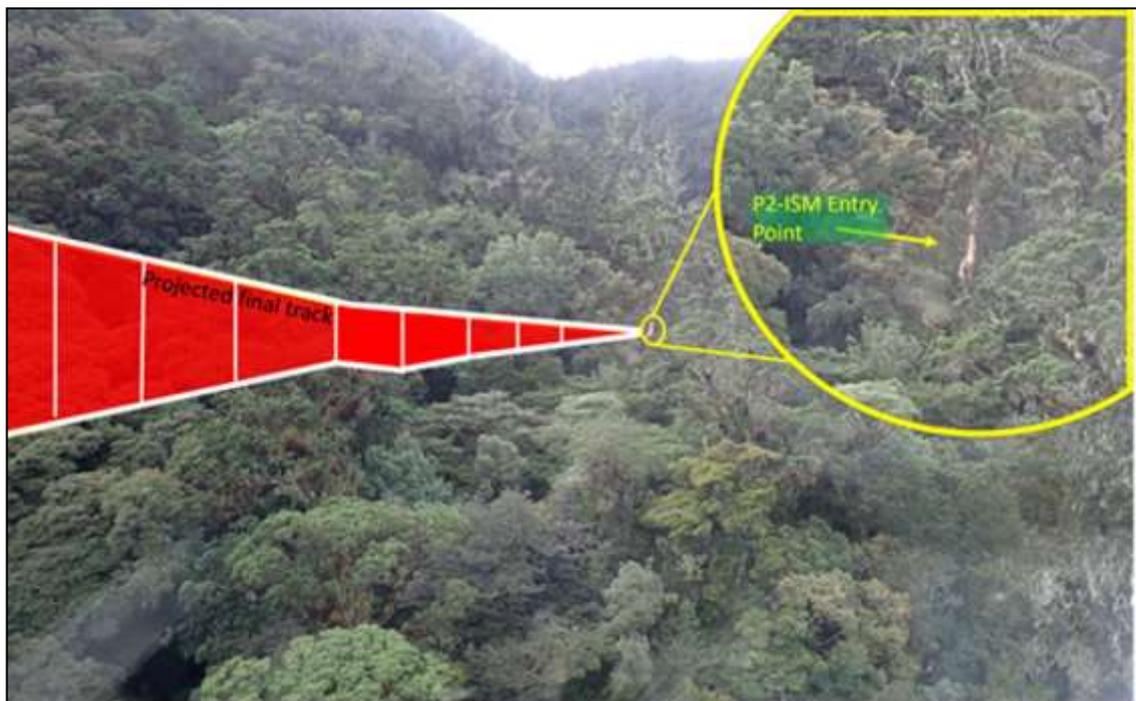
The remainder of the wreckage was found about 130 m from the aileron along the projected track. The aircraft impacted the ground in a steep nose-down, right wing-low attitude

Figure 3: Projected entry point

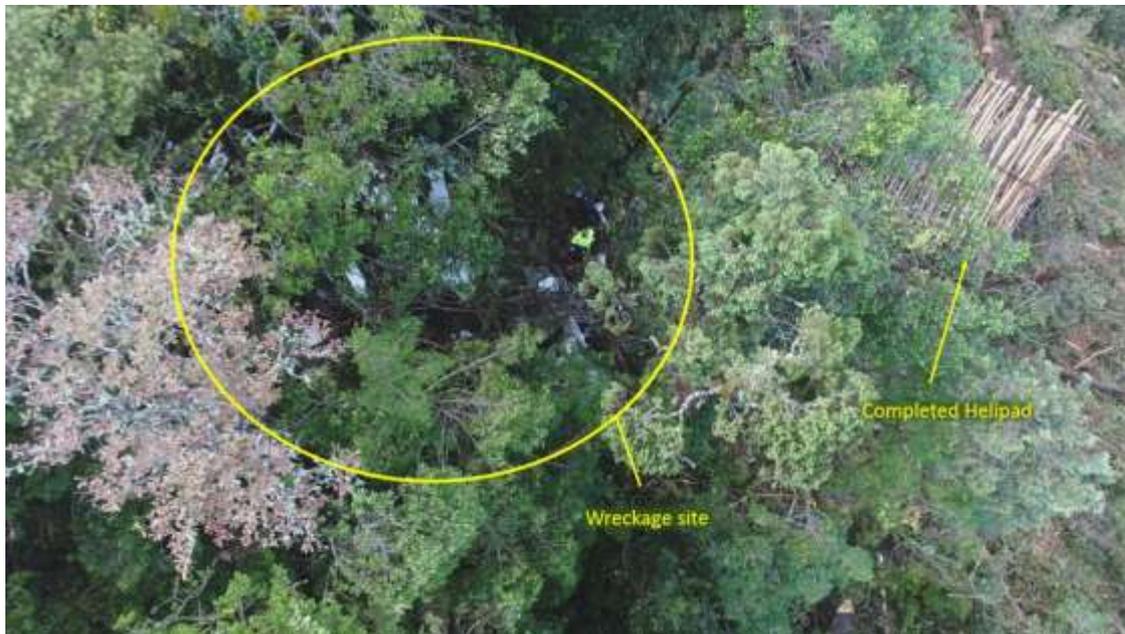
The majority of the aircraft wreckage was contained at the ground impact point. The aircraft was destroyed by impact forces. The pilot, the sole occupant, who initially survived, was reported deceased by the rescue team on 27 December 2017 at 22:10. The pilot had made contact with one of the operator's pilots at 16:15 on 23 December. The pilot's time of death, recorded on the Death Certificate, was 10:40 am local on 24 December. Rescuers felled trees on the steep heavily timbered, densely vegetated slope about 20 metres from the wreckage and constructed a helipad.

Figure 4: Accident site through the canopy (overhead)

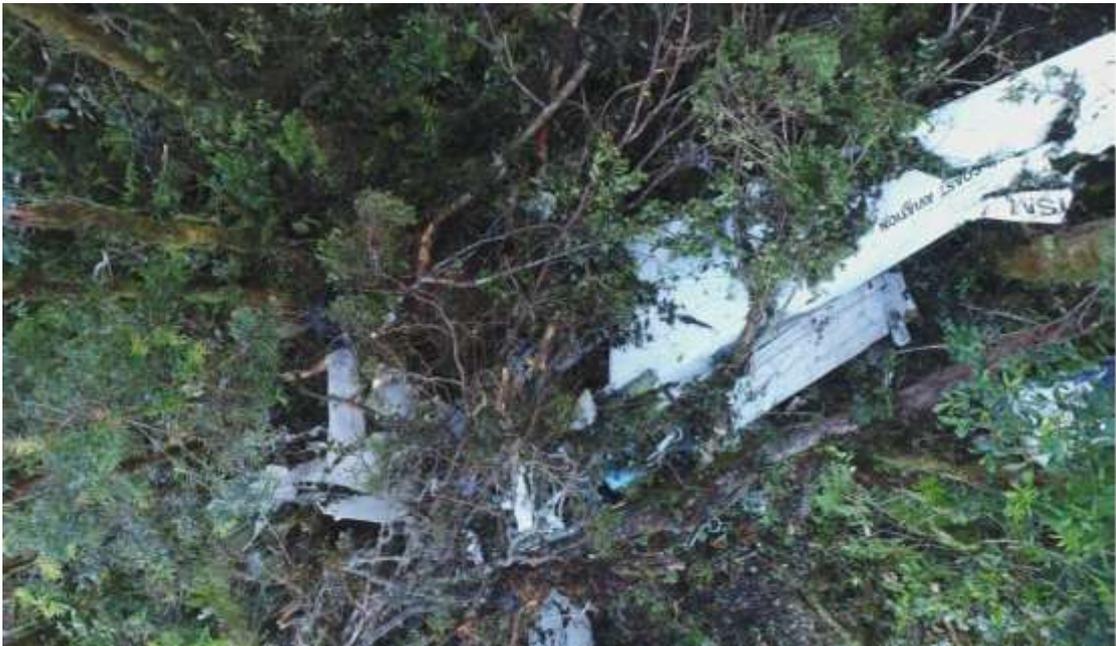
It is likely that the aircraft flew another 130 metres unobstructed (about 3 to 4 seconds) before it impacted another tree and rapidly descended at a steep nose-down attitude, between 55 and 60 degrees, through the forest canopy and impacted the ground. The forest canopy for the most part closed over after the aircraft went through it. Few signs of entry were left, and it was almost impossible to sight the wreckage from the air. The majority of the wreckage was confined to the main impact area. All major parts were accounted for during the site investigation.

**Figure 7: P2-ISM wreckage (overhead view)**

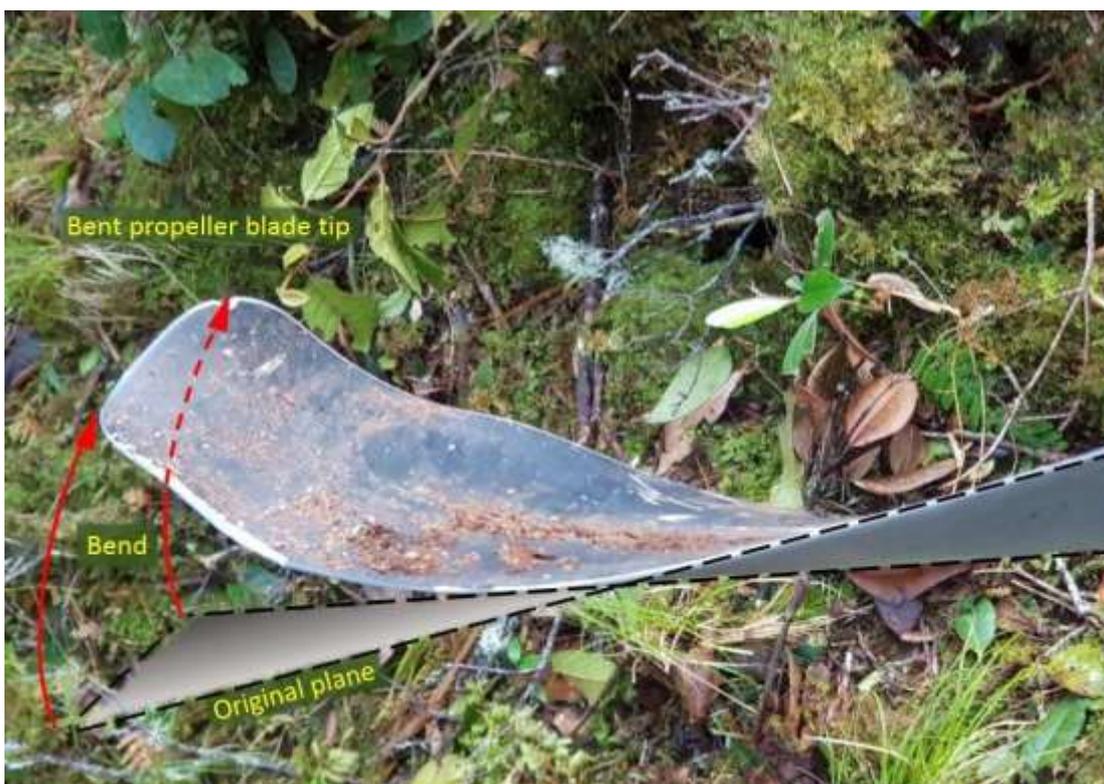
The tip bending on all propeller blades was consistent with the blades impacting solid objects, with the propellers being driven by the engines. The amount of propeller blade bending shows that there was considerable power being produced by the engines at the time of impact. (see figure 8)

**Figure 8: Propeller tip bending**

Propeller blade damage and bending was consistent with the engines producing significant power at impact.

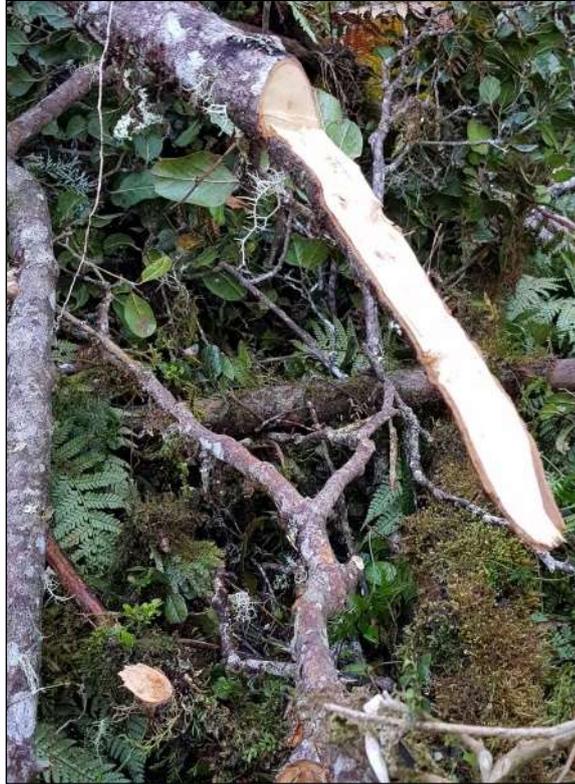
The investigators who travelled to the accident site made use of a drone to capture evidence in video and photographic form. Close-up pictures and video of damage to the trees, including propeller slash marks, was made easy by use of the drone.

**Figure 9: Tree branch showing definitive propeller slash**
