# National Transportation Safety Board Aviation Accident Final Report

<b>Location:</b>	Punta Islita, Costa Rica	<b>Accident Number:</b>	CEN18FA063
<b>Date &amp; Time:</b>	12/31/2017, 1156 CST	<b>Registration:</b>	TI-BEI
<b>Aircraft:</b>	CESSNA 208	<b>Aircraft Damage:</b>	Destroyed
<b>Defining Event:</b>	Aerodynamic stall/spin	<b>Injuries:</b>	12 Fatal
<b>Flight Conducted Under:</b>	Non-U.S., Commercial

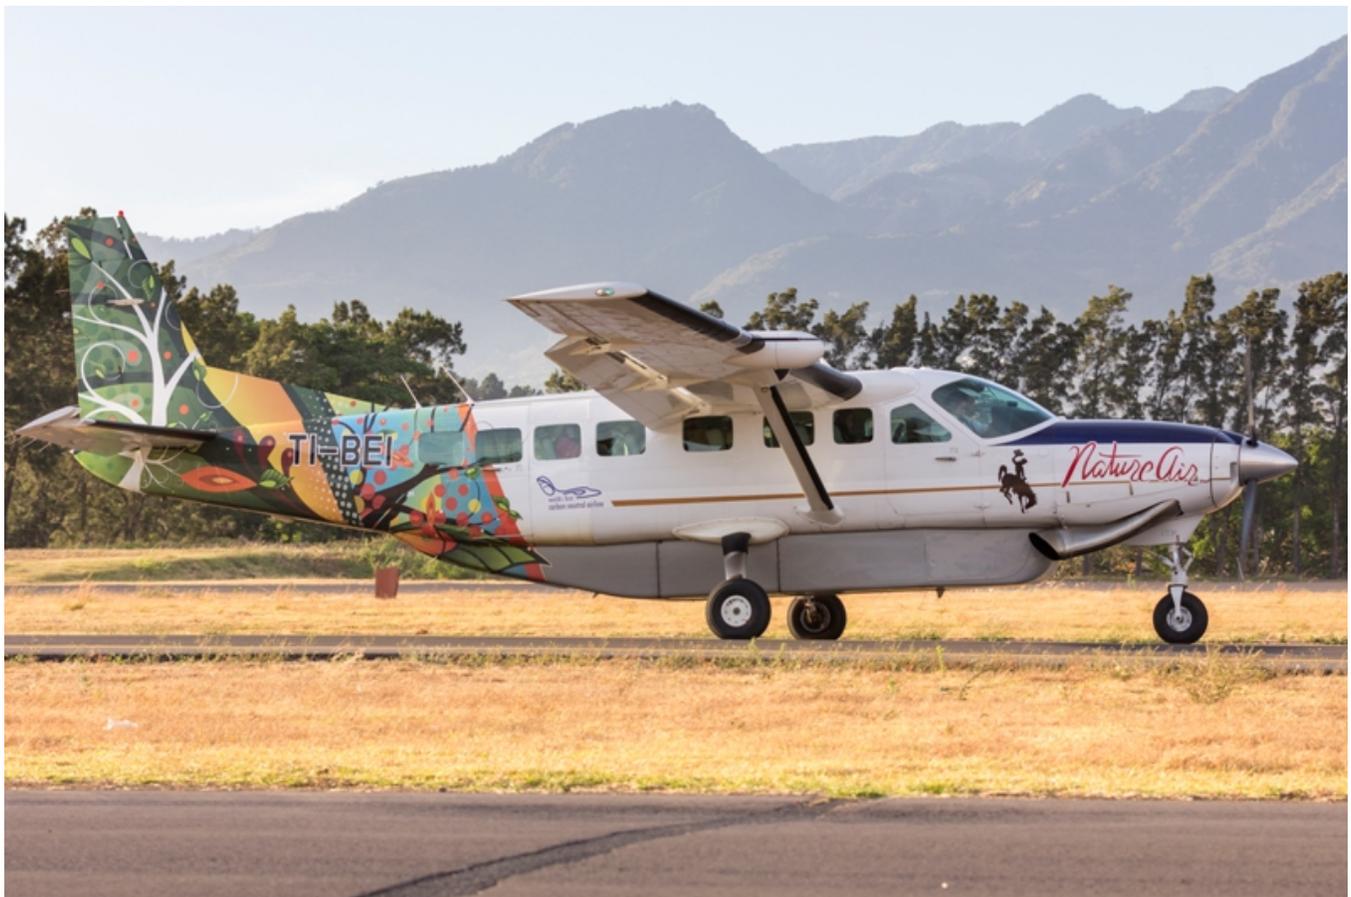
Figure 1 - Photograph of the accident airplane

The accident airplane was a Cessna 208B Caravan, serial number 208B0900 (Figure 1). It was a high-wing, single-turboprop-powered airplane with a fixed, tricycle landing gear configuration. The accident airplane was configured to seat 12 passengers in addition to the 2 flight crewmember seats. The airplane was powered by a 675-horsepower Pratt & Whitney Canada PT6A-114A turboprop engine, serial number PC1545, which drove a constant speed, full-feathering, reversible pitch propeller.

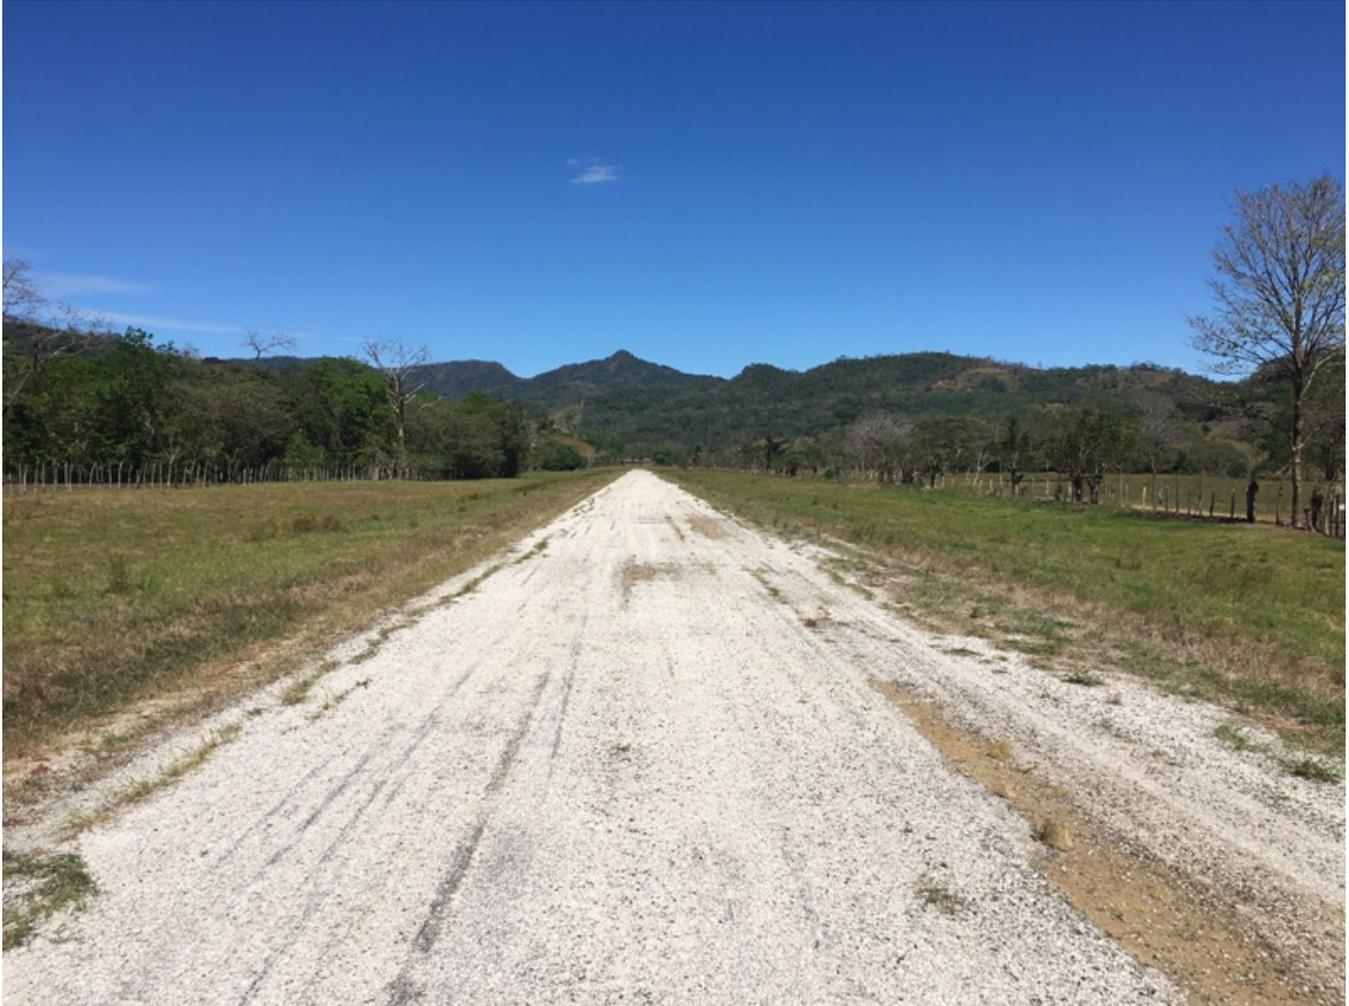
The airport had a single paved runway, runway 3/21, that was about 3,000 ft long and 30 ft wide (Figure 2). The runway pavement was cracked and had vegetation growing through the cracks at the south end. There was a hut located at the northeast end of the runway adjacent to a taxiway turnaround. Other than the turnaround at the north end, there were no other taxiways, requiring airplanes to use the runway for taxi operations. The runway was in a valley with rising terrain on all sides except to the south, which led to the Pacific Ocean. The witness who saw the accident reported that he spoke with the pilots of both airplanes before the flights departed and that the pilots acknowledged the need to use the eastern pass in order to clear terrain when departing from runway 3.

Figure 2 - View from runway looking north toward the mountains

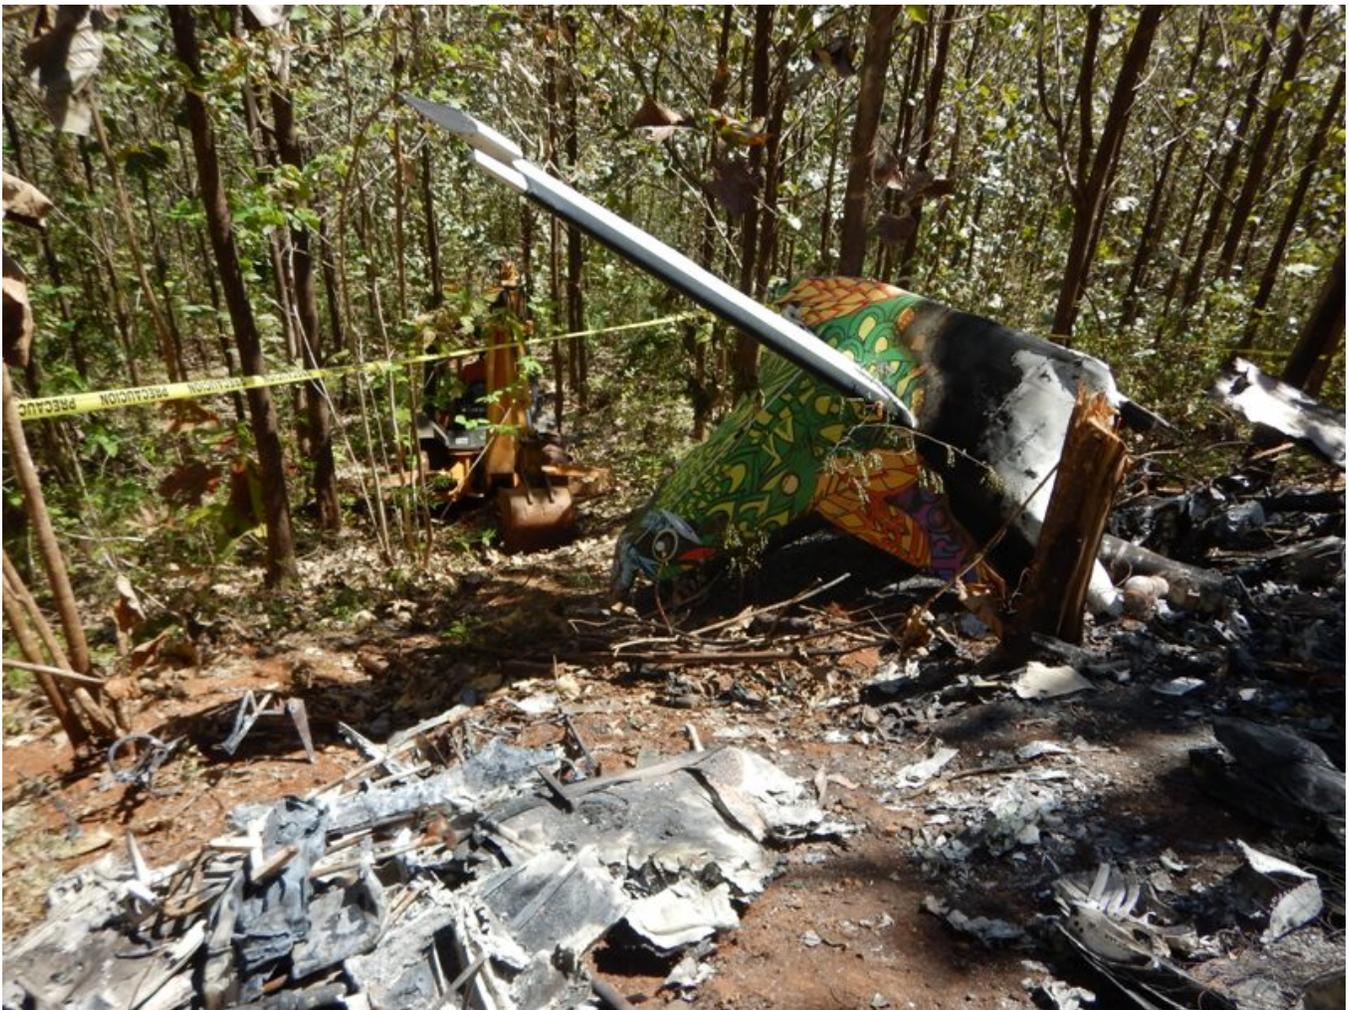
The airplane wreckage was removed from the accident site before NTSB arrival. The accident site was located on a heavily wooded hillside about 0.4 sm northeast (024°) of the departure end of runway 3 at an elevation of 238 ft msl. Several trees and limbs scattered about the accident site, ranging in diameter from a few inches to about 6 inches, displayed relatively clean diagonal cuts consistent with propeller contact. Based on the limited damage to

surrounding tree canopy, the airplane impacted the slope in a near-vertical attitude. There was evidence of a postcrash fire (Figure 3).

Figure 3 - View of the airplane's tail section at the accident site.

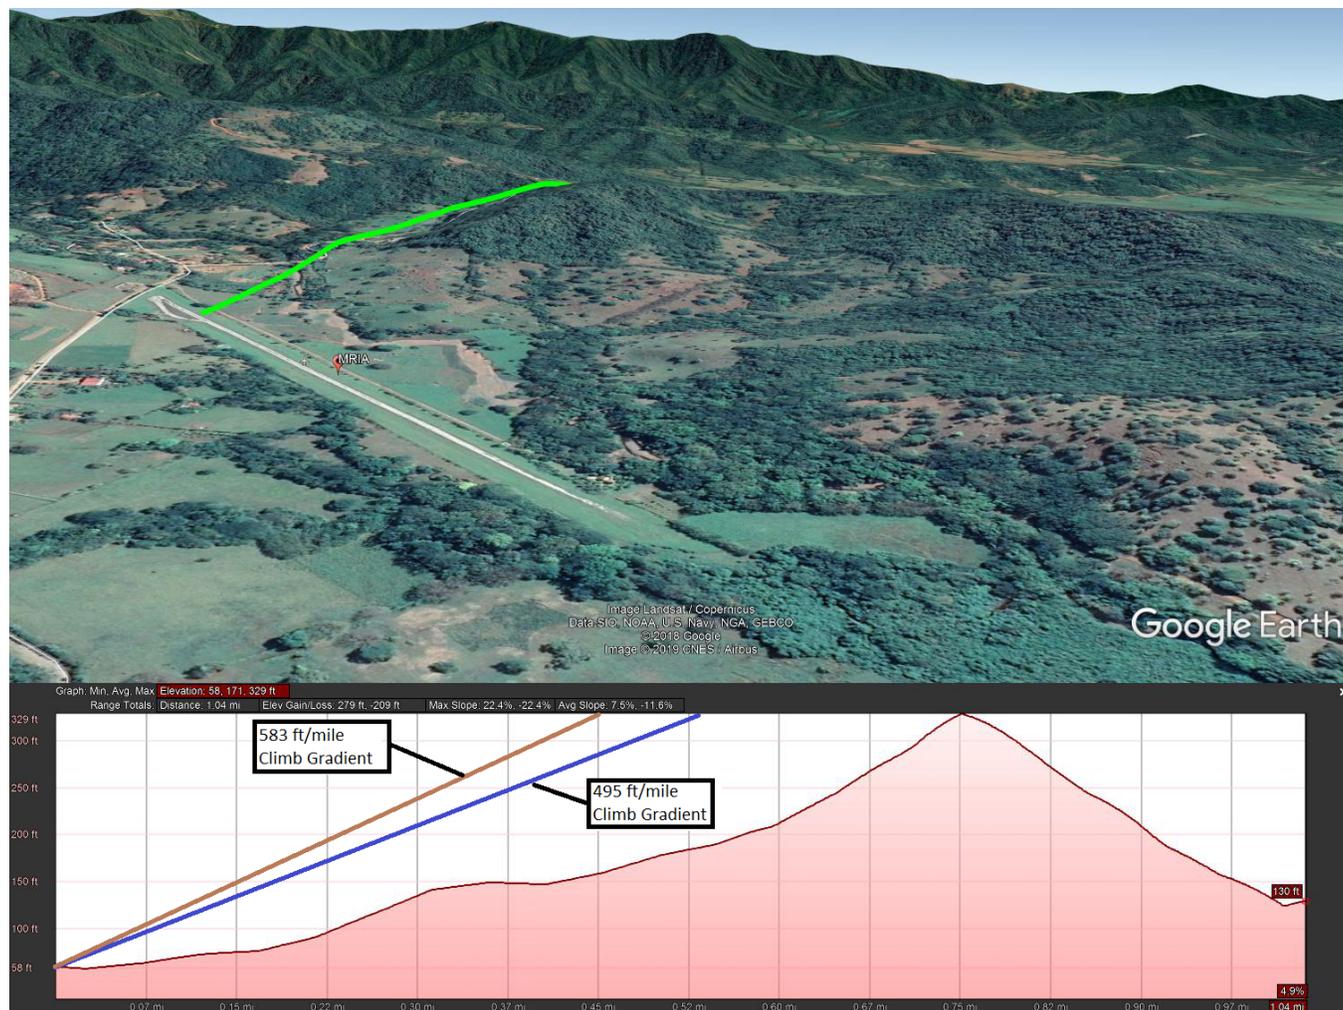
Three different takeoff scenarios were examined to determine if the airplane had sufficient climb performance to clear the terrain surrounding the airport. The first scenario (Figure 4) examined a takeoff using the approximate ground path used by the previous airplane. The calculations showed that the airplane would have had sufficient climb performance along this route, with a minimum climb gradient margin of 40% using  $0^\circ$  flap at the maximum allowable weight, and a 65% margin using  $20^\circ$  flap and the minimum fuel weight. A positive margin

indicates that the calculated climb performance exceeded the minimum needed to clear terrain. A 0% margin indicates that the airplane would have cleared terrain with no excess altitude gained. A negative margin indicates that the calculated climb performance was not sufficient to clear the terrain.

Figure 4 – Departure scenario 1 depicting the ground path of the previous airplane and the possible climb performance of the accident airplane overlaid on an elevation profile of the path.

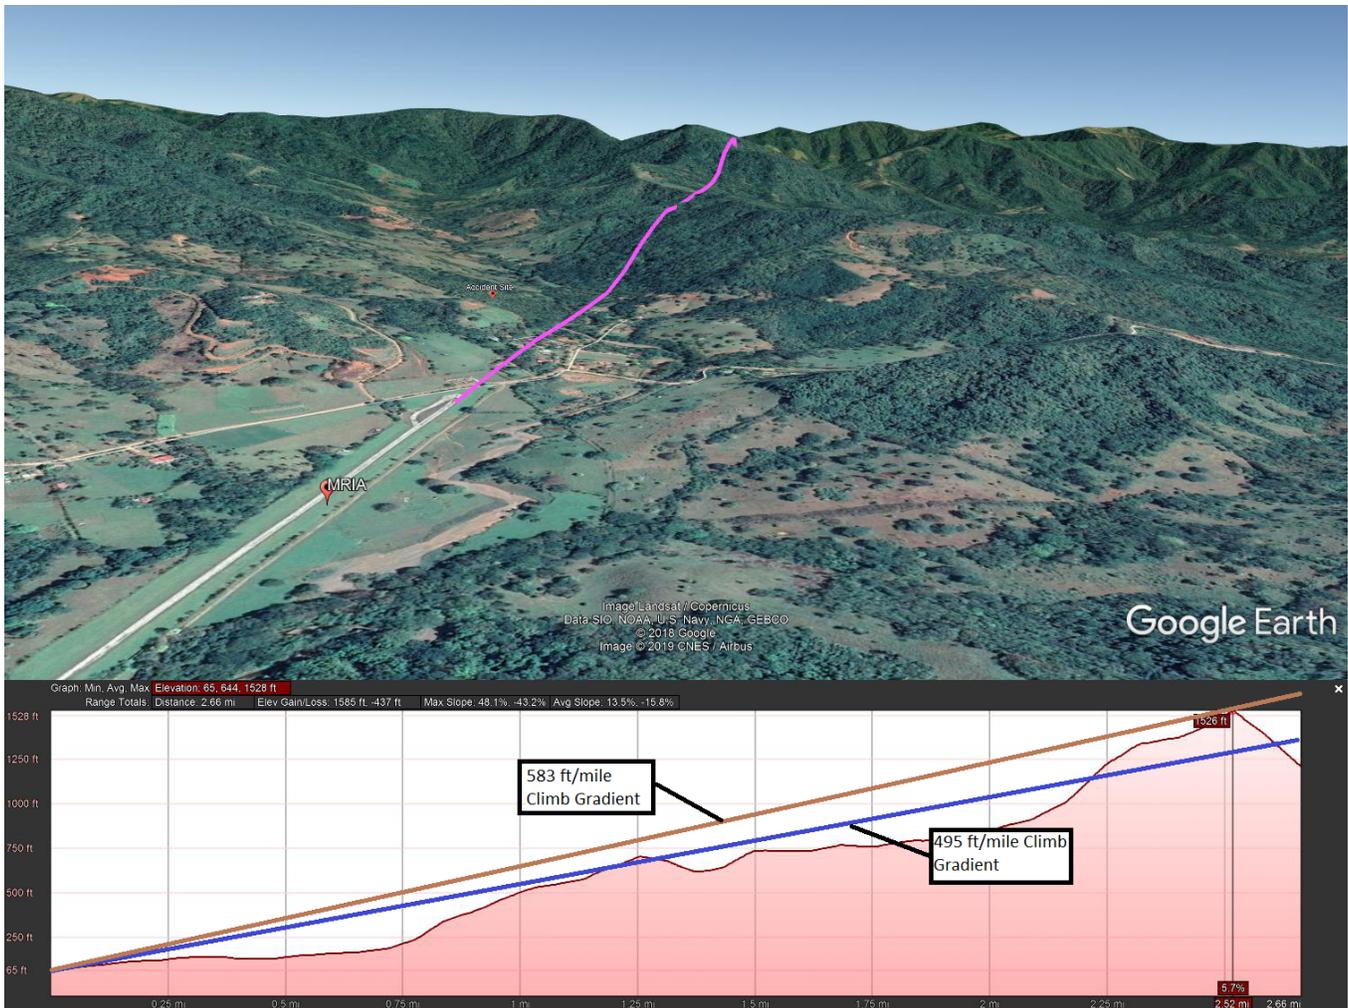
The second scenario was a straight-out departure maintaining runway heading. Calculations showed that the airplane may not have had sufficient climb performance to clear the mountains using this route. The climb gradient margin at the maximum allowable weight and 0° flap setting was -14%, and at the minimum fuel weight using 20° flap setting was 1%.

Figure 5 - Departure scenario 2 showing a takeoff path using a straight-out departure from runway 3, and the possible climb performance of the accident airplane overlaid on an elevation profile of the path.

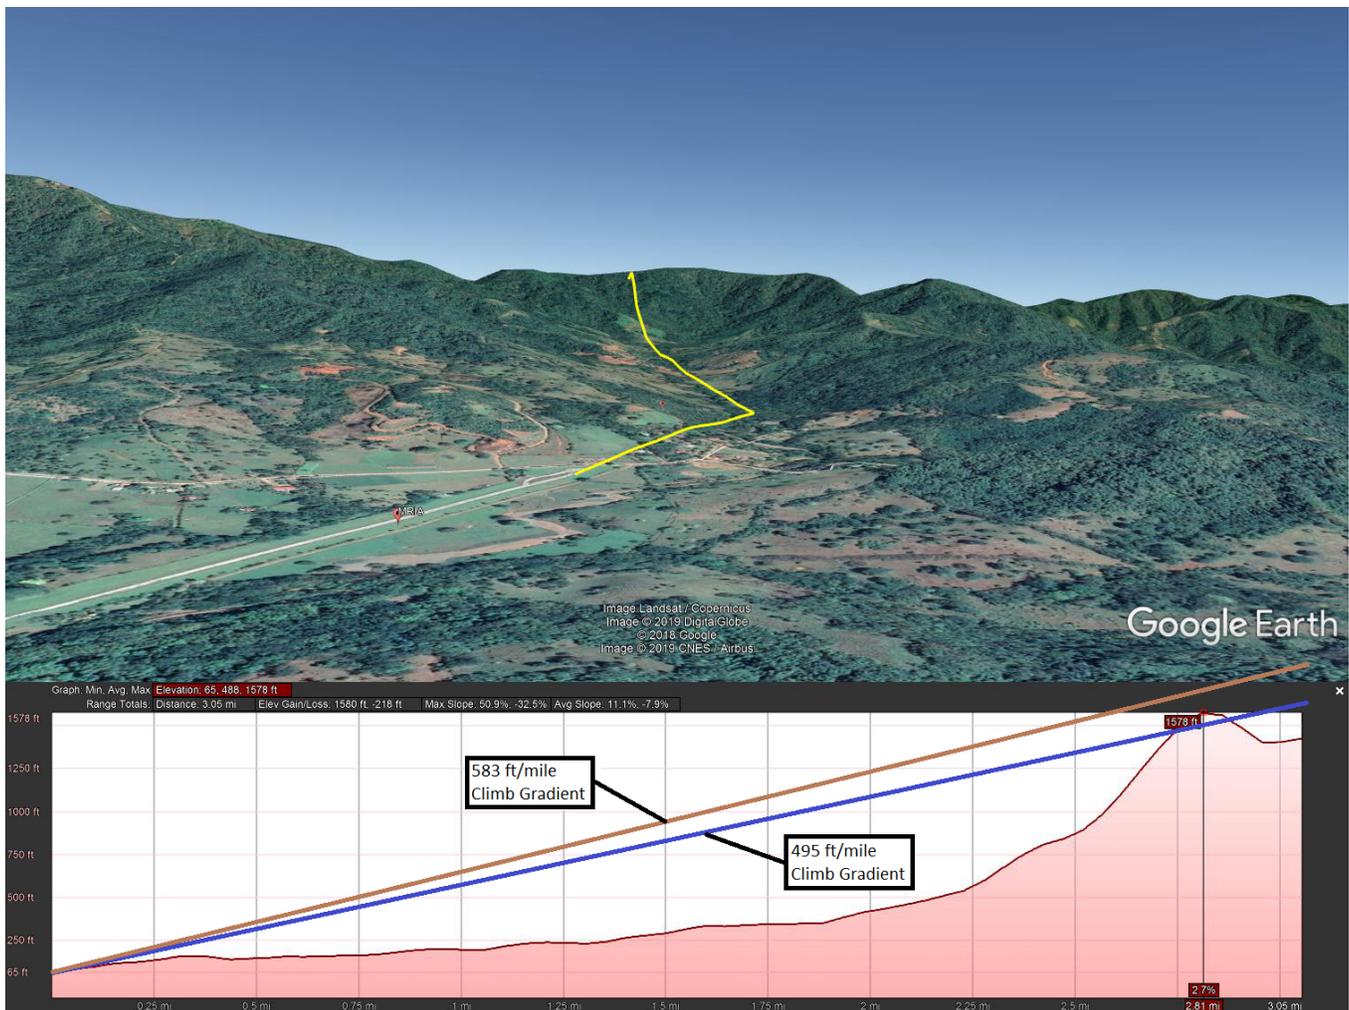
The final scenario was a path that turned left after takeoff, following the valley floor (Figure 6). Calculations showed that the airplane may not have had sufficient climb gradient performance to clear the mountains using this path. The climb gradient margin at the maximum allowable weight and 0° flap setting was -8%, and at the minimum fuel weight using 20° flap setting was 9%.

Figure 6 – Departure scenario 3 showing a takeoff from runway 3 over the valley floor to the north of the airport, and the possible climb performance of the accident airplane overlaid on an elevation profile of the path.

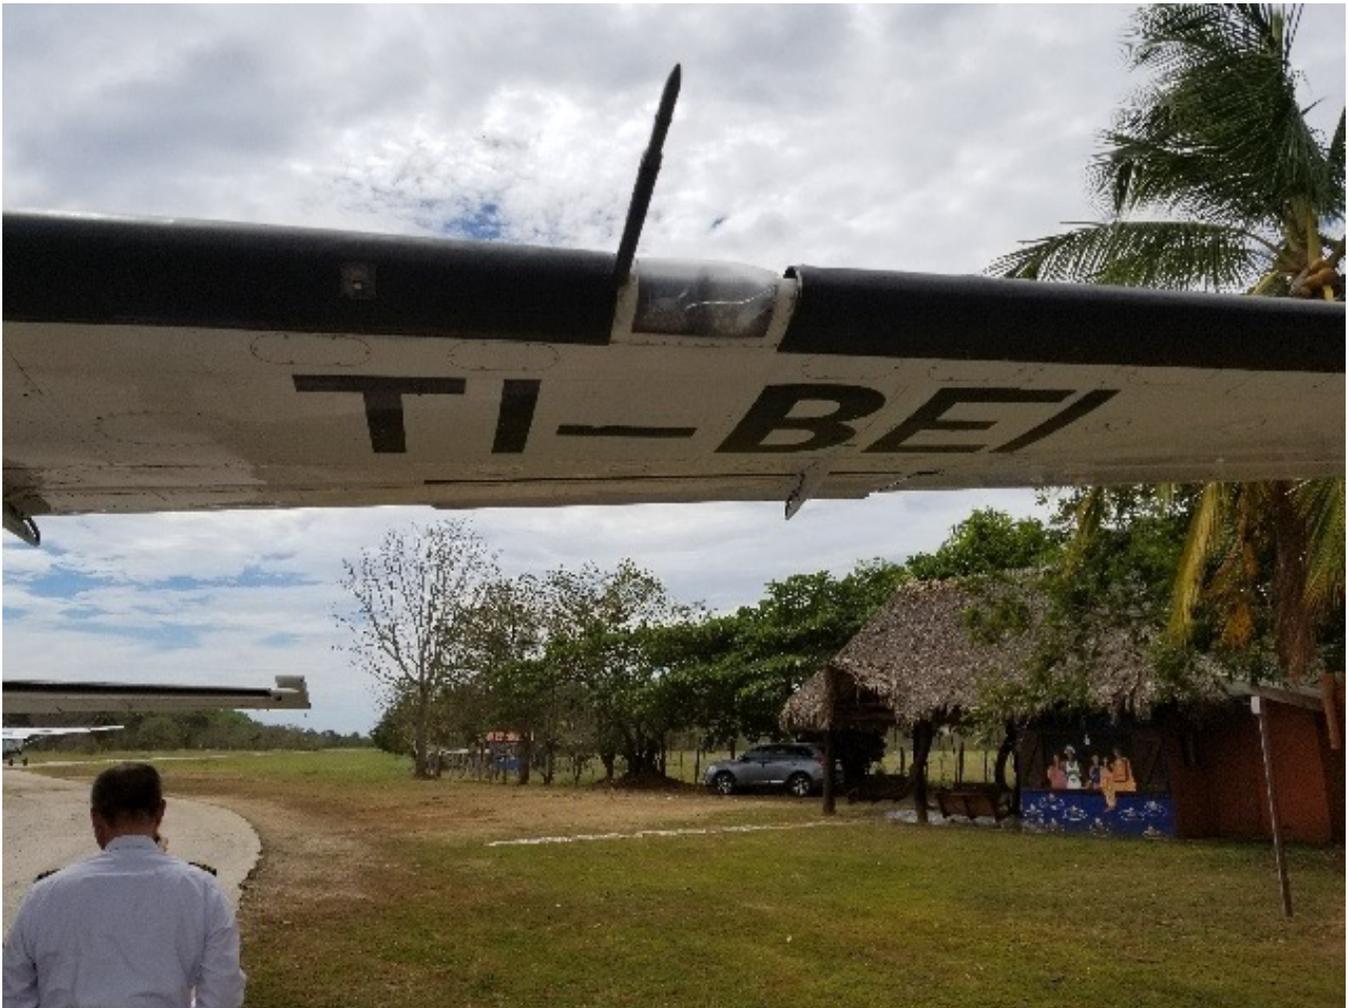
A friend of one of the passengers reported that he had received a text message from the passenger before the flight indicating that the airplane had been involved in a bird strike during its arrival to MRIA. The passenger's friend provided the text messages along with the pictures showing the damage to the airplane. The photographs showed that wing's left leading edge had incurred localized damage near the landing light. The landing light lens was cracked, and the leading edge appeared to display some deformation adjacent to the landing light. The damaged area was located ahead of the landing flaps and inboard of the aileron. Due to the localized extent of the damage, the flight characteristics and controllability of the airplane would not have been adversely affected.

The witness reported that the flight crew was aware of the damage and that the captain had contacted the operator's maintenance facility to discuss the damage. He stated that the captain

waited for a release from maintenance before proceeding with the flight and that this was the reason the accident airplane left about 15 minutes after the first airplane.

Figure 7 - Photograph showing the bird strike damage to the leading edge of the left wing.
