# Aviation Short Investigation Final Report

Runway Excursion

EMB-110, C6-MIC

**AO-18-000002**

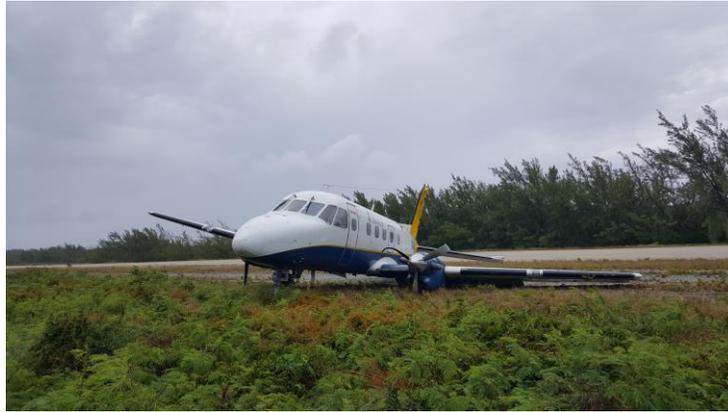
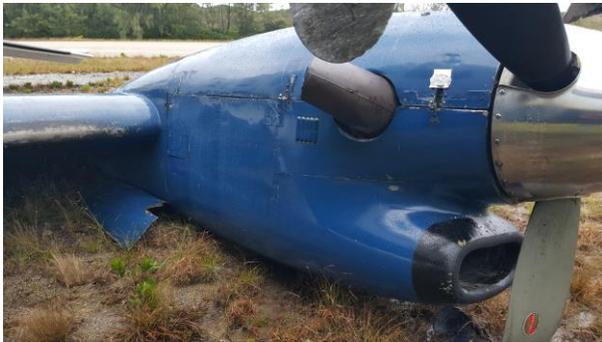
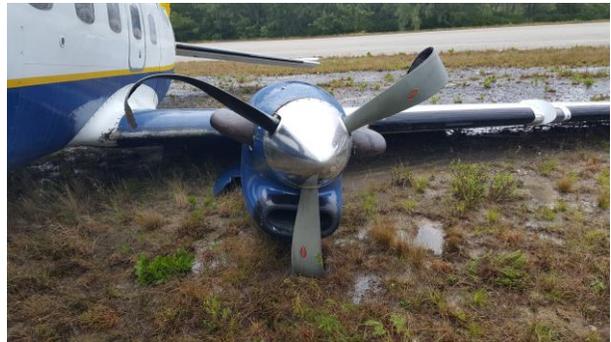
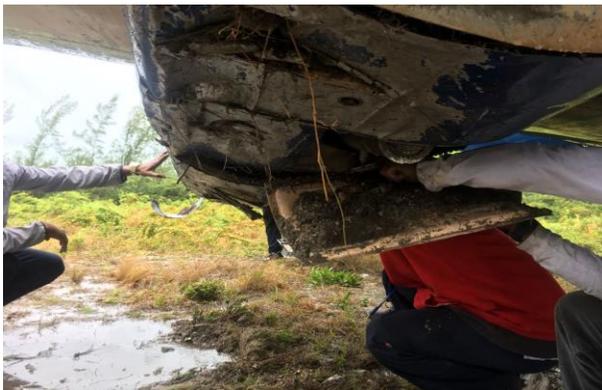
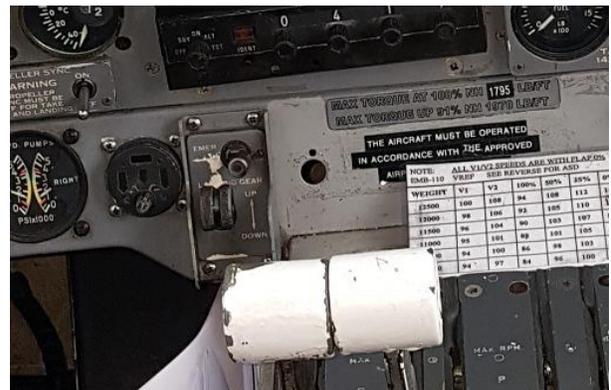
The aircraft involved was an Embraer Bandeirante (EMB-110), 15 passenger aircraft, registration C6-MIC, registered to Pineapple Air Limited, (a Bahamas Air Operator Certificate (AOC) holder), operating as Pineapple Air flight 978. Information received was that at approximately 8:05 pm, after landing, the left main landing gear of the aircraft collapsed, resulting in a runway excursion to the left side of runway 33.

The investigation team traveled to the scene of the accident on 10 January 2018 and during the onsite documentation of the aircraft and the flight deck, noted the landing gear selector switch located in the “UP” position. Consultation with the operator’s maintenance personnel and the aircraft manufacturer has determined, based on the systems operation, that if the landing gear switch is placed in the “UP” position and the “gear contact micro-switch” on either landing gear is “contaminated with dirt, water or other contaminants, or if the switch is “shorted out” for whatever reason, it is possible that the gear may not retract when commanded by the selection of the gear switch. In this instance, it is possible that the gear position lights may still indicate “3-green lights” (which normally indicates the gear as being “down and locked”) despite the gear selector handle being selected to the “UP” position. However, once you land or the contaminant is removed or the “system short” is corrected, or no longer exists, there is a possibility that the gear could collapse (if the gear selector switch is in the “UP” position, as was the case).
