Aircraft Accident Investigation Board

Final Investigation Report

State File Number: A961127EPFQF
Type of Occurrence: Accident
Date of Occurrence: 16 Feb 2018
Place of Occurrence: Mashhad Airport, I.R Iran
Aircraft Type: Fokker 100
Registration: EP-FQF
Operator: Qeshm Airlines

Date of Issue: 24 Dec 2018

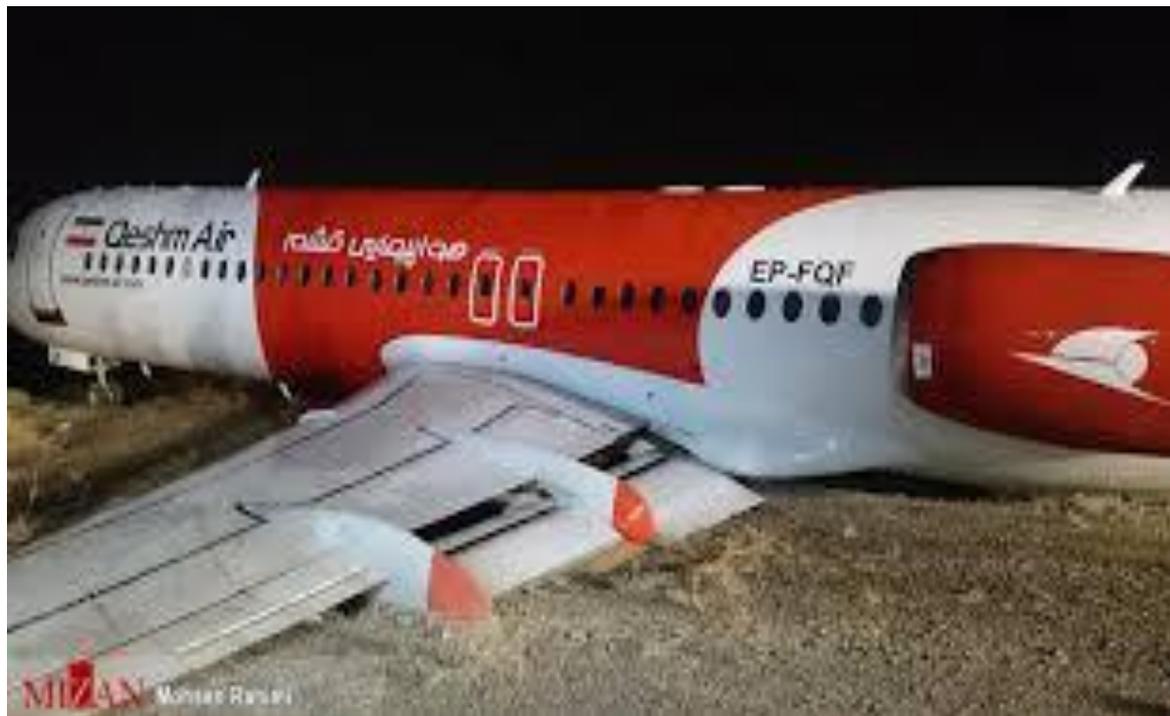
Figure 1 -Accident Site

The Aircraft was substantially damaged as a result of scratching to the ground. The damaged areas are summarized as:

- The right-hand landing gear wheels
- The left wing trailing edge, especially flap area was damaged.
- The lower surface of left wing by scratching on the ground
- LH main L/G wheel bay doors were damaged

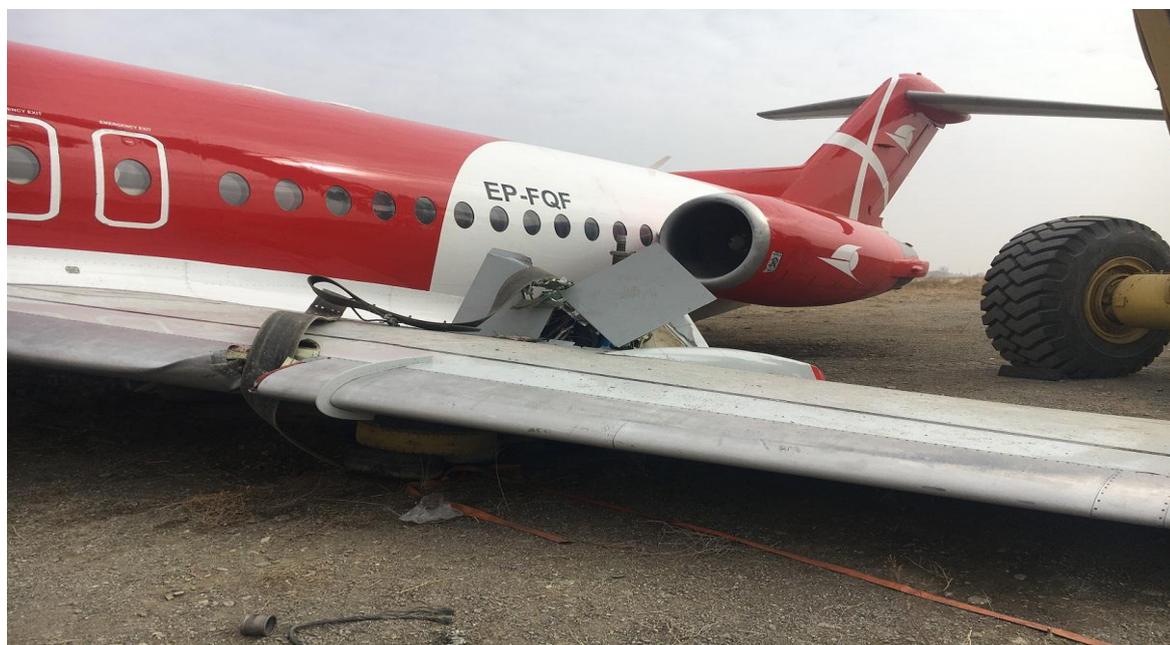
Figure 2 -Unsuccessful recover of Aircraft

During recovery of the wreckage and transferring from the accident site; the left wing structure was severely damaged during operation of weak crane and security belts.

Following the rescue team operation, they tried to remove the aircraft from the area between runway 31L & 31R. They tried to lift the left wing with crane belt and put lifting jack under jack point of left wing but the crane and shoulder belts couldn't sustain the aircraft weight. The belt was ruptured suddenly and the aircraft fell down to the ground while the jack was not in suitable position and jack point. Subsequently the left wing structure was damaged by lifting jack.

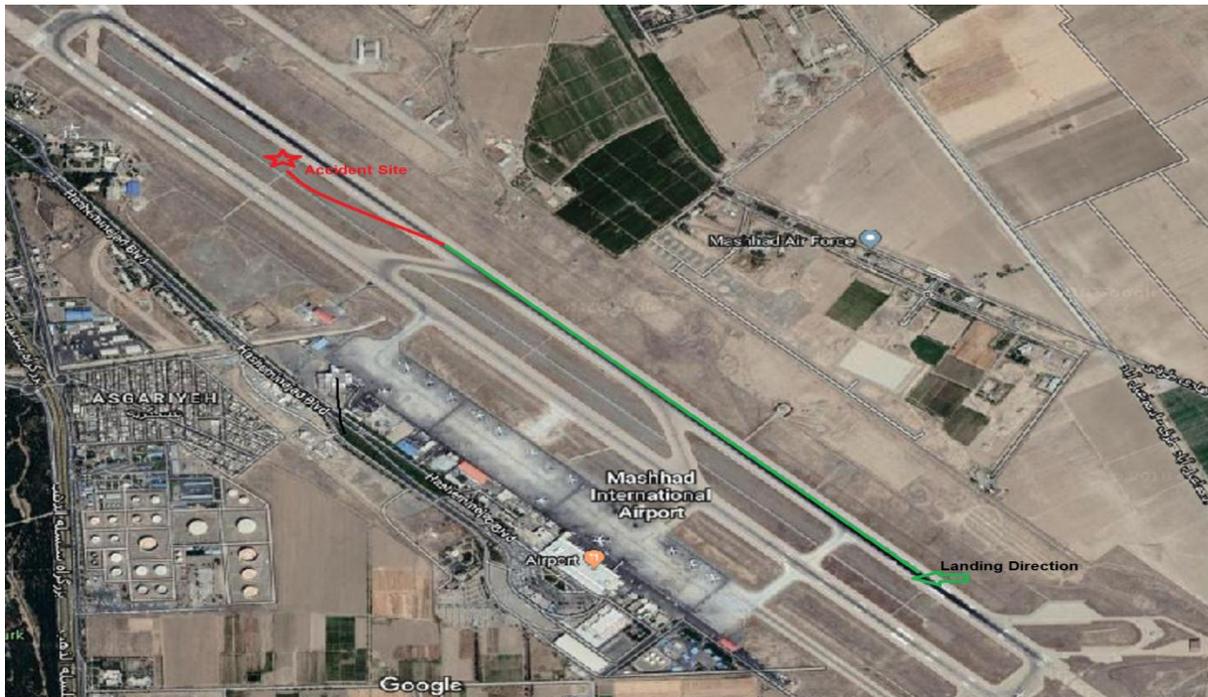
Figure 3- Position of Accident Site at Aerodrome

The accident was occurred on Runway 31R after passing by taxiway G.

First the nose landing gear wheels of the aircraft skidded on runway shoulder and entered the area between runway 31L & 31R on soil area and subsequently the left wing has come down to the ground, and there was some damages on left wing trailing edge and related flap and aileron.

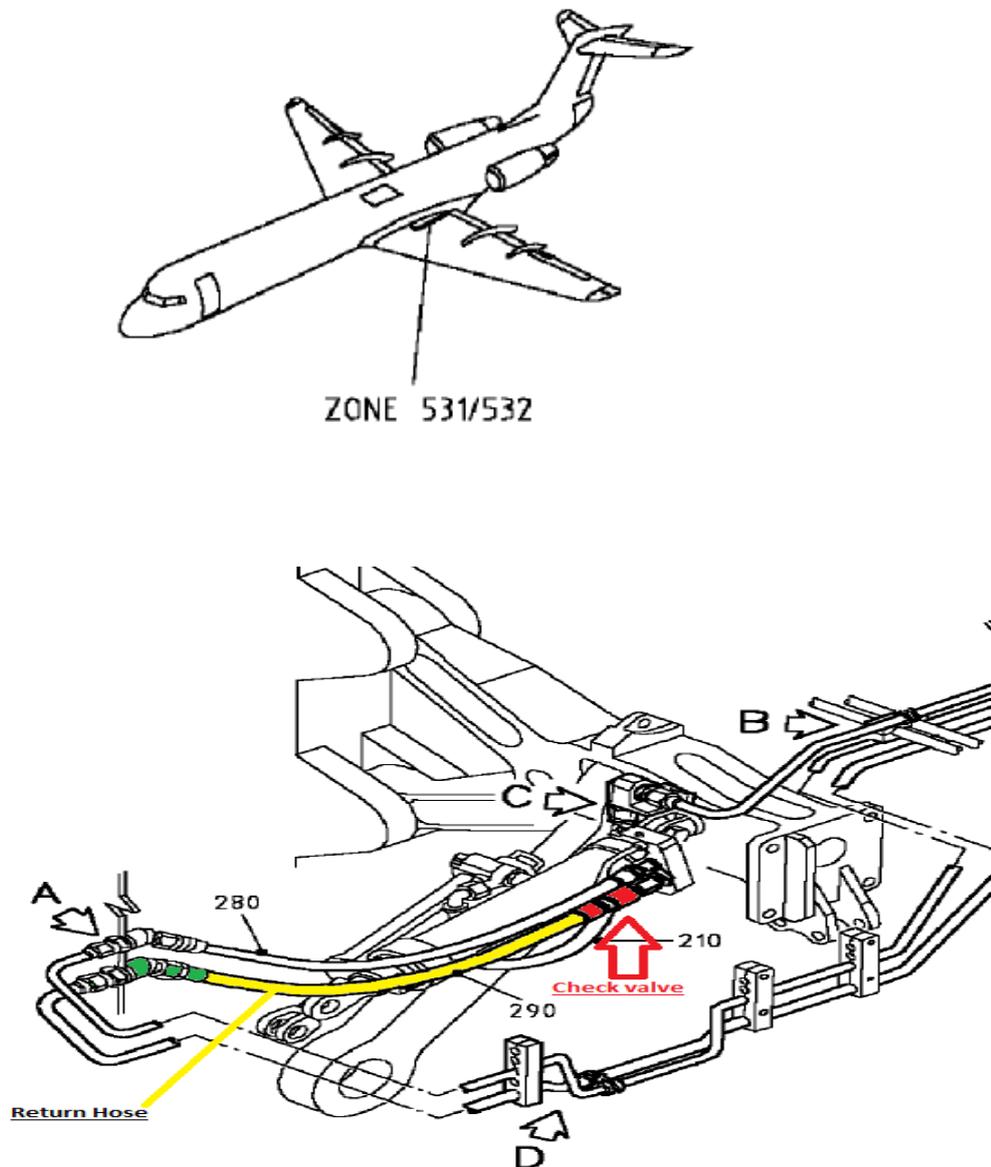
Figure 4- Position of Failed Check Valve

On the zone 531/532 the research was continued and relative hose and tubes were inspected. There was some debris on up pressure AND/OR Return hose. The restrictor Check Valve ASSY P/N; 99240/6F2876 from return line also has been focused on. The hydraulic interval screen filter of the restrictor on system side was damaged so the check valve was removed from its position on the system. The check valve was opened and inspection showed the sign of very tiny foreign contamination (similar to Media Blasting particles).

The screen filter on the check valve was damaged by passing some tiny particles were congested at screen and blocked the nozzle; consequently the left

landing gear failed to open both in normal mode and in manual mode release by gravity (Alternate Mode).

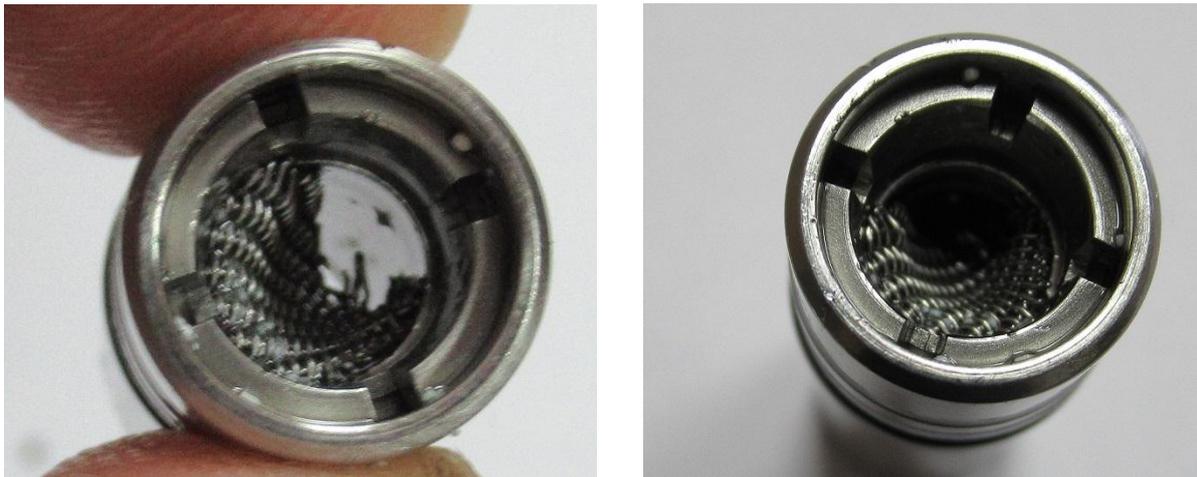
Figure 5- The L/H restrictor screen filter (HYD restrictor check valve)

The damaged screen filter of Restrictor was on Hydraulic side and it seems the debris had been present in the hydraulic lines from the hydraulic system and was not on the return line of the retraction actuator

Following wreckage removal and displacing the aircraft to the safe place, due to the nature of accident and abnormal displacement of hydraulic linkages on left hand landing gear; the up pressure and /return, hosing restrictor check valve was opened and there was found that the inlet screen filter 3000psi (gear up

selection) on restrictor check valve was ruptured; therefore this component was dispatched to Tehran for further investigations.

The screen filter near hydraulic restrictor check valve was damaged by reflected force of Pollution and sediment available in the hydraulic system between and caused blockage the nozzle downstream to down lock LH landing gear mechanism.

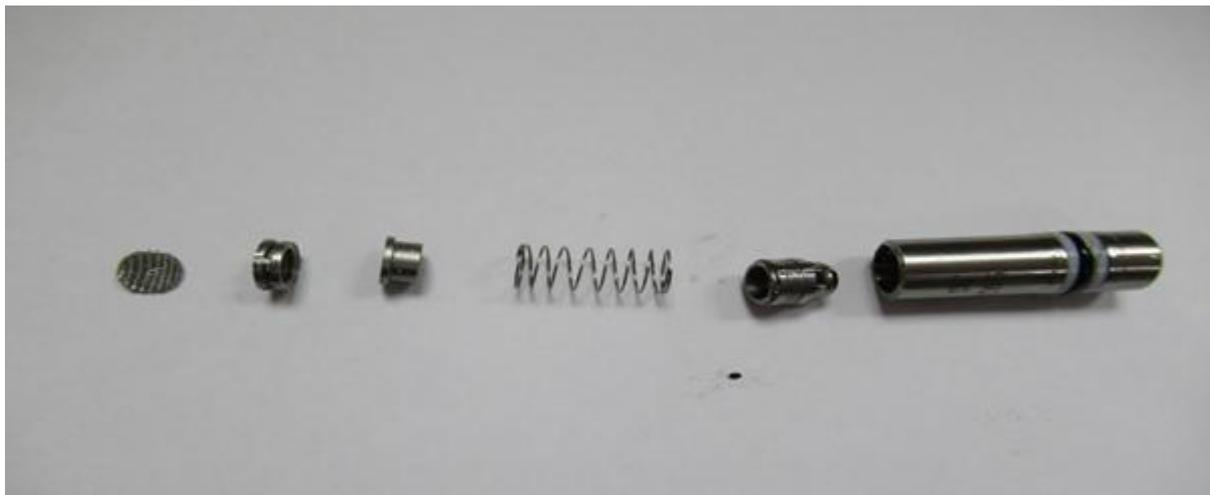
Figure 6- The Opened L/H HYD Restrictor Check Valve

The polluted restrictor valve was opened and white small particles were observed also a black small particle had blocked the central orifice. The pollution seemed to be the same as Plastic media blasting particles which are used for removing paint form the aluminum & composite aircraft skins. So sample of Blasting Composition Material was provided. The polluted restrictor valve and sample of material were sent to the laboratory and microscopic evaluation was made.

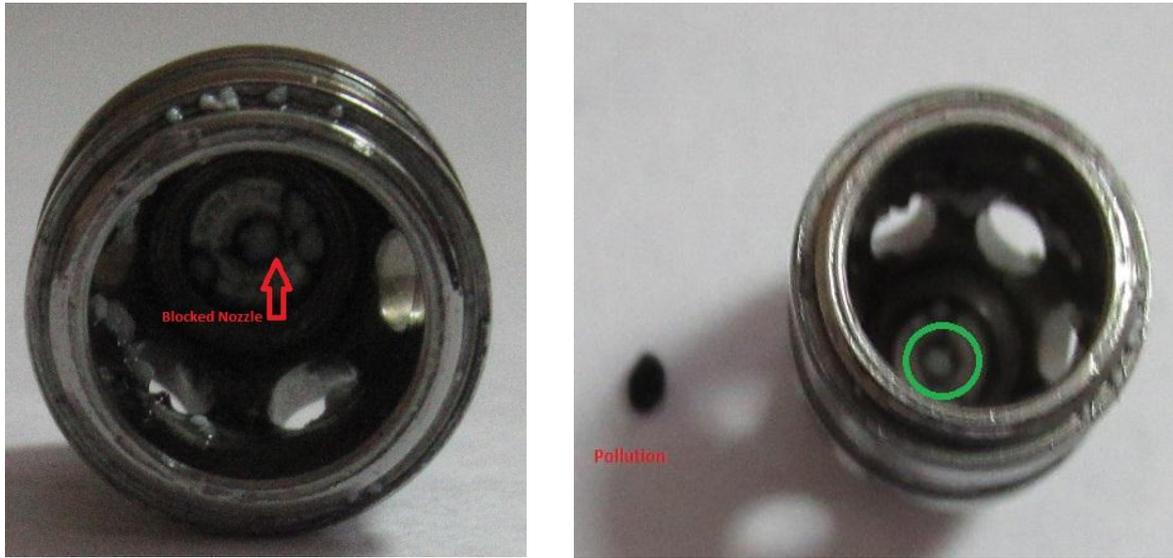
Figure 7- The Blocked Restrictor Check Valve

The evidences on the “Check Valve” showed that the orifice related to Landing Gear Extension was blocked by a small part of pollution but the orifices related to Landing Gear Retraction were not blocked from any pollution but pollution was seen internally.

During the investigation, the evidences proved that the main reason for filter rupture was accumulation of debris at extremity of filter entrance which blocked the orifice and caused back pressure, consequently has ruptured the filter (3000psi), which caused foreign contamination entered into the restrictor.

- 96FQF4 Review the design of the filtering hydraulic system at the landing gear retraction of the Fokker F.28 Mark 0100 and require operators to modify their airplanes and procedures to prevent system failure by foreign object contamination

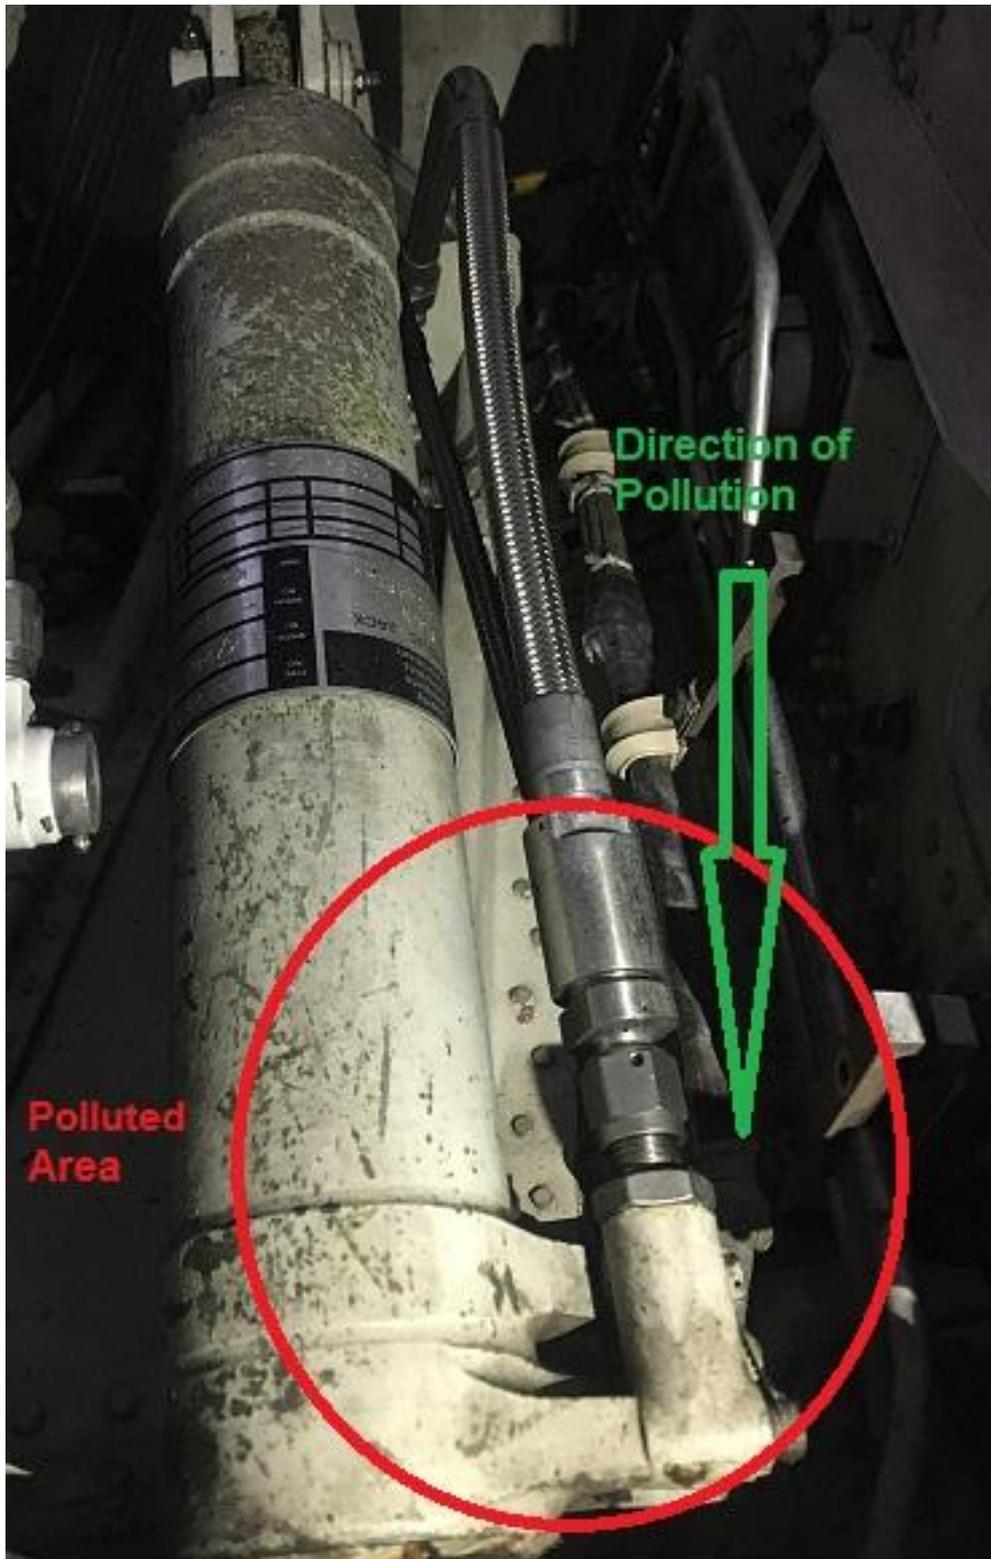
Figure 10- Retract actuator of left main landing gear

The investigation team continued the research in the hydraulic system from other components of the return line and did not find any abnormalities in the system so it is confirmed that only the pollution was available in the last **“Return Hose”** and export port of L/G actuator with P/N; 114220002 , S/N;DH-0028-92.

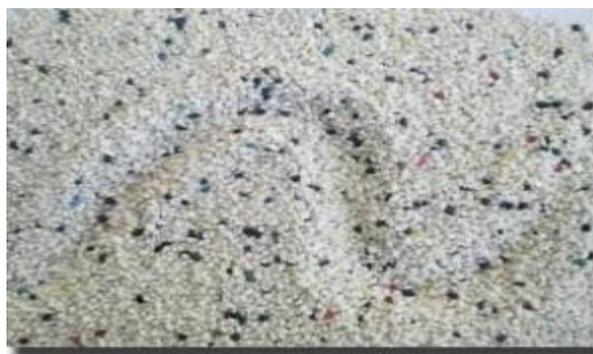
Figure 12-Sample of Media Blasting Material

Due to low quantity of pollution, the material evaluation was not done, but macroscopic images showed similarity with the sample of Blasting composition material and other metal white particles but the black particle which caused blockage of restrictor was not same as sample of Blasting materials. The black pollution was expected as foreign contamination in the hydraulic system.

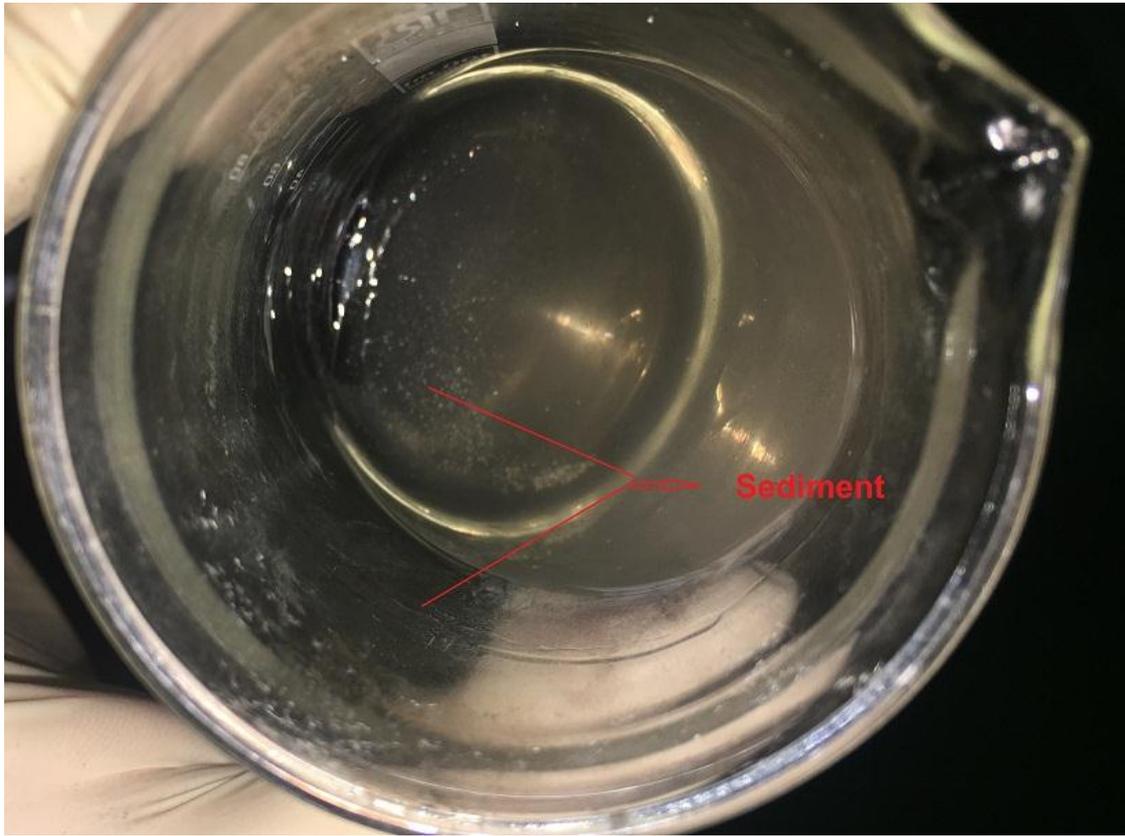
Figure 15- Cylinder of Retracting Actuator

The retract actuator of left main landing gear was removed from the aircraft and was opened and analyzed in "Iran Air" hydraulic shop based on its CMM. There was some white pollution as sediment in the hollow cylinder which was seen on the check valve. All internal rings and spacer were normal without any cut in shapes so the black particle was not suspected to have originated from cylinder parts accordingly.

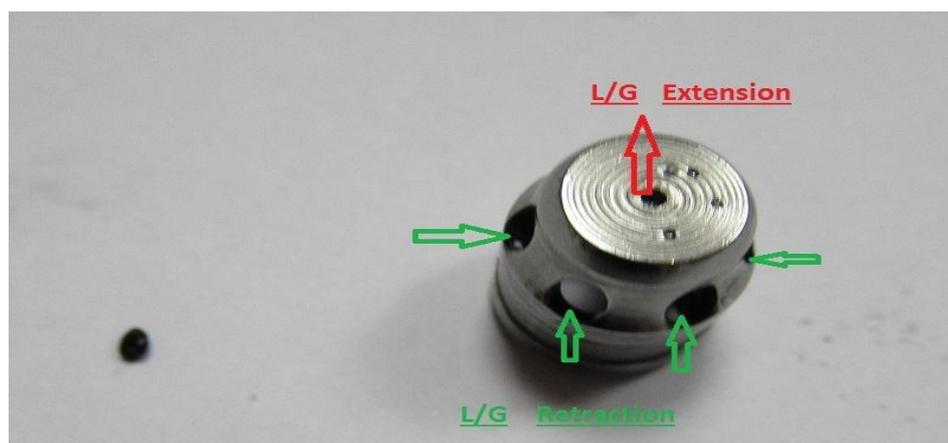
Figure 17- Hydraulic Flow Path from Restrictor

The design configuration of internal section of restrictor is in such a manner that in 3000psi, (gear up selection) the hydraulic fluid flows from the 7 orifices simultaneously and causes landing gear retraction in fastest way, but in gear down selection, the main gear extension is delayed as a result of restrictor which is assisted by spring pressure and make slower movement of main gear at extension.

In the Retraction mode, the hydraulic fluid passage in restrictor is done via 7 wide orifices and foreign contamination and Hydraulic sediment can flow easily from them. In extension mode, the interval hydraulic flows from a small orifice in mid-section of restrictor and the foreign contamination blocked the hydraulic

flow between restrictor and main gear actuator at the time of accident and consequently the left main landing gear failed to open completely. The attempts of pilot to recycle landing gears could not change the condition of restrictor and force out the foreign contamination from mid hole.
