Aircraft Accident Investigation Board

Final Report

State File Number: A961129EPATS
Type of Occurrence: Accident
Date of Occurrence: Feb 18th 2018
Place of Occurrence: Near Yasouj Airport
IR of IRAN
Aircraft Type: ATR 72-212
Registration: EP-ATS

Date of Issue: 15 Jun 2020

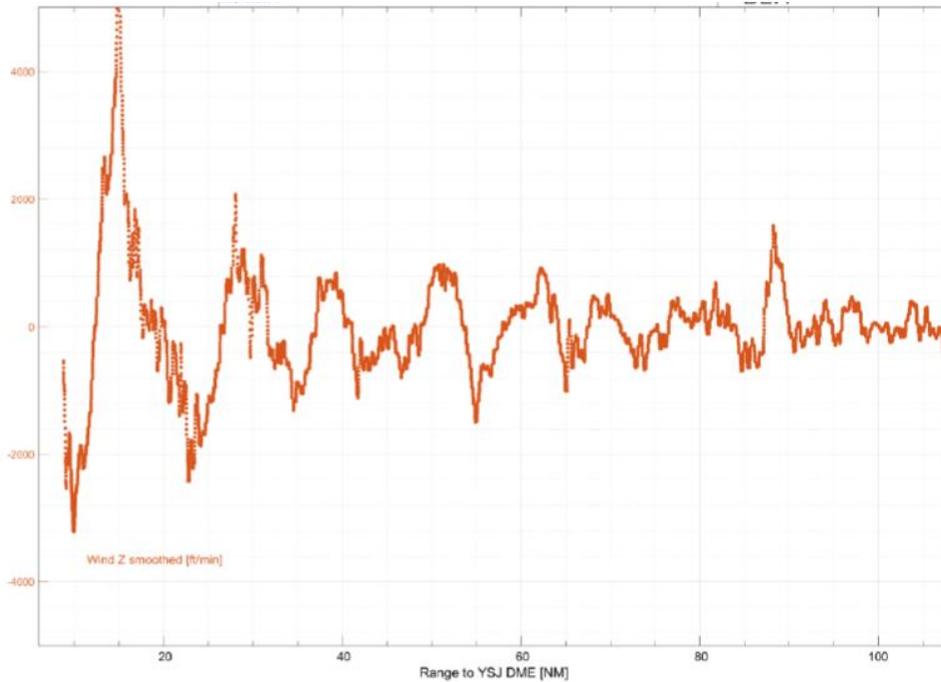
Figure No. 6 calculated Vertical Wind

Based on FDR Analysis by BEA, drawing the computed vertical wind values versus the range to the DME of Yasouj really shows the oscillations of the vertical wind (Figure 6) with a long range period during the accident flight.

It was estimated that the accident site had moderate turbulences with conditions moderate up to locally severe icing. There were unstable conditions and stormy in the accident site and it was covered by clouds. The rebuilt SIGWX type chart at the time of accident, computed after the event with global forecast models and available information from daily measurements, was received on 03/03/2018 from METEO France and is provided in Fig.7.

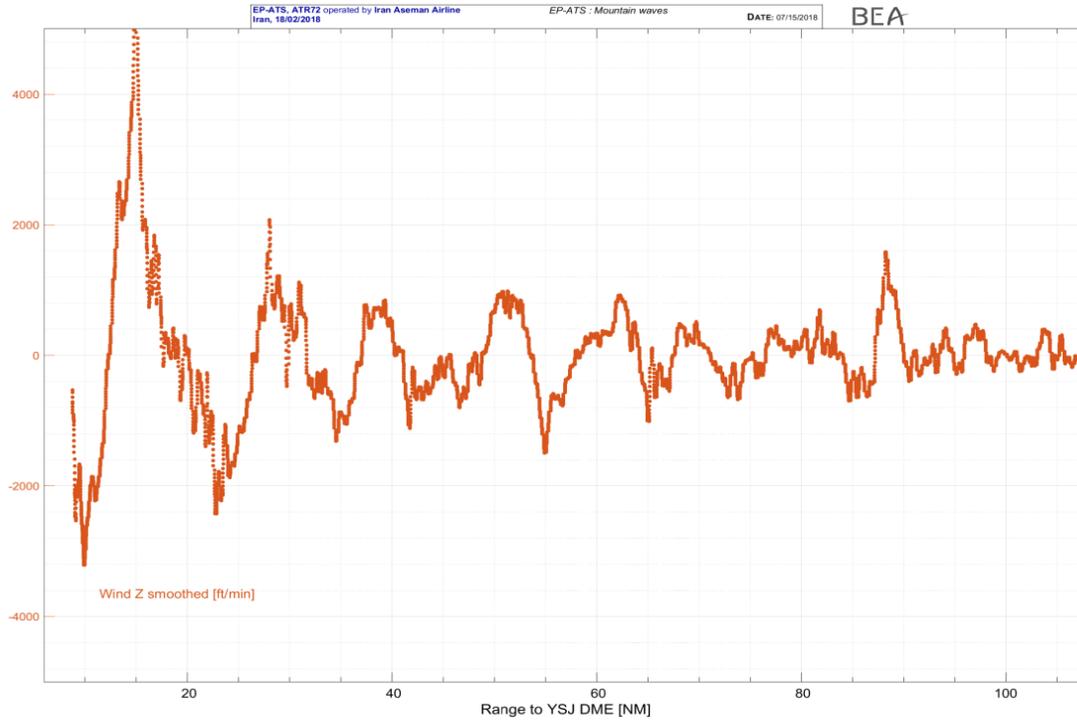
Figure 12: Computed vertical wind during the accident flight.

Drawing the computed vertical wind values versus the range to the DME of Yasouj really shows the oscillations of the vertical wind with a long-range change during the accident flight.

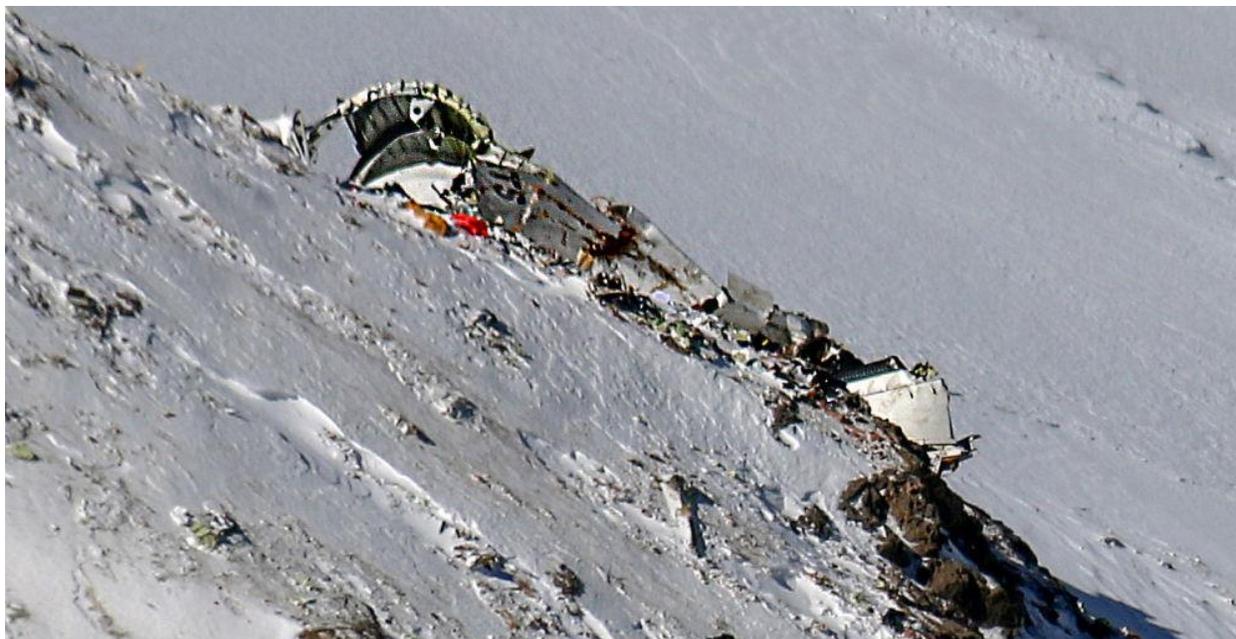
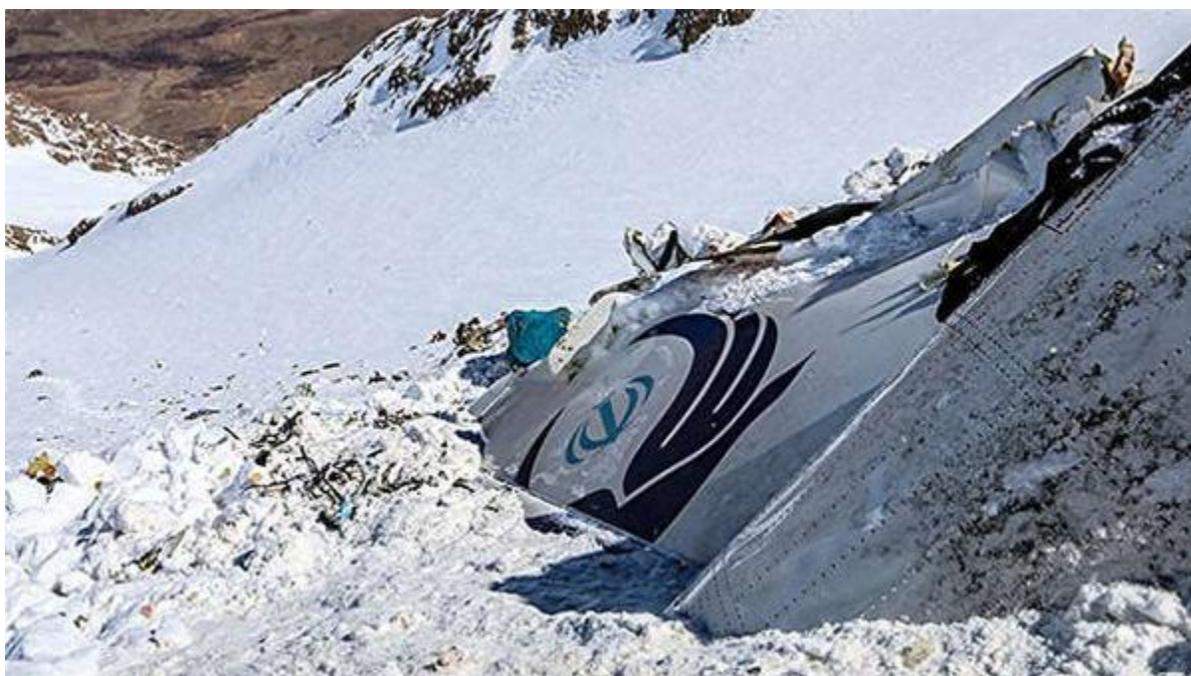
Figure No. 13 Accident Site:

The wreckage was fragmented with a large amount of debris spread over an area in a sloping rocky ravine which was covered by snow. Due to snowfall during the night the after accident time, the wreckage was covered with snow completely and it was not possible to find parts of the aircraft and transfer the pieces easily. The technical investigation on wreckage parts was not possible. At the scene of the accident, the Mountain ravine and local winds had been felt to endanger any flight to the accident site to access the site.

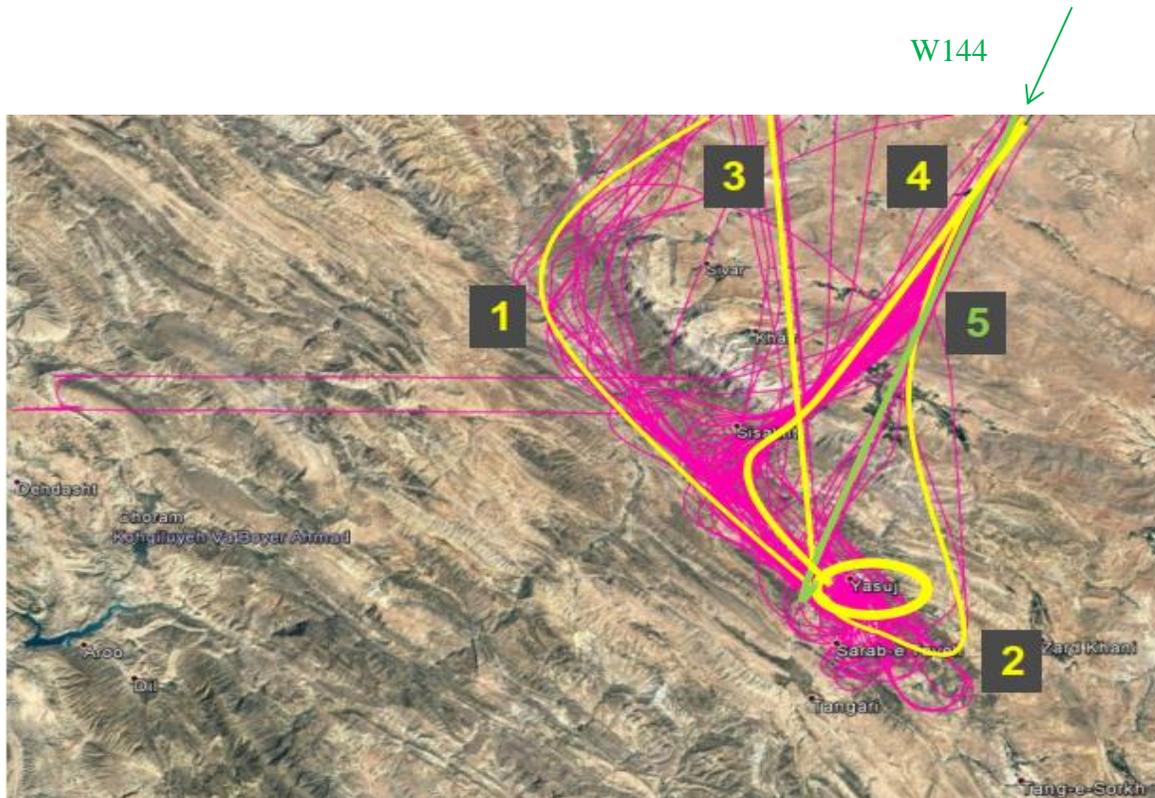
Figure No. 18 Flight Paths of ATR Fleet previous flights

- 114 flights from Teheran to Yasouj
- 5 “types” of approach paths identified
- 26 flights on W 144 (N°5 in green)
- The Flights on trajectories 1,2,3 and 4 were not on the published IFR procedure and made as Visual approaches

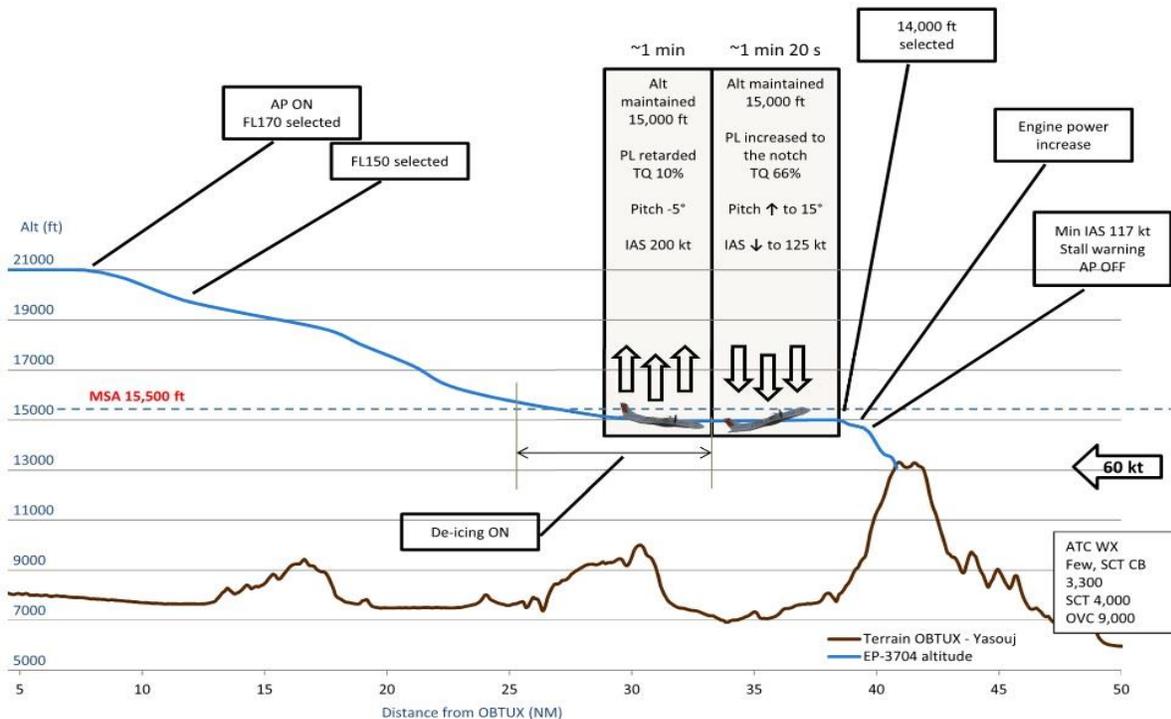
Figure No. 21 Up & Down draft for flight prepared by ATR

The aircraft tracking and FDR analysis showed the flight crossed the Up & down draft. The updraft and downdraft computed wind values were confirmed by the aircraft attitude. Following the engagement of the altitude hold mode, an updraft wind made the autopilot request a pitch down attitude, while a downdraft wind made the autopilot request a pitch up attitude. The reactions of the autopilot were consistent with maintaining the aircraft at the target altitude. The crew increased the engine power from 47% to 73% TQ by moving the PL up to the notch. However, despite the continuous decrease of the indicated airspeed, the crew did not increase the engine power until its full capacity (no change of the power management, no selection of a propeller speed of 100 %, no move of the PL beyond the notch position). The selected power (max power with the engine settings at that time: 2132 SHP) is more than 22 % below the maximum power of the engine (max power with PL at the ramp and propeller speed at 100%: 2750 SHP). This selected engine power was not sufficient to stop the decrease of the airspeed. The aircraft performance was not enough against high rate of down draft (about 3200 ft. /min). So, near the mountain the aircraft experienced significant reduction in airspeed and wing lift factor as effect of down draft.

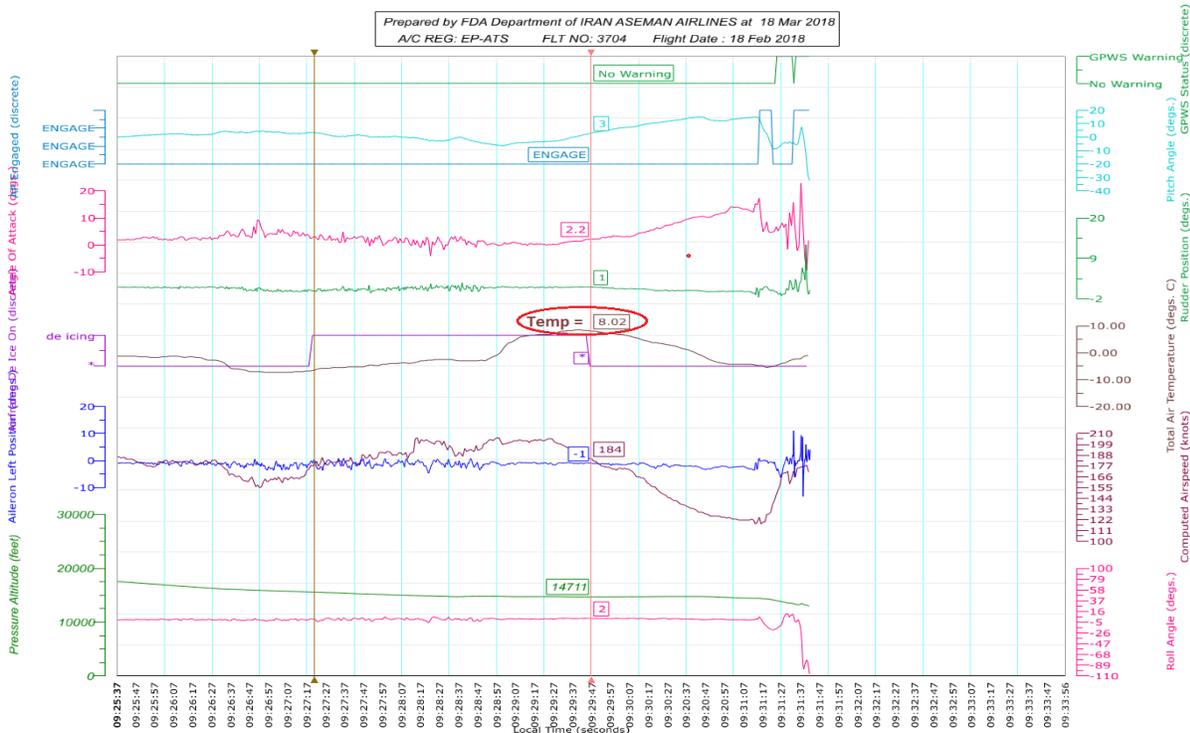
Figure No. 22 Temperature Graph of FDR

Based on FDR & CVR, the crew canceled Icing AOA caption and never spoke about any observation on Ice Evidence Probe (IEP).

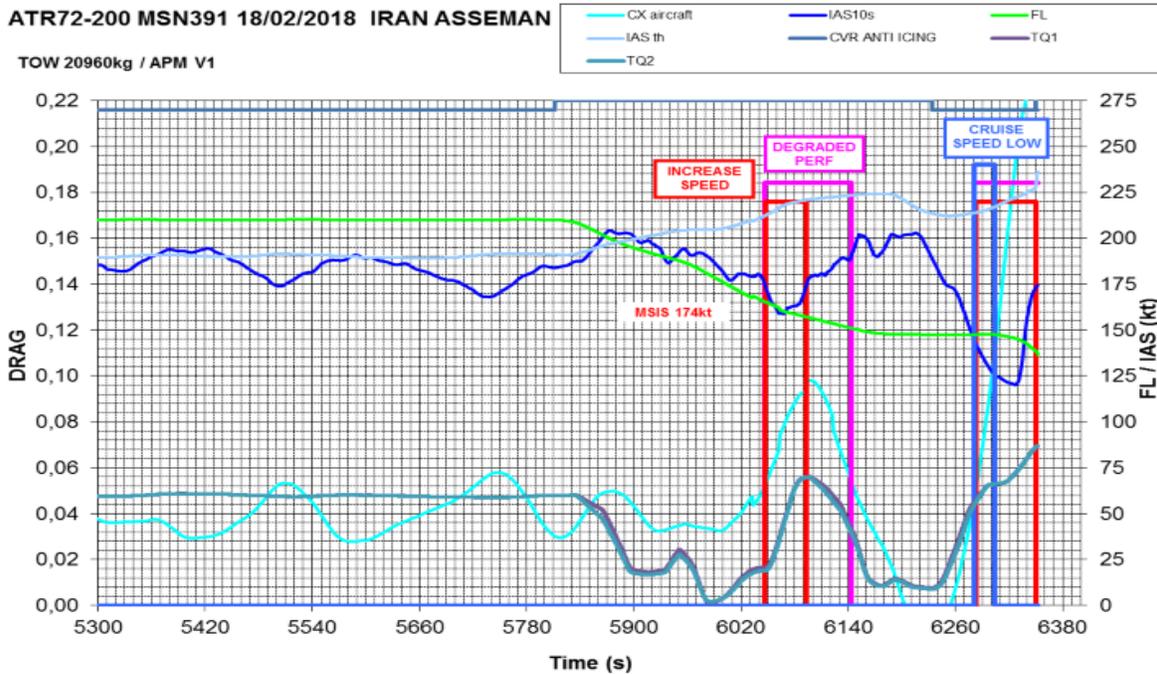
Figure No. 23 APM Simulation Analysis

As a conclusion, the APM simulation tends to show that the alerts that would have triggered are linked to a decrease in performance due to external conditions (wind gradient) rather than icing, as illustrated in the following Figure:

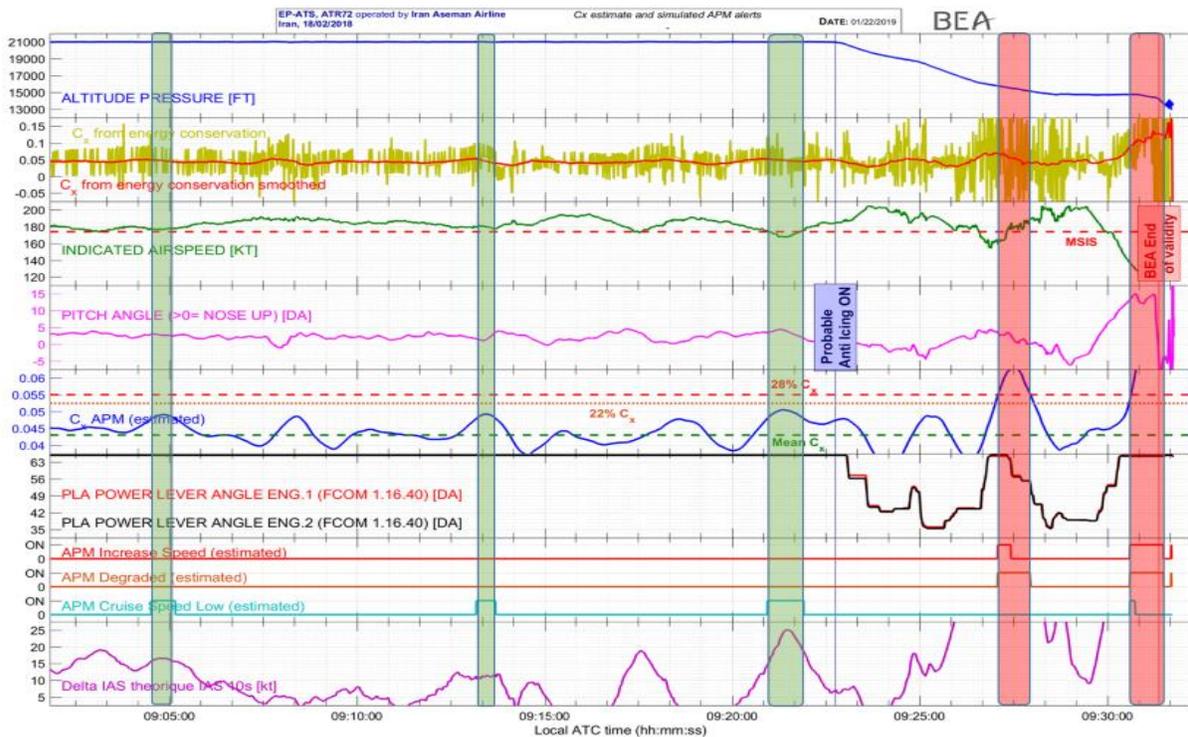
Figure 25. Estimate of C_x and potential APM alerts

The average value of the computed C_x was 0.043 during the level off at FL 210 which is a consistent value for this aircraft. Specific periods of interest that are highlighted in the figure:
