National Transportation Safety Board Aviation Accident Final Report

Location:	Crozet, VA	Accident Number:	ERA18FA127
Date & Time:	04/15/2018, 2054 EDT	Registration:	N525P
Aircraft:	CESSNA 525	Aircraft Damage:	Destroyed
Defining Event:	Loss of control in flight	Injuries:	1 Fatal
Flight Conducted Under:	Part 91: General Aviation - Personal

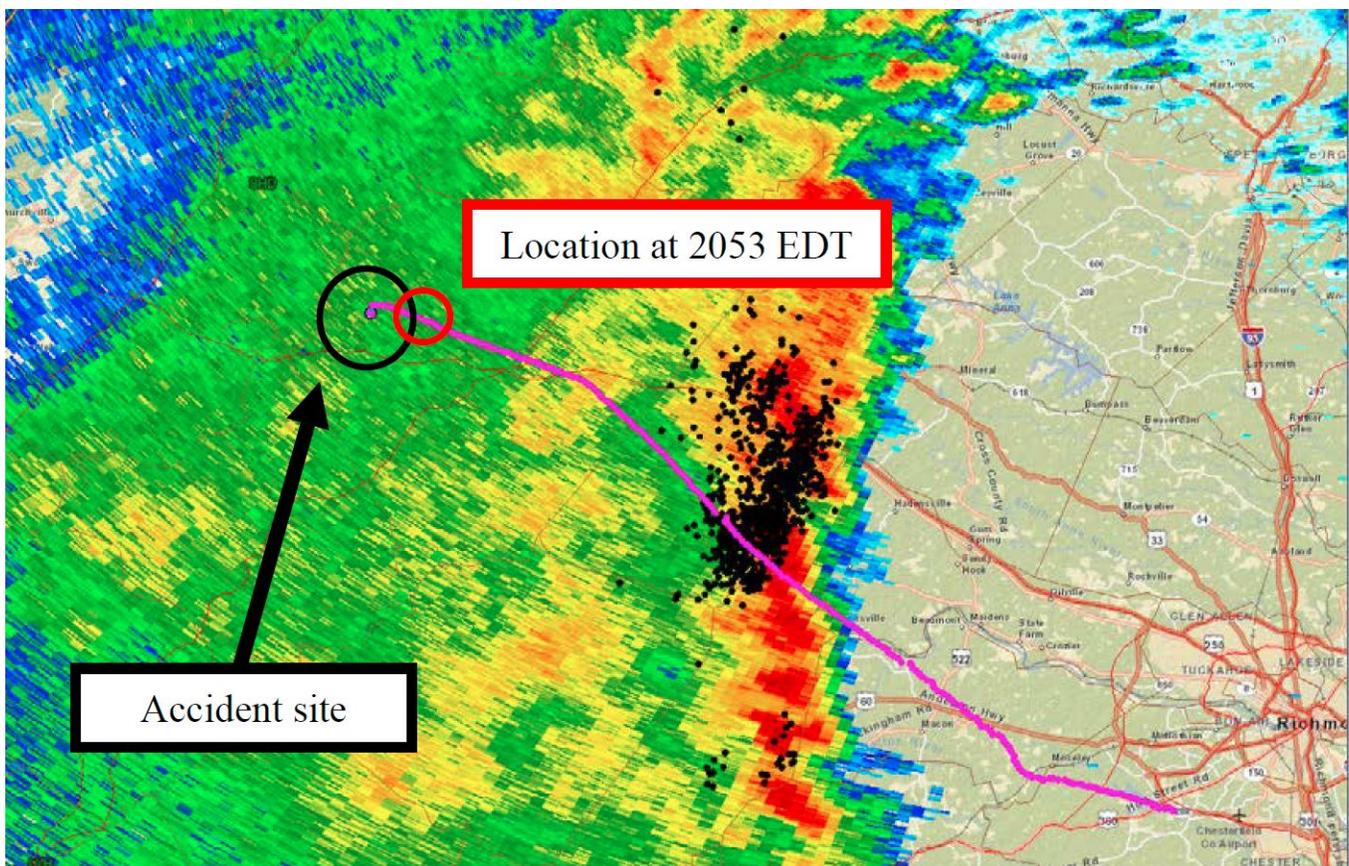
According to reviewed radar data, reflectivity values between 25 and 35 dBZ were located above the accident site at 2053 (see figure 1), which corresponded with the surface observation precipitation reports from W13, SHD, and CHO. The reflectivity bands were moving from south-southwest to north-northeast between 2004 and 2103. The reflectivity targets indicated of moderate-to-heavy rain moving northward across the accident site at the accident time.

The accident airplane flew through a thunderstorm line between 2042 and 2047. There were no lightning strikes within 10 miles of the accident site about the accident time.

Figure 1. Radar reflectivity at 2053 with the accident site marked with a black circle, the accident flight track in pink, the airplane's position at 2053 marked with a red circle and the lightning flashes represented by the black dots.
