# Report A-012/2018

Accident involving a Cessna 525C – CJ4,  
registration EC-MOQ, operated by Aluminios  
Cortizo, at the Santiago de Compostela Airport  
(La Coruña) on 4 May 2018

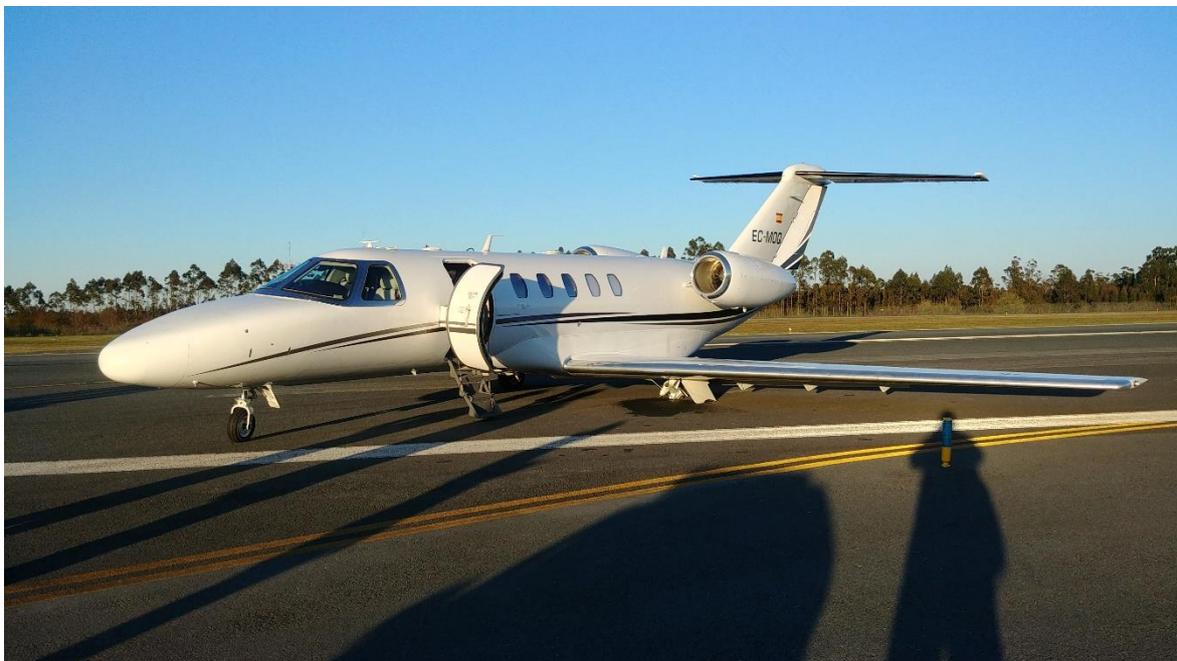
Figure 1 – Position and condition of the aircraft after collapse of left leg.

The damage to the aircraft was limited to the left landing gear assembly and part of the left wing, which had been affected by the collapse of the same-side landing gear leg. These deformations and damage to the left wing affected primary structural components.

A check of the landing gear and subsequent inspection showed that the bolt was incorrectly installed in the aft trunnion pin on the left leg, which allowed the trunnion pin to move backward and decouple from the trunnion. This caused the leg to collapse as it turned forward and to the right, pivoting on the hydraulic actuator.

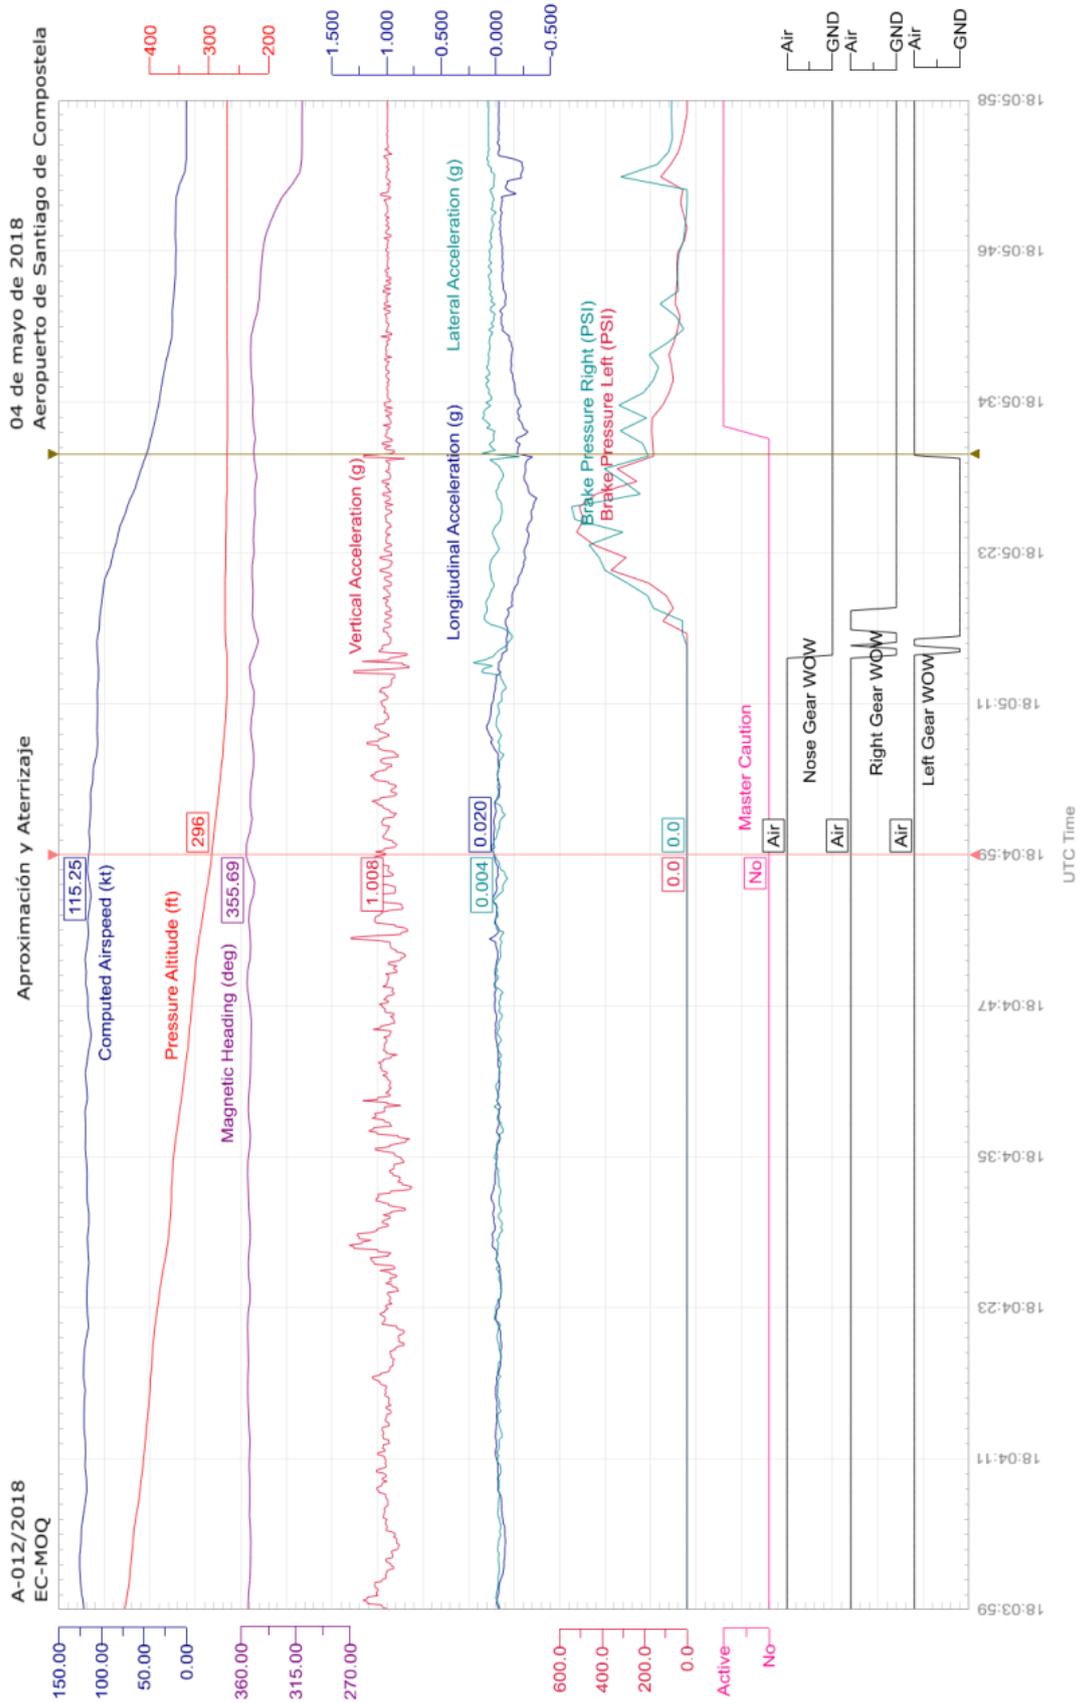
The graph below shows the trends in the DFDR parameters over two minutes during the landing, which clearly indicate the instant when the left leg collapsed.

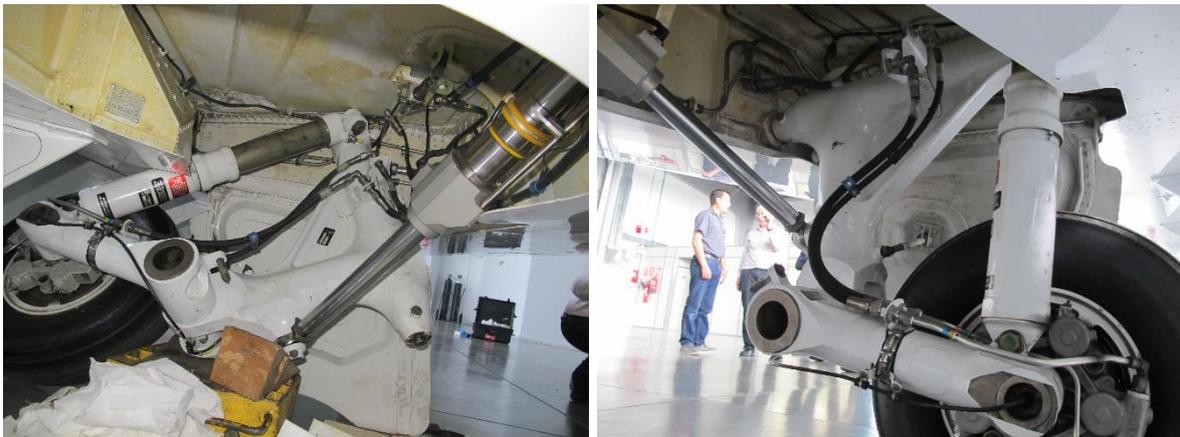
The left leg trunnion fitting was found outside its forward and aft supports at both wing spars (**star-shaped** reinforcement with a support coupling where both trunnion fittings rest). After coming out of the longitudinal axis of the gear (about which it extends and retracts), it turned

Figure 2 – Left leg outside the wheel well (l), and right leg in its normal extended position (r).

forward and to the right. This leg remained attached by the hydraulic extension/retraction actuator, and its weight was supported by the lower wing structure.

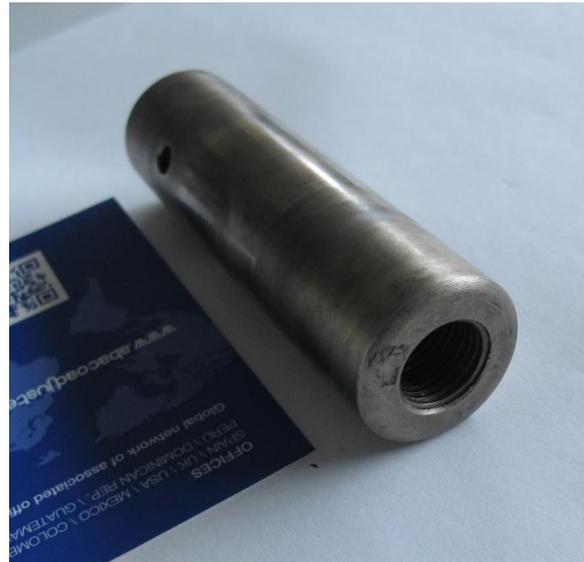
This condition is consistent with an incorrect installation already described by the manufacturer, which led it to issue Alert Service Letter (ASL) 525C-32-01, "Landing gear – Aft main landing gear trunnion pin inspection", on 19 July 2012.

Figure 3 – Left aft trunnion pin.

Coincident with the investigation into the event and the analysis of the components removed from the landing gear, the aircraft manufacturer, Textron Aviation, issued service letter SL 525C-32-12 on 9 July 2018, compliance with which is mandatory, which provided instructions for inspecting the bolts on the aft trunnion of the main landing gear in case this bolt was incorrectly installed on more aircrafts. As a precaution, this document instructed that an airplane with an incorrectly installed bolt must not be moved until this condition is corrected.

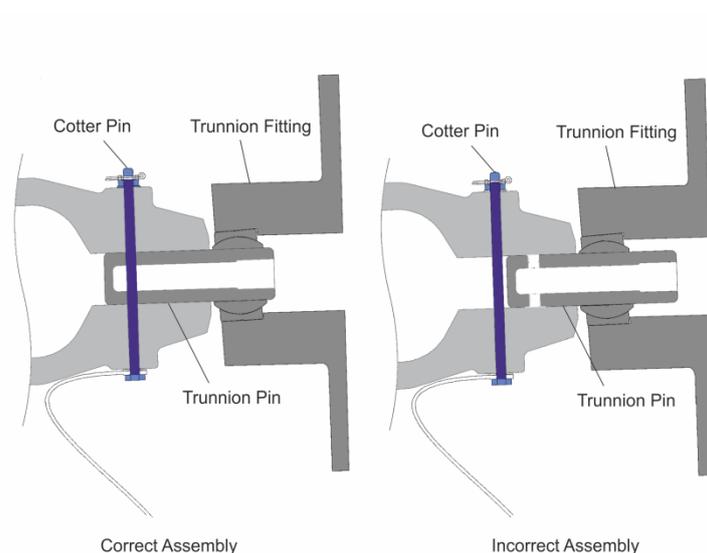
Provided in this report are illustrations supplied by Cessna in its ASL 525C-32-01, Figure 1 Aft Main Landing Gear Trunnion Inspection (sheet 1)", with two close-ups showing the position of the bolt, one correctly installed and another incorrectly installed, as well as two views from behind showing both conditions.

Diagram 2 – Detail of the bolt installed correctly and incorrectly.

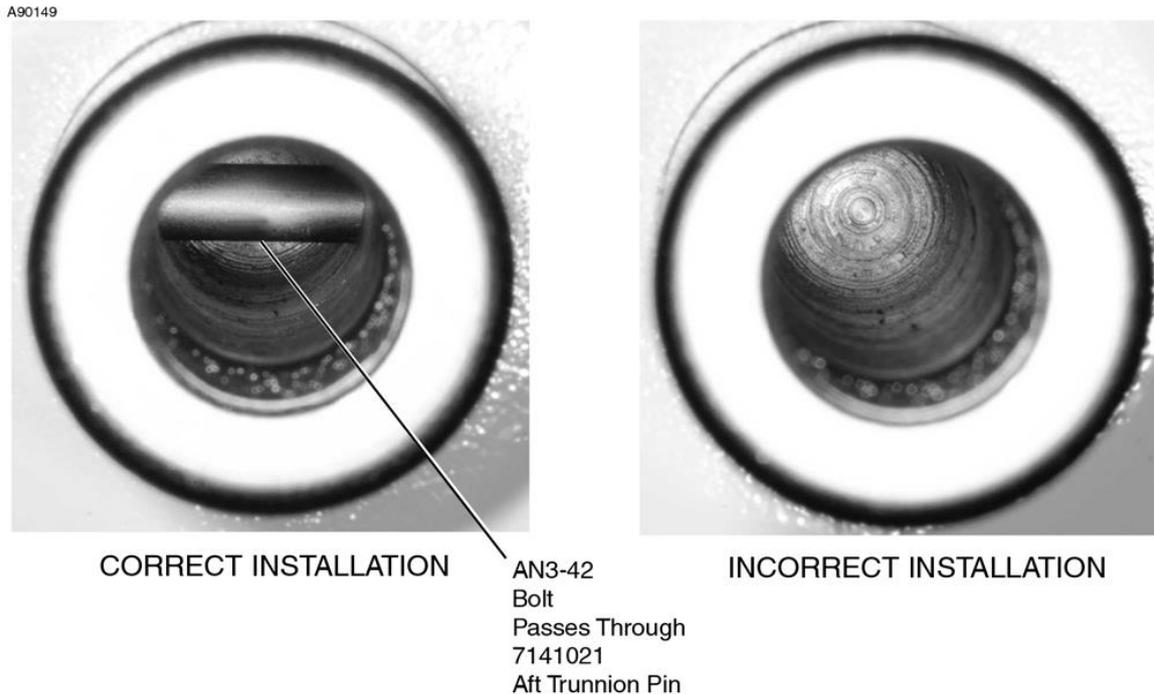
Figure 4 – View inside the aft trunnion pin.

4. The aft trunnion pin on the left side, P/N 7141021-5, was not damaged, but the contact marks on the outer diameter made by the coupling and the cadmium residue on the flat side of one end, deposited by bolt AN-3-42, suggest that the bolt was not inserted through the trunnion pin. The trunnion pin was made of a low-alloy steel of satisfactory strength, as per the design specifications. The associated bolt, AN-3-42, exhibited an overload failure in the perforation of the threaded area for the braking wire. This bolt was made of a low-alloy steel of satisfactory strength, as per the design specifications.

5. Fluorescent liquid penetrant tests in the area of the shaft of both rear trunnion pins revealed wear in two support/assembly positions, suggesting these pins had been correctly installed at some point prior to their last installation.
