**AIRCRAFT ACCIDENT INVESTIGATION**

**CONTROLLED FLIGHT INTO TERRAIN**  
**INVOLVING**  
**EAST AFRICAN SAFARI AIR EXPRESS LTD**  
**TEXTRON AVIATION INC.**  
**CESSNA 208B GRAND CARAVAN,**  
**KENYAN 5Y-CAC**  
**THE ABERDARE RANGES, KENYA**  
**05 JUNE, 2018**

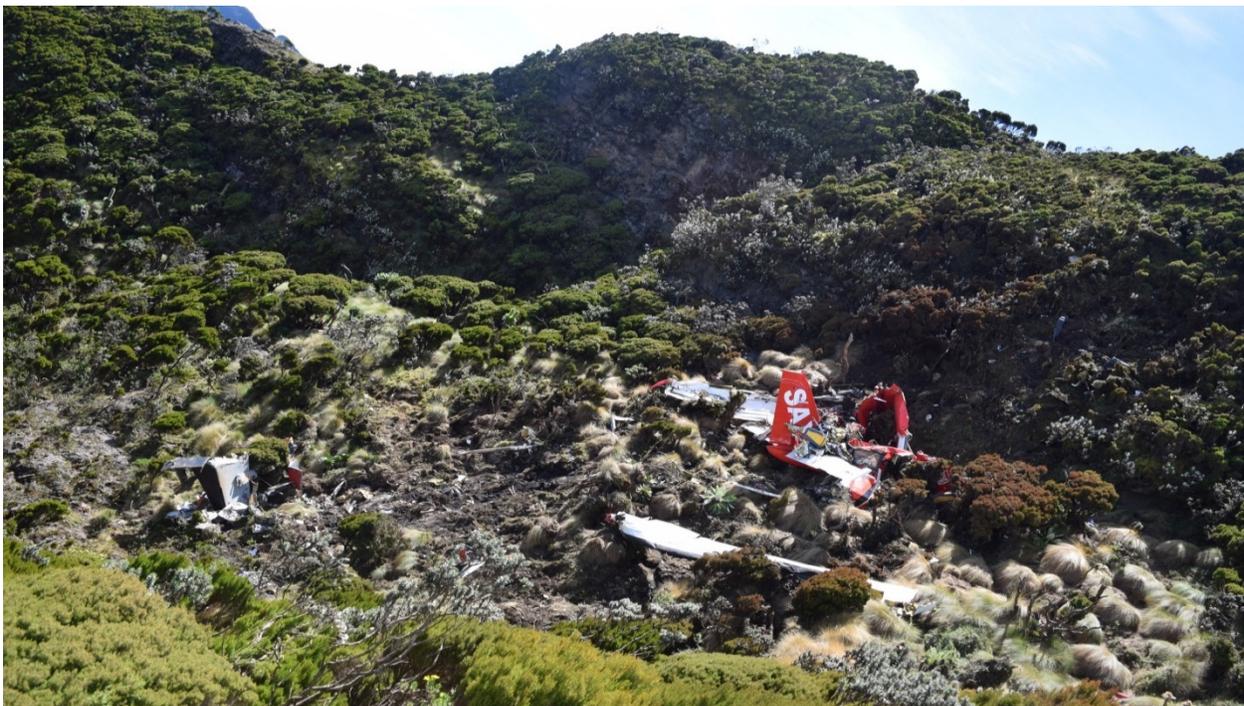
Figure 6: The wreckage of 5Y-CAC

The aircraft was destroyed by impact forces.

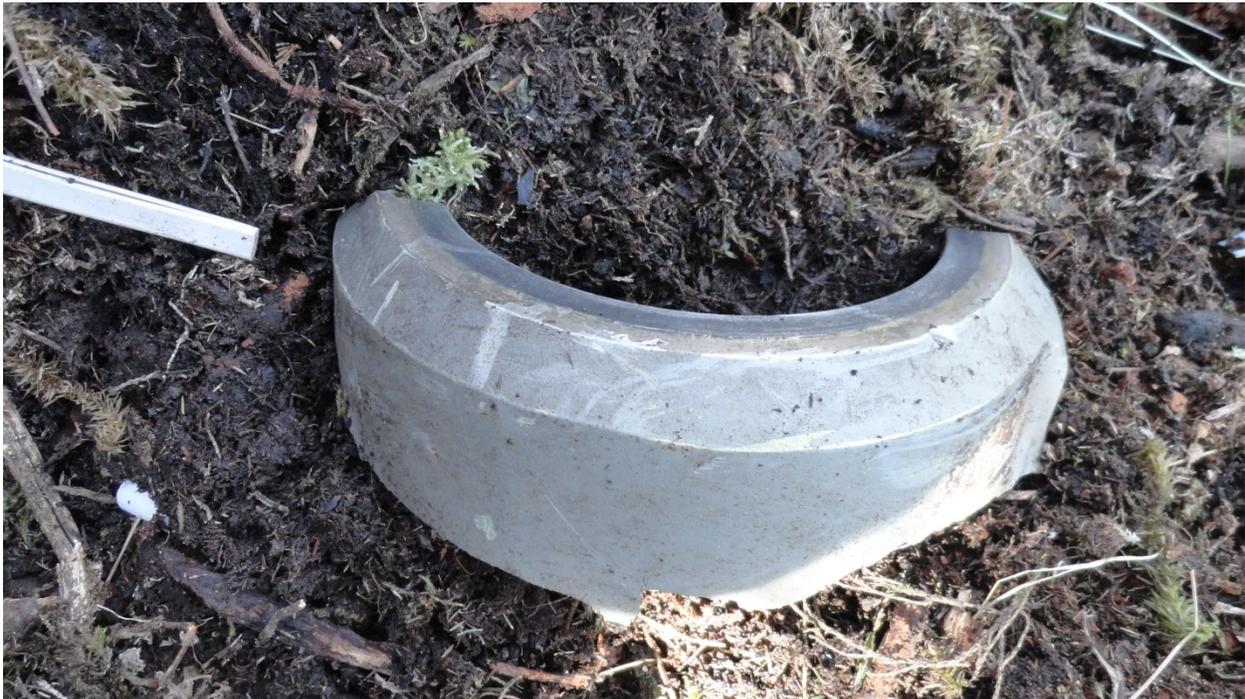
**Figure 7: The severed and sheared portion of the bulkhead**

All the three propellers were accounted for at the accident site. They had sheared off from the main hub in a manner consisted with high setting. The spinner got embedded into the crater created by the impact forces and furrowed. The bulkhead failed in a manner typical of existence of high torsion forces.

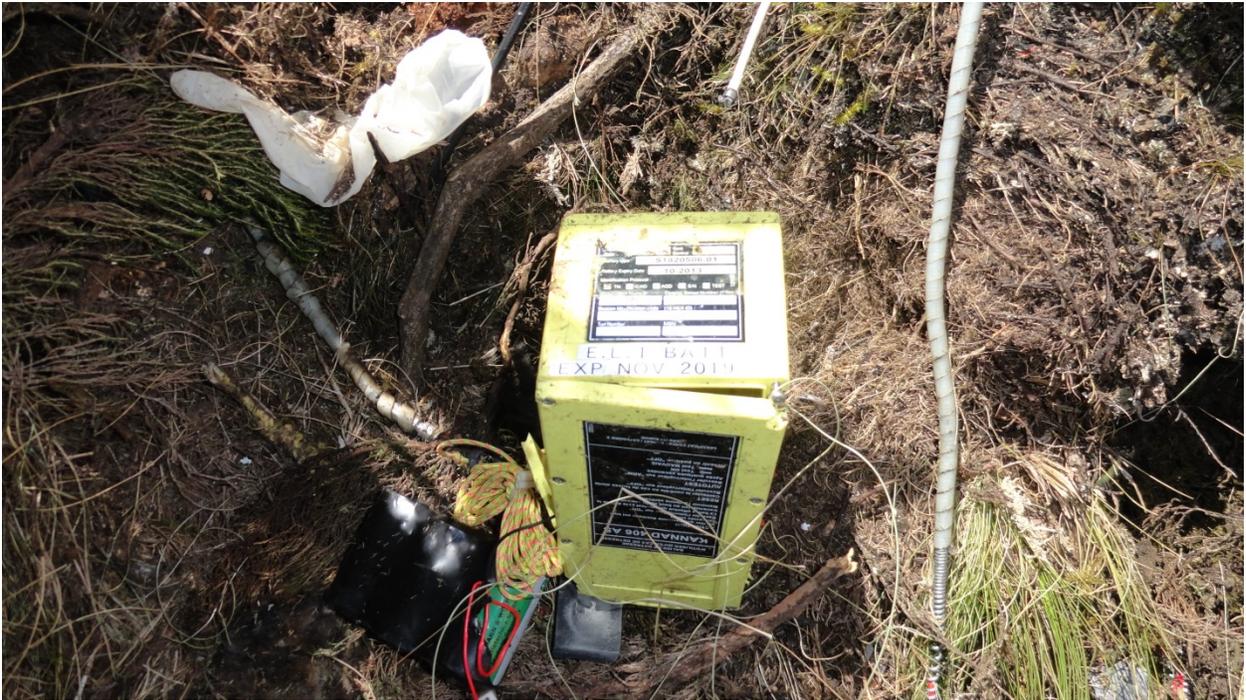
Figure 12: The ELT with the batteries still attached at the accident site

5Y-CAC was equipped with a Kannad 406 AS- COMPACT ELT, part number S1820506-01, serial number 15260294. After recovery from the wreckage, during field examination of the wreckage, the ELT was noted to have been dislodged from its mounting tray with both the batteries and the antenna cable still attached to it.

The switch was still in the 'ARM' position. The remote control panel wires were broken near the plug on the ELT. The antenna had been broken off by ground contact, and its cable was continuous from the antenna base to the ELT. Due to loss of the antenna, no 406 MHz signal was recorded by the Search and Rescue Coordination Centre, nor was a 121.5 MHz signal received.

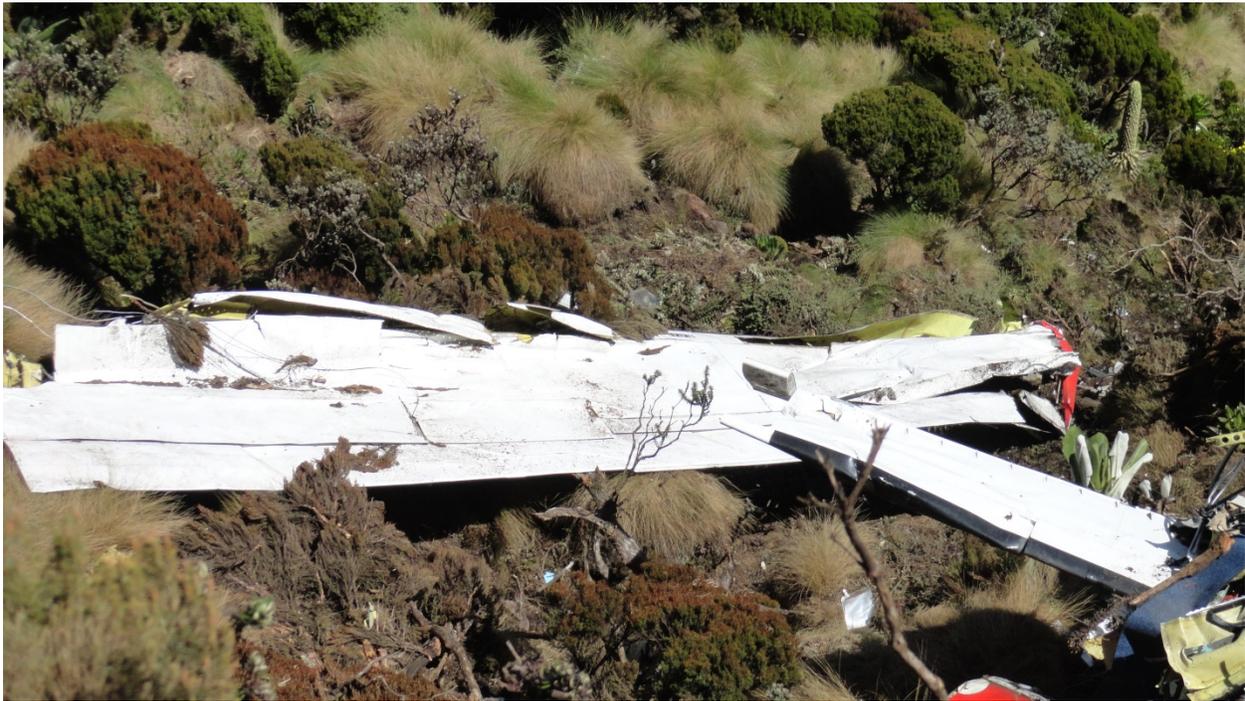
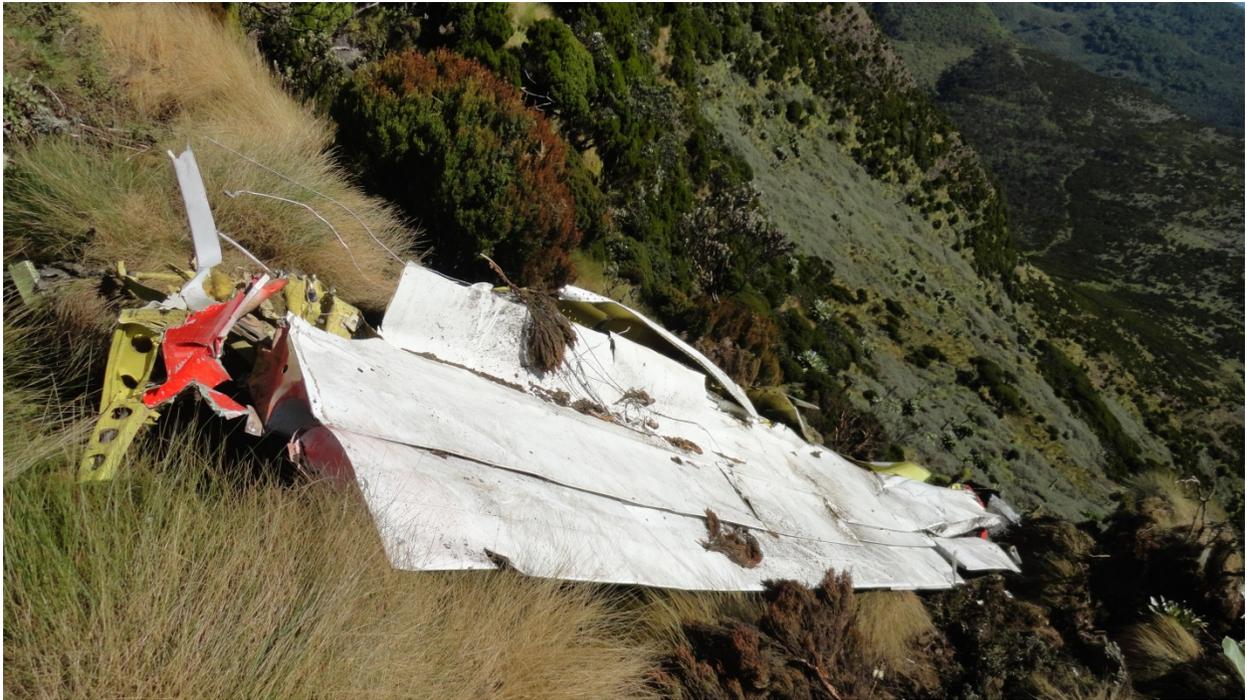
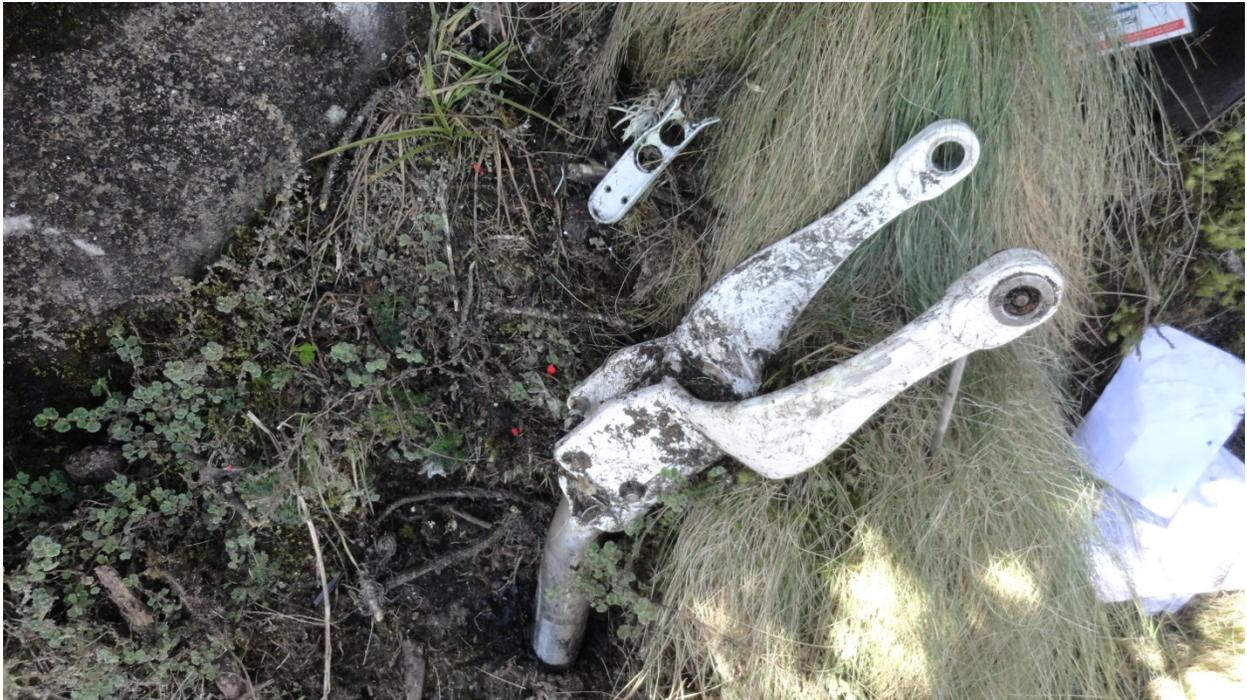
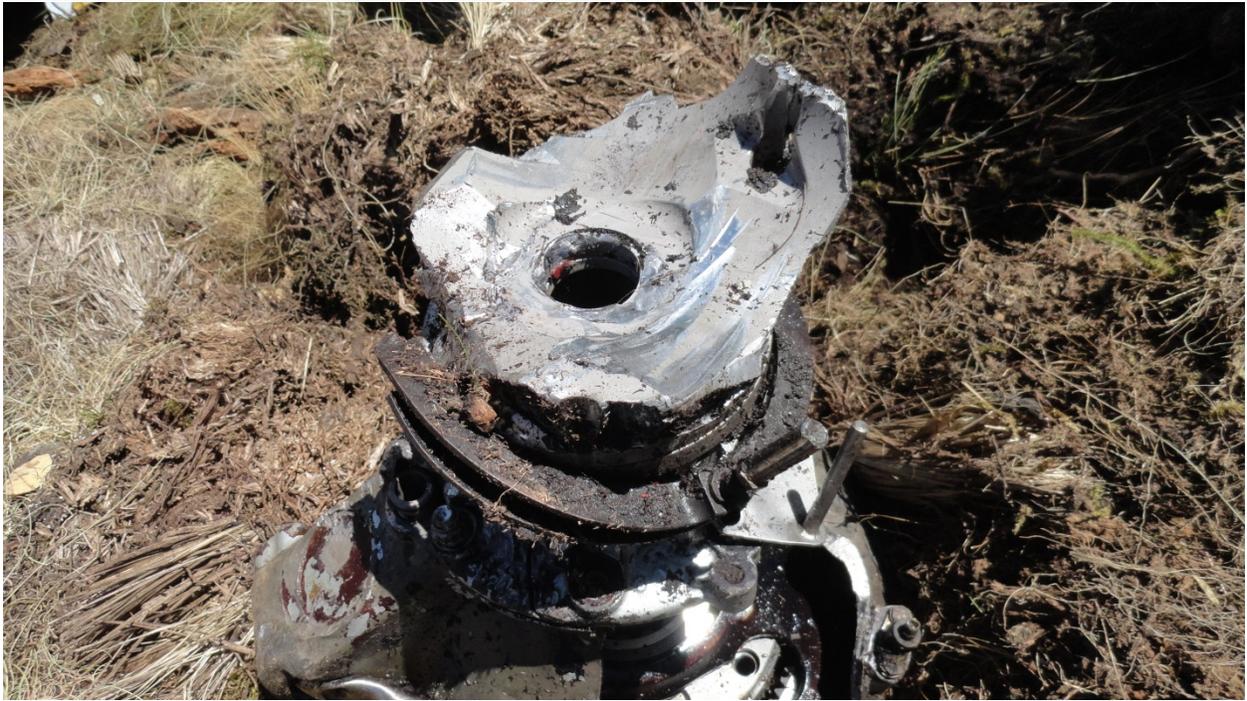
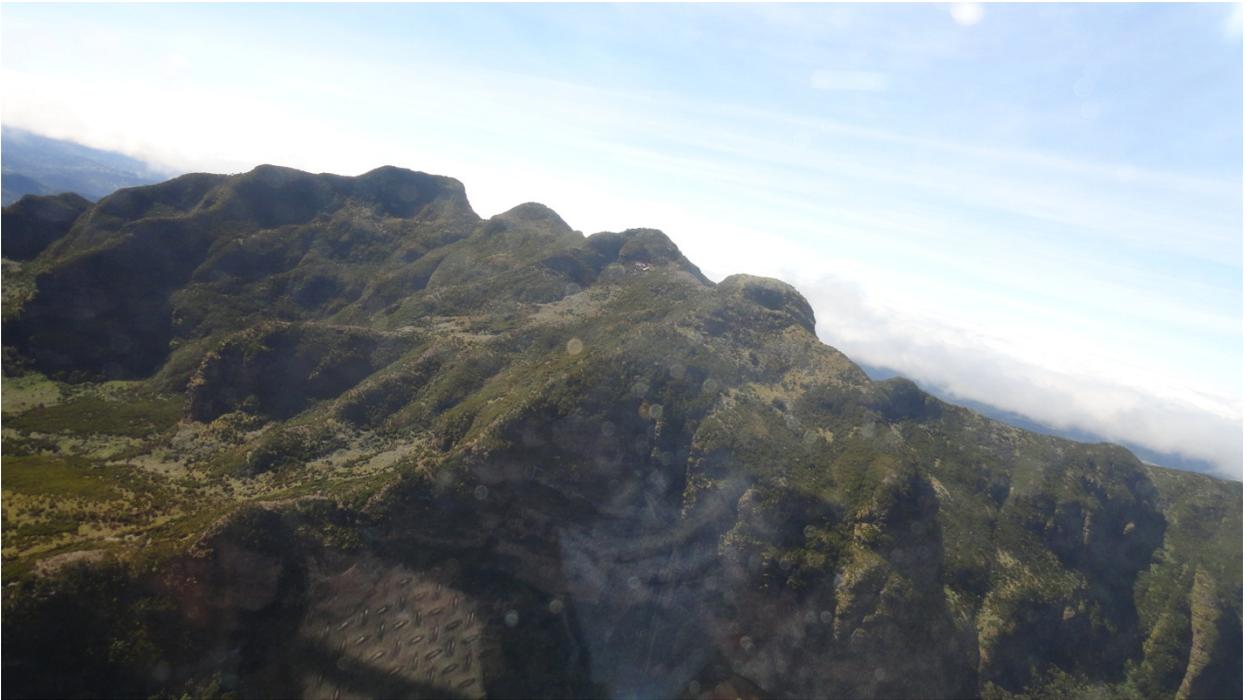
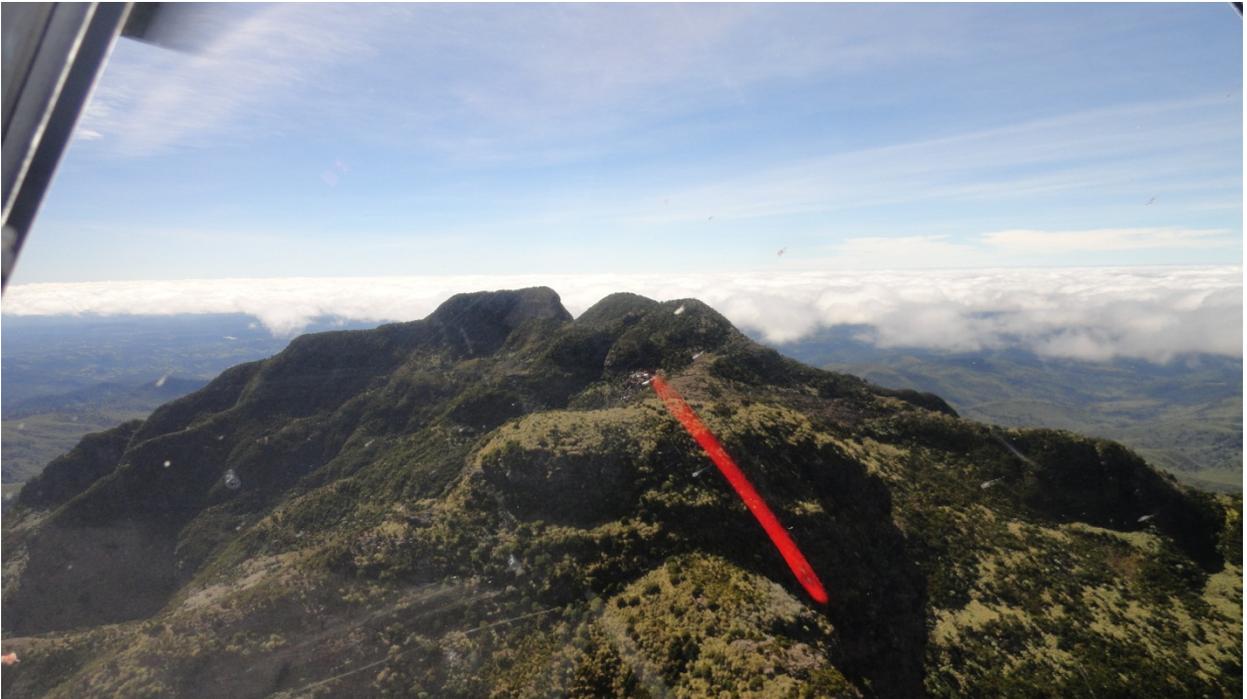
Figure 20: Accident pictures of the site

The wreckage had extensive ground impact with no fire damage. Part of the fore main fuselage, cockpit/cabin area, and engine were found embedded in a large crater.

The Pratt & Whitney PT6A-114A turbine engine was found imbedded, horizontally, into the terrain, leaving only the aft portion of the engine accessory gearbox detached and visible.

Portions of the incinerated fuselage structure and the wings of the airplane were in a horizontal, nose-level attitude. The longitudinal axis of the fuselage was oriented on a magnetic heading of about 158 degrees. (All heading/bearings noted in this report are oriented toward magnetic north.)

The entire fuselage of the airplane was separated into several main groups. The wings were separated from the fuselage and displayed extensive span wise, leading-edge-aft crushing and folding.

The forward spar of each wing was compressed to its respective aft spar. The wings were oriented in a horizontal. Each aileron and flap assembly remained attached to the trailing edges of their respective wings with a fifth portion of it partly separated from the wing root. Both wing lift struts were isolated from the wings and fuselage-attach points as a result of the incineration. The empennage was still intact with bends on the leading edges of the horizontal stabilizer. The Empennage was inclined at 40 degree to the left hand side and located just aft of the incinerated fuselage.

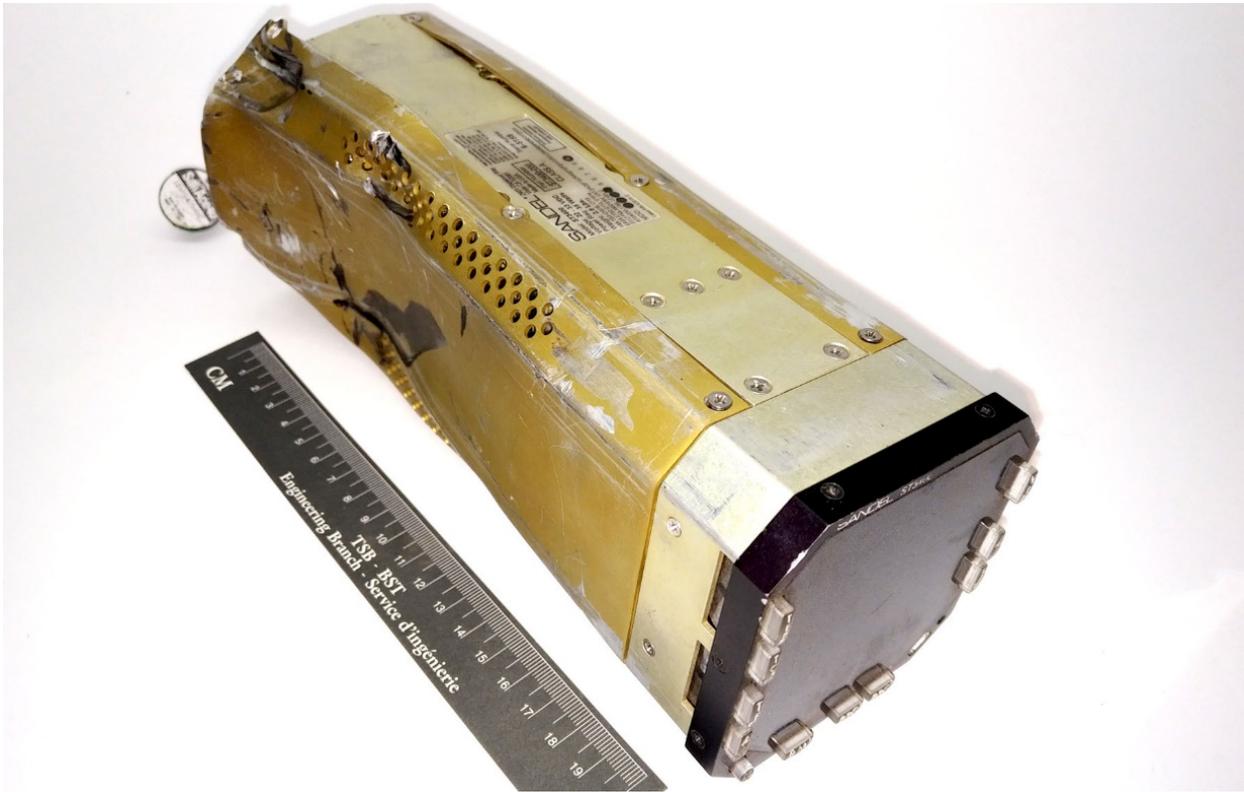
TAWS as received.

The TAWS unit received was significantly damaged with portions of the unit missing. It would not have been possible to repair the unit and power it on to perform a download of the stored data. The motherboard (Figure 2) was removed from the unit and the memory chips were inspected (Figure 3), it was determined that the memory chips were physically undamaged. The four chips were then removed from the circuit board, cleaned, and then reballed.

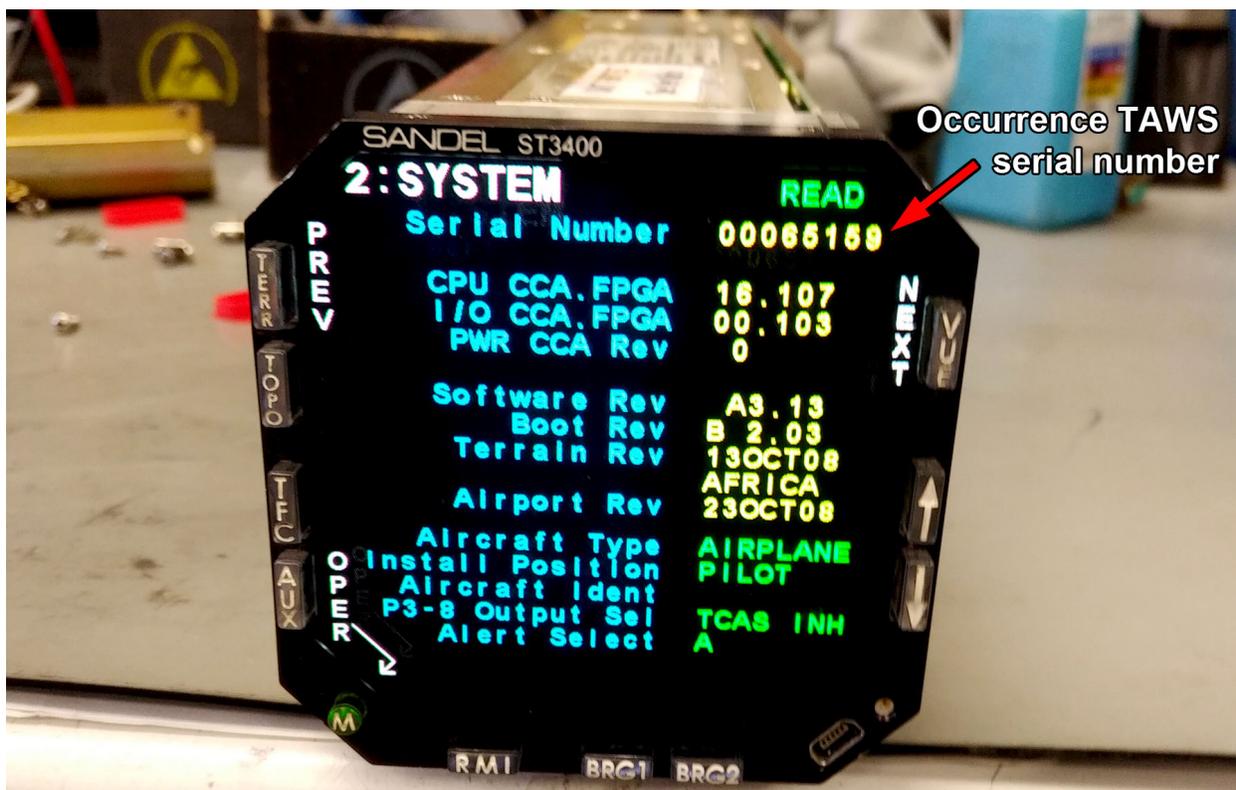
Settings for occurrence unit

The unit was powered up in maintenance mode to prevent the unit from deleting any of the previously recorded data. The settings were examined and it was noted that the parameters now matched the occurrence unit and no longer had the lab unit settings; this confirmed that any data downloaded would be from the occurrence unit.

It was noted that in the setup information, the terrain database version loaded into the system was dated 13 October 2008; the newest available version is from 2018. The unit was configured to use units as defined in the following Table.

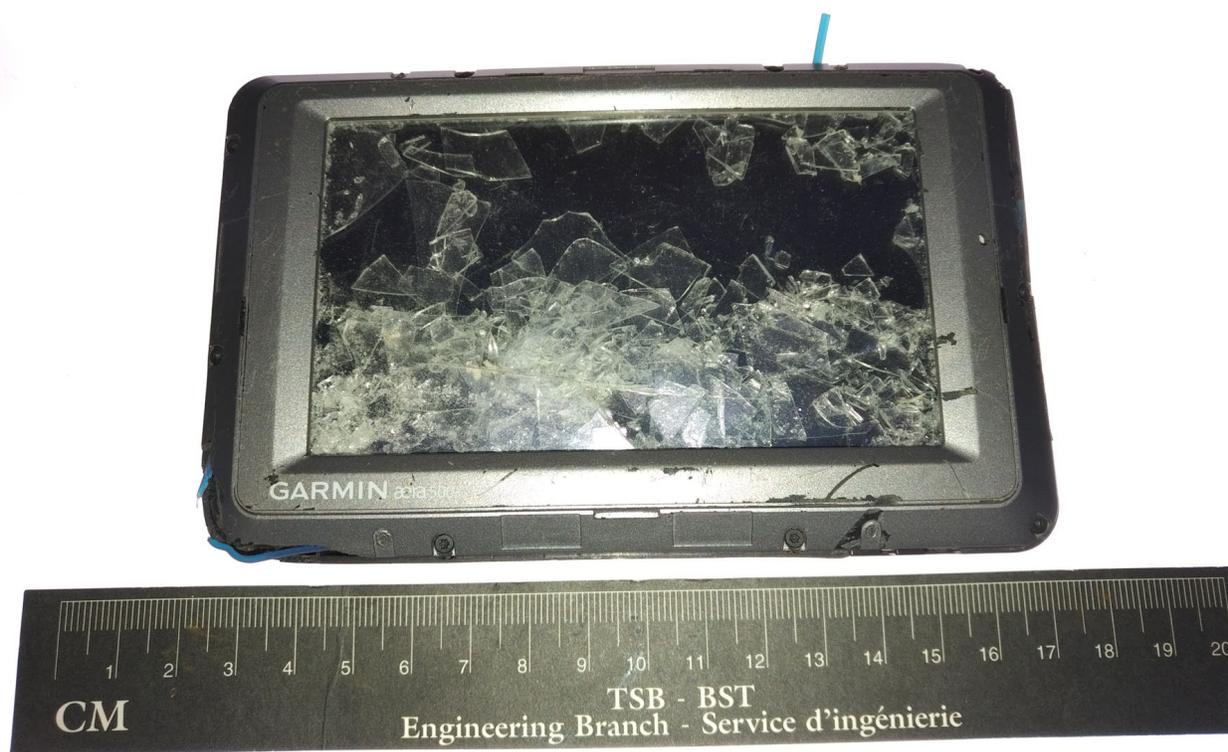
#### The GPS receiver

**The GPS received was significantly damaged. Some component and board repairs were performed and a lab power supply was connected directly to the main circuit board. The unit was connected to a lab computer and all data was successfully extracted.**

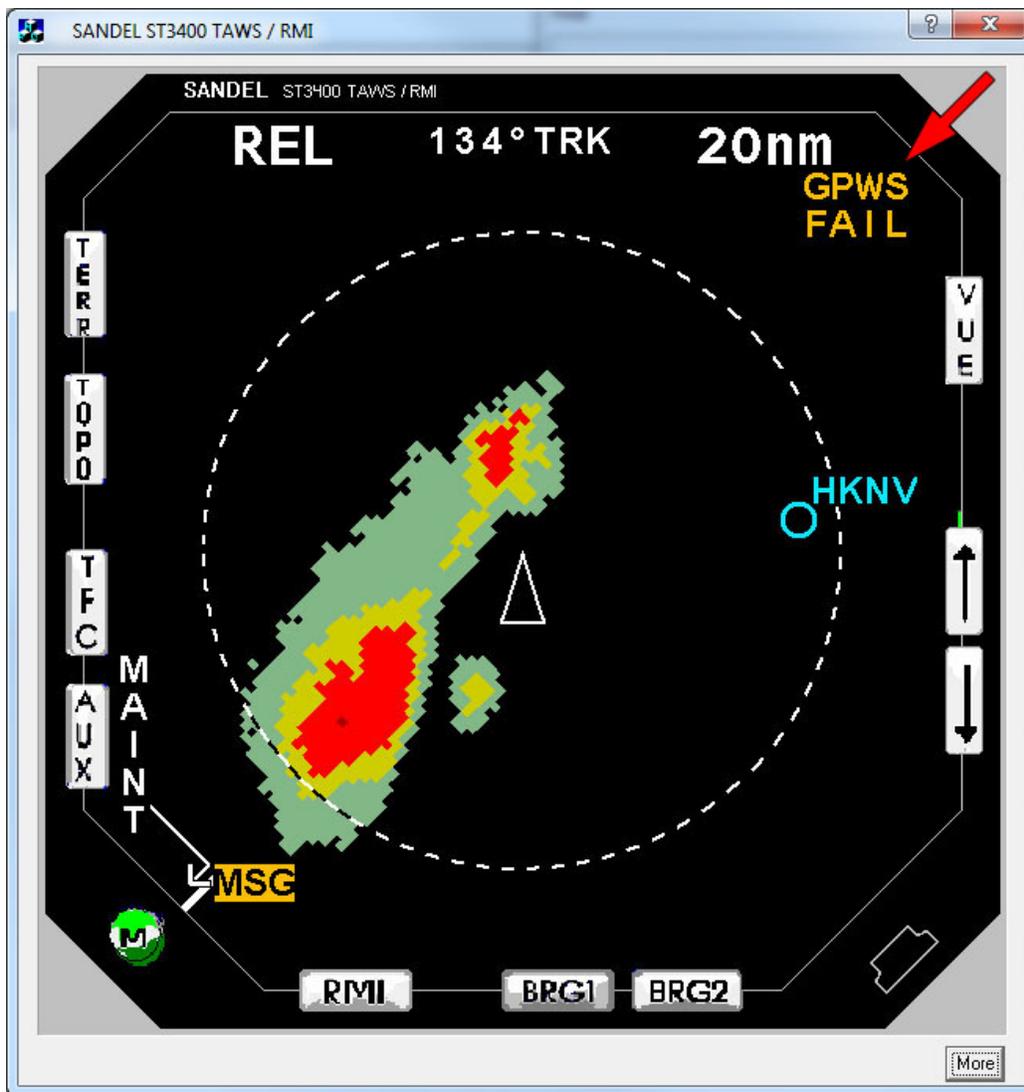
**GPWS failure screen – 20 nm**

The data from all four flights recorded in the TAWS unit were examined and it was noted that the radar altimeter was timed-out for all four flights and was not unique to the occurrence flight. The failure of the barometric altitude data was also noted on all recorded flights. These failures would have been noticeable to the pilots, as the timed-out state would have produced “GPWS Fail” message on the screen as shown in Figure below;

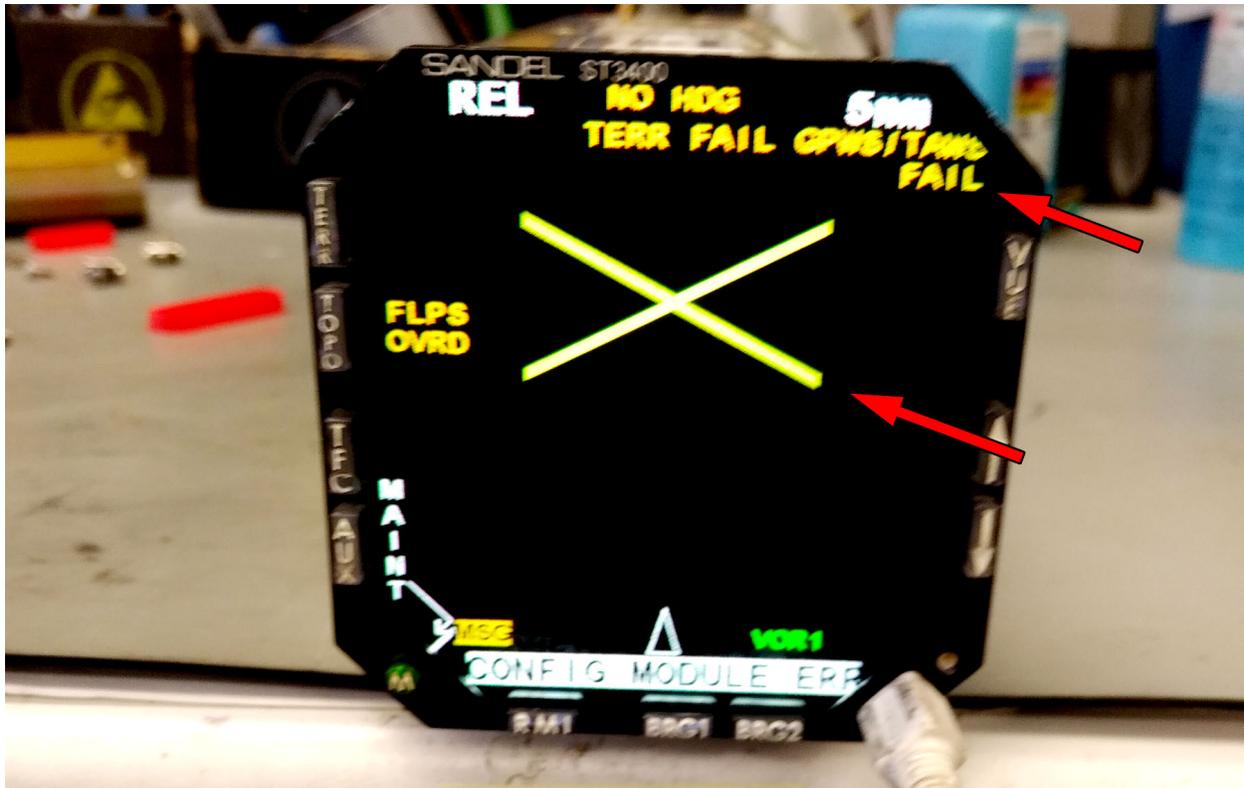
**TAWS failure screen with “X”.**

The relative terrain screens were emulated with the last recorded data from the occurrence flight. It is possible that the missing inputs also induced a TAWS failure which would have produced a large “X” on the top half of the TAWS screen and a “GPWS Fail” message on the screen as shown below, but as there was a terrain caution produced at the end of the flight this mode is unlikely.

Due to the failed inputs, the unit would default to a Class B installation even though it was configured as Class A; it would still give forward looking alerting as seen by the unit giving a terrain caution alert towards the end of the recorded data.
