National Transportation Safety Board Aviation Accident Final Report

Location:	Hydaburg, AK	Accident Number:	ANC18FA053
Date & Time:	07/10/2018, 0835 AKD	Registration:	N3952B
Aircraft:	De Havilland DHC 3	Aircraft Damage:	Substantial
Defining Event:	Loss of visual reference	Injuries:	6 Serious, 4 Minor, 1 None
Flight Conducted Under:	Part 135: Air Taxi & Commuter - Non-scheduled

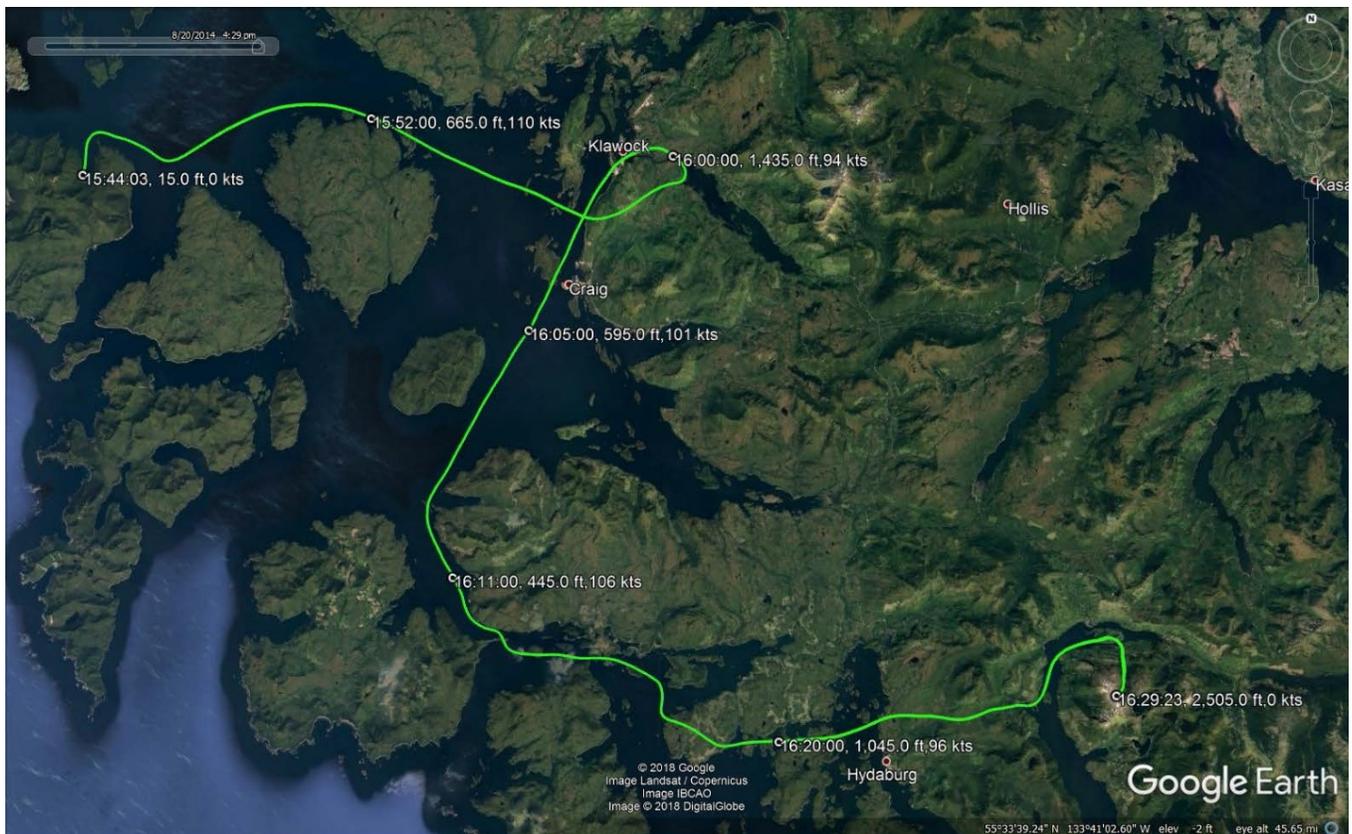
Figure 1. Google Earth overlay of the entire accident flight on July 10, 2018. Indicated airspeed (IAS) values are shown.
