FINAL REPORT OF L-410 UVP UR-TWO

L-410 UVP (UR-TWO) Crashed, On 9, Sept 2018

At Yirol, Eastern Lake State, Republic Of South Sudan.

FINAL REPORT OF L-410 UVP ACCIDENT IN YIROL.

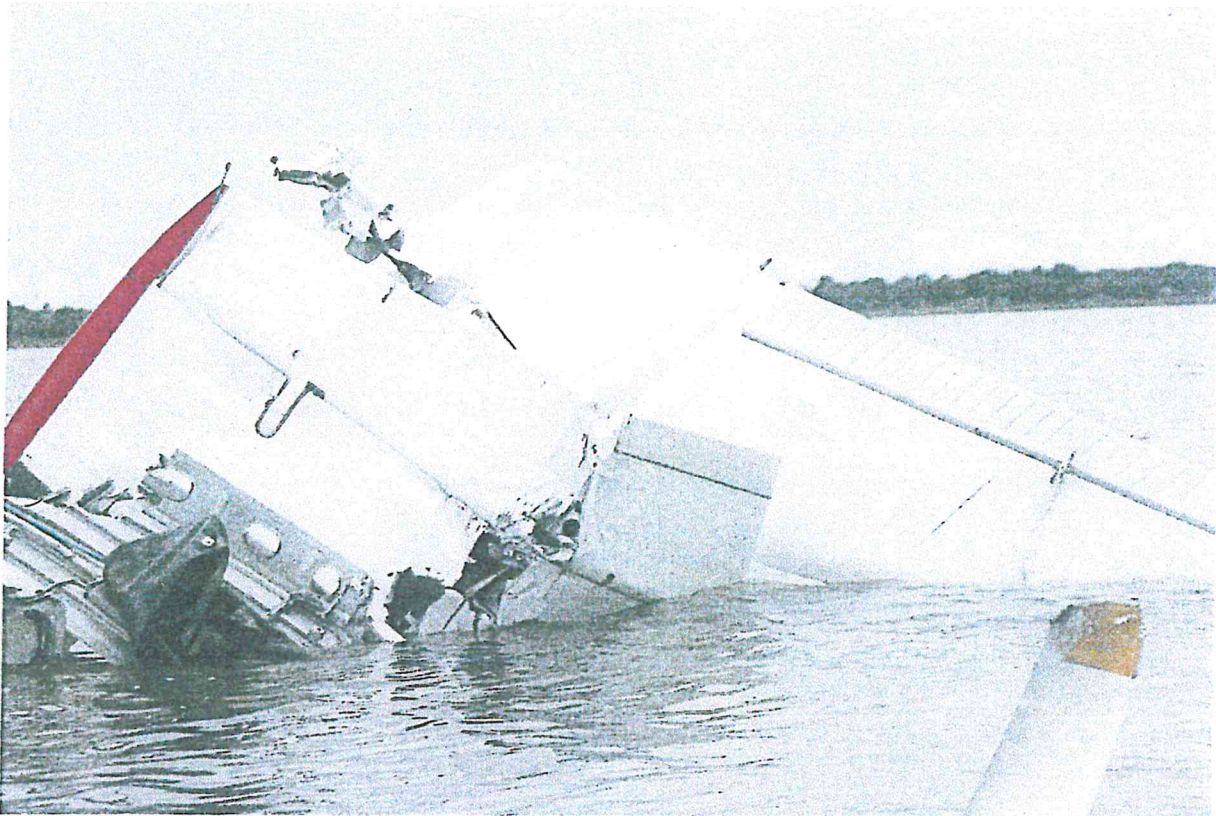
Figure 2: After the crash of UR-TWO.

There was visible damage to the aircraft fuselage where the passengers and the crew were seating. The whole fuselage was compressed due to severe impact to the water. The cockpit section scattered into pieces, and the cockpit was compressed. The main fuselage where the passengers were seating also experienced the same damage.

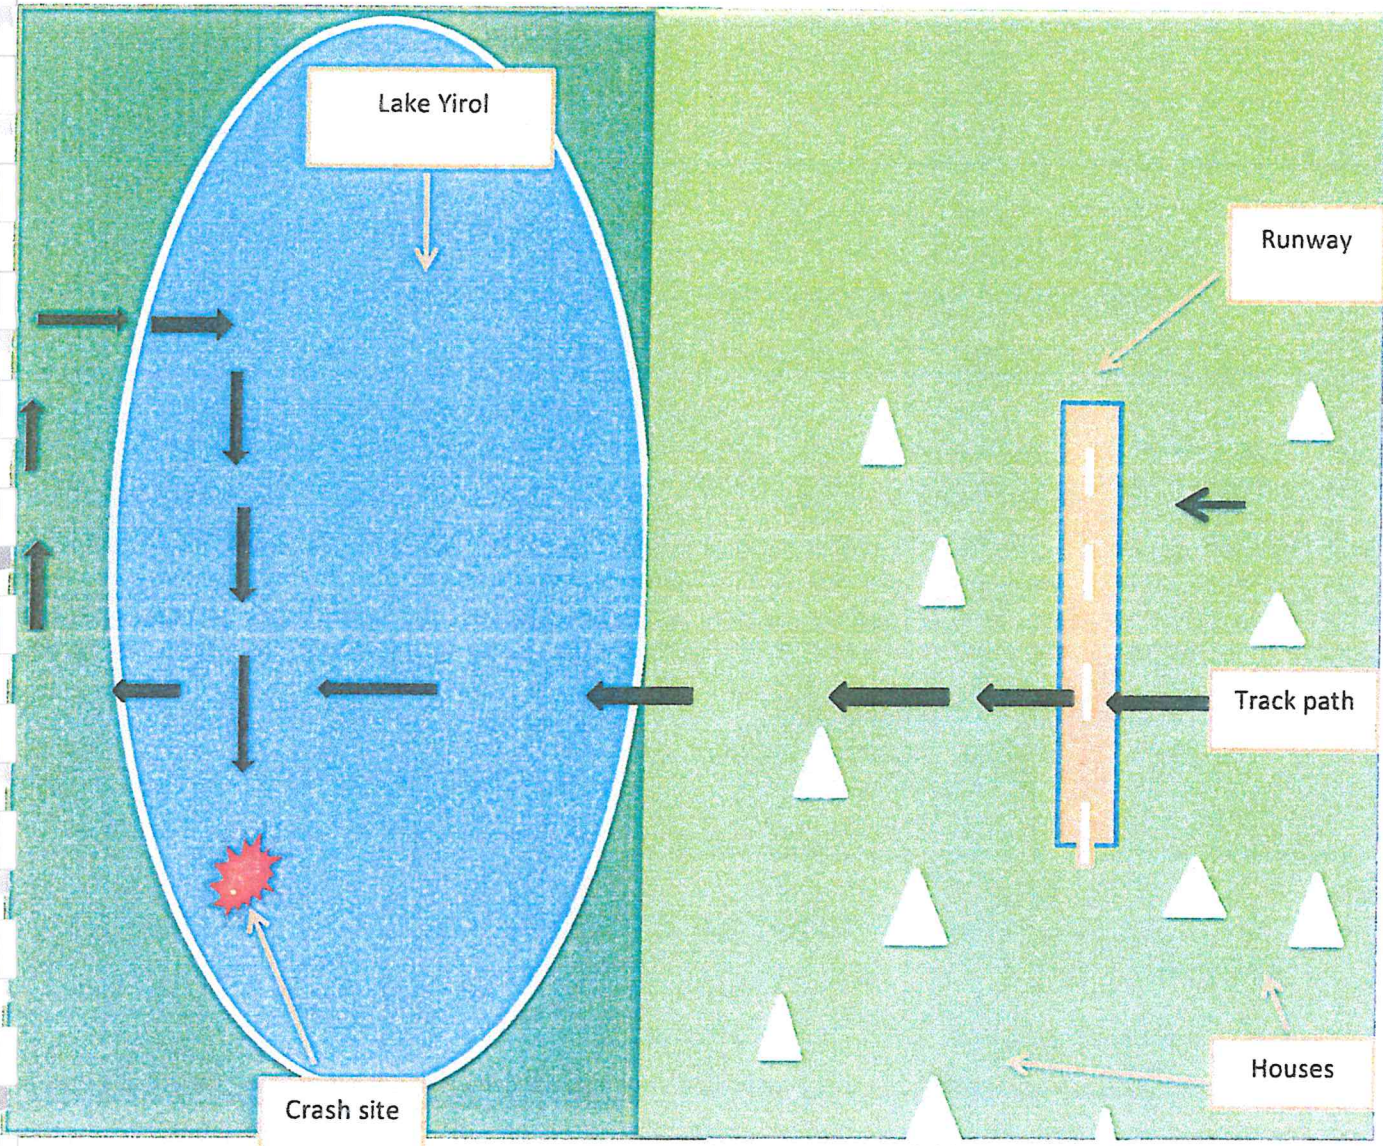
Figure 3: Sketch of the Aircraft crash path.

manifesto, the aircraft had 21 passengers, comprising of 17 adult, 4 children and 2 flight crew totaling to 23 people onboard. The aircraft flew for a total of about 45 minutes to Yirol Town before it crashed into the western side of Lake Yirol about 1.6 km west of the Yirol airstrip.

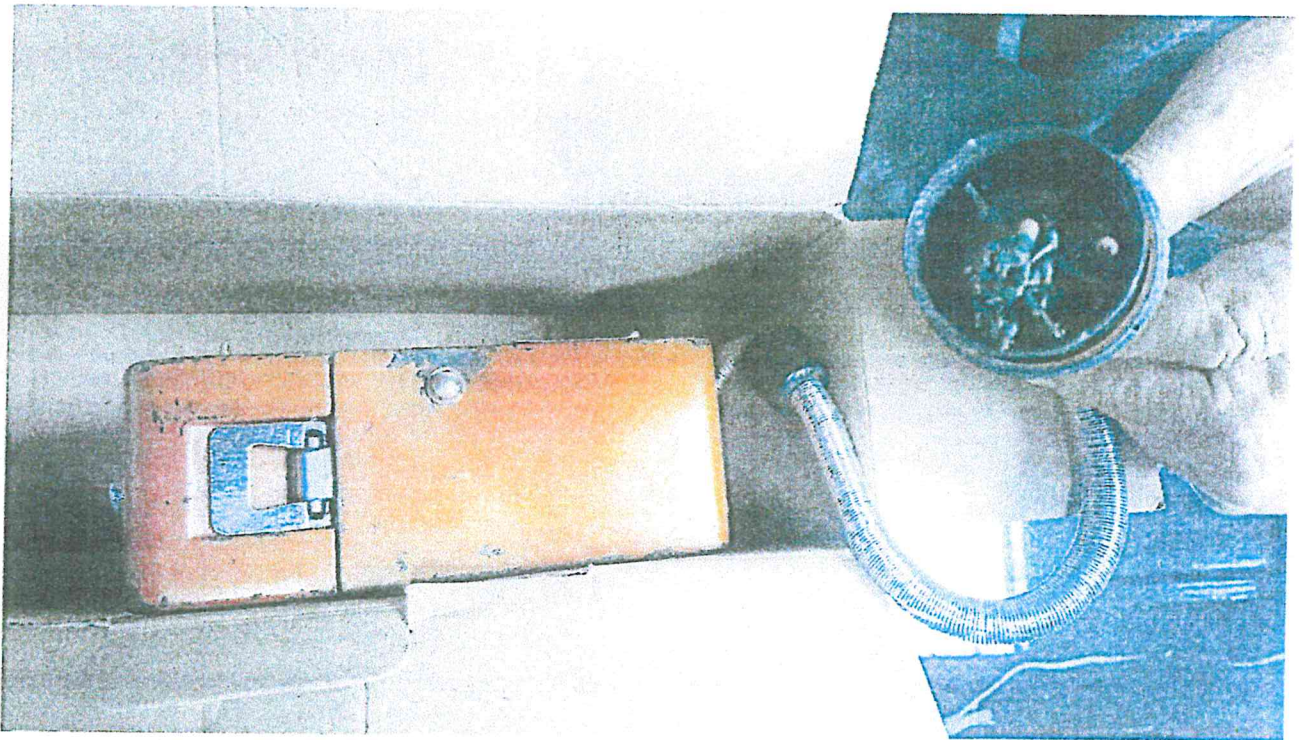
During the visual examination of the recording device, no damage was found, therefore, a decision was made to extract the recording cassette with a photosensitive film and carry out the development of the film in a special chemical medium at the photo laboratory. After the film development, the presence of flight data on the photosensitive film was confirmed.

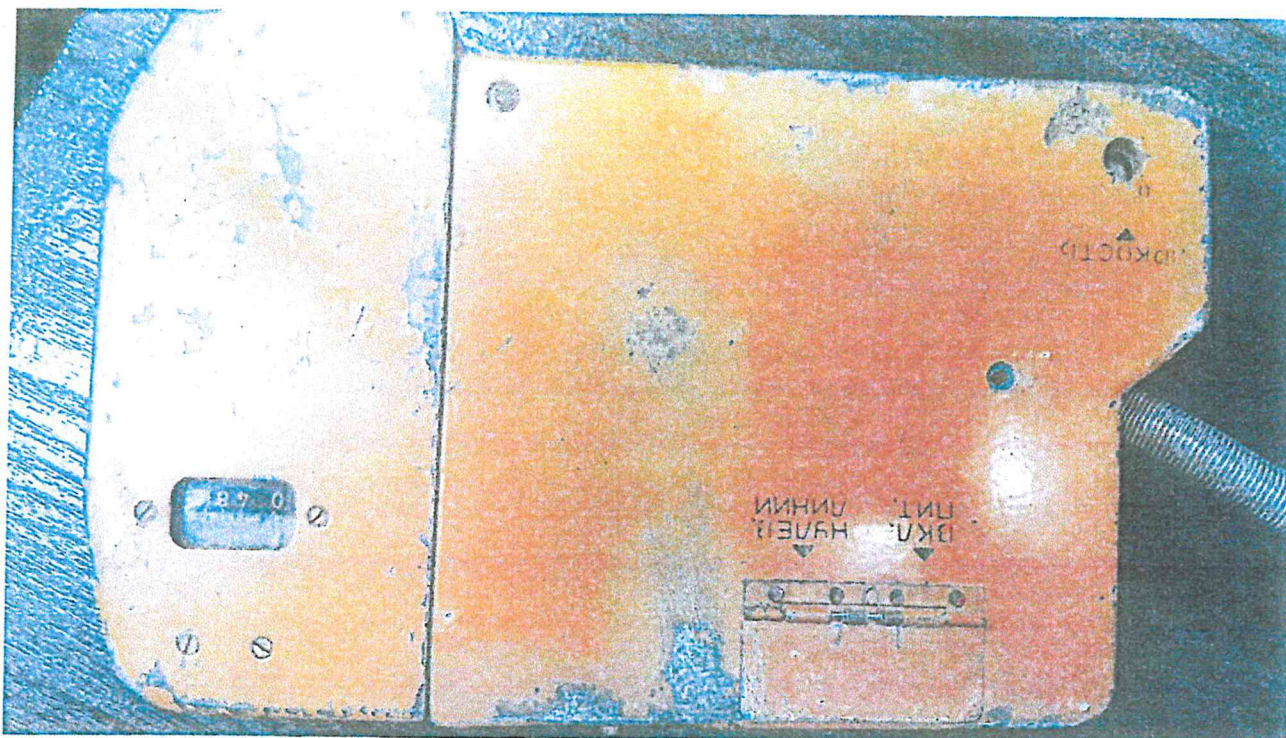
As a result of analysis performed by the laboratory experts, it was found that the accident data is missing on the photosensitive film because, by the time of the accident, the photosensitive film inside the cassette had come to its end. As a result of the analysis, experts concluded that the lack of flight data information does not provide a chance to determine the cause of the accident by this flight data recorder.
