Aircraft Accident Investigation Board

Final Report

State File Number: A971228EPIDG
Type of Occurrence: Accident
Date of Occurrence: 19 Mar, 2019
Place of Occurrence: Tehran Mehrabad Airport
I.R of Iran
Aircraft Type: F28 MK 100
Registration: EP-IDG

Operator: IRAN AIR

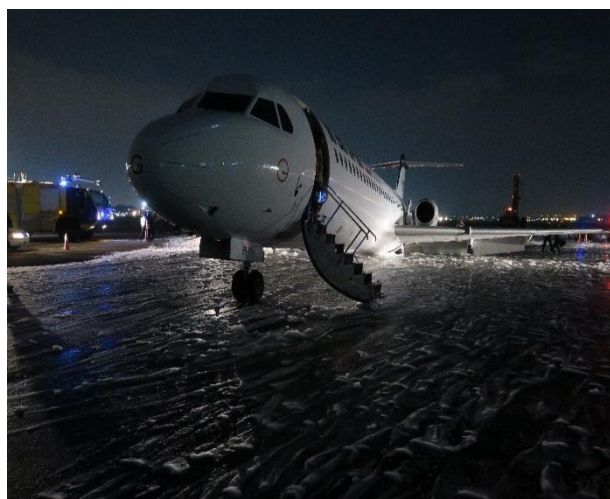
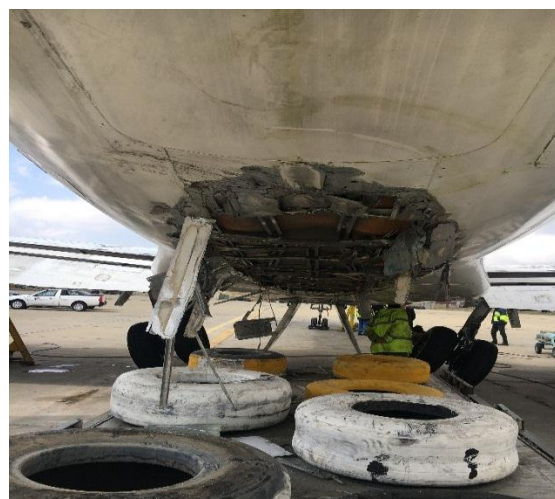
On the next day, by lifting up the aircraft from the trolley cart, the main landing gear doors automatically opened and the main landing gears were lowered and locked. The aircraft was pushed to a hanger for further inspection and related analysis.

As a result of emergency landing with MLG up, the beneath structure of the aircraft (aft part) and MLG doors were damaged substantially and rear edge of Flap sustained damage partially too.

The fuselage was damaged from frames 18921 to 19861 and frames 20320 to 25016 on lower belly (stringers 1 to 4 and 70 to 74),

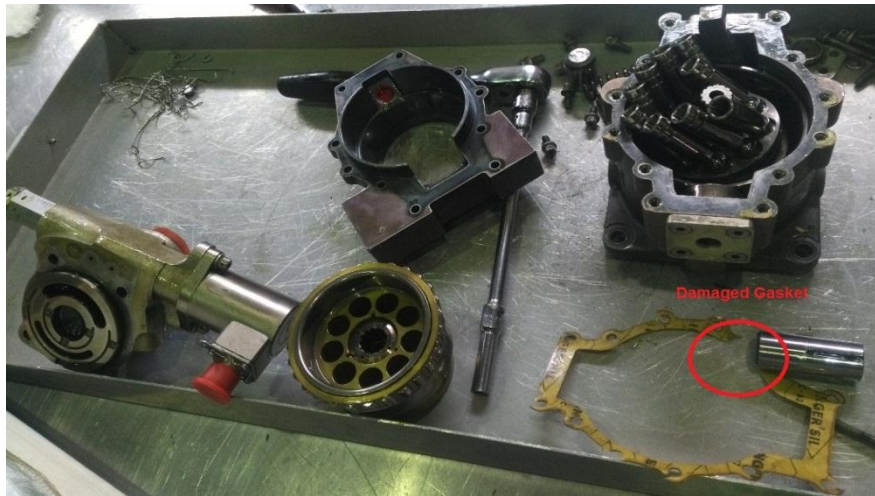
- Task 29-00-00-811-811-A "Engine Driven Pump (EDP) Failure.
- The Pump Leakage at the time of accident occurrence was inspected. Hydraulic Pump {Aerohydrous" P/N #42046 S.N: B159AB "{Shelf Life Expiry: 26.3.2021 }

The inspection showed that due to faulty check valves, the high pressure of hydraulic fluid occurred and caused pressure and temperature to rise in return line and consequently EDP case outlet pressure rose, EDP overheated and subsequently gasket no. 295 was dismantled from its original position and caused hydraulic "leakage".

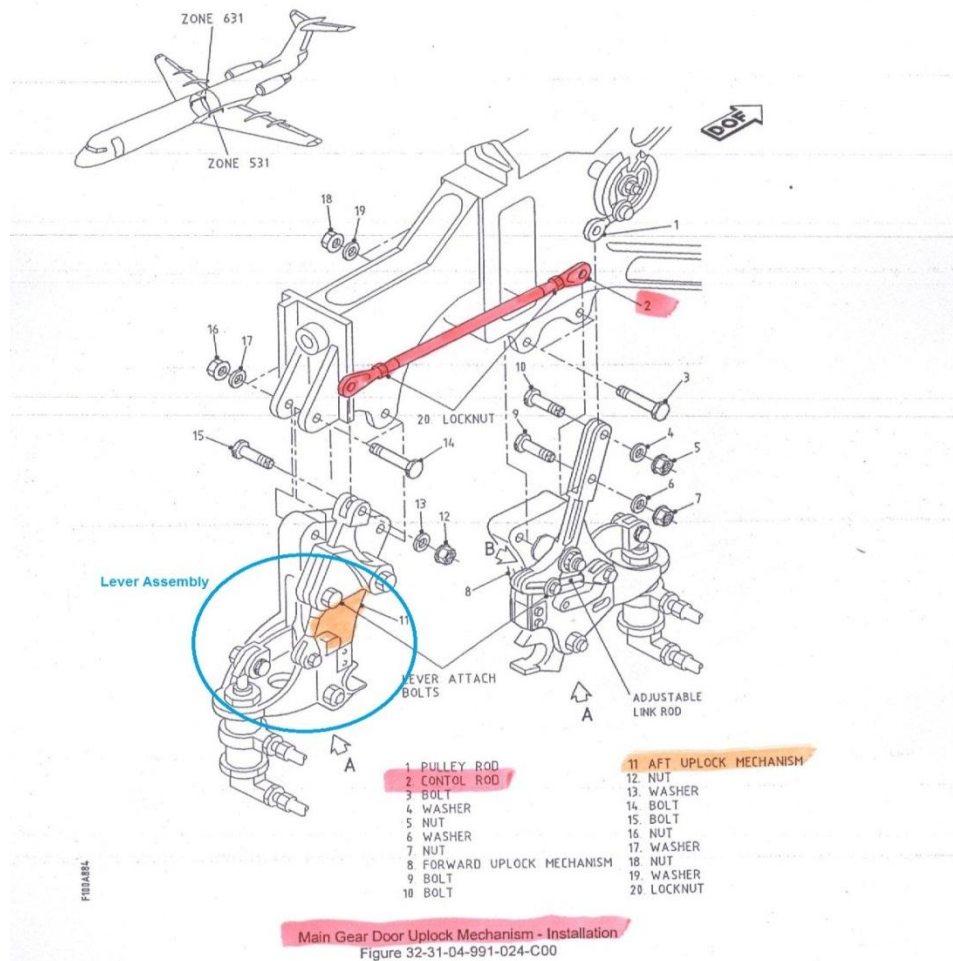
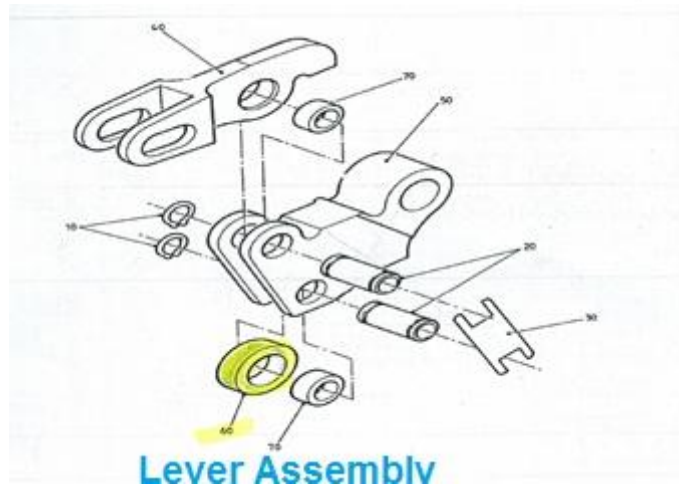
According to the design characteristic of the aircraft, the L/G should extend with their weight force normally, while alternate manual L/G extension by releasing up-lock mechanism. All four door up-lock mechanisms of aircraft landing gears were focused on. In accordance with CMM:32-31-04, page 1076, item No.60 , rollers of the door up lock, especially in FW R/H position (3EA) found seized, which caused hard movement of alternate extension lever.

1. The control rod of up-lock mechanism required small adjustment.
2. Investigating on up-lock mechanism lever assembly with maintenance reference CMM32-31-04 on page 1076, items 40&50 revealed that shape and measurement of holes of this lever has changed too.
3. In the troubleshooting process of up- lock mechanism, required fine adjustment on control rod was done in accordance with AMM 32-31-04.
4. Required lubrication on up- lock mechanism.
5. With the made rectifications on the above cases, the alternate control lever force was reduced to its lb40 within limit and the procedure for performing the functional test landing gear alternate control had been performed smoothly according to Task: 32-33-720-815-A.

Evidence such as the seized rollers, lever assembly deformation and up-lock mechanism failure may have emerged due to component aging and some other defects need adjustment and lubrication. Only 297 cycles and 327 hours of flight after “C” check could not have caused such an extensive failure on the alternate landing gear extension. It can be analyzed that periodical L/G inspections at the last maintenance action (C06 check) might not have been of good quality. The existence of each item mentioned above is indicative of the long time they took to occur; clearly, these problems did not happen suddenly. To analyze seizing of up-lock mechanism, generally the following subjects should be noted:
