ACCIDENT

Aircraft Type and Registration:	Britten-Norman Islander, VP-MNI	
No & Type of Engines:	2 Lycoming 0-540-E4C5 piston engines	
Year of Manufacture:	1971 (Serial no: 183)	
Date & Time (UTC):	23 September 2019 at 2020 hrs	
Location:	John A Osborne Airport, Montserrat	
Type of Flight:	Commercial Air Transport (Passenger)	
Persons on Board:	Crew - 1	Passengers - 6
Injuries:	Crew - None	Passengers - None
Nature of Damage:	Left tailplane spar and elevator bent, left wingtip and aileron damaged	
Commander's Licence:	Commercial Pilot's Licence with Montserrat Certificate of Validation	
Commander's Age:	30 years	
Commander's Flying Experience:	660 hours (of which 303 were on type) Last 90 days - 85 hours Last 28 days - 21 hours	
Information Source:	AAIB Field investigation

Synopsis

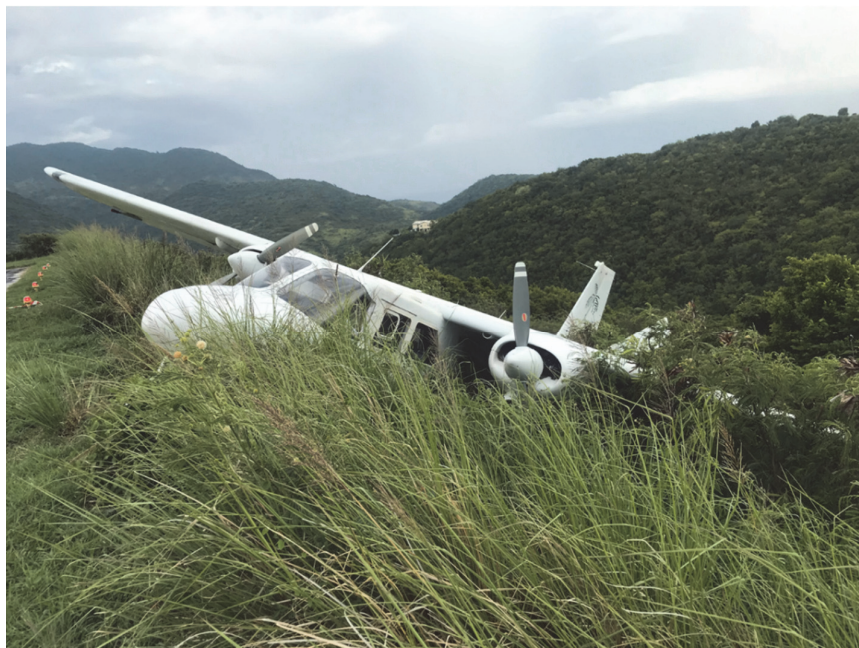
Figure 1
Aircraft accident site

Faint scald marks made by the tyres on the runway showed the aircraft skidded approximately 150 m before veering on to the grass approximately 19 m from the end of the runway. The aircraft continued across the grass whilst braking, leaving discoloured tyre marks in the grass. The right main wheels struck one of the runway threshold lights. During the transit across the grass the aircraft rotated through 180° immediately before dropping backwards down the sloping side of the ravine at the end of the runway. The aircraft's rearward motion was slowed by dense reeds and bushes on the sides of the ravine. It stopped when the left tailplane and wingtip hit the barbed wire and chain link perimeter fence approximately 8 m below the level of the runway. As the aircraft stopped the Bendix-King KX165 Nav-Comm unit fell out of its rack mount onto the cockpit floor. Figure 1 shows the aircraft after the accident held by the fence and at an approximate angle of 30°.

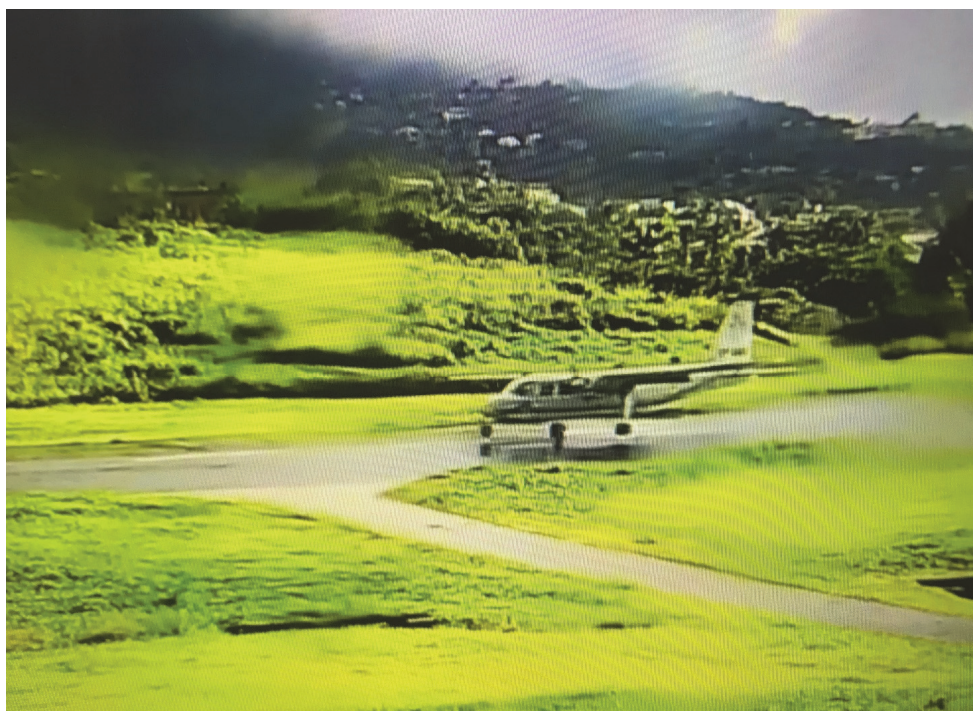
A CCTV camera was mounted on the ATC tower and recorded the latter stages of the final approach and touchdown. From these images, the touchdown groundspeed was estimated to be 79 kt. Figure 2 shows a single frame of the recording at the point of touchdown with the wet runway and water spray being produced by the main landing gear wheels.

VP-MNI at the point of touchdown on Runway 10

The evidence derived from the CCTV recording shows the aircraft to be landing at 79 kt. On landing the wheel brakes were applied but were ineffective. The tyre marks on the runway, the very faint white tyre edge lines, show the tyres were locked and skidding on the tarmac surface. They were generating enough heat to scald and blister the vulcanised rubber of the tyres. The tyres were therefore in contact with the surface and created superheated steam from the moisture present hence the white marks. This evidence leads to the conclusion that the aircraft was skidding but not aquaplaning but is consistent with the description of the runway being 'wet'.

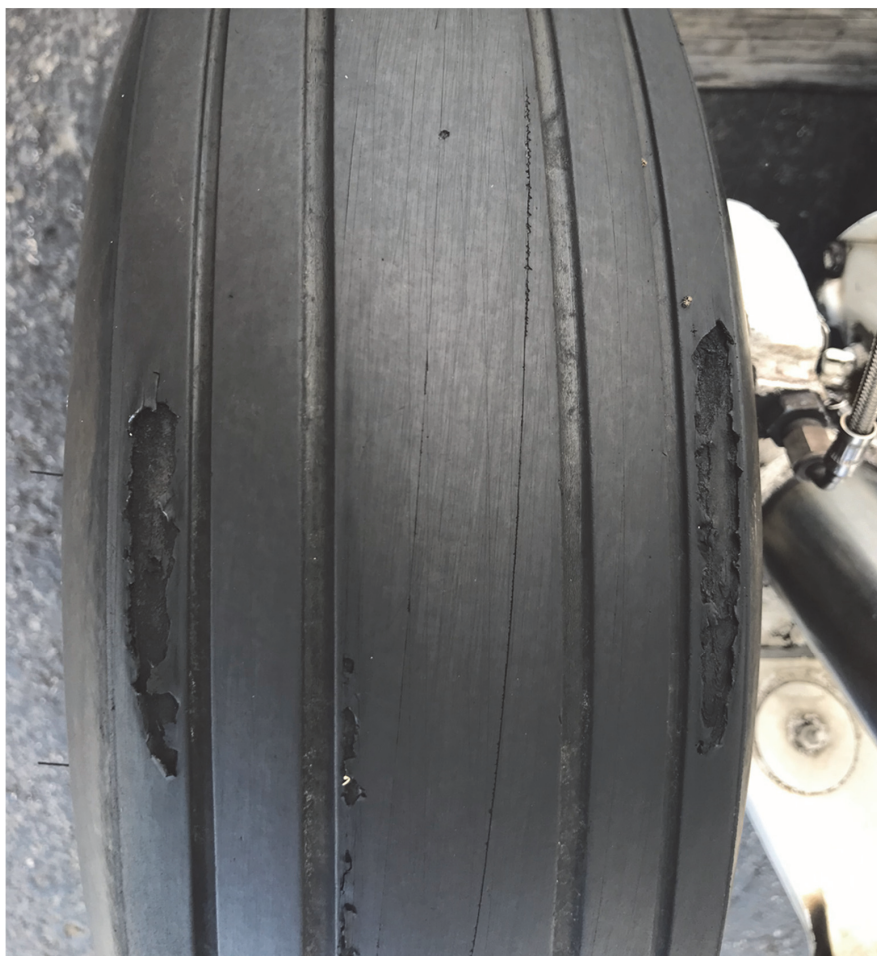
Figure 4

The landing gear and wheel brakes were undamaged. The tyres did not deflate but the nose and right inner mainwheel had tufts of grass trapped between the tyre bead and rim. Blistering was present on three of the mainwheel tyres; the right outer tyre rolling surface showed evidence of blistering, approximately 75 to 100 mm long, at its edges and to a lesser extent on its centre tread (Figure 4). In general, the tyres showed wear commensurate with normal use.

Tyre wear and damage

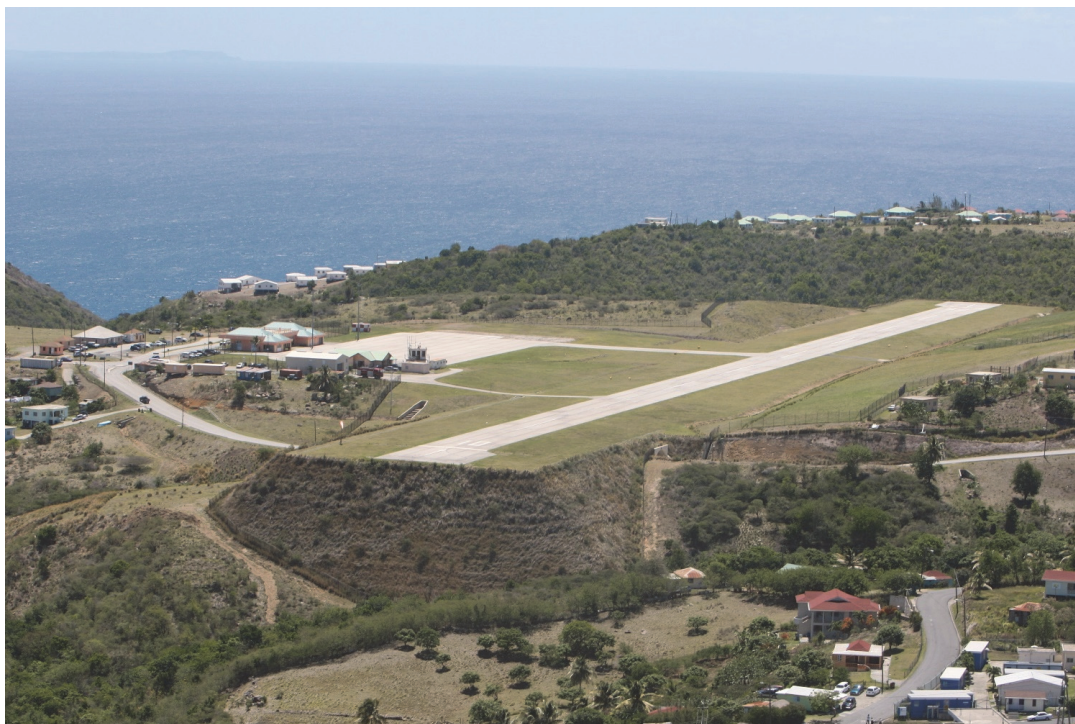
A significant aspect of the airport and its surroundings is the graded, downslopes at both ends of the runway, which in the event of an overrun have the potential to cause damage to an aircraft and injury to those onboard. Runway 28 has a clearway of 277 m and an open departure towards the sea; Runway 10 has a clearway of 70 m over a ravine, at the end of which is a hill rising to 67 ft above the threshold elevation, 350 m from the end of the runway.

Figure 6 shows the airport from south-west of the Runway 10 threshold end, revealing the proximity of the graded bank to the runway end and the hill at the far end.

It is recommended that the operator of John A Osborne Airport provide adequate access to the Difficult Environs at the east end of Runway 10 to ensure that emergency services can reach expeditiously the location of an aircraft which has overrun the end of the runway.

It is recommended that the operator of John A Osborne Airport install a means of arresting the progress of an aircraft that has overrun either end of the runway in order to minimise the risk of injury to those onboard and to ensure that emergency services can reach them expeditiously.

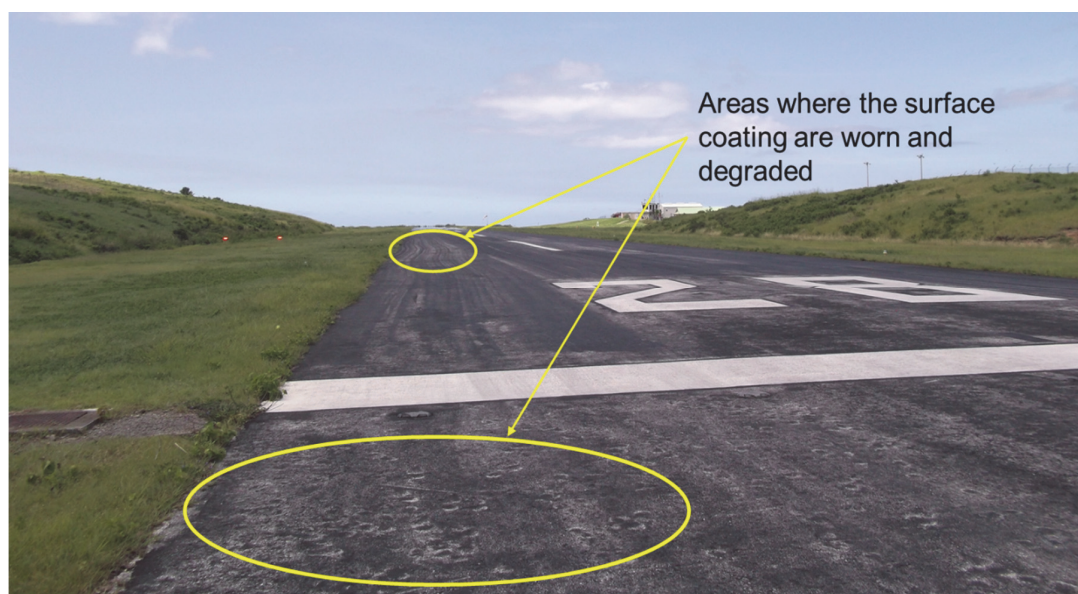
Figure 7

The runway has an asphalt on concrete surface 596 m long and 18 m wide. Over most of the runway surface the asphalt has been applied uniformly but showed evidence of mis-application and wear in some areas, examples of which are shown in Figure 7.

Examples of areas of surface degradation on the runway

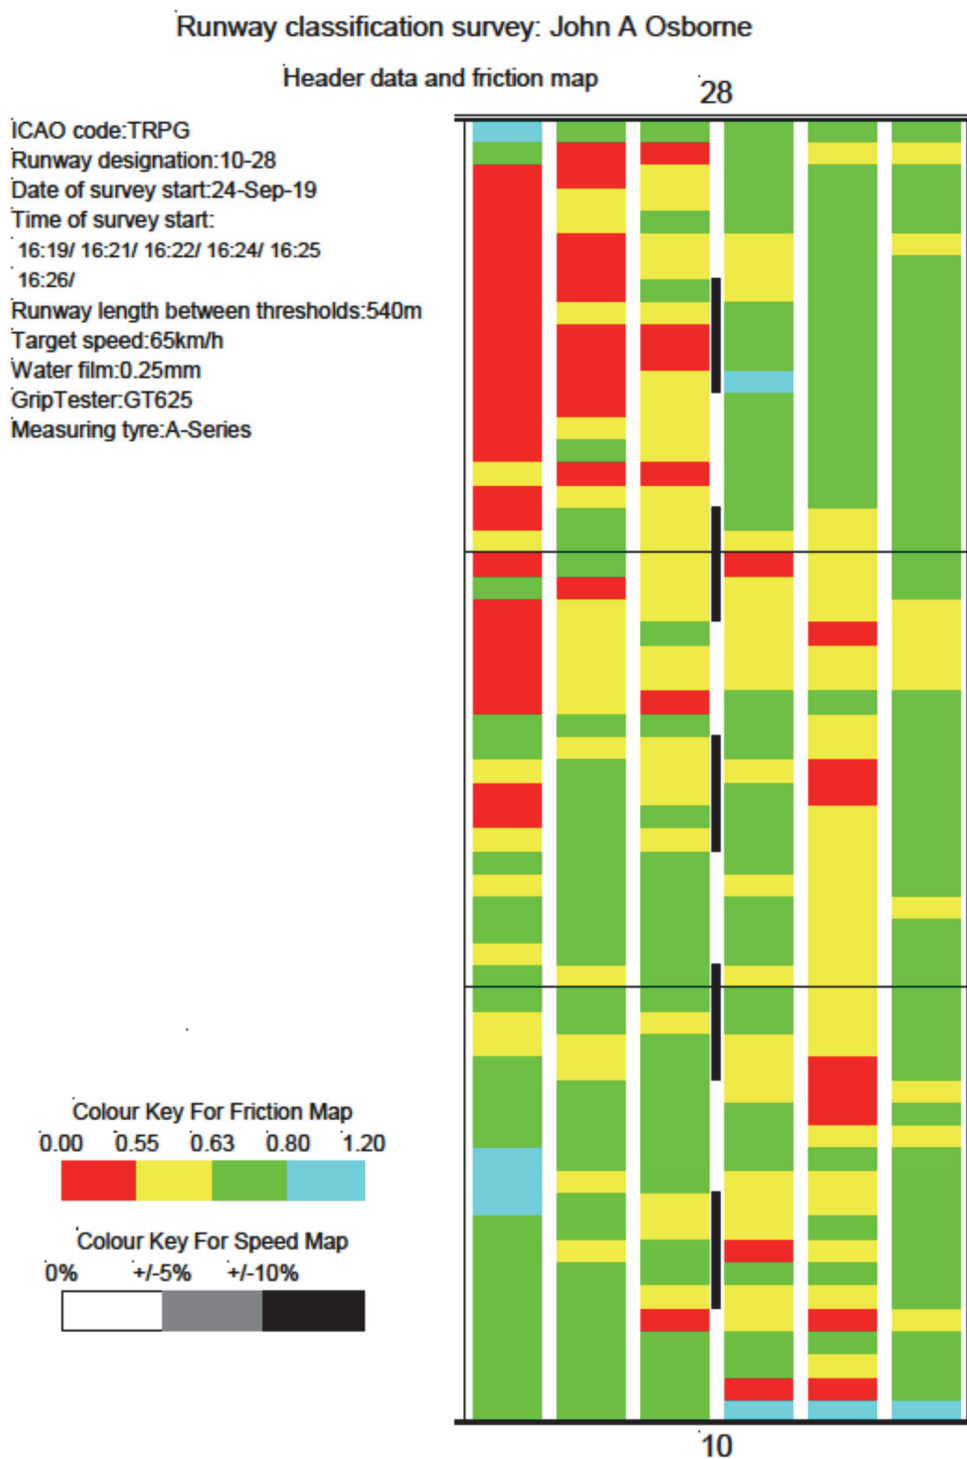
**Figure 8**

The test on 24 September 2019 showed that 54% of the surface was 'green' with a reading of above 0.63. There was insufficient information available to determine how much, if any, of the surface was also above the minimum design objective level of 0.74. 31% of the surface was 'yellow' with a reading between 0.55 and 0.63, indicating that it was above the minimum of 0.53 below which corrective maintenance activity should be considered. 15% of the surface was 'red' between 0 and 0.55. There was insufficient information available to determine how much of that surface was below the 0.53 maintenance planning level, and how much was below the minimum friction level.

Runway surface friction map (24 Sep 19) and colour key

The Grip Tester map (Figure 8) shows that the friction characteristics of part of the runway may have been below the maintenance planning level or below the minimum friction level, especially to the right of the centre line on Runway 28 adjacent to the '28' marking. Surface friction was not uniform and the surface preparation was wearing out, so plans were in place for resurfacing. A NOTAM was issued warning pilots the runway may be slippery when wet.
