FINAL REPORT

Final report of the investigation into the probable causes of the accident with the KLM Cityhopper flight KL433, Saab 340B, PH-KSH at Schiphol, Amsterdam Airport on 4 April 1994, conducted by the Netherlands Aviation Safety Board, composed of:

Hoofddorp, October 1995

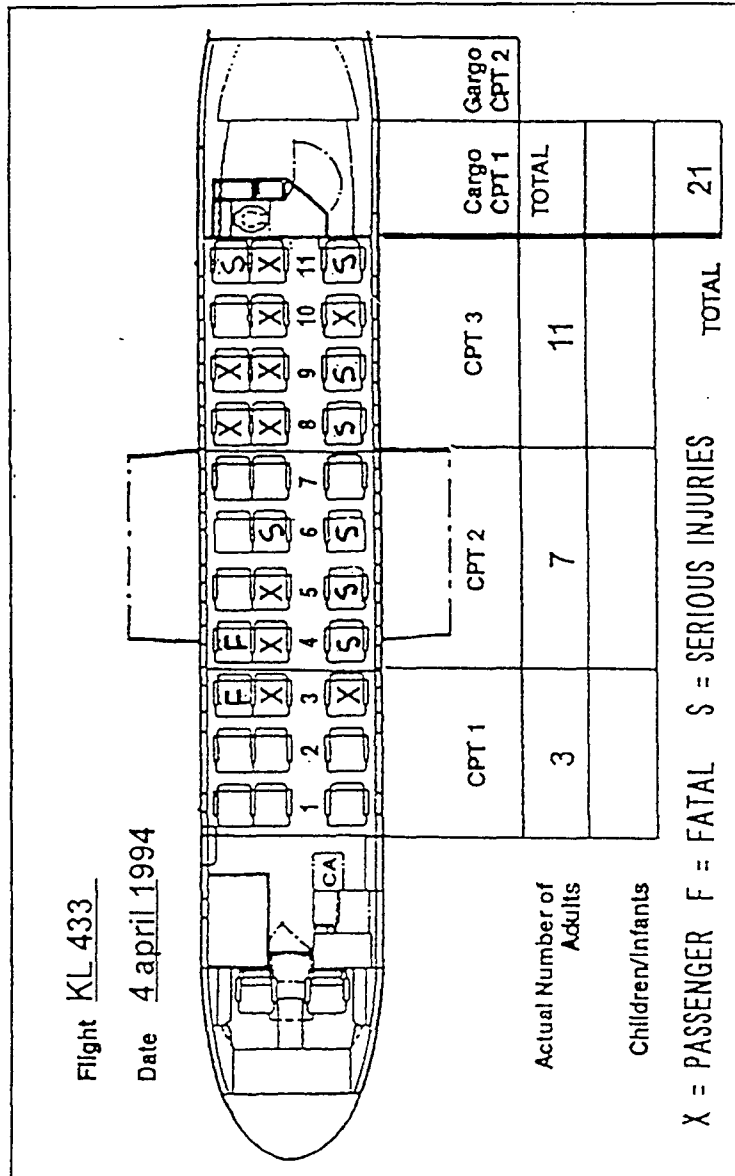
SEATING PLAN

The passengers were seated throughout the aircraft. Most of the minor or uninjured passengers were seated on the RH side of the cabin. The serious injured passengers were seated on the LH side of the cabin. Injuries varied from broken legs and arms to cuts and bruises, pelvis fractures and brain concussions. Of the wounded passengers, 8 were seriously injured and 11 suffered only minor injuries.

Saab 340B Passenger Cabin Compartments.
Seating of passengers at moment of accident.

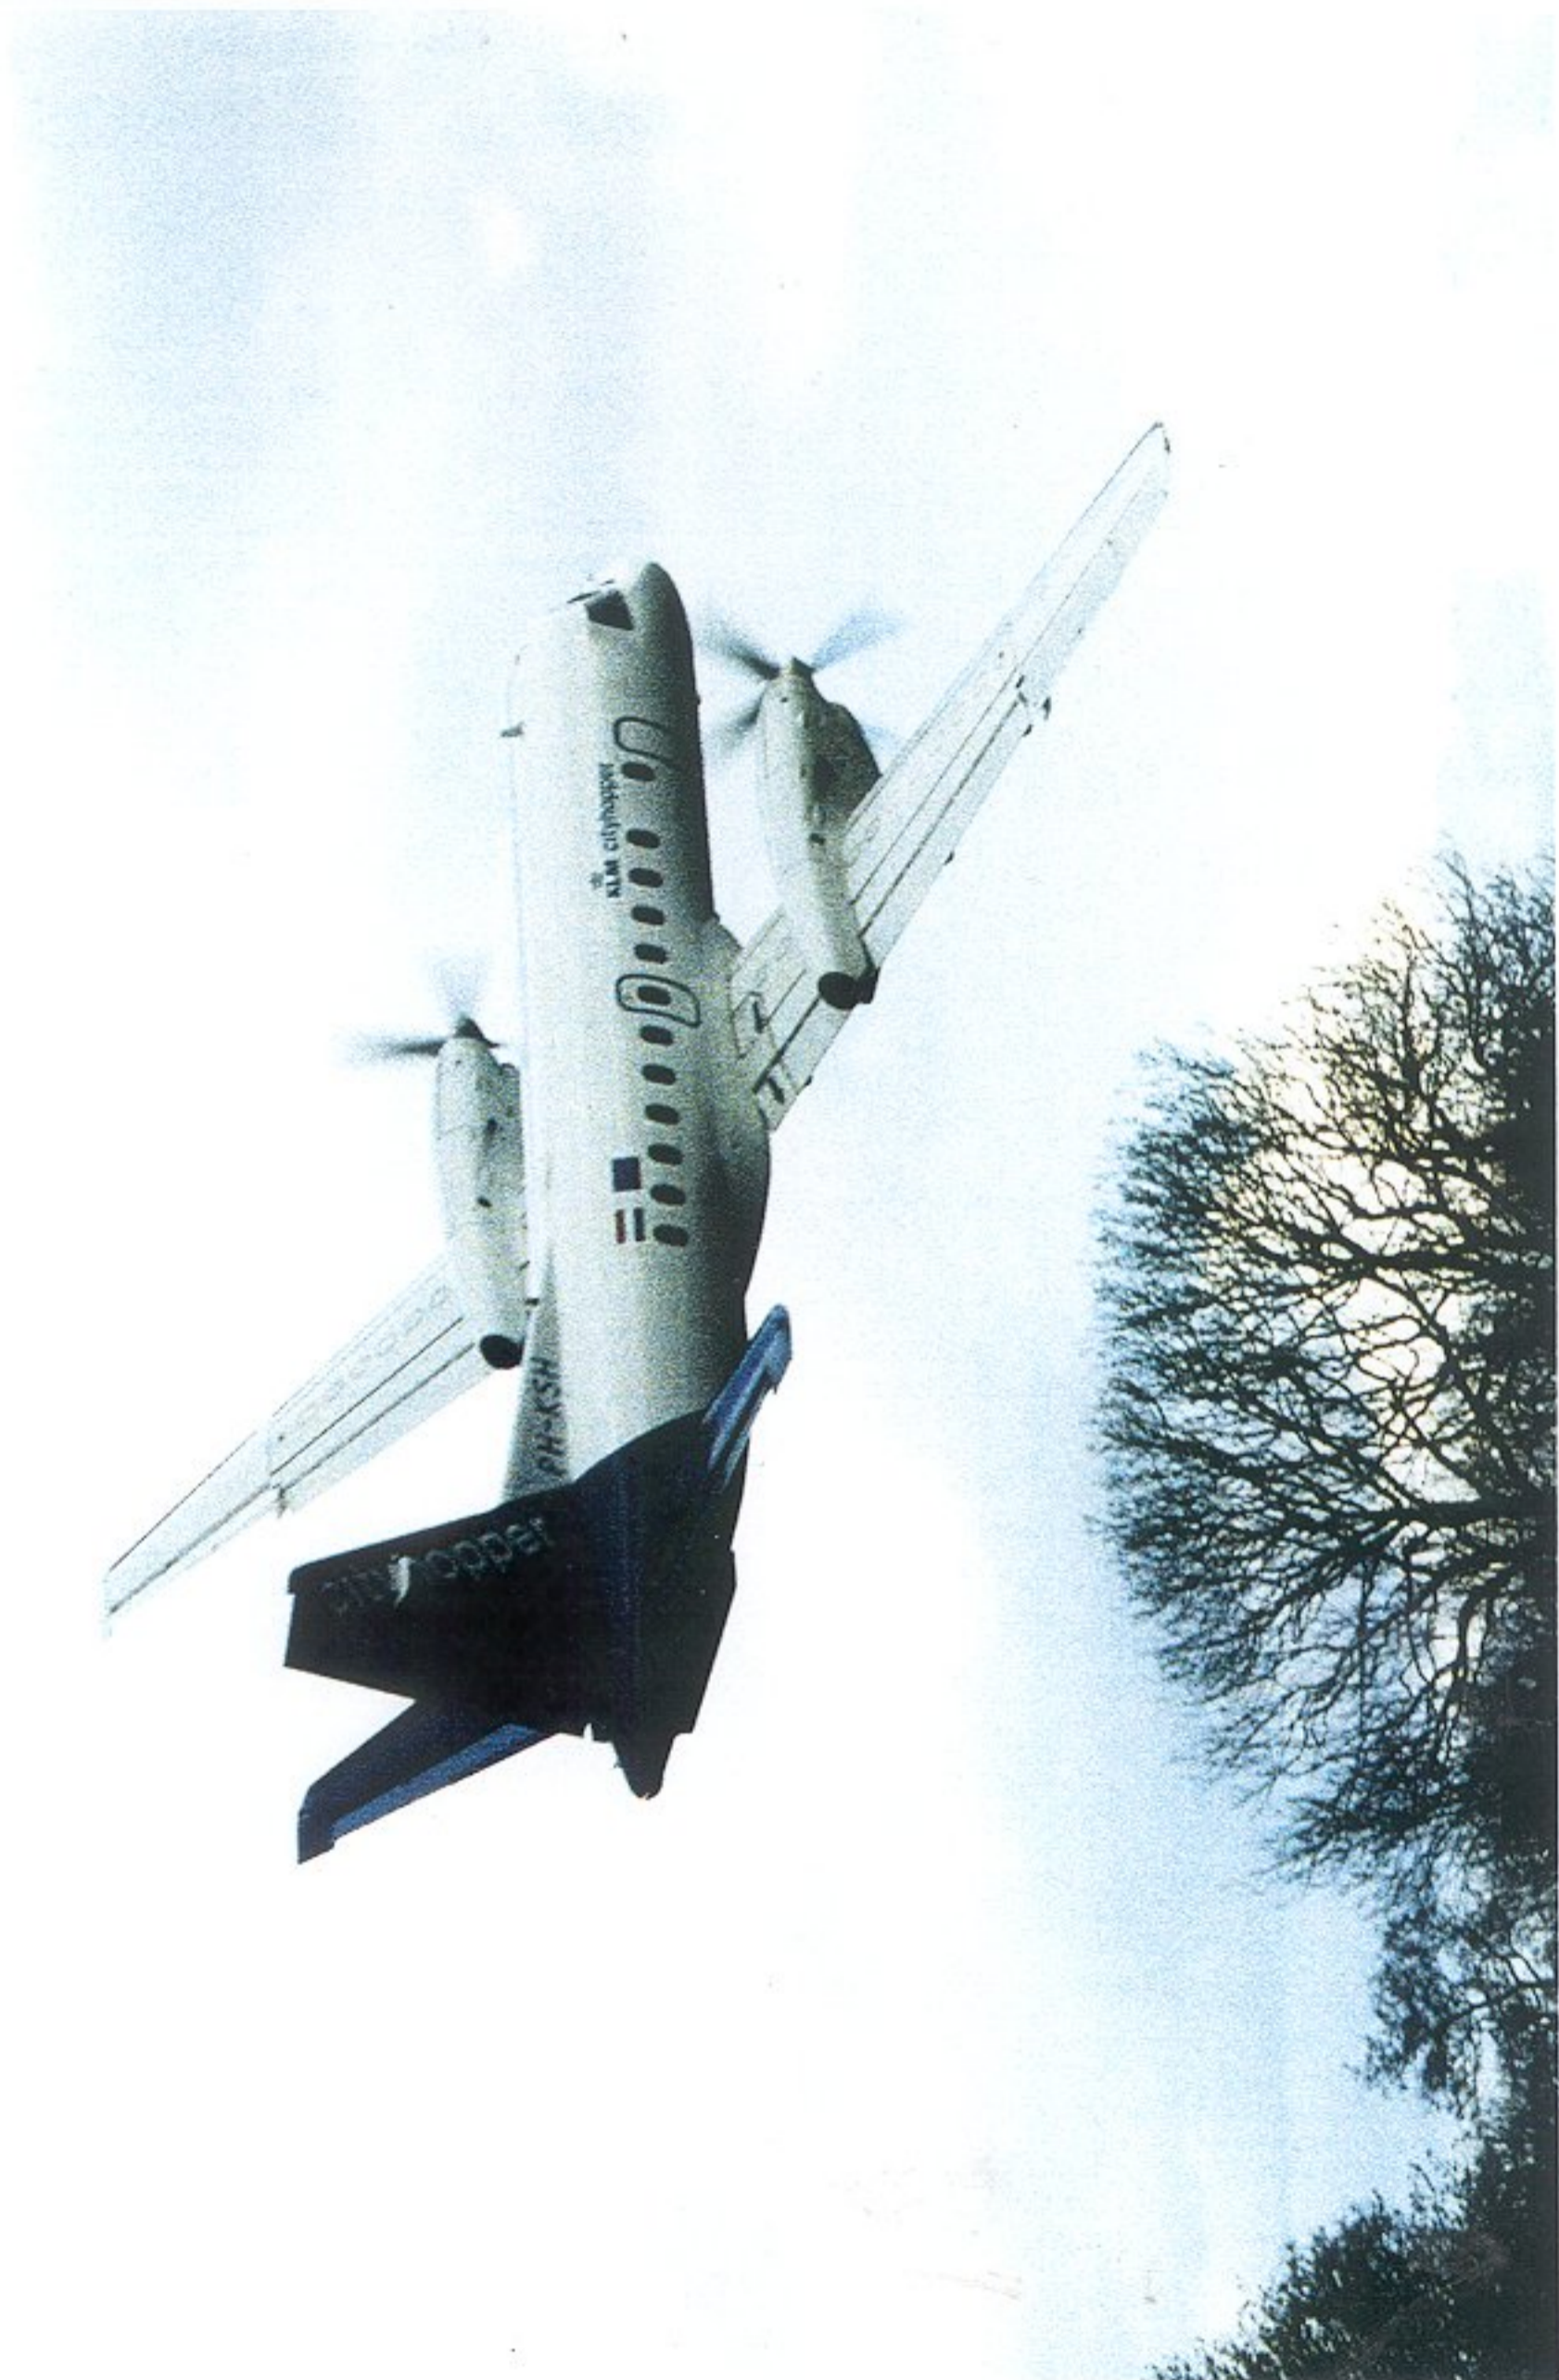
At 12:46:06, the flaps were at 7°. No conclusive data could be found on the UFDR to confirm that the landing gear reached its fully retracted position, but it could be verified from pictures taken by witnesses that the landing gear functioned normally and that it reached its fully retracted position approximately 8 seconds after the landing gear was selected up.

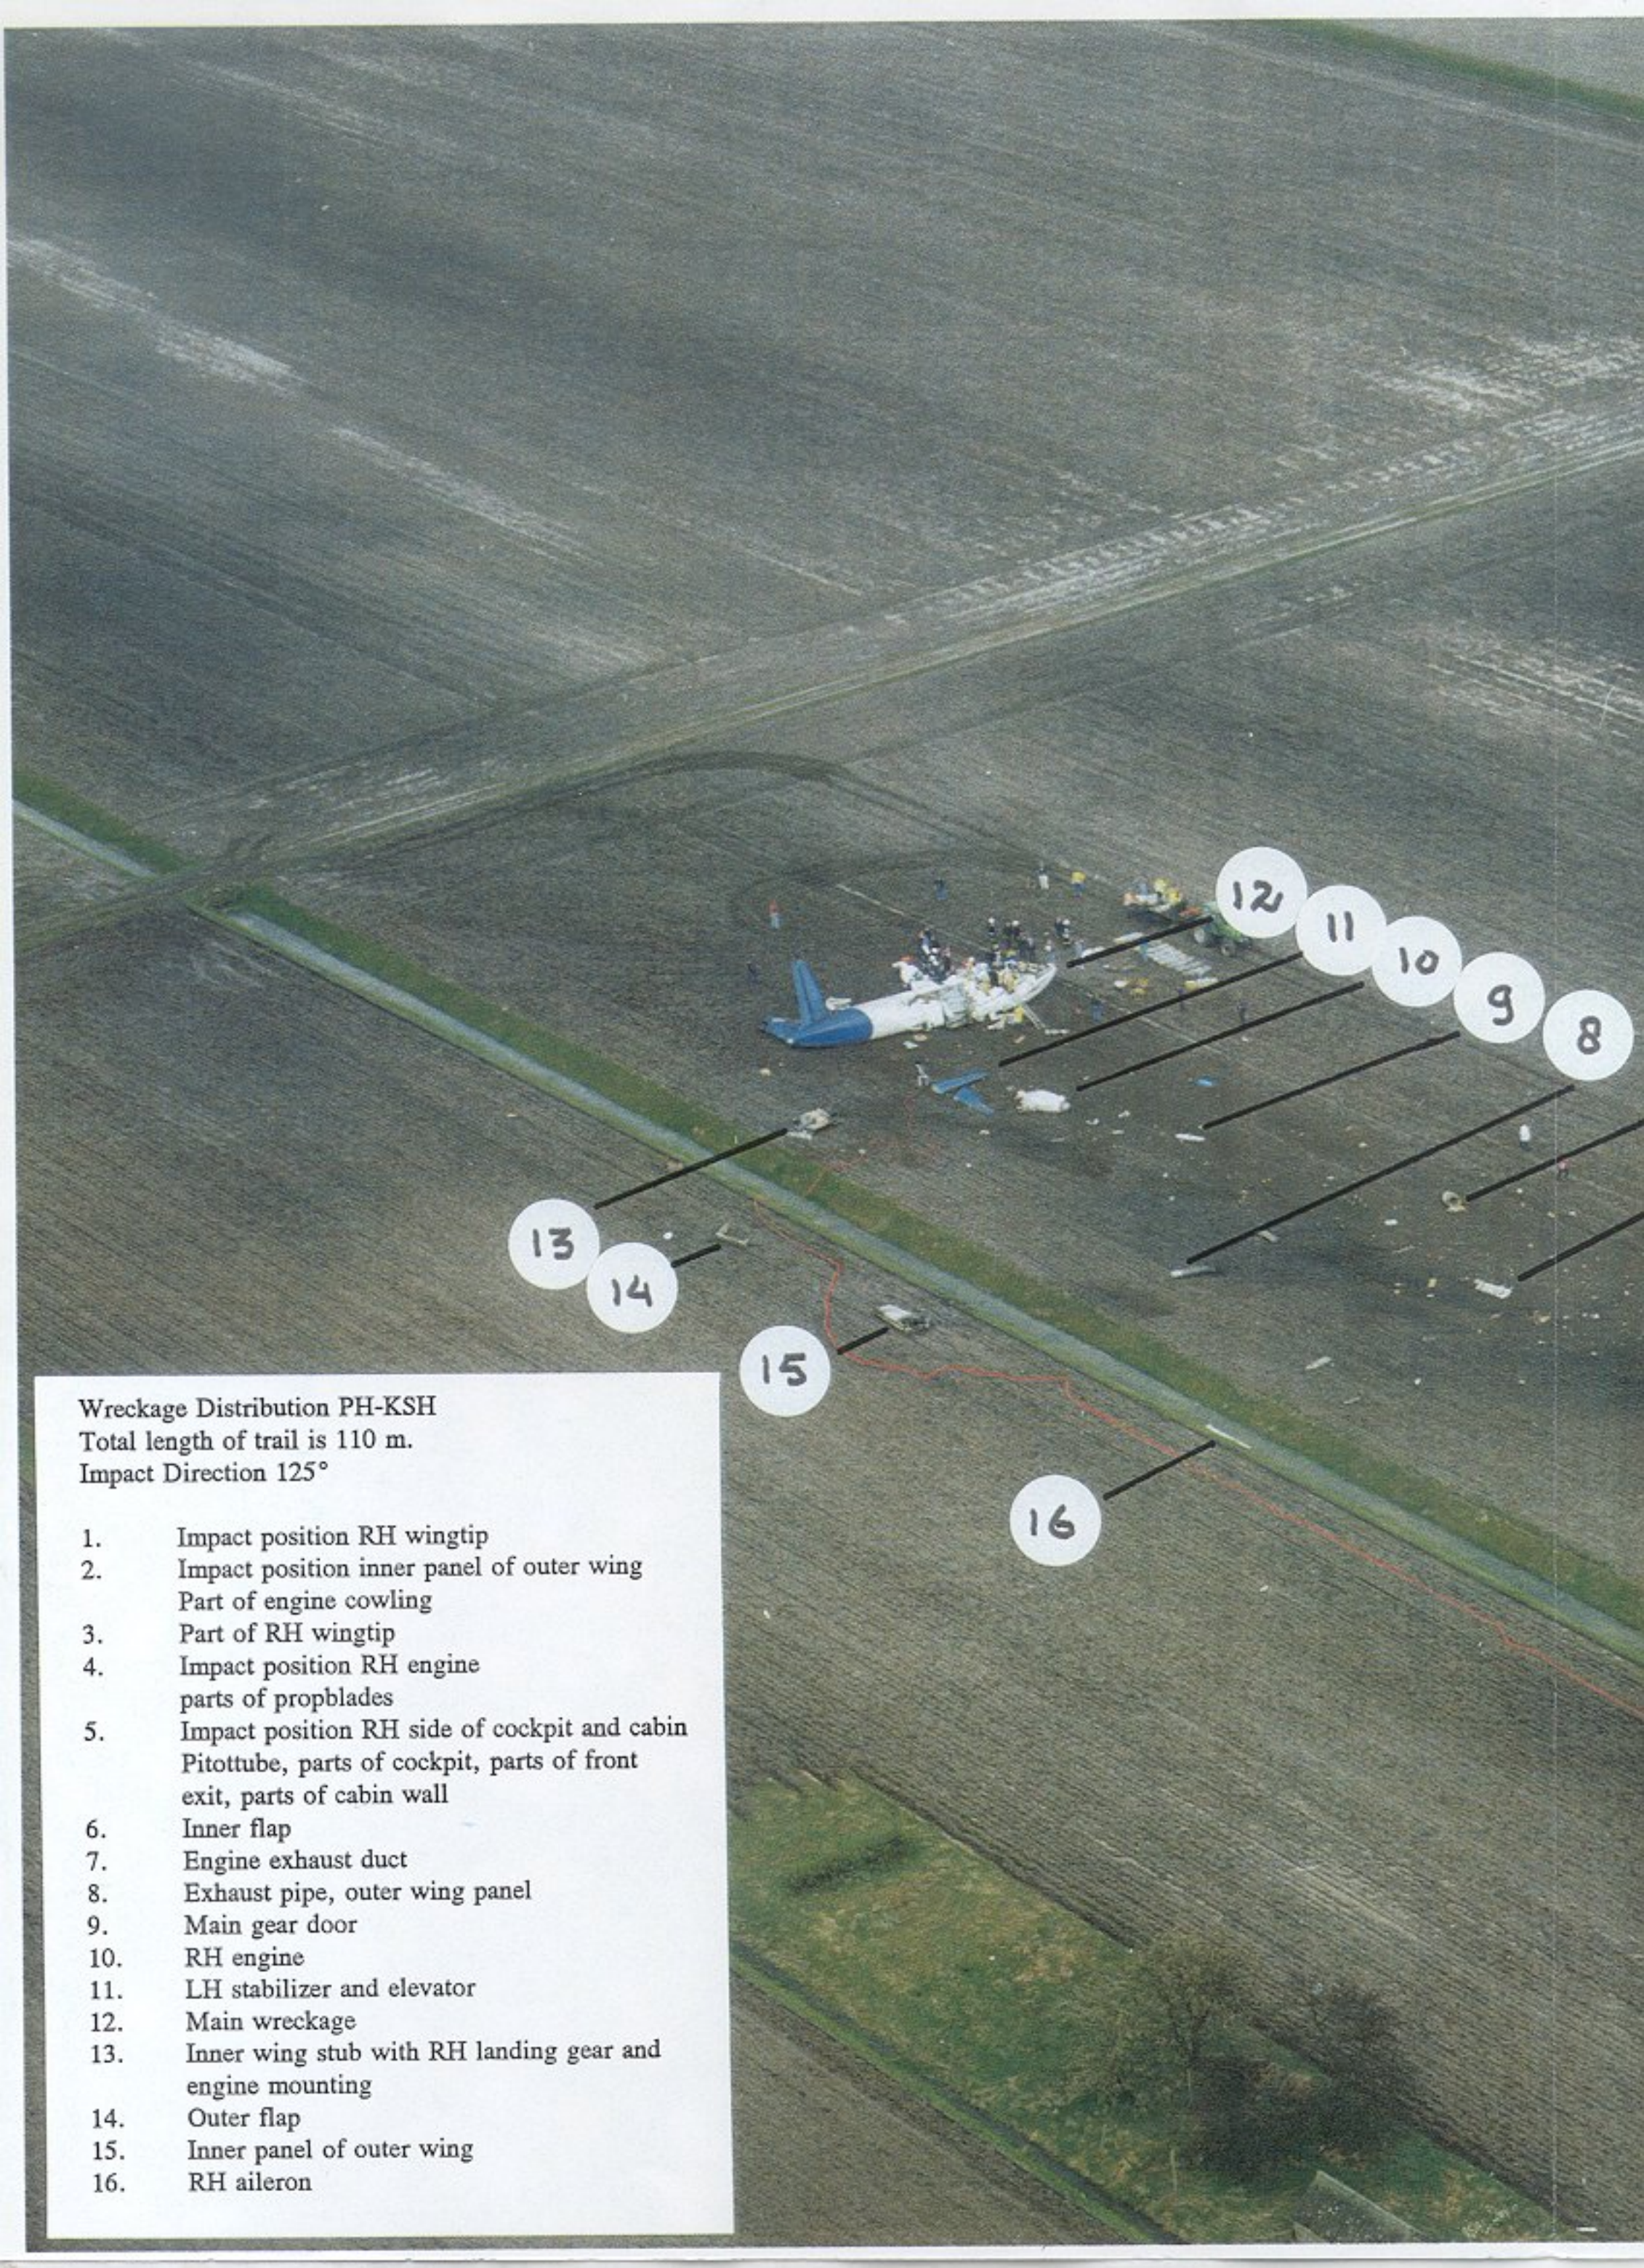
Wreckage Distribution PH-KSH

The accident site was located just outside Schiphol Airport, in agricultural terrain. The terrain condition of the accident site was wet and muddy. The wreckage came to rest approximately 560 meters right of the runway centreline and 1,125 meters beyond the threshold of runway 06.

Total length of trail is 110 m.

Impact Direction 125°

1. Impact position RH wingtip
2. Impact position inner panel of outer wing
Part of engine cowling
3. Part of RH wingtip
4. Impact position RH engine
parts of propblades
5. Impact position RH side of cockpit and cabin
Pitottube, parts of cockpit, parts of front
exit, parts of cabin wall
6. Inner flap
7. Engine exhaust duct
8. Exhaust pipe, outer wing panel
9. Main gear door
10. RH engine
11. LH stabilizer and elevator
12. Main wreckage
13. Inner wing stub with RH landing gear and
engine mounting
14. Outer flap
15. Inner panel of outer wing
16. RH aileron
