Accident on 24 March 2001 at Saint-Barthélemy (971) to the DHC-6-300 registered F-OGES operated by Caraïbes Air Transport

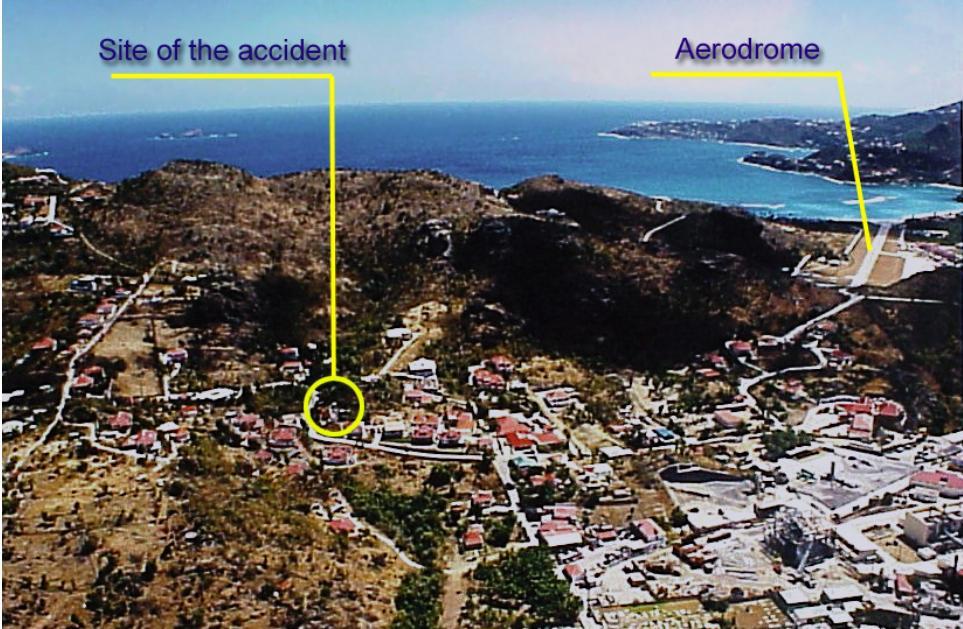
Aerial view of the site and the aerodrome

The accident occurred north-west of the aerodrome, on the west slope of the La Tourmente pass, at around six hundred metres from the threshold of runway 10.

The aircraft struck the ground right next to a dwelling located along the Corossol road, on a steep, hard piece of land planted with trees and bushes. The wreckage was spread over an area of around nine hundred square metres.

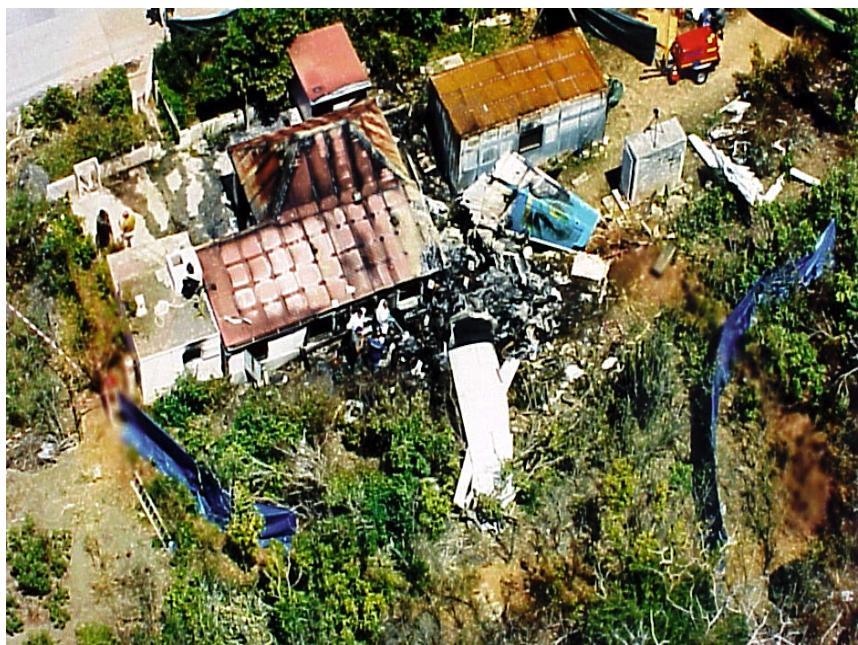
The main wreckage was grouped together. The fuselage, collected in an area of about five metres in diameter, was completely destroyed by the impact and the fire.

On either side, and in immediate proximity to the area of fire, the main wreckage found was the aircraft's two wings and tail assembly. Not much affected by the fire, they were separated from the fuselage and exhibited significant compression deformations. There were no traces of a bird strike. The rupture marks on the flaps show a symmetrical extension of 37.5% on impact.

No signs of anomalies in relation to the integrity of the controls and mechanical linkages were found.

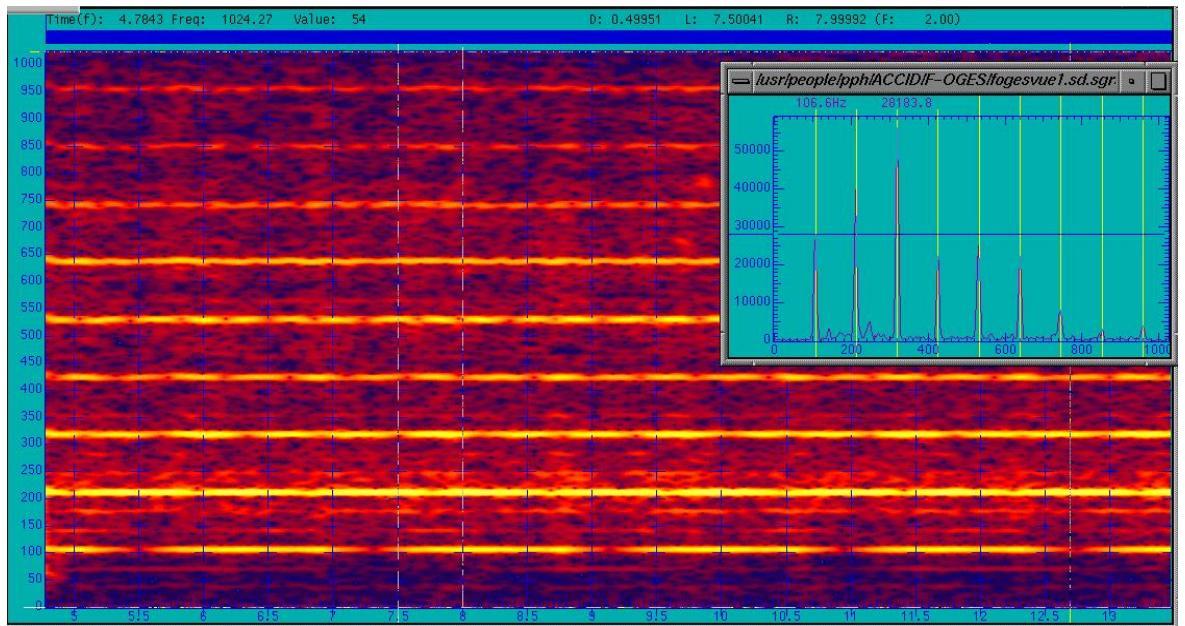
Spectral analysis of the soundtrack on take-off

<u>Take-off</u>: the fundamental frequency measured on the soundtrack was 106 Hz with eight to ten visible harmonics. The propeller rotation speed deduced from this was 2,120 RPM (in this phase of flight the manufacturer specifies a rotation speed of around 2,110 RPM). The absence of a double peak shows that the propellers were turning at the same airspeed.

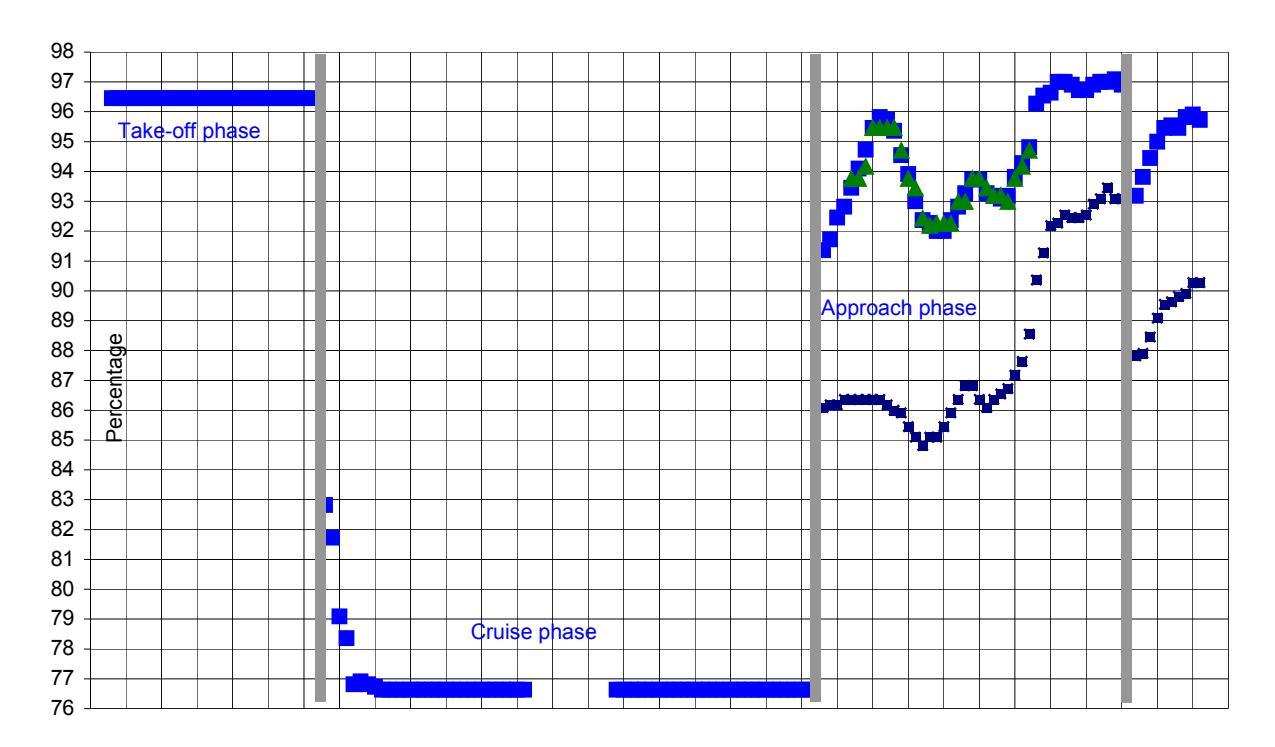
The rotation speeds of the propellers during flight TX 1501, expressed as a percentage of the reference rotation speed as defined by the manufacturer, are represented on the following graph. The discontinuities between the points correspond to the ends of each recording.

The asymmetry between the two propellers during the approach phase was around 9%, which is consistent with normal use (see following). An increase in RPM of the order of 6% to 8% was also noted.

In conclusion, examination of the film found in the wreckage did not bring to light any malfunctions or anomalies for that part of the flight which was recorded.

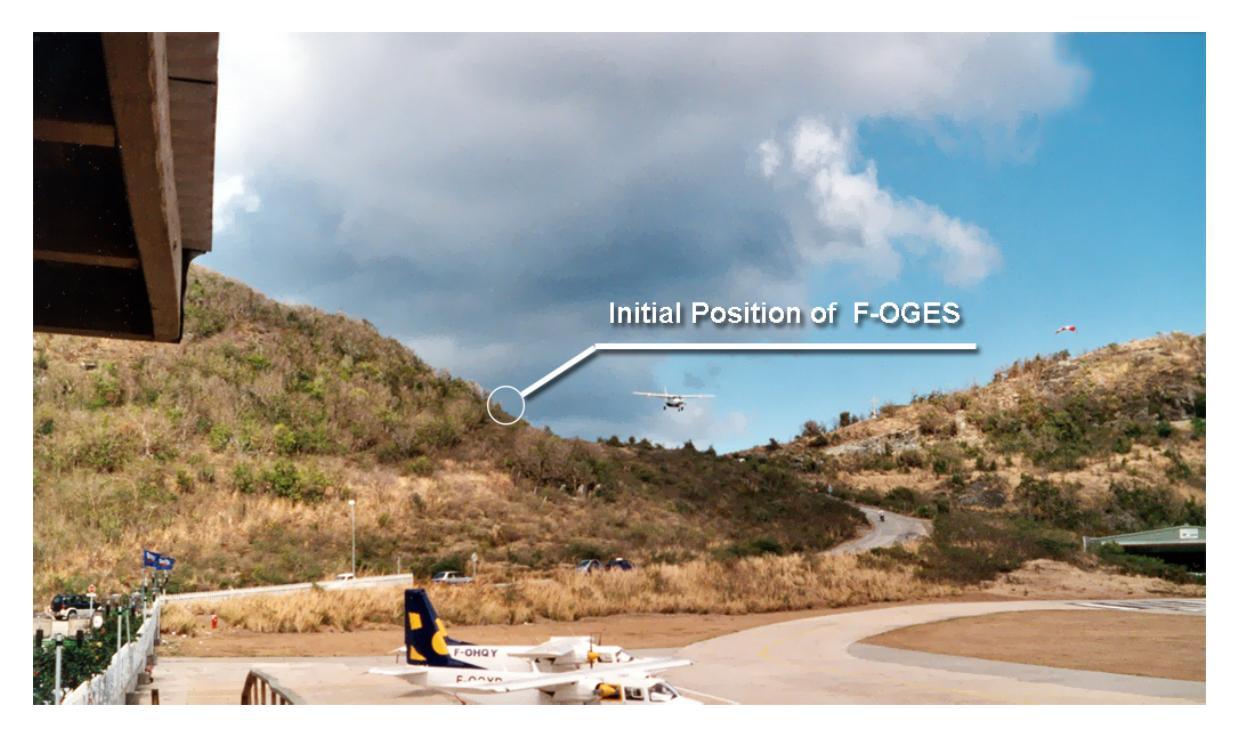
The photo shows an airplane belonging to another airline on passing the pass. The circle indicates the initial position of F-OGES during its turn to the left.
