**PRELIMINARY**  
**KNKT.15.08.17.04**

**KOMITE  
NASIONAL  
KESELAMATAN  
TRANSPORTASI**

*Aircraft Accident Investigation Report*

**PT. Trigana Air Service  
ATR 42-300; PK-YRN  
Near Oksibil, Papua  
Republic of Indonesia  
16 August 2015**

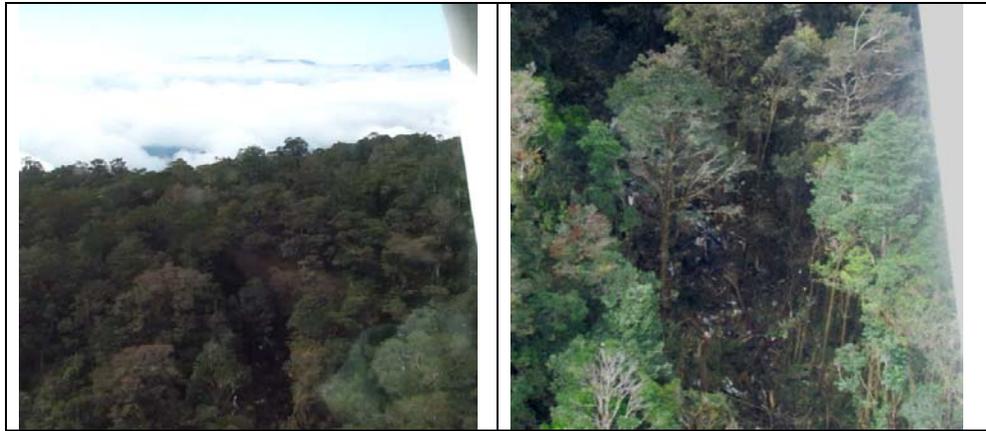
**Figure 3: The accident site pictures taken from an aircraft**

The aircraft wreckage was found on a ridge of Tanggo Mountain, Okbape District, Oksibil at approximately 8,300 feet AMSL at coordinates of 04° 49.289'S, 140°29.953'E, approximately 10 NM from Oksibil Aerodrome on bearing of 306°.

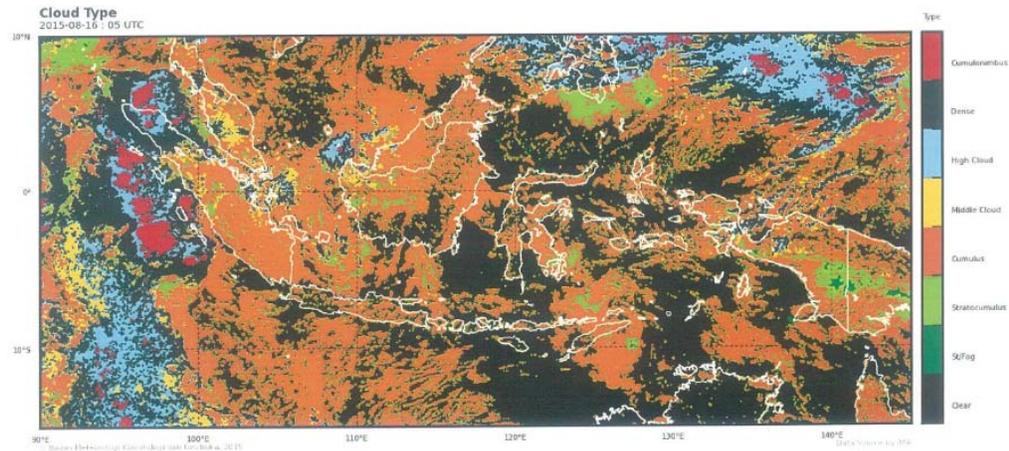
**Figure 4: The satellite weather image at 0500 UTC**

Wind : 110 / 08 knots  
Visibility : 4000 m – 5000m  
Weather : Nil  
Cloud : BKN (broken) <sup>3</sup>8000 feet (4000 AGL)

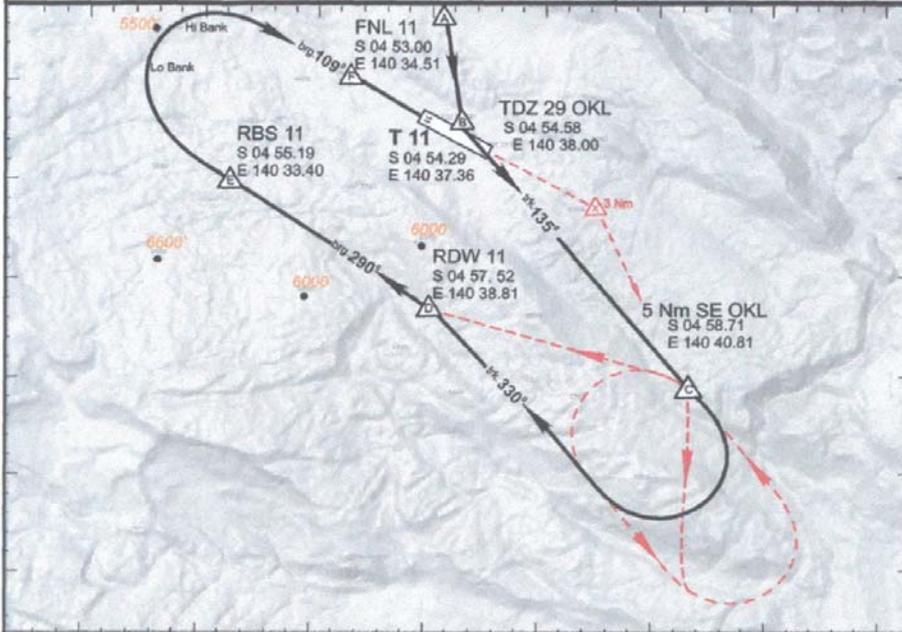
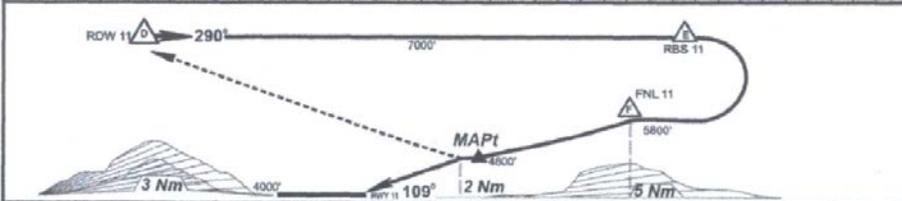
**Figure 5: Visual approach chart guidance issued by the operator**

- A. Start descend from 10 Nm OKL with speed 160 kts, ROD 1000ft/min descend to 10000 ft until overhead OKL, (TQ setting  $\pm$  10% - 15 %).
- B. 1 Nm before OKL turn left to heading 135° proceed to 5 Nm SE OKL and continue to 8500 ft with speed 160 kts and ROD 1000 ft/min.

- C. At point 5 Nm OKL turn right (high bank) heading 330° proceed to point RDW 11, continue descend with speed 160 kt to 7000 ft and maintain altitude.

- D. At 0,5 Nm before point RDW 11 left turn to heading 290° (Hi bank) for intercepting bearing 290° RBS 11, Maintain altitude 7000 ft until point RBS 11, maintain speed 140 kts then select flaps 15 (TQ setting  $\pm$  35% - 40%), Monitor RA minimum 2000 ft.

- E. At point RBS 11 select L/D gear down (*check three green down and lock*) then continue start turning Low Bank to initial heading 090° for intercepting bearing 109° Tdz 11 and continue descend to 5800 ft with speed 130 kts ROD 1000 ft/mn. (*set GPS to TDZ 11*).

- F. At point FNL 11 (*5 Nm Tdz 11*) with target altitude 5800 ft select flaps 30 and CL maximum, and continue descend to 4800 ft, ROD 1000 ft/m with Vapp + 5 kts.

MApt : At Mapt, 2 Nm, Alt 4800 ft with bearing 109° from Tdz 11 Approach  
**(Must be Stabilized).**

7. The pilot reported that they intended to direct left base leg runway 11.
8. The air operator issued visual guidance approach for internal use which contain procedure to fly overhead the airport prior to land.

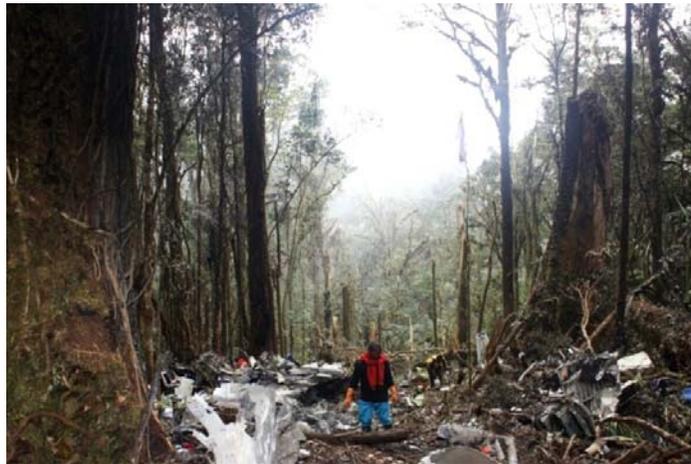
**Figure 6: The view from the accident side toward the aircraft flight path**

According to the information of the pilot observing the accident site, the wreckage distributed on direction approximately 195°-200°.

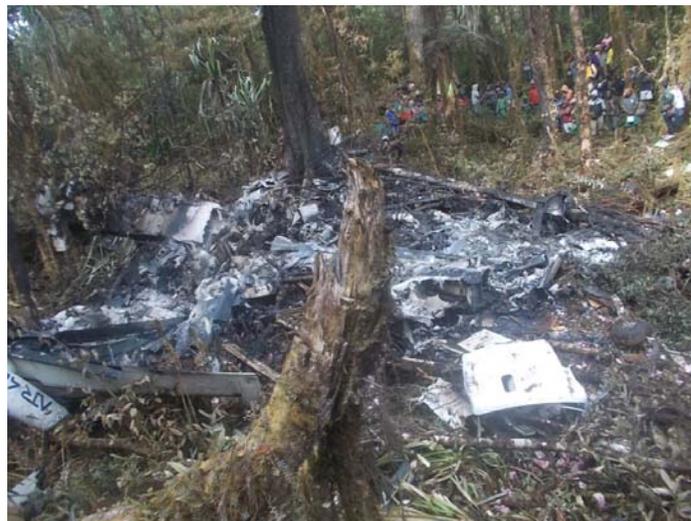
**Figure 7: The wreckage of the fuselage damaged by post-impact fire**

The area of the aircraft fuselage debris was destroyed by post impact fire.

There was no indication of in-flight fire and the fuselage wreckage was destroyed by post impact fire. The fire extinguished when the search and rescue team arrived at the accident site.
