COMANDO DA AERONÁUTICA
CENTRO DE INVESTIGAÇÃO E PREVENÇÃO DE
ACIDENTES AERONÁUTICOS

FINAL REPORT
A - 501/CENIPA/2015

OCCURRENCE:	ACCIDENT
AIRCRAFT:	N988AR
MODEL:	MD-11F
DATE:	13 OCT 2012

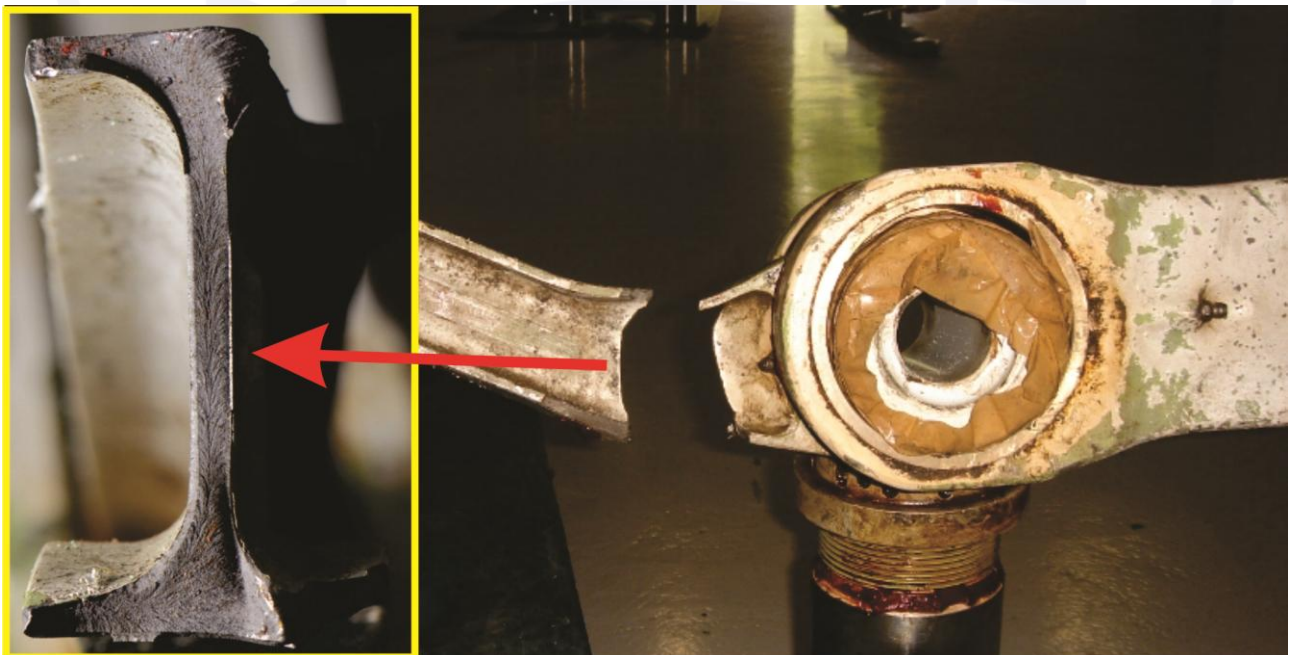
Figure 3 – Fractured articulated-arm seen from the side and from the front. The fracture occurred on account of overload.
