**CIVIL  
AVIATION  
ADMINISTRATION  
OF CHINA**

**AIRCRAFT ACCIDENT REPORT**

**Controlled Flight Into Terrain  
KOREAN AIR FLIGHT KE6316  
MD-11F, HL7373  
SHANGHAI, PEOPLE'S REPUBLIC OF CHINA  
APRIL 15, 1999**

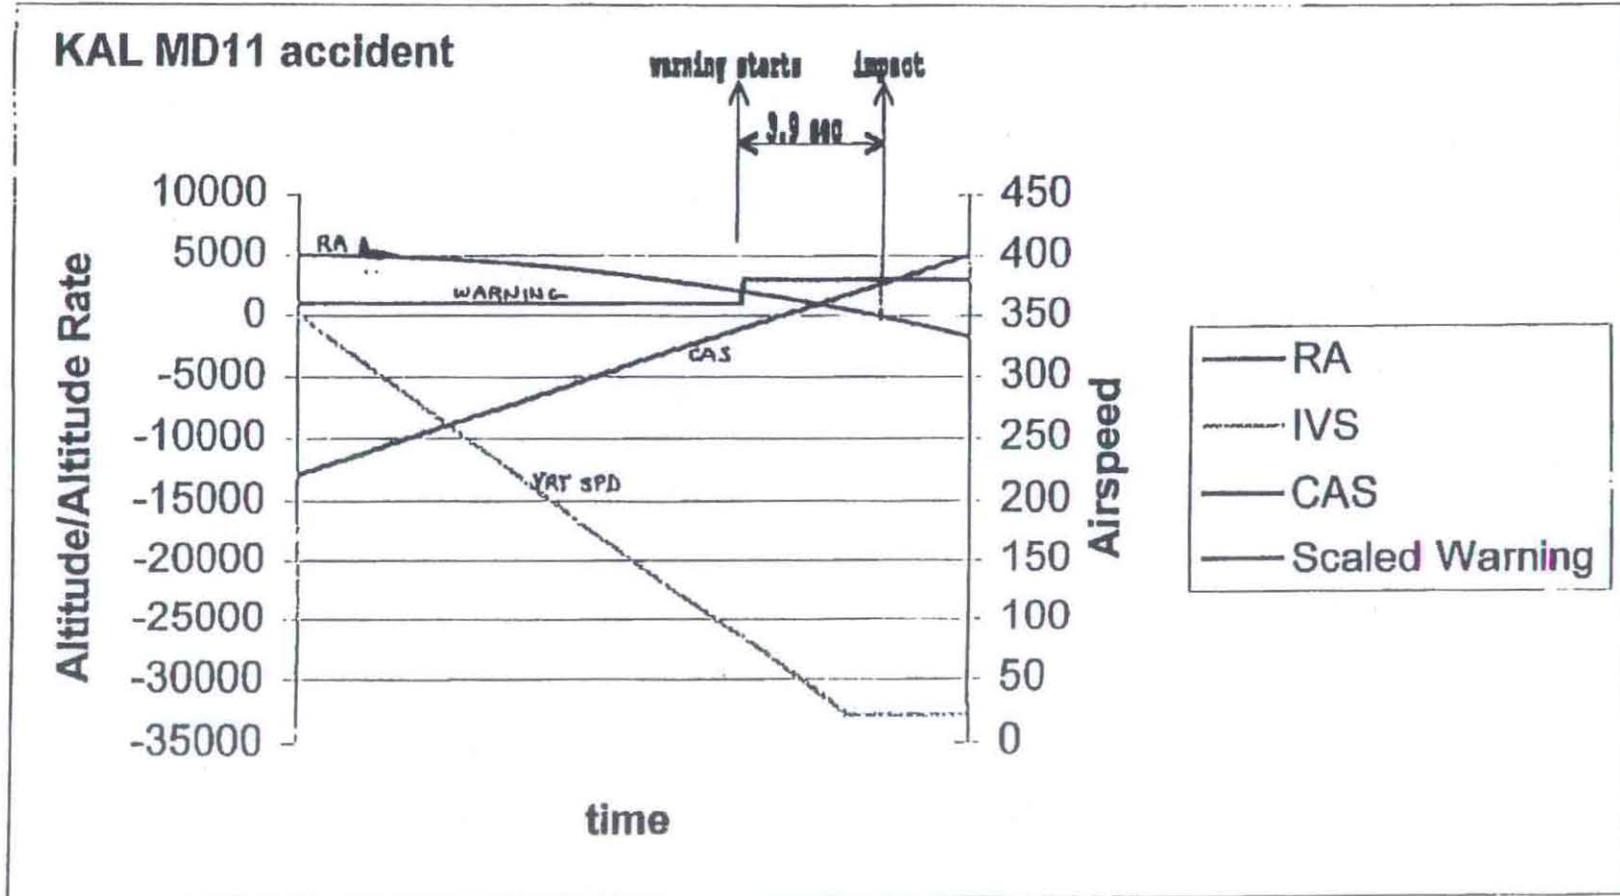
Attachment 2 of Appendix 7:

Using the 3.9 seconds of warning time until impact we have constructed a possible scenario for this warning. Understand that Mode 2 is a very dynamic mode, and the static warning curve does not always indicate exactly when a warning will occur. System time delays and filter time constants can cause the alerts to be given later than depicted in the specified ‘static warning curves’. When the Mode 2 warning occurs depends on the following:

So a simulation that just varies Radio Altitude to obtain a 3.9 second warning will not necessary reflect what actually happened. We have simulated several sets of dynamic conditions, where Radio Altitude, Vertical Speed and Airspeed are all varied to reflect accelerated flight towards level terrain. The conditions that produced a 3.9 second warning were as follows:

Accelerated flight down at level terrain
