**Statens haverikommission**  
Swedish Accident Investigation Board

***Report RL 2010:01e***

**Accident to aircraft SE-IVF at the northern basin of  
Falsterbo canal, Skåne County, on 26 October 2006**

Case L-27/06

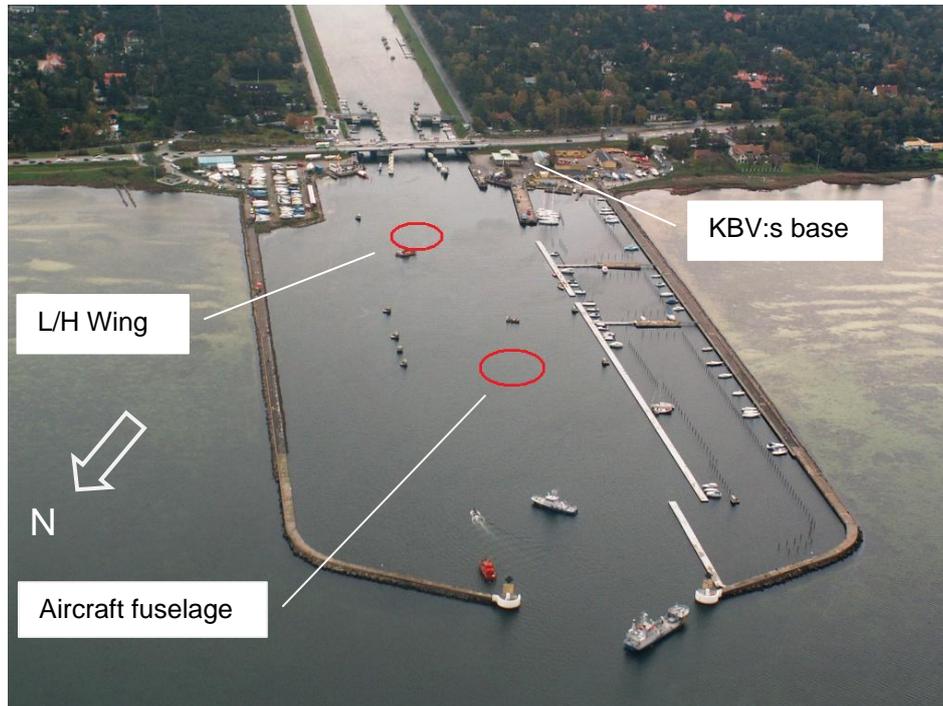
Most of the aircraft ended up at about the centre of the basin, where on impact with the water it broke into a large number of pieces that sank to the bottom. Wreckage that did not sink floated in towards the northernmost pier.

The separated wing with the engine went into the basin about 100 metres from the bridge and soon thereafter sank to the bottom.

Figure 11. The approximate impact locations shown by ellipses

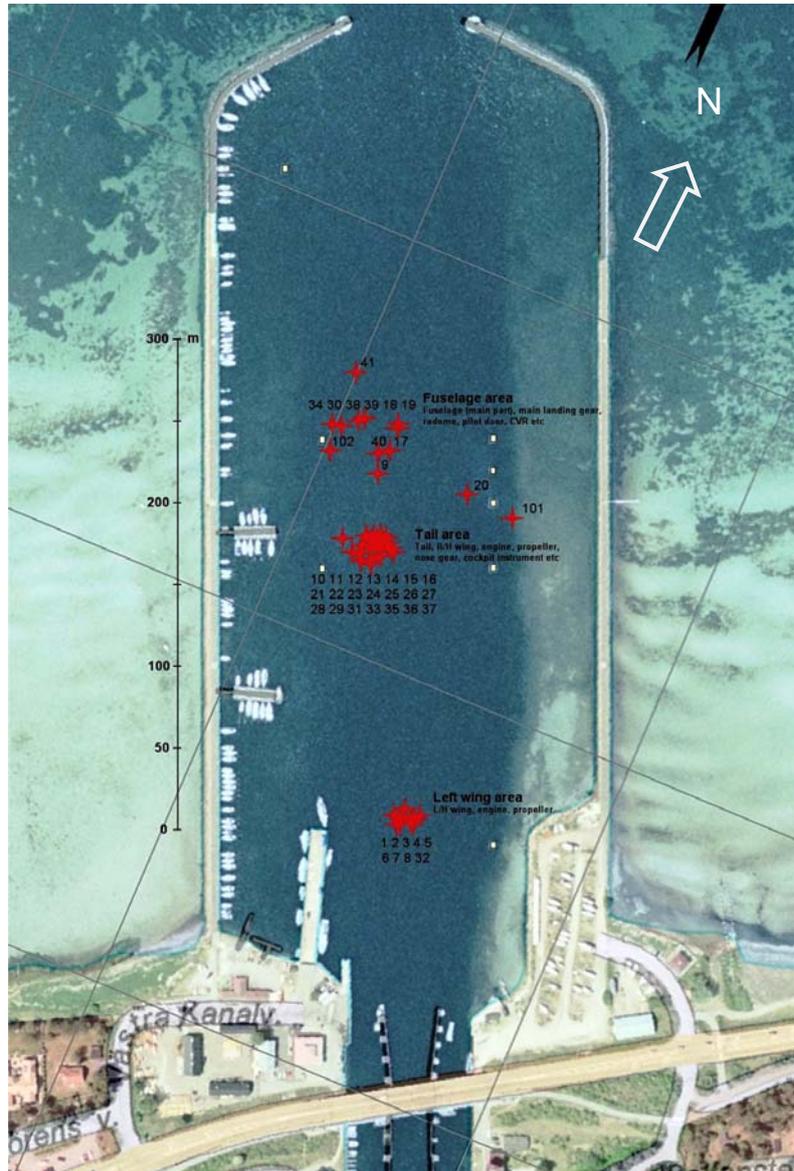
*Area 2, Concentrated and located about 325 metres from the canal bridge*  
The tail section, right wing, parts of the right wing, right engine, right propeller, cockpit, instruments and nose wheel.

*Area 3, Spread out and located about 400 metres from the canal bridge*  
Fuselage, CVR, main landing gear, doors and hatches.

Figure 12. Plot of the pieces of wreckage

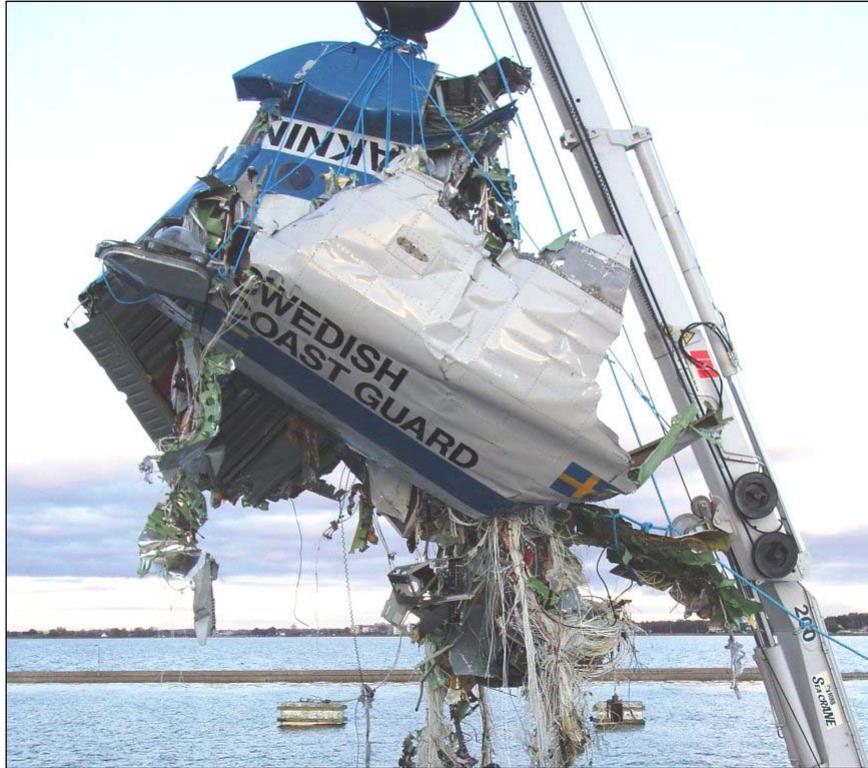
The aircraft was severely damaged and had broken into a large number of pieces.

Figure 13. The aircraft fuselage

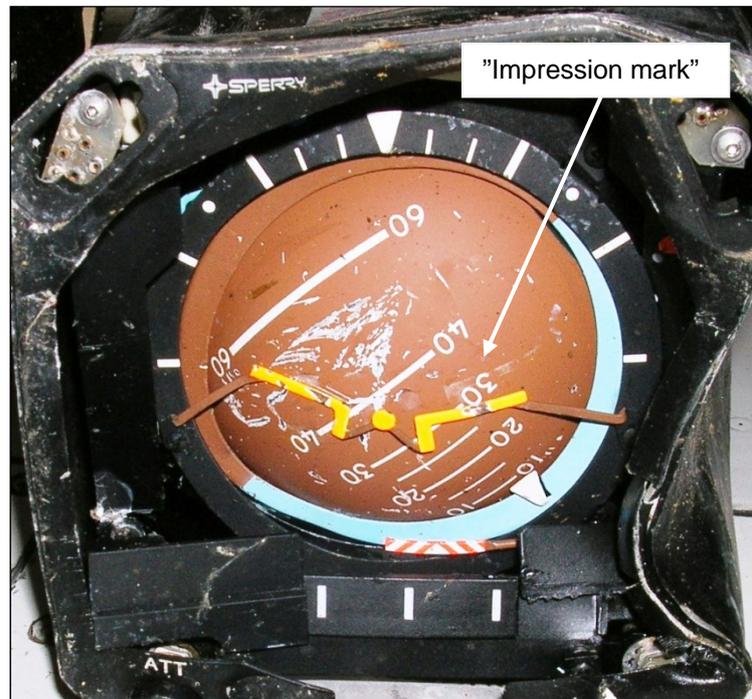
The aircraft was equipped with two mechanical gyro horizon attitude indicators. These instruments were severely damaged but on the moving horizon panels of both the instruments there was a clear "impression mark" from the aircraft symbols of the instruments. Experience shows that such marks can occur on flight instruments as the result of high G-forces associated with a collision.

The location of these marks is approximately the same on both instruments and indicates that at the moment of impact with the water the aircraft was about  $40^\circ$  from a completely inverted attitude and in a dive at an angle of almost  $40^\circ$ . This attitude is equivalent to the aircraft rolling to the left at  $140^\circ$  or rolling to the right at  $220^\circ$  before impact.

Figure 15. Left gyro horizon

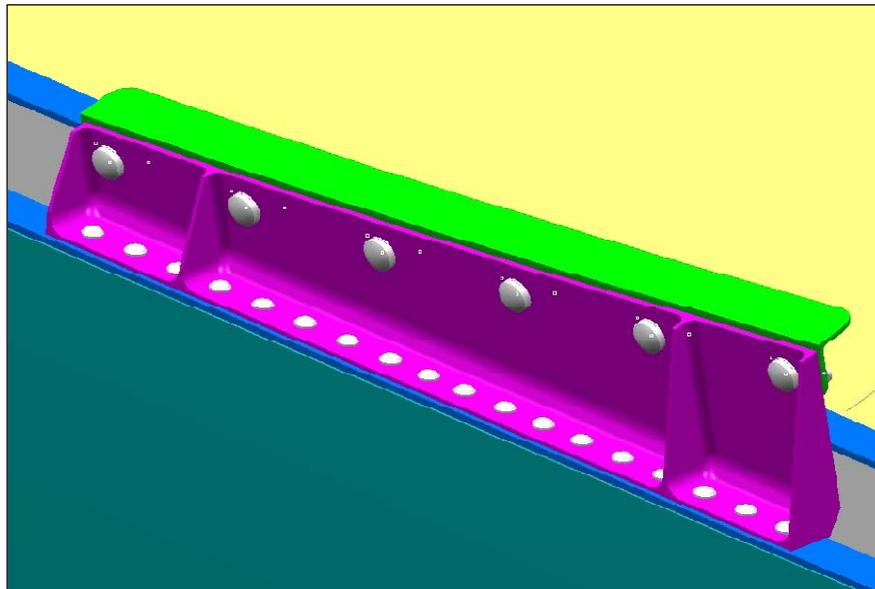
Figure 39. New attachment fitting – left rear

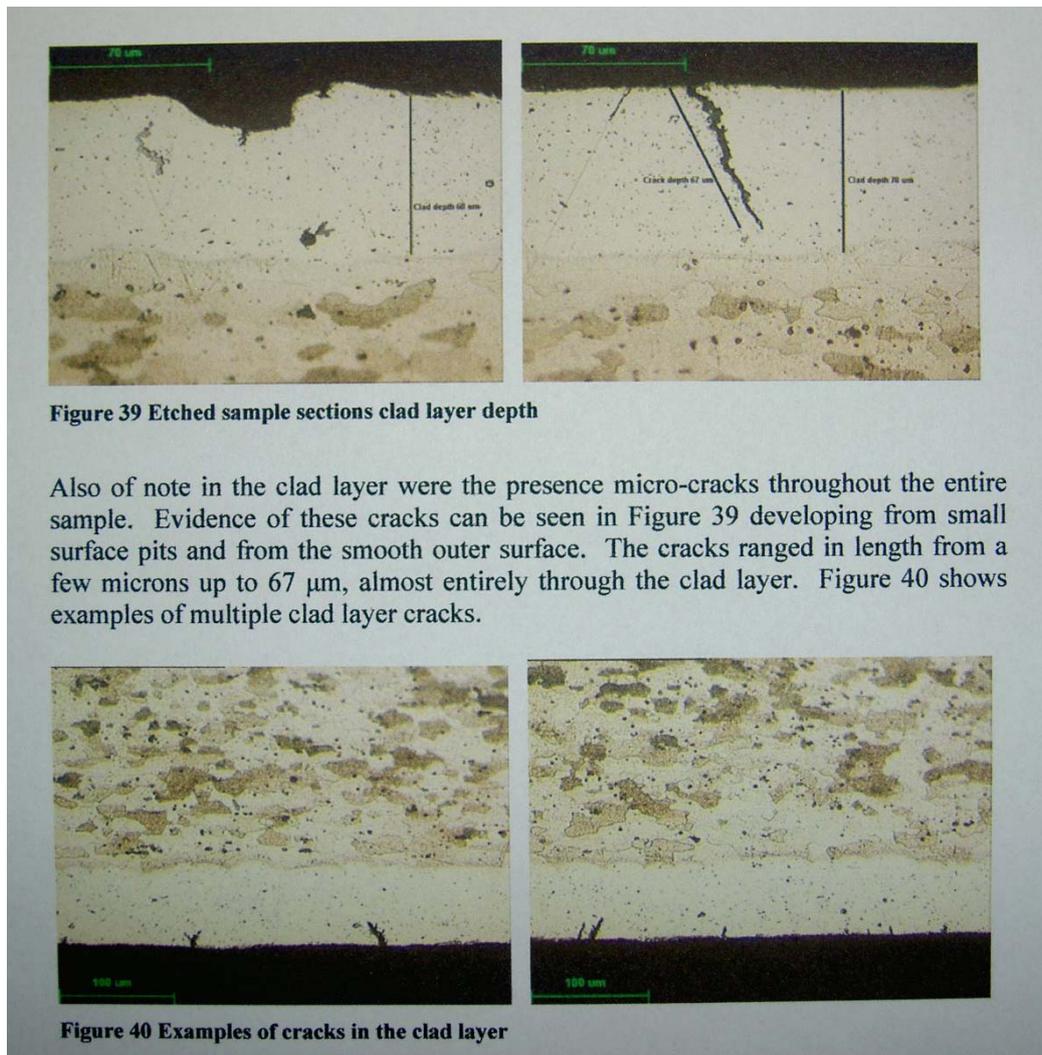
Metallographic examinations of sections taken from the test pieces showed the presence of micro-cracks throughout the samples. These were multiple cracks with depths from a few  $\mu\text{m}$  up to  $67 \mu\text{m}$ , i.e. almost the whole depth of the cladding. Some images of typical micro-cracks are shown below:

Figure B6. Micro-cracks

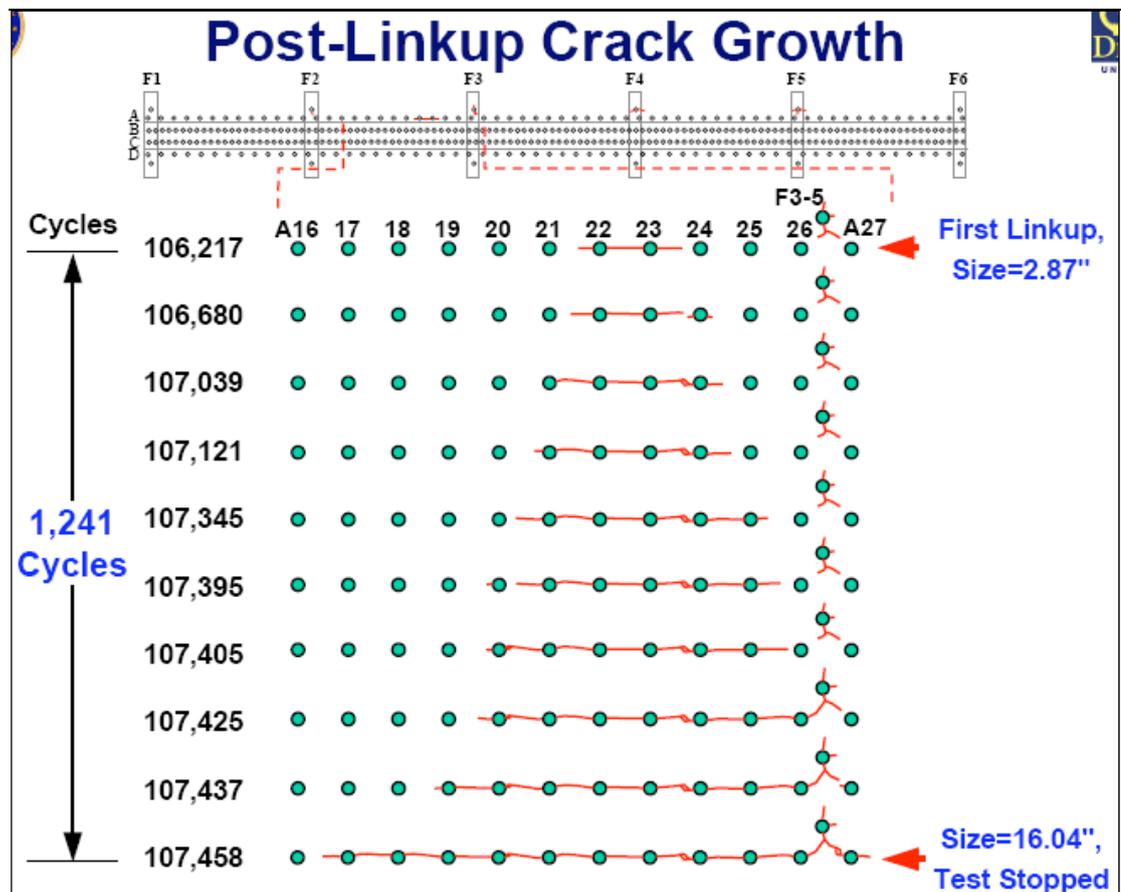
Figure B12. Crack growth

Subsurface crack indications along the rivet row were recorded by eddy current after 12,600 cycles. The first visual damage occurred after 51,500 cycles.

The first MSD link-up occurred after 106,217 cycles, forming a lead crack. Subsequently the lead crack grew very rapidly, along the outer rivet row, eventually forming a 400mm long crack after 107,458 cycles.

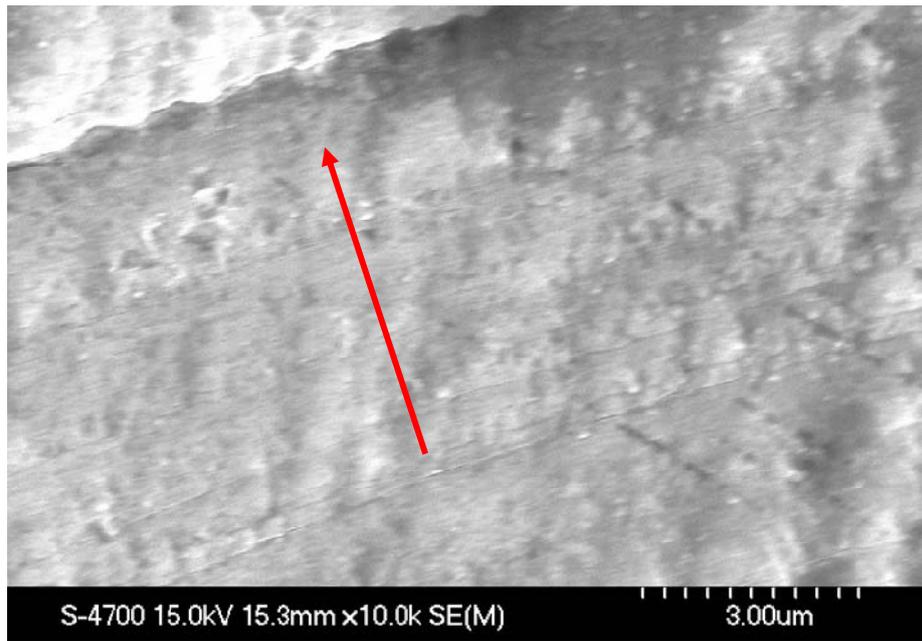
Figure B13. Sweep electron microscope image of the type A crack surface

The image shows the type A crack surface; the striation separation distance is short, about  $0.05\ \mu\text{m}$ , which is representative of the initial stage of crack development, i.e. a crack depth of less than half the thickness of the wing skin. The arrow shows the direction of growth.

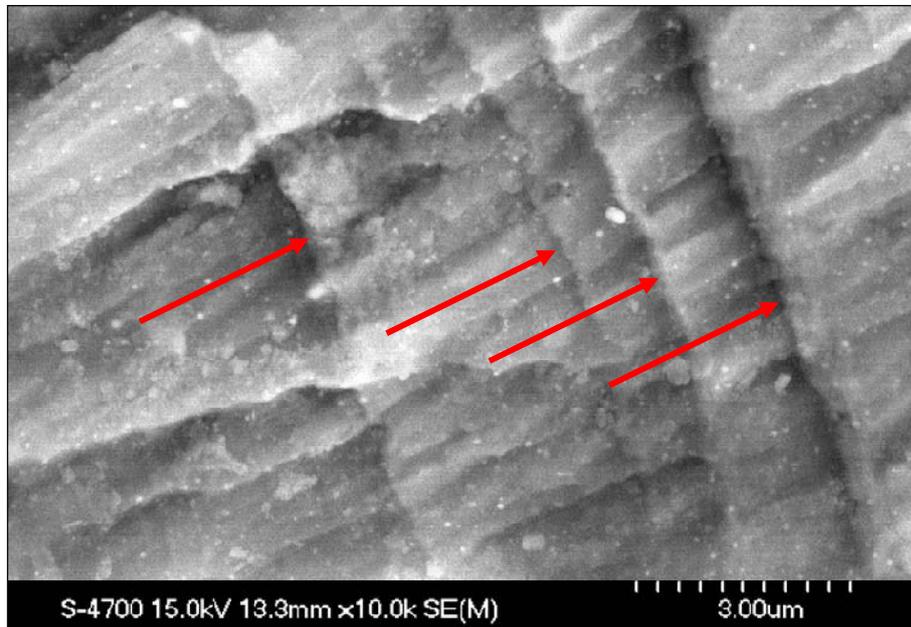
Figure B14. Sweep electron microscope image of the type B crack surface

The image shows the type B crack surface; the striation separation distance is large and varies between  $1$  and  $5\ \mu\text{m}$ . The arrows mark the secondary cracks, at right angles to the direction of spread. This type of coarse striations is found at the deepest crack depth and the spread has taken place in jumps due to high loads.

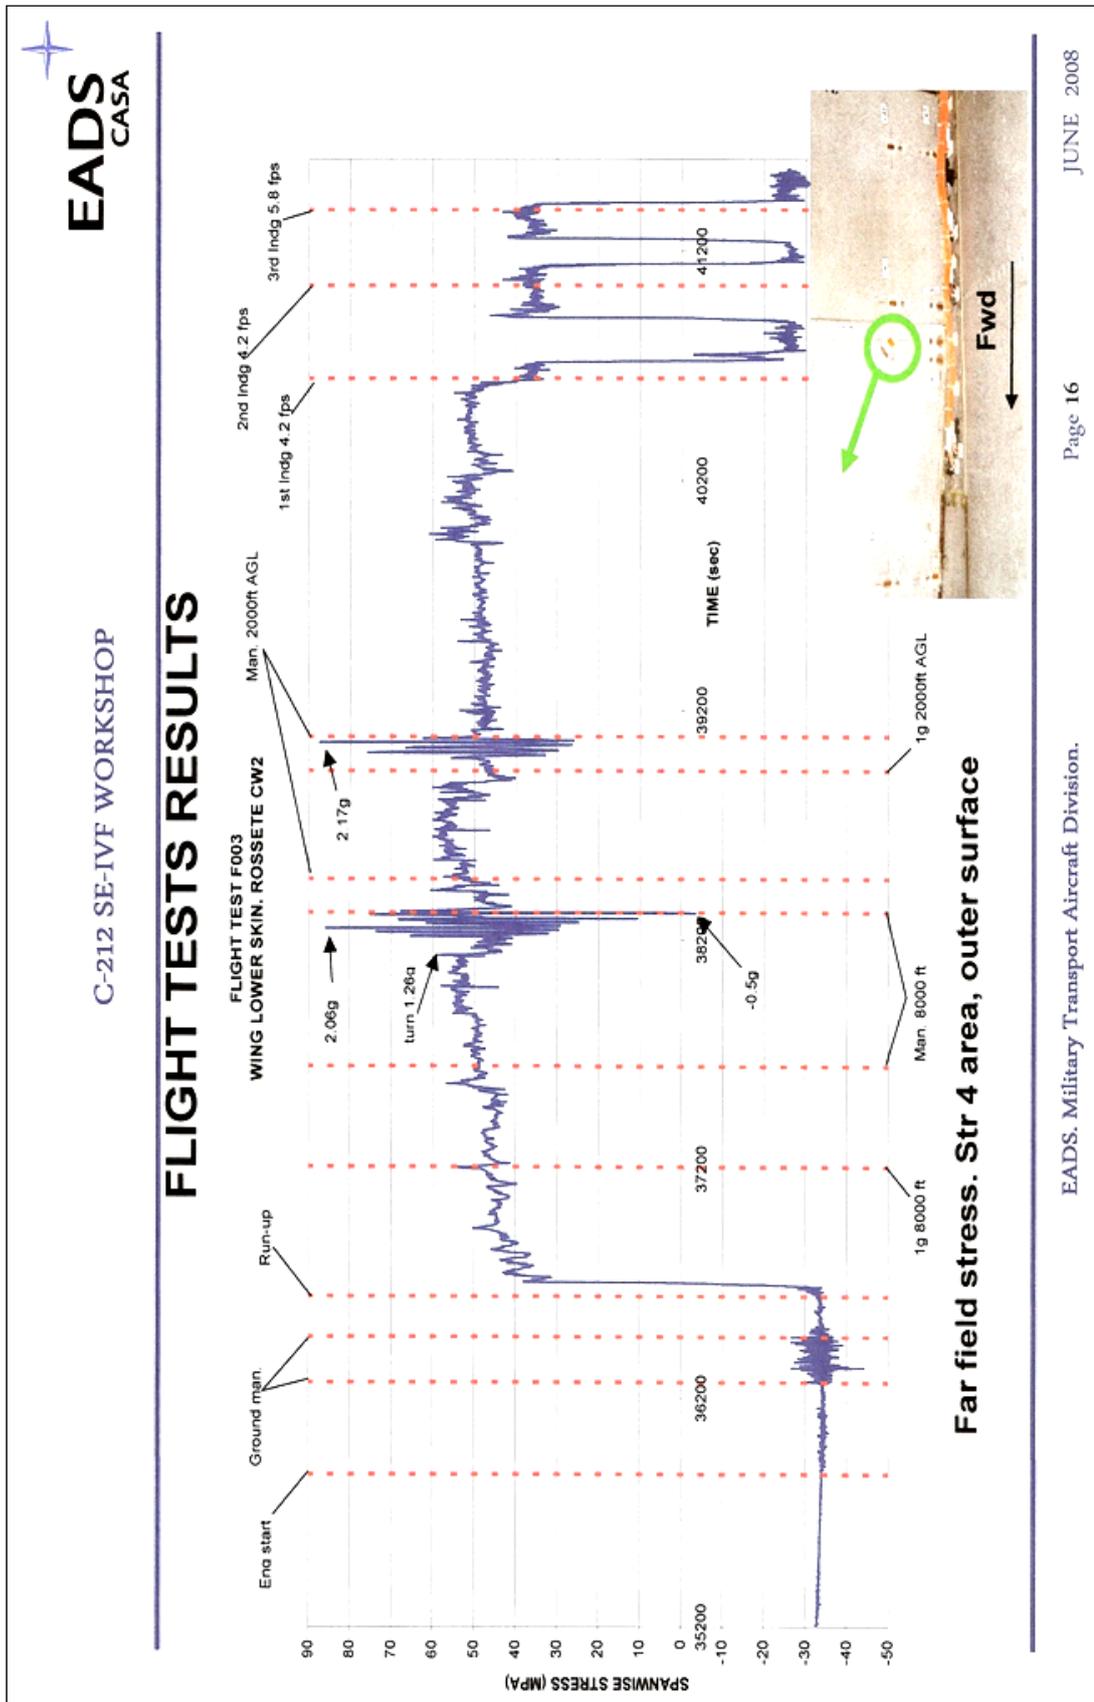
Figure B18. Material stress during one flight

From the diagram it can, among other things, be seen that the material stress during this flight peaked at about 88 MPa, which is about 33 % of the material yield strength. (It can be worth noting that the stress level at an early stage of the crack sequence was calculated by BMT by means of fracture mechanics to be about 1/3 of the yield strength.)

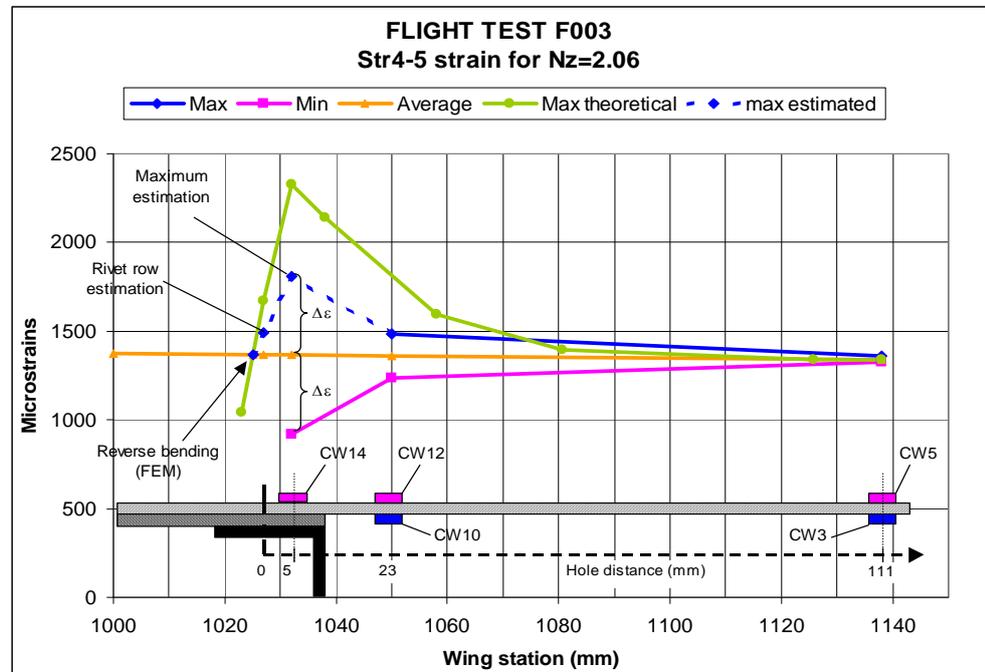
Figure B19. Span-wise material tensile stress

From the diagram it can be seen, among other things, that the measured tensile stress is at a maximum just outside the critical row of rivets and that the tensile stress does not exceed that which was theoretically calculated.
