**AIRCRAFT ACCIDENT INVESTIGATION COMMITTEE
MINISTRY OF TRANSPORT, THAILAND**

AIRCRAFT ACCIDENT FINAL REPORT

**ONE TWO GO AIRLINES COMPANY LIMITED
MCDONNELL DOUGLAS DC-9-82 (MD-82)
HS-OMG**

**PHUKET INTERNATIONAL AIRPORT
THAILAND**

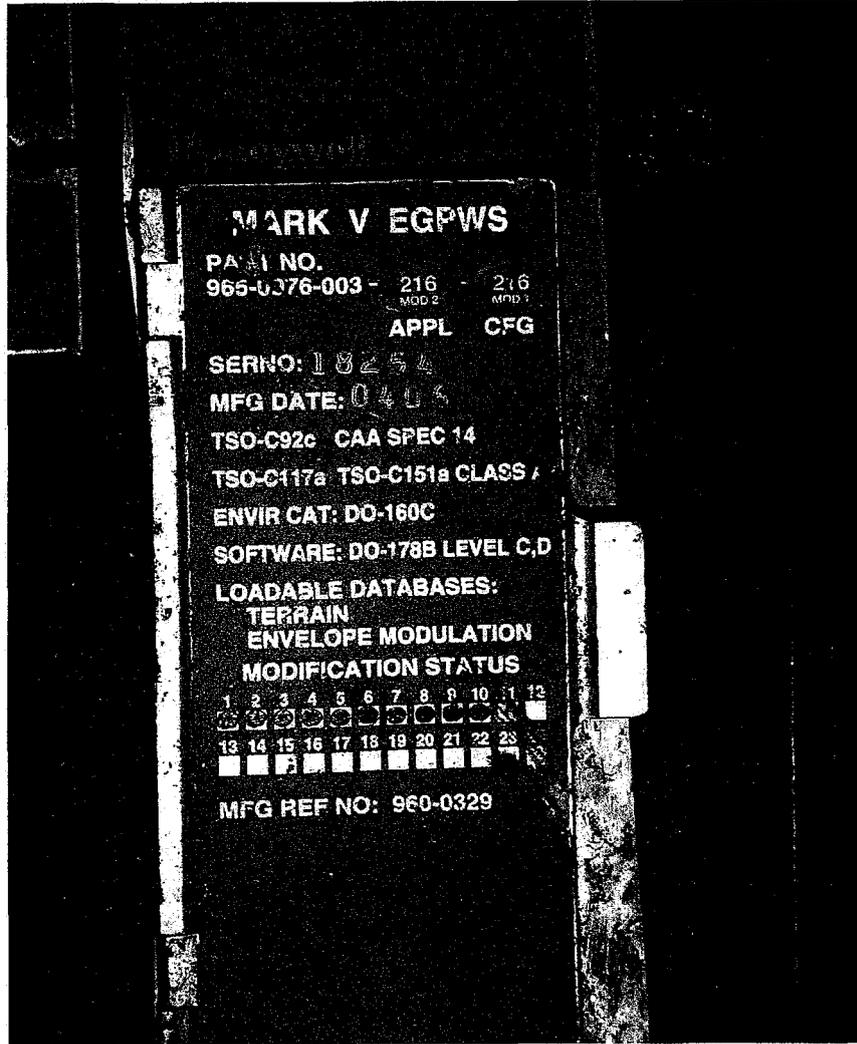
PHOTO 3

Unit Data Plate

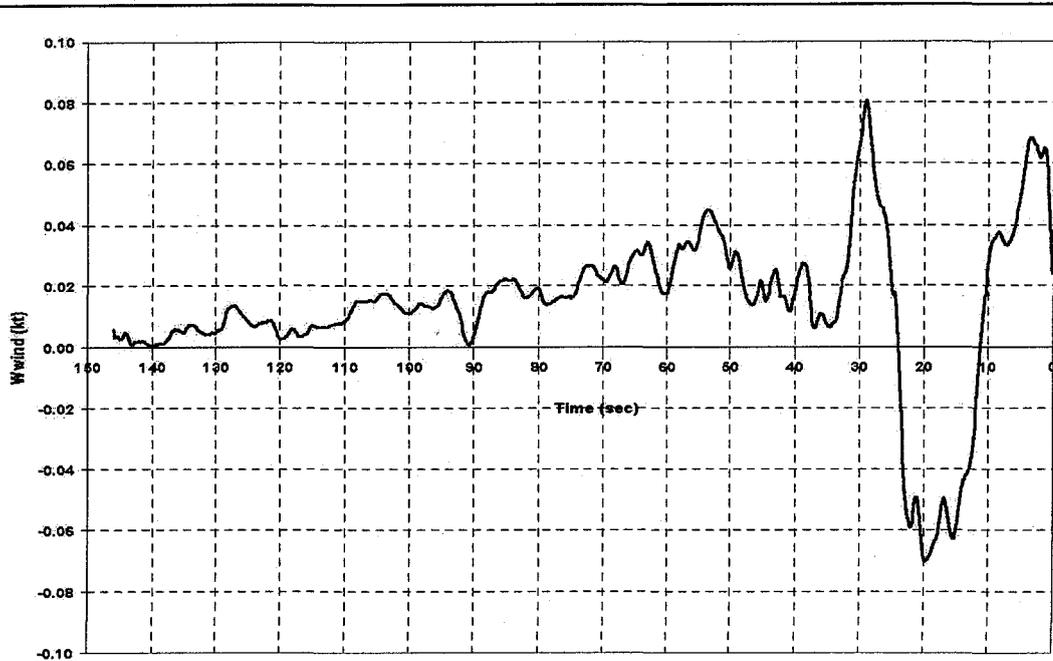
Figure 1. Vertical Wind

The wind data provided by the NTSB (Reference 3) shows that there was a relatively insignificant vertical component of wind during the landing approach (Figure 1), and it is not expected that a windshear alert should have been issued based on the vertical shear. The variable within the legacy Honeywell algorithm which is most responsive to vertical shear is the variable TVERT, and the response of this variable is shown in Figure 3.

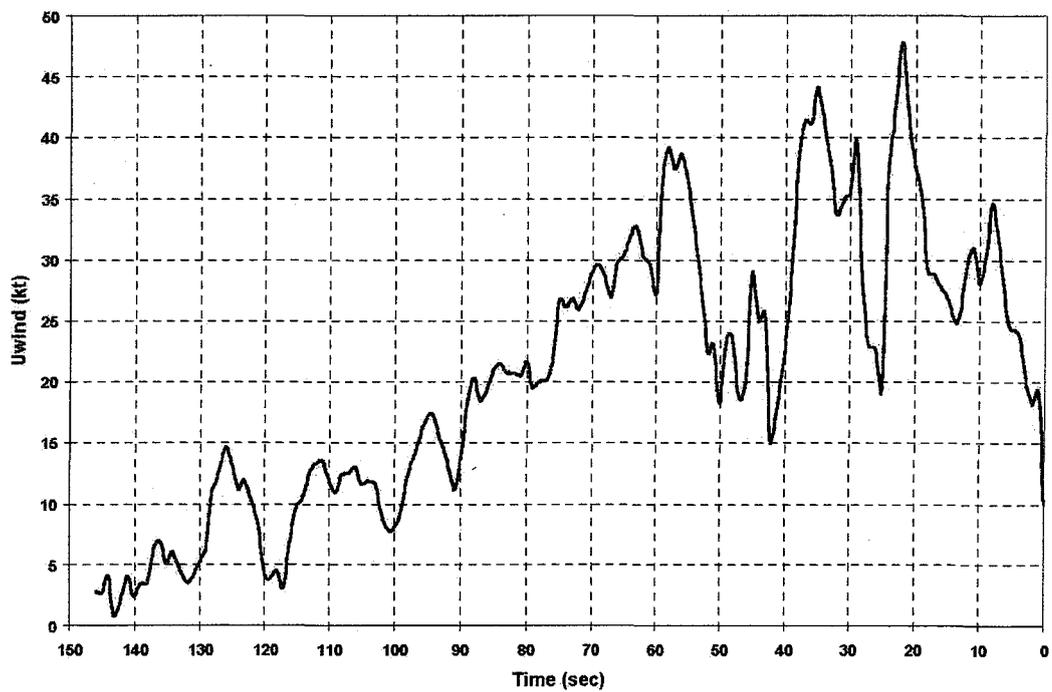
Figure 2. Horizontal Wind

The horizontal wind component (Figure 2) shows a general increase from a headwind of 3 knots to a headwind of 47 knots during the majority of the approach, and then a rapid decrease to 10 knots at the end-of-data time. During the 'increasing' phase the wind speed oscillated considerably. These oscillations were attenuated by the gust filters of the windshear algorithm, as intended.

Towards the end of the approach, the headwind component (Figure 2) decreases, and the negative shear value eventually reaches a magnitude sufficient to cause the system to issue a warning alert (Figure 5).

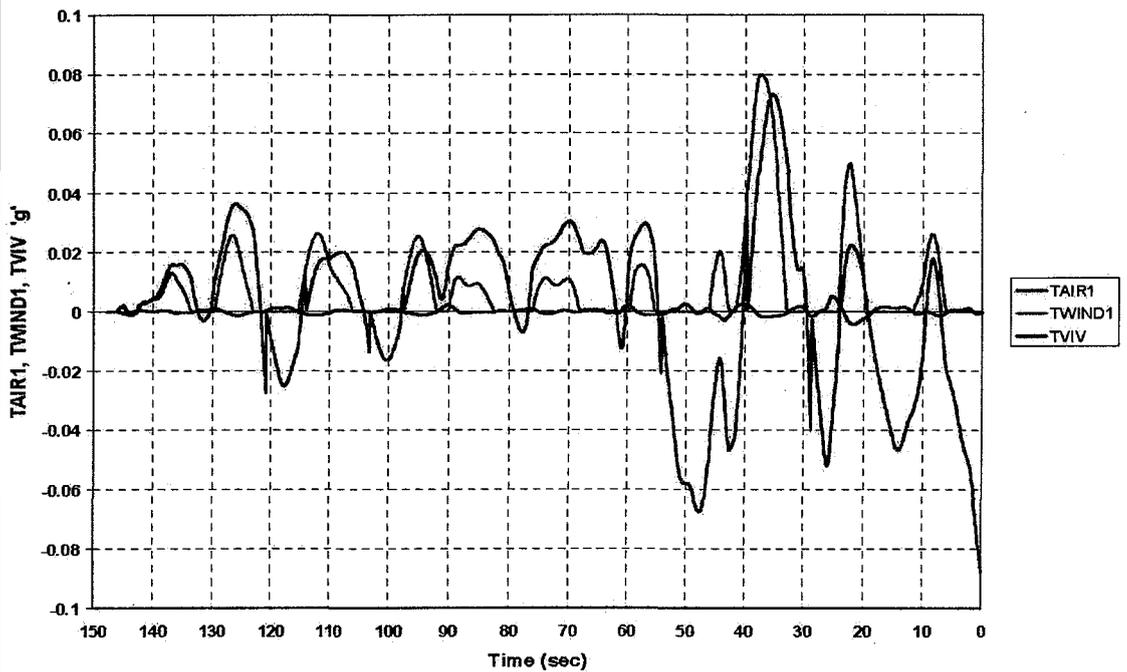
Figure 4. Simulation Time Histories of Windshear Algorithm Variables TAIR1, TWIND1 and TVIV

The variables within the legacy Honeywell algorithm which are most responsive to horizontal shear are the variables TAIR1, TWIND1 and the 'wind vector rotation' variable TVIV. Plots of these variables against time from the simulation are shown in Figure 4. It is the variable TAIR1 which finally exceeds the threshold and causes an alert, as shown in Figure 5.

From the simulation data and accident data, the preliminary conclusion is that the legacy windshear detection system performed its function as intended, and that the performance was compatible with the requirements of FAA TSO-C117.
