AIRCRAFT ACCIDENT REPORT

DANA/2012/06/03/F

Accident Investigation Bureau

**Report on the Accident to
DANA AIRLINES NIGERIA LIMITED
Boeing MD-83 aircraft with registration 5N-RAM
which occurred at Iju-Ishaga Area of Lagos State,
Nigeria
On 3rd June 2012**

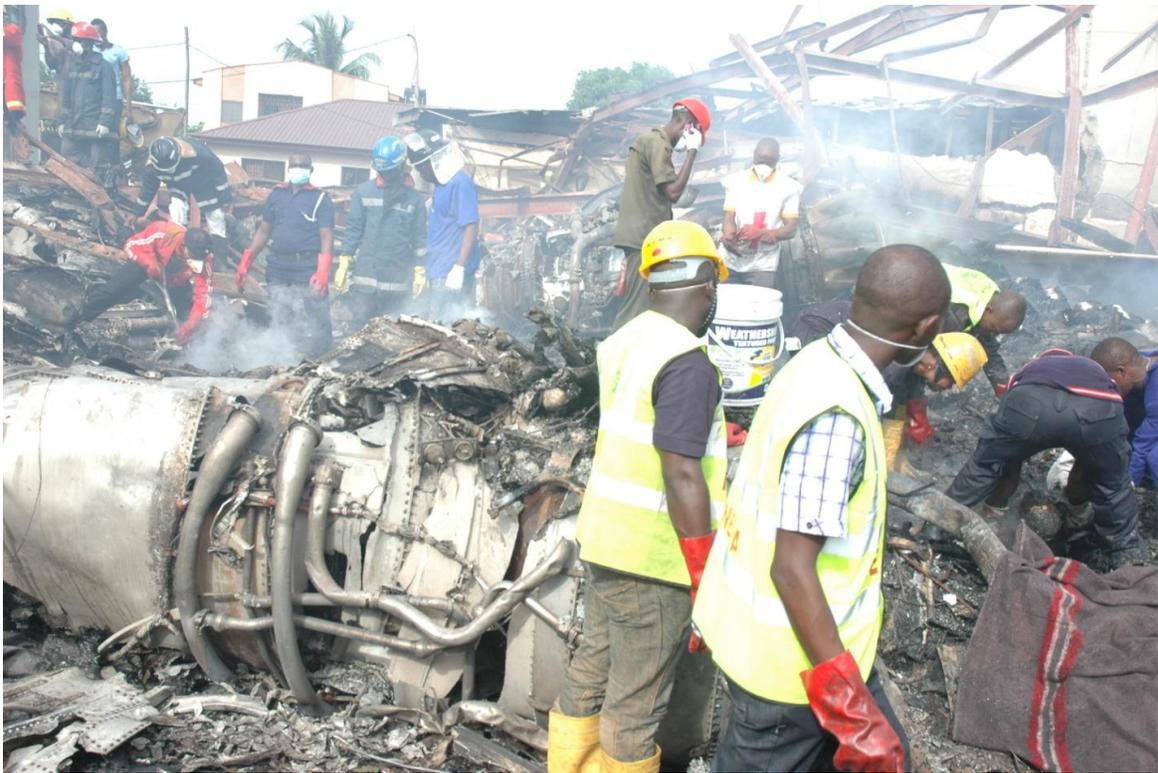
FIGURE 2: LEFT HAND ENGINES AND WHAT WAS LEFT OF PRINTING PRESS AT THE CRASH SITE

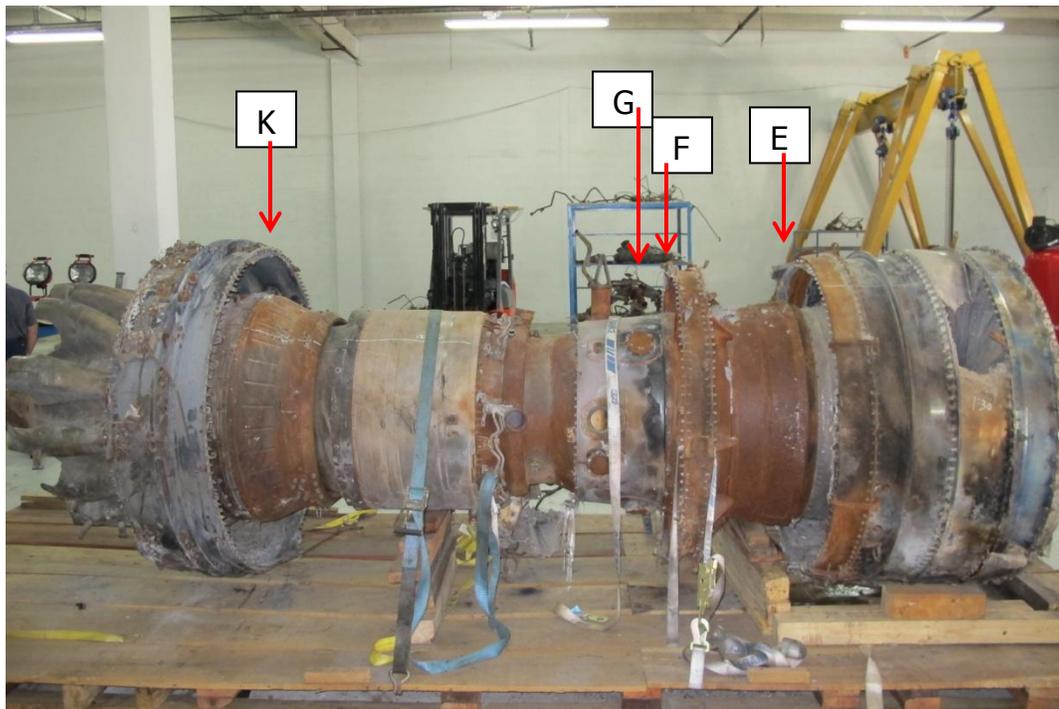
The engine was un-crated and placed on pallets for examination and disassembly (**FIGURE 16**). The engine was intact from the nose bullet aft to the exhaust tail cone with all major modules in place. Engine cases appeared round and did not exhibit signs of structural deformation or case breach. Fan and exhaust ducting was missing from the "E"-flange (aft flange of the fan exit guide vane (FEGV) Outer Case) aft to the "F"-flange (forward flange intermediate case outer diameter ring) and from the "G"-flange (aft flange of the intermediate case outer diameter ring) to the "K"-flange (forward flange of the turbine case outer diameter ring). Some wiring, and pneumatic and oil system plumbing along with crash debris were removed to facilitate teardown (**FIGURE 17**).

FIGURE 17: RIGHT-HAND SIDE OF NO. 2 ENGINE WITH FLANGE LOCATIONS

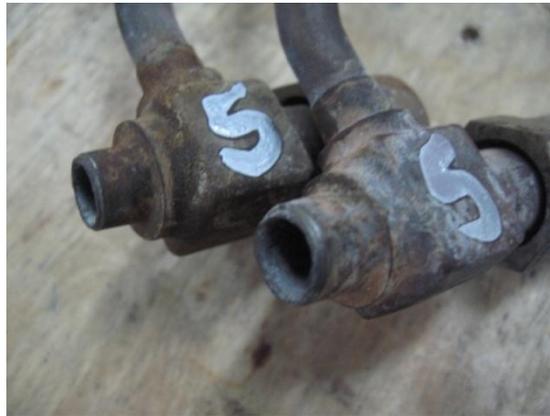
The fuel-feeder lines that attach to the No. 5 fitting were both (primary and secondary) fractured flush with the No. 5 fitting and a piece of the fuel-feeder tubes remained within the No. 5 fittings in both manifolds (**FIGURE 23**). These fractured fuel-feeder tubes both exhibited shear lips. The left-hand manifold exhibited the following damage and observations:

FIGURE 23: RIGHT-HAND FUEL MANIFOLD WITH FRACTURED FEEDER TUBE

Looking at Figures 23, 24 and 25, it is very clear that the tubes were either broken or bent, which will cause loss or restriction of fuel flow and will further translate into failure of the engines to respond to throttles movement.

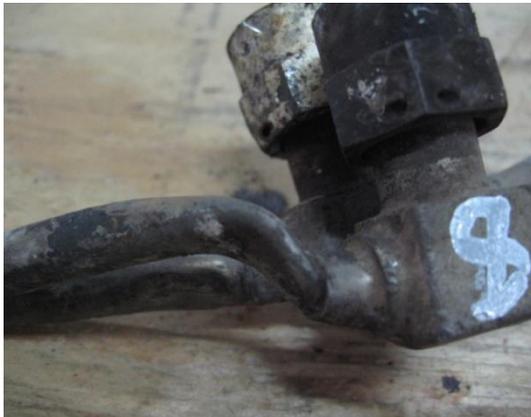
- 1) heavily sooted at fuel nozzle fitting Nos. 8, 9 and 1,
- 2) the primary fuel transfer tube was pinched almost closed at the No. 8 fuel nozzle fitting (**FIGURE 24**), and
- 3) the primary fuel transfer tube diameter was reduced at the No. 7 fuel nozzle fitting. The fuel-feeder lines that attach to the No. 6 fitting were both fractured at the No. 6 fitting with an appreciable piece of the secondary feeder tube was still attached and twisted/crimped (**FIGURE 25**).

FIGURE 24: PINCHED TRANSFER TUBE

- 1) heavily sooted at fuel nozzle fitting Nos. 8, 9 and 1,
- 2) the primary fuel transfer tube was pinched almost closed at the No. 8 fuel nozzle fitting (see **FIGURE 24**), and
- 3) the primary fuel transfer tube diameter was reduced at the No. 7 fuel nozzle fitting.

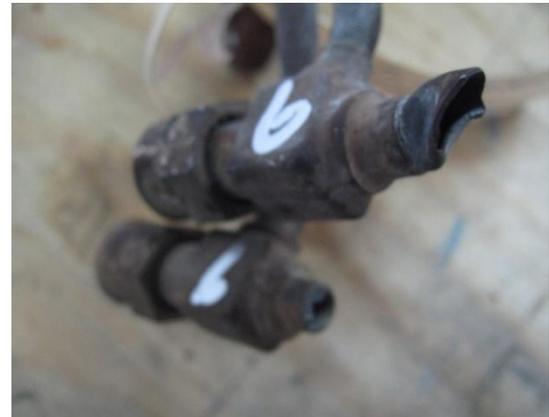
FIGURE 25: FRACTURED FEEDER LINE

The fuel-feeder lines that attach to the No. 6 fitting were both fractured at the No. 6 fitting with an appreciable piece of the secondary feeder tube still attached and twisted/crimped (see **FIGURE 25**).

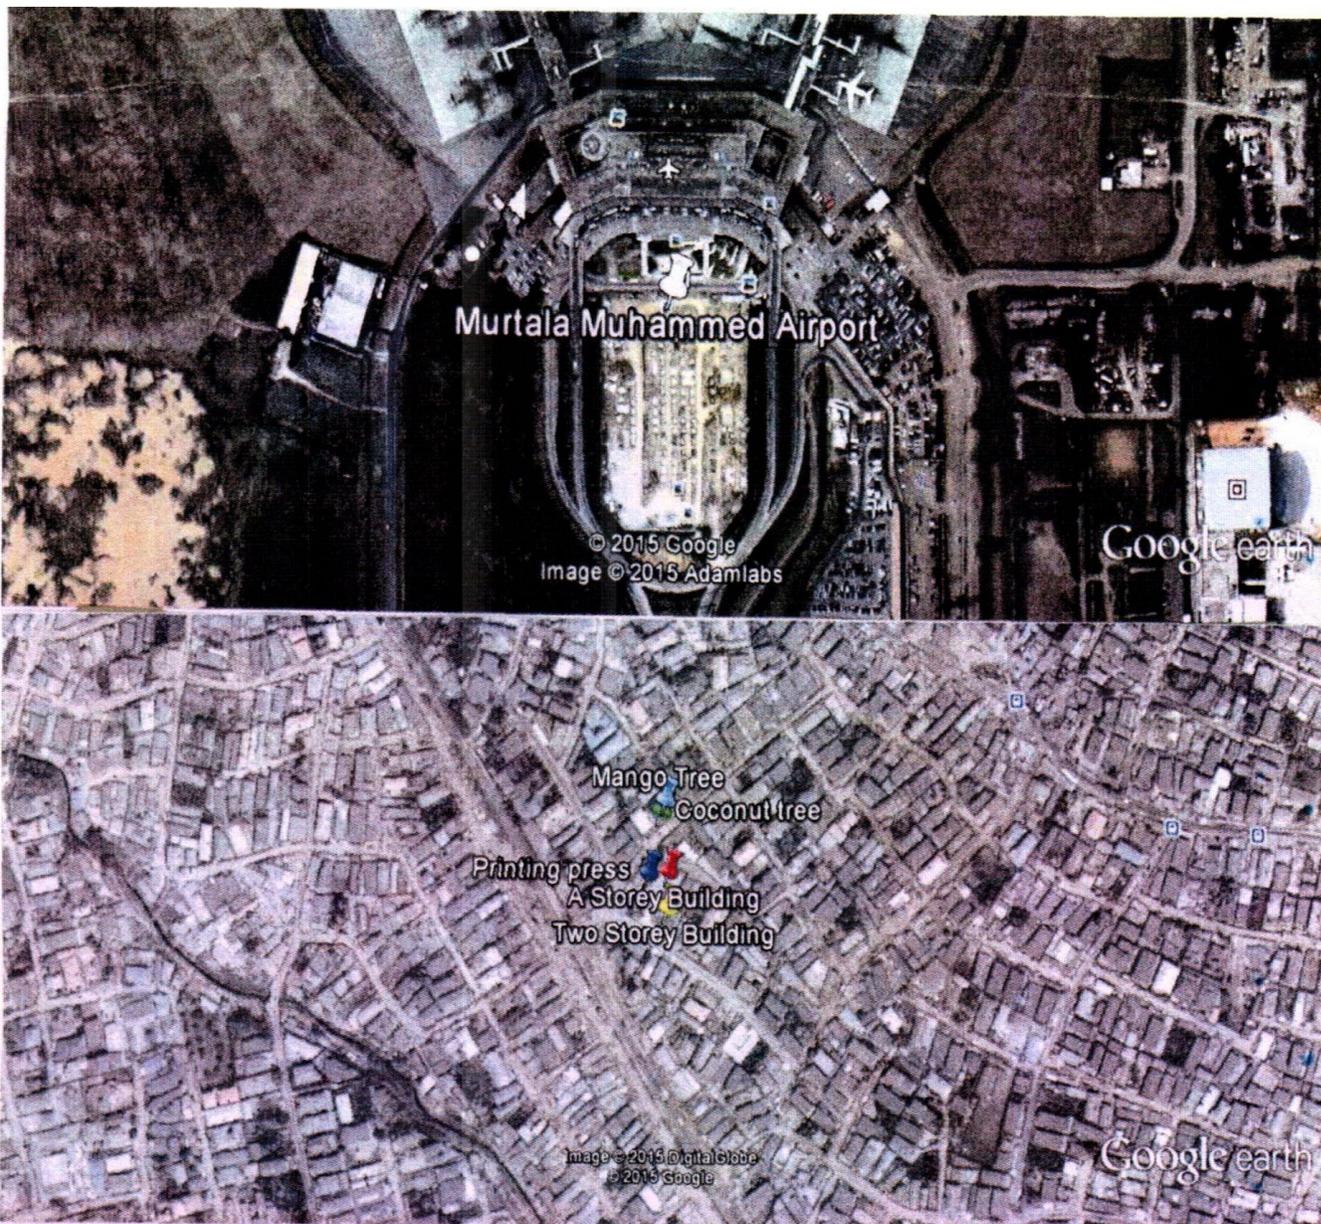
The airplane crashed in a residential area about 5.8 miles north of LOS. The airplane wreckage was on approximately the extended centreline of runway 18R, with the main wreckage concentrated at N 06° 40.310' E 003° 18.837' coordinates, with Elevation of 177ft. See Figure 28 below.

During the impact sequence, the airplane struck an uncompleted building, two trees and three other buildings. The wreckage was confined in a small area, with the separated tail section and engines located at the beginning of the debris trail. See Figures 28 and 29 on the following page.

FIGURE 28: PICTORIAL REPRESENTATION OF CRASH SITE

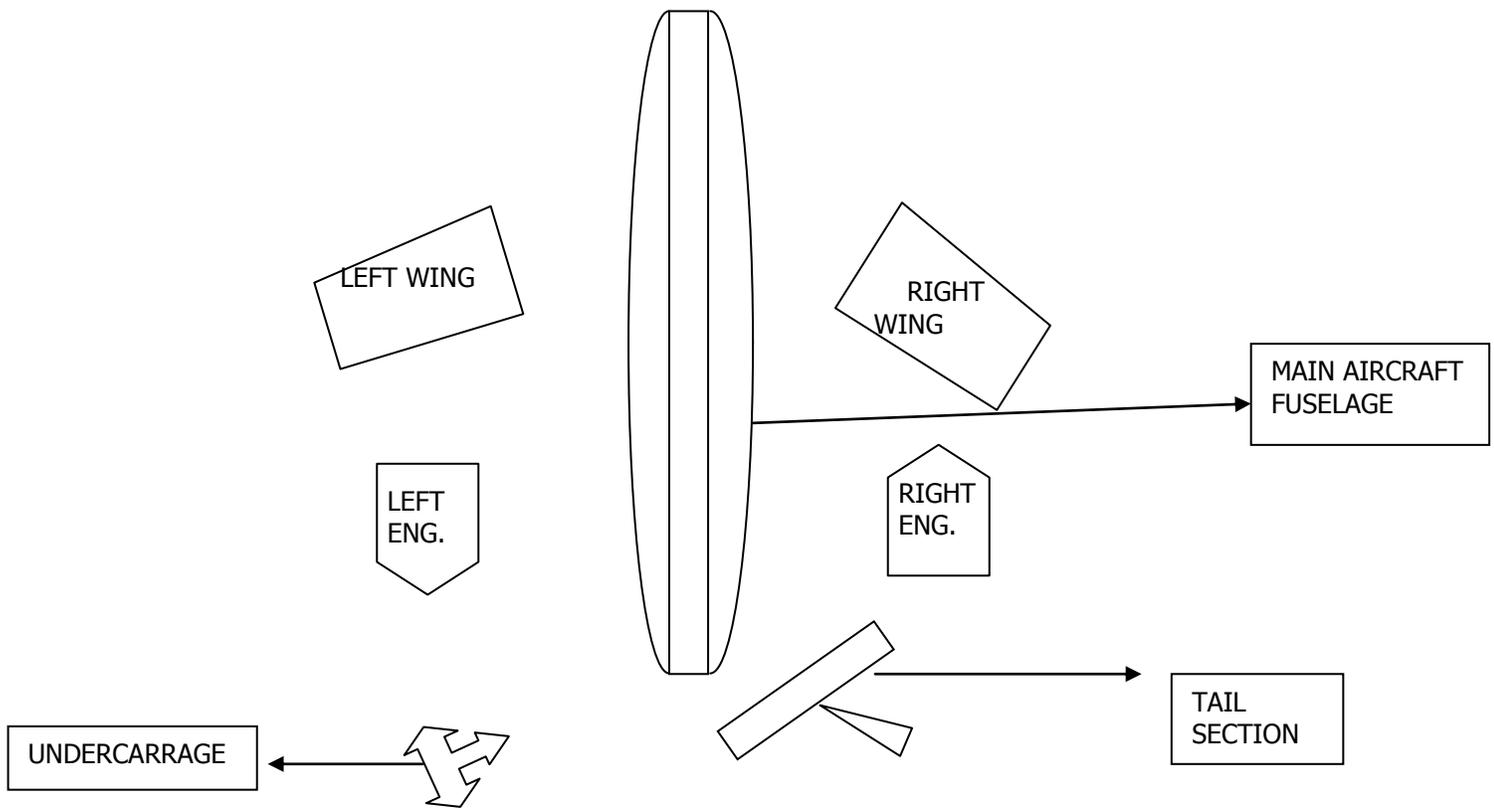
FIGURE 29: THE CRASH SITE WRECKAGE DISTRIBUTION

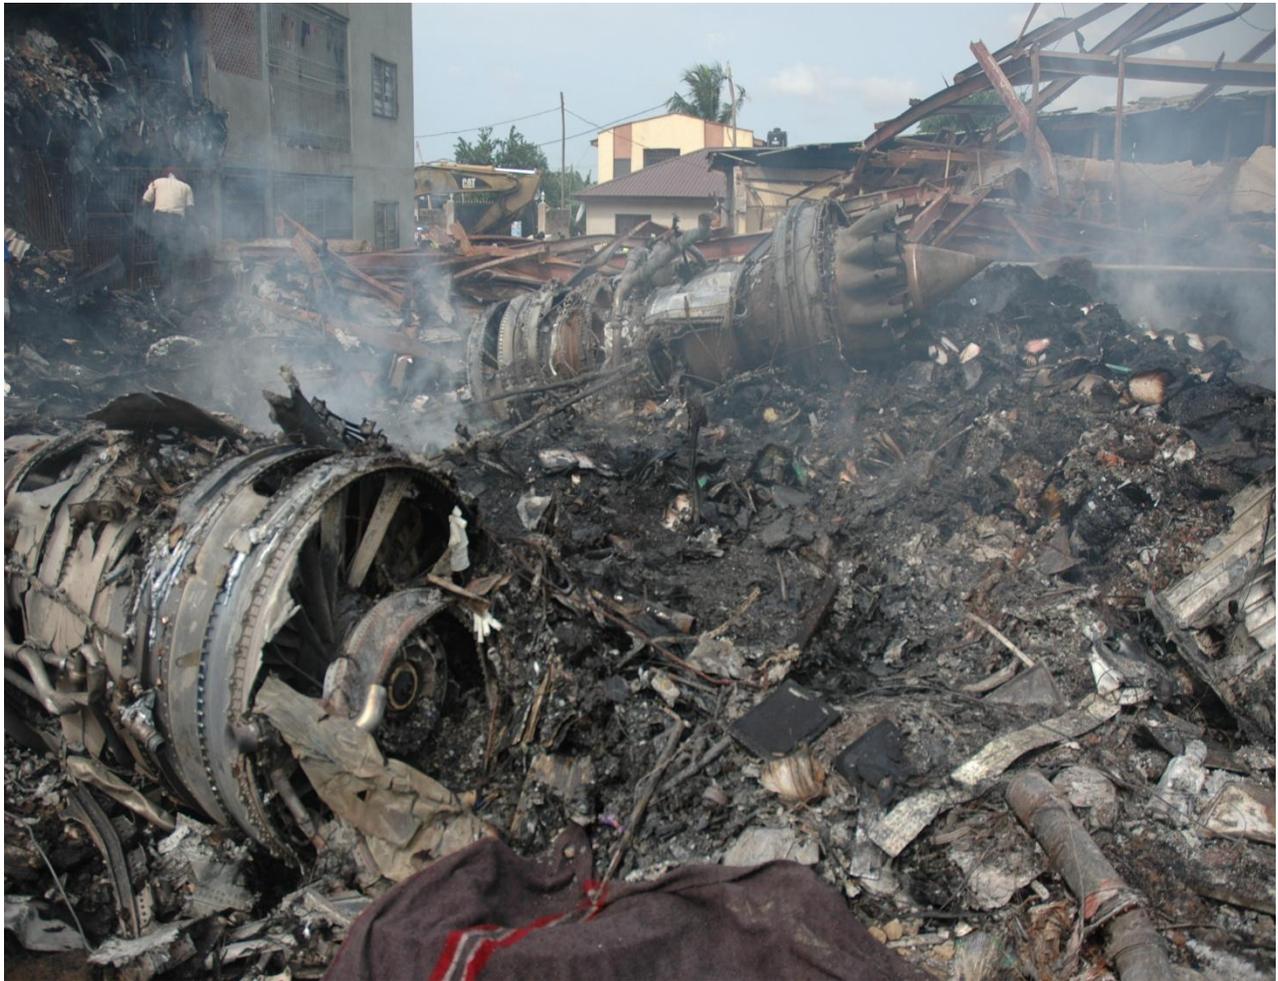
FIGURE 30: THE TWO ENGINES LYING SIDE BY SIDE IN THE WRECKAGE AT THE CRASH SITE

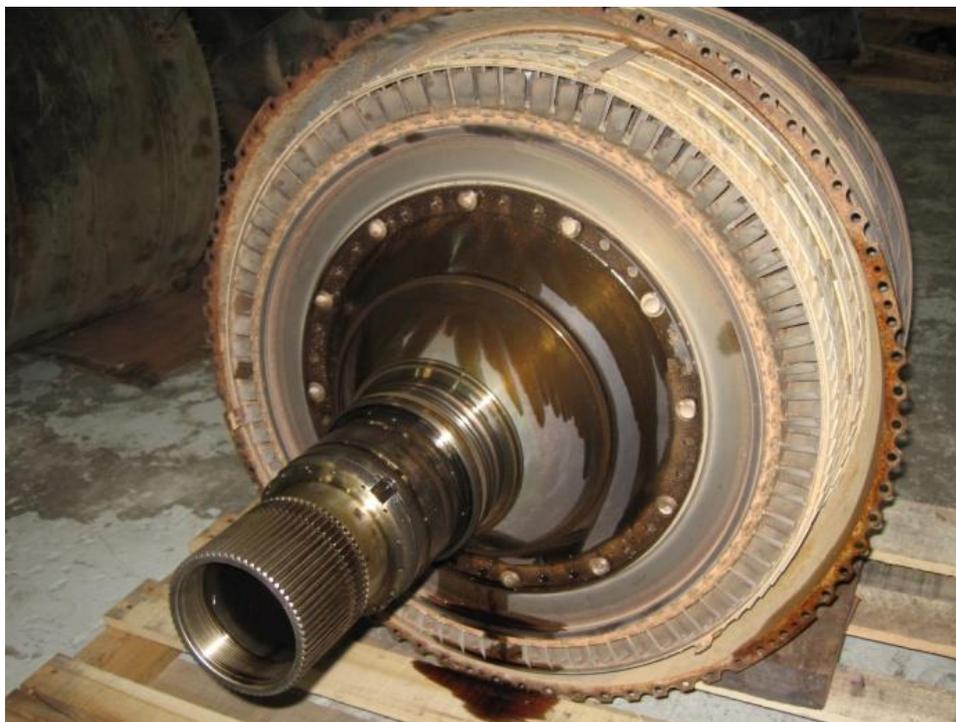
PHOTO 9: HPC STAGE 13 BLADE - UNDAMAGED

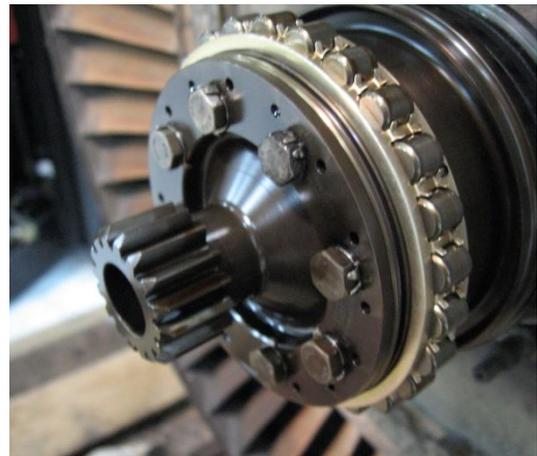
PHOTO 20: No. 6 BEARING AND SCAVENGE DRIVE GEAR

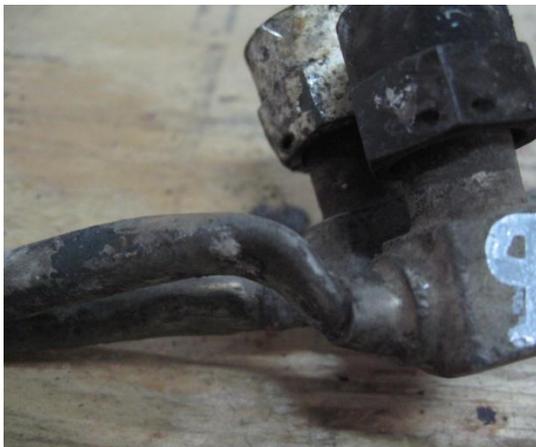
PHOTO 22: PINCHED TRANSFER TUBE

A flow test of the fuel manifolds were conducted using shop air at approximately 130psi. On the left-hand manifold, shop air was introduced into the primary No. 1 fuel nozzle fitting and a steady stream of air was felt at all the fuel nozzles positions with the No. 7 and 8 positions flowed at a noticeably reduced rate. The same flow test was conducted on the right-hand secondary, and both the primary and secondary on the left-hand manifold (air introduced at the No. 2 fitting) and all flowed steadily. No significant debris came out during the flow test but some residual water did flow out.

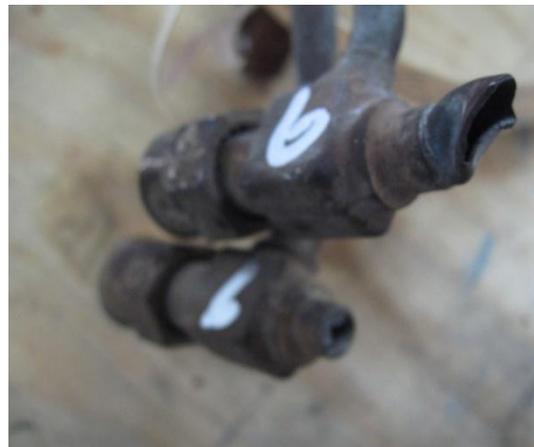
PHOTO 23: FRACTURED FEEDER LINE

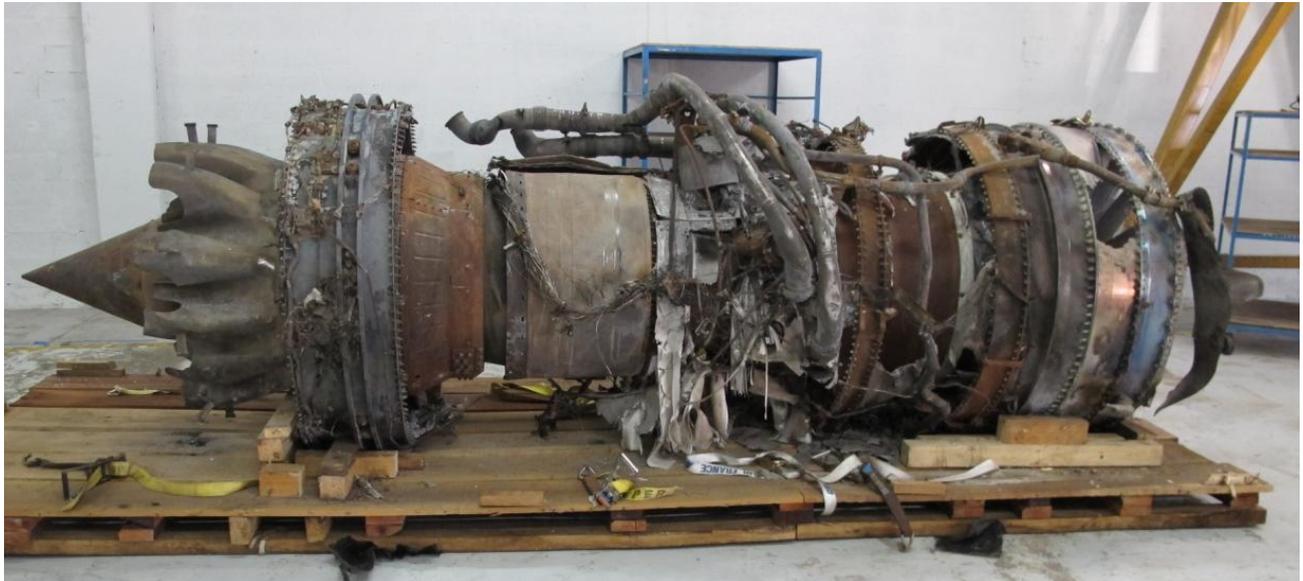
The engine was uncrated and placed on pallets for examination and disassembly (**PHOTO 24**). The engine was intact from the nose bullet aft to the exhaust tail cone with all major modules in place. Engine cases appeared round and did not exhibit signs of structural deformation or case breach. Fan and exhaust ducting was missing from the "E"-flange (aft flange of the fan exit guide vane (FEGV) Outer Case) aft to the "F"-flange (forward flange intermediate case outer diameter ring) and from the "G"-flange (aft flange of the intermediate case outer diameter ring) to the "K"-flange (forward flange of the turbine case outer diameter ring). Some wiring, and pneumatic and oil

PHOTO 24: RIGHT-HAND SIDE OF THE NO. 2 ENGINE SN 728113

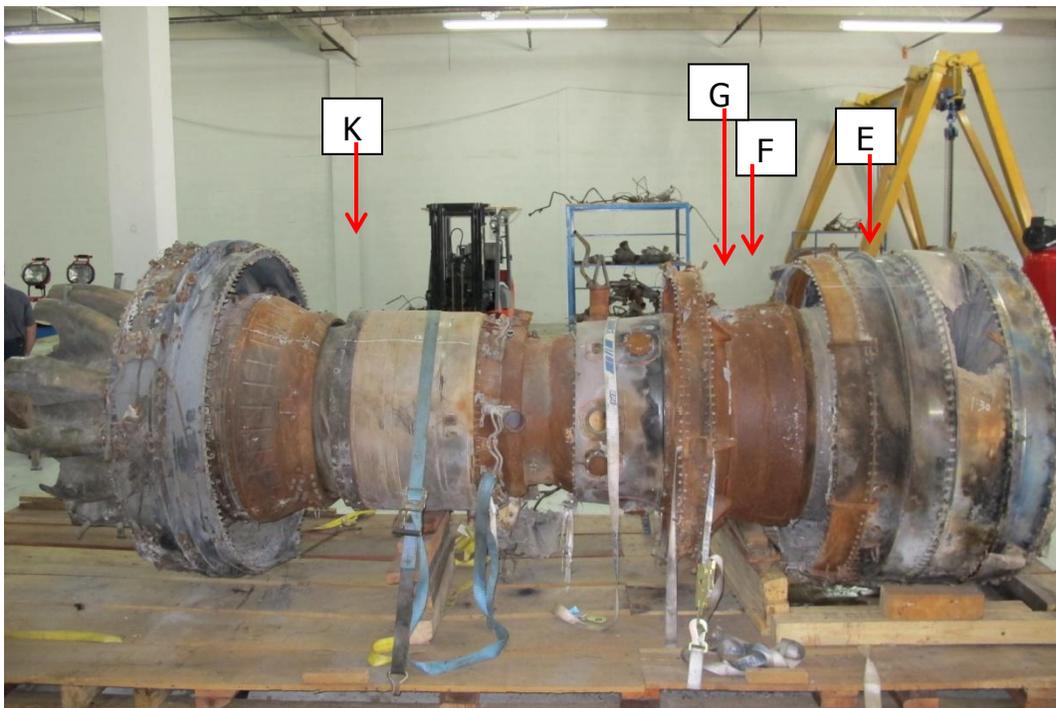
system plumbing along with crash debris were removed to facilitate teardown (**PHOTO 25**).

PHOTO 25: RIGHT-HAND SIDE OF NO. 2 ENGINE WITH FLANGE LOCATIONS

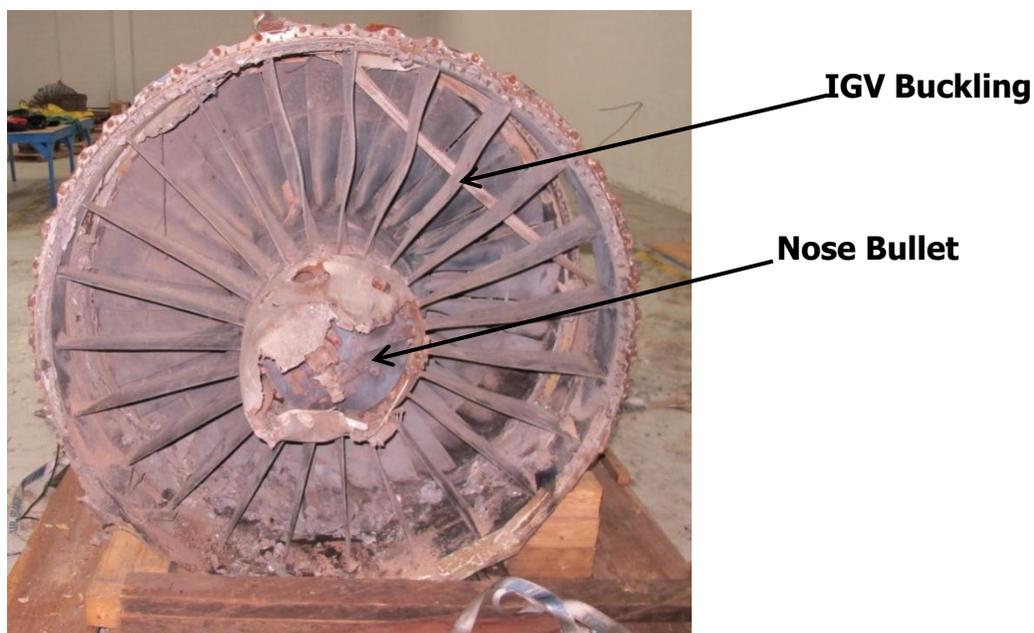
The inlet area was inspected and it was noted that the inlet nose bullet was partially melted exposing the front accessory drive cover. All the IGV's were in place and secure with five vanes, located between the 10:00 o'clock and 12:00 o'clock positions, buckled at the mid-span (**PHOTO 26**). No significant leading edge impact damage was noted.

PHOTO 26: ENGINE INLET

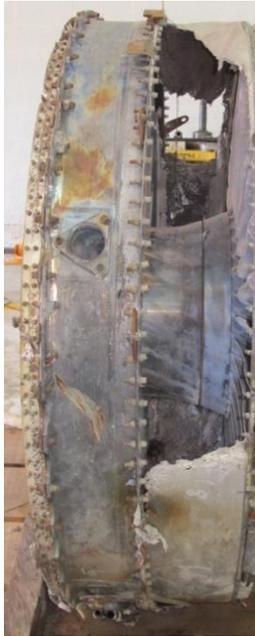
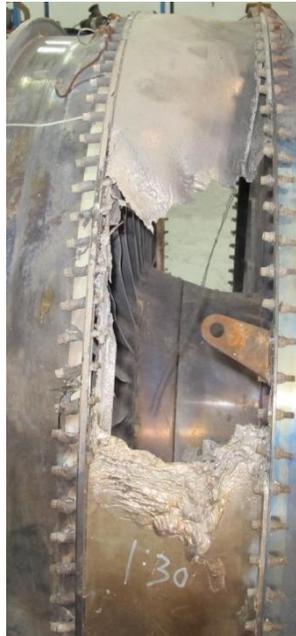
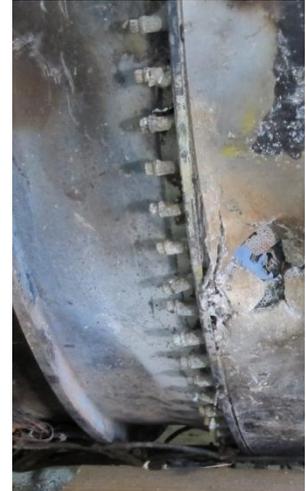
The forward fan case exhibited damage in three locations. Case material was missing circumferentially from the 12:00 to 1:30 positions and from the 8:00 to 11:00 o'clock positions, the edges of these holes exhibited thermal distress and indications of melting. An inward puncture with associated case deformation was present at the 4:00 o'clock position, approximately 4 inches in diameter with indications of melting around the fracture surfaces (**PHOTO 27**).

PHOTO 27: FORWARD FAN CASE THERMAL AND IMPACT DAMAGE

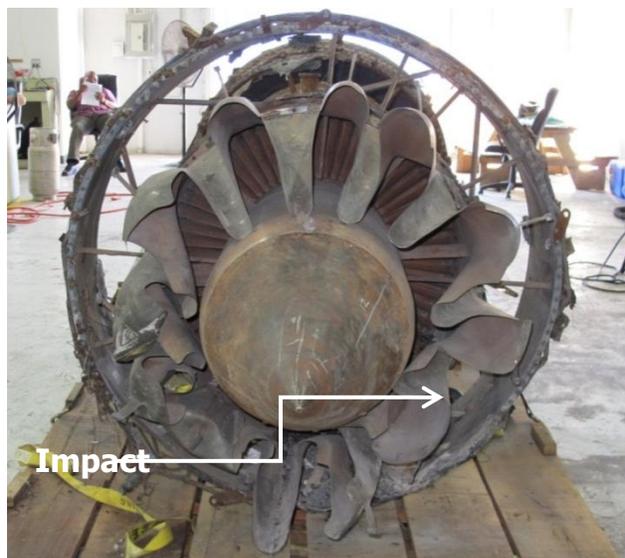
The exhaust mixer lobes exhibited crushing damage both radially inward and forward from the 6:00 to 9:00 o'clock positions. The tail cone and inner exhaust duct were both present and undamaged (**PHOTO 28**). There was no distress noted in the exhaust duct mount rails.

PHOTO 28: EXHAUST CASE AND MIXER

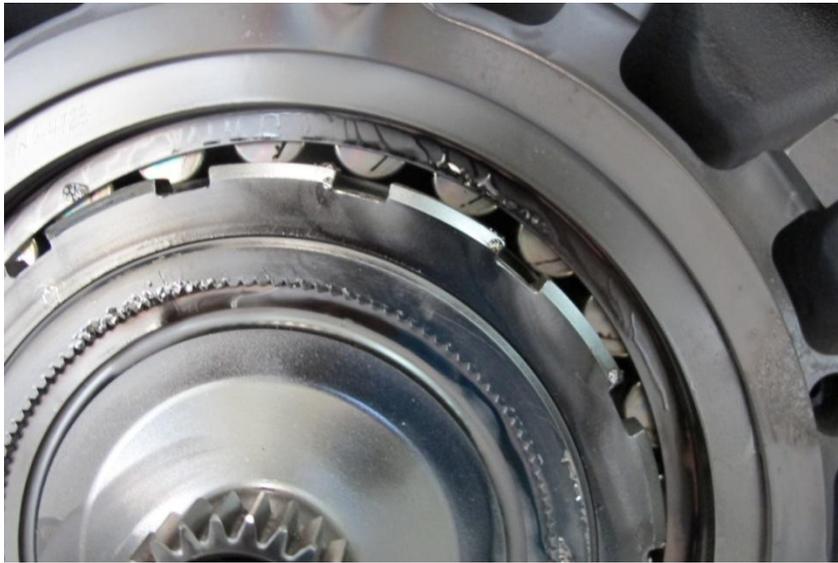
The front accessory drive cover was removed exposing the No. 1 bearing. All rollers were present, intact, shiny, and oil wetted. No damage was noted on the bearing cage or races (**PHOTO 29**). The front compressor was removed from the core of the engine and not disassembled further. Except for the stator 1 case and shroud, the low pressure compressor cases and shrouds were round without indication of deformation or breach. A uniform coating of light gray ash was found throughout of the observable gaspath hardware in the LPC. The ash coated easily brushed or blown off (**PHOTO 30**).

PHOTO 29: No. 1 BEARING

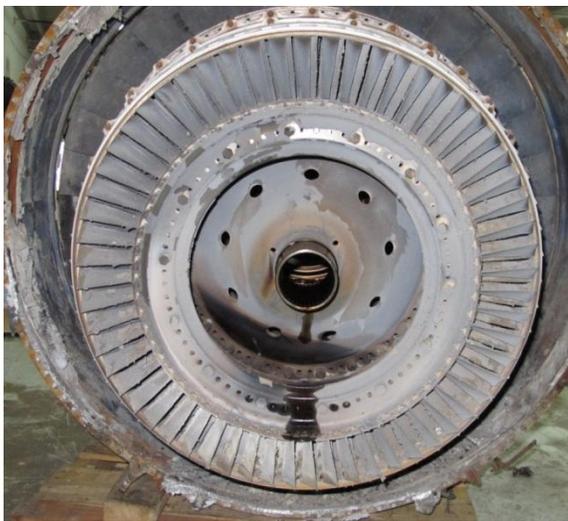
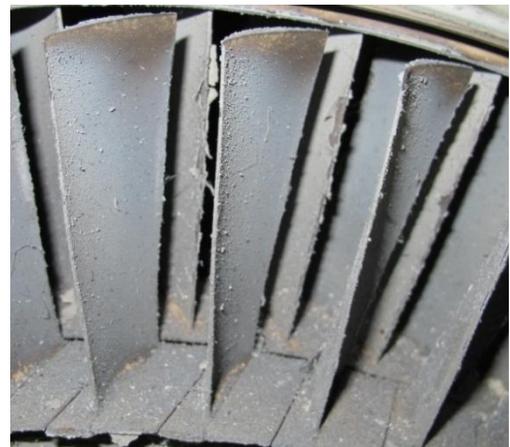
PHOTO 30: LPC STAGE 6 BLADES WITH ASH COATING

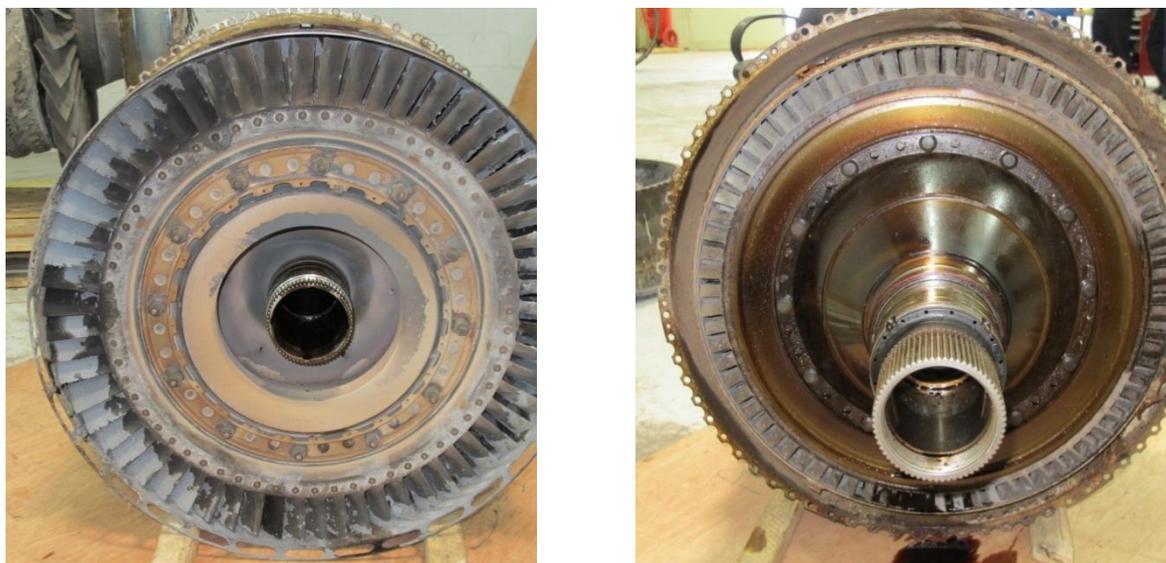
any circumferential rub. Looking through the stage 7 blades, the stage 7 vanes were visible; all were intact and exhibited no leading edge impact damage. The stage 13 blades were all present, full length, and exhibited no trailing edge damage or tip rub **(PHOTO 33)**. Looking through the stage 13 blades, the stage 12 vanes were visible; all were intact and exhibited no trailing edge impact damage. The stage 13 blade shroud (located in diffuser case, but discussed here for documentation purposes) did not exhibit any circumferential rub. The visible airfoils in the HPC exhibited a uniform coating of light gray ash.

PHOTO 33- HPC STAGES 7 AND 13 BLADES IN GOOD CONDITION

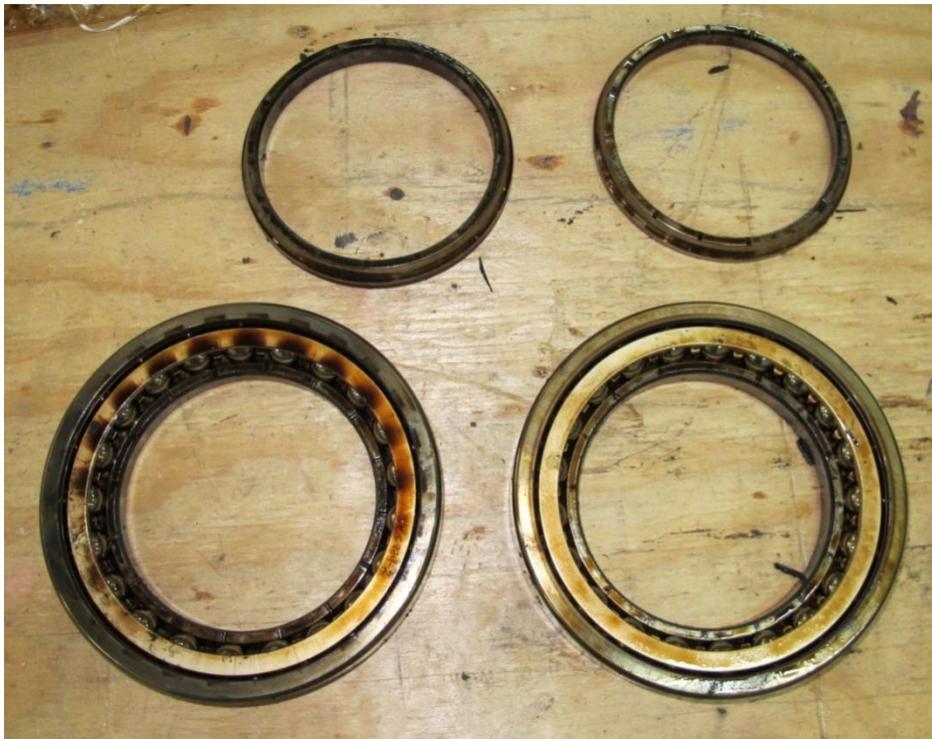
The No. 4 duplex ball bearing spun freely and smoothly when turned by hand. All balls were present, shiny, oil-wetted, and secured in their cages which were also intact (**PHOTO 11**). The inner races were shiny, oil wetted, and in good condition.

PHOTO 34: No. 4 BEARING - GOOD CONDITION

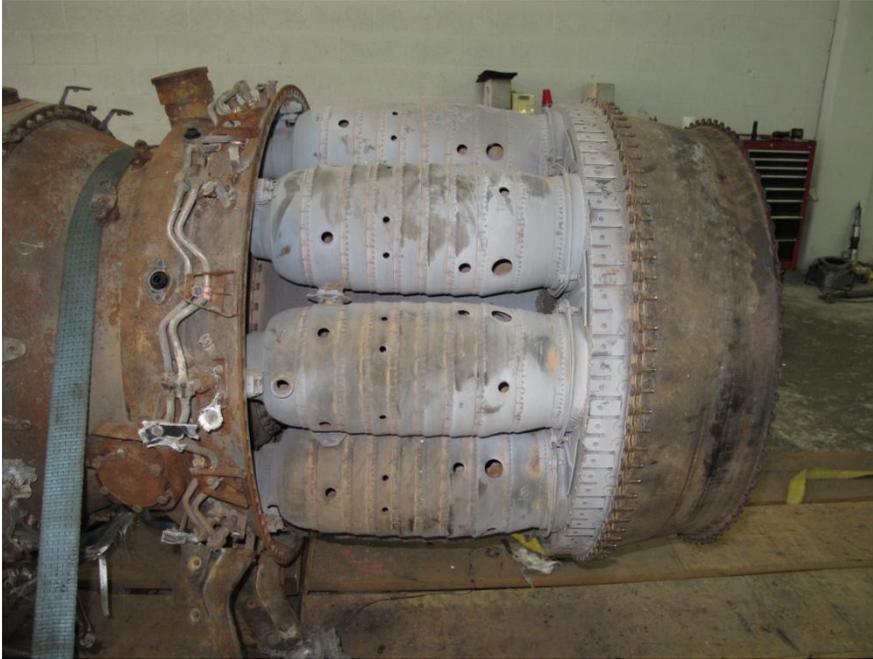
The combustion chamber outer case was intact and exhibited no punctures, breaches, or impact damage. The combustion chamber outer case was removed to expose the combustion chambers. All nine combustion chambers were present, secure, intact, and exhibited no thermal distress, cracking in the louvers or dilution holes, burn-through, or impact damage (**PHOTO 35**). The outside of all nine combustion chambers had a light gray coating of ash. All nine combustion chambers were secured at the front by positioning pins that were intact and safety wired. The aft ends of the combustion chambers were secured into the front of the combustion chamber rear support assembly. All the interconnecting cross-over tubes were present, secured, and lockwired. The combustion chambers were removed to expose the interior of the chambers and the fuel nozzles. All nine combustion chambers exhibited a similar condition: 1) no thermal distress, 2) no localized sooting, or evidence of nozzle streaking in the ID of the chambers, 3) some minor flaking/chipping of the thermal barrier coating on the ID chamber, 4) no significant contact wear on the pin support, fuel nozzle port, cross-over tubes, or rear skirt, and 5) no significant cracking of the dilution holes or louvers. Loose dirt and mud were present in the combustion area. All the combustion chamber support pins were intact and no appreciable wear was noted.

PHOTO 35- COMBUSTION CHAMBER INSTALLED IN THE ENGINE- NO VISIBLE THERMAL DISTRESS

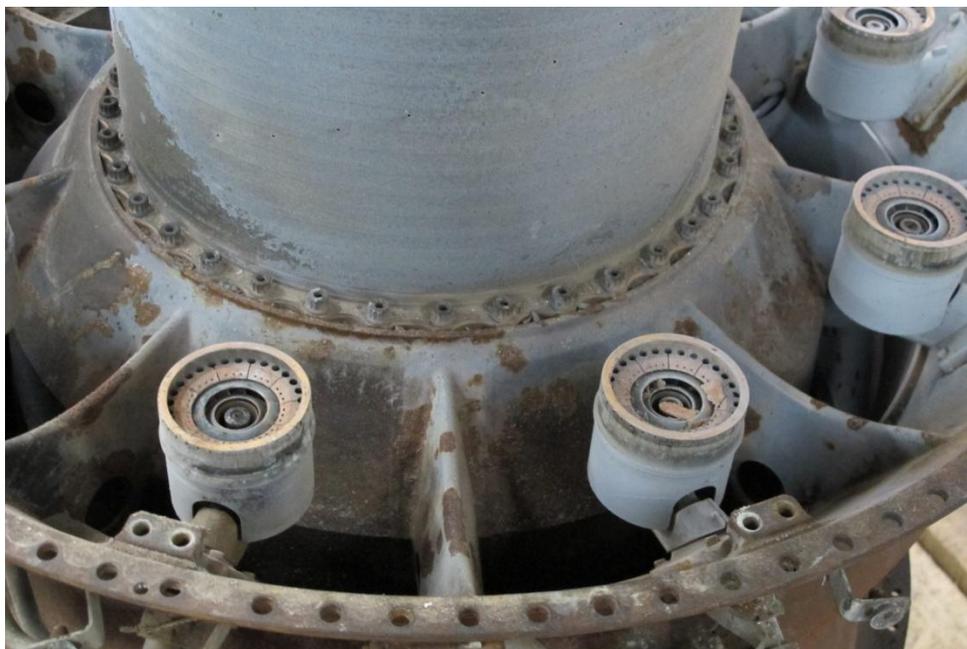
All the fuel nozzles were intact and secure in the diffuser case with no notable distress (see section 3.2.7 for details) (**PHOTO 36**).

PHOTO 36: FUEL NOZZLES INSTALLED AND SECURE IN THE DIFFUSER CASE

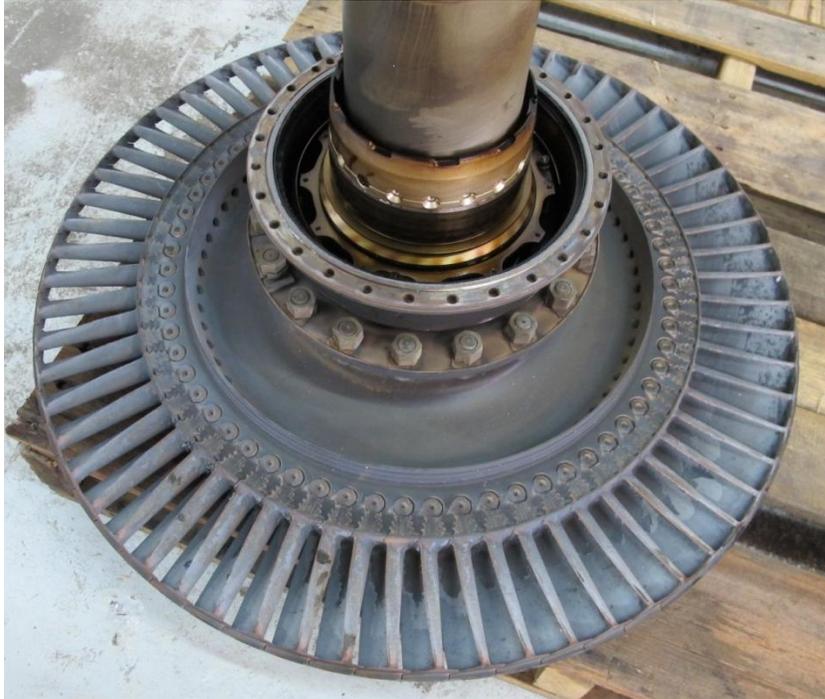
All HPT stage 1 vanes were present, intact, and secure. No signs of thermal distress, no leading edge erosion, and no trailing edge cracks were observed. The thermal barrier coating on the nozzles was in good condition. All the HPT stage 1 blades were present, full length, and no signs of thermal distress were observed (**PHOTO 37**). The OD surface of the tip shrouds exhibited a light, shiny 360° circumferential rub on the cooling air channel and the forward seal land (**PHOTO 38**). The HPT outer air seal ring exhibited a light shiny 360° circumferential rub of the honeycomb, as well as an approximately 4 inch rub through the honeycomb that was dark and oxidized suggesting a pre-existing rub. HPT shaft serial number, BKLBBW1127 was recorded from the outer diameter of the HPT flange and it did not match maintenance records. A serial number could not be located on the HPT disk. HPT airfoils exhibited a coating of light gray ash. The HPT shaft was intact and did not exhibit any rubs or circumferential scoring.

PHOTO 37- HPT STAGE 1 DISK

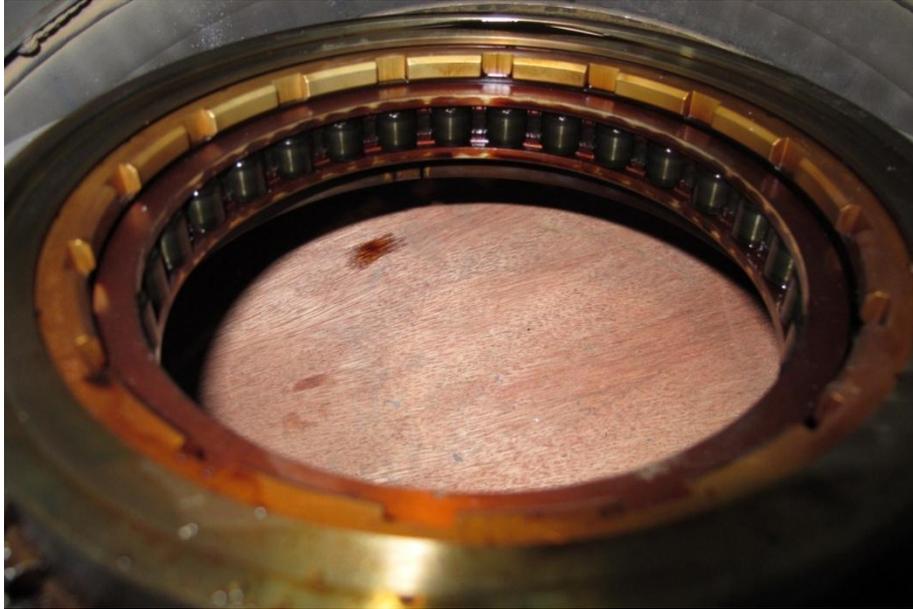
All the No. 5 bearing rollers were present, shiny, oil wetted, and secured in their cage which was also intact. The No. 5 bearing spun freely and smoothly when turned by hand. The No. 5 bearing inner race was shiny and in good condition (**PHOTO 39**). The oil from the No. 5 bearing compartment was dark brown in color but did not have an acrid odor.

PHOTO 39-No.5 ROLLER BEARING- GOOD CONDITION

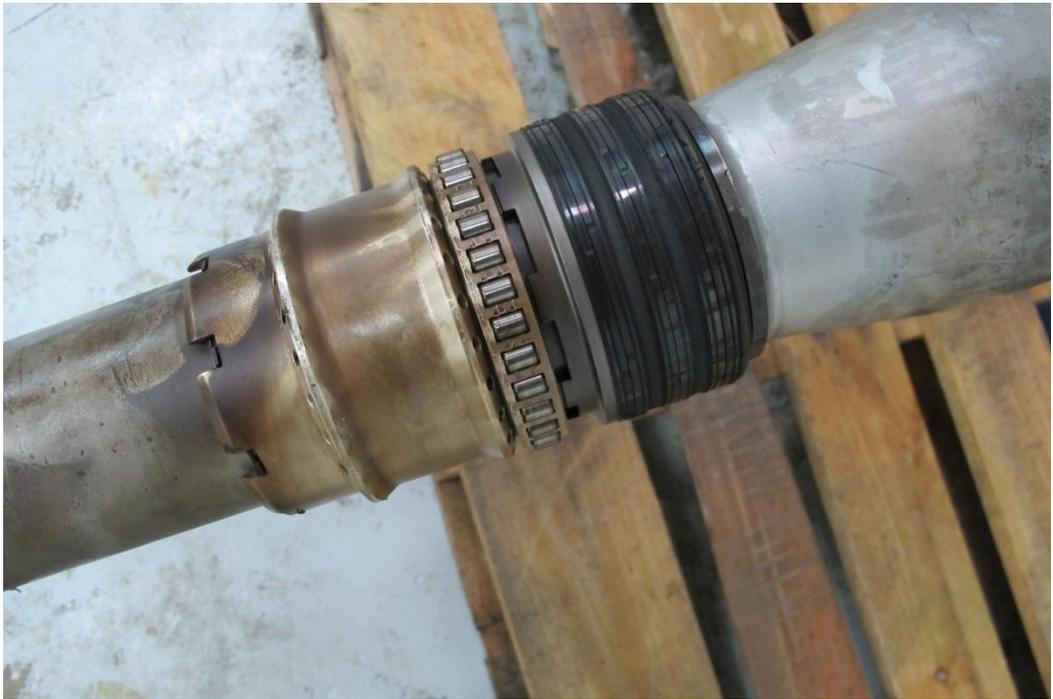
The LPT module was removed from the core of the engine and was not disassembled further. No circumferential rubs were noted on the LPT shaft. All the No. 4½ bearing rollers were present and secured in their cage, which was also intact with no noted distress (**PHOTO 40**). The No. 4½ bearing spun freely and smoothly when turned by hand. The No. 4½ bearing carbon seal and inner race coupling nut were both present and intact. Soot was noted on the forward part of the LPT shaft as well as on the No. 4½ bearing inner race lock nut. The LPT stage 2 vanes were all present, in good condition, and no leading edge damage was noted (**PHOTO 41**). The stage 2 vanes outer air sealing ring spacer was fractured at the 9:00 o'clock position and part of the

PHOTO 40-COUPLING NUT, No. 4 1/2 BEARING, CARBON SEAL- GOOD CONDITION

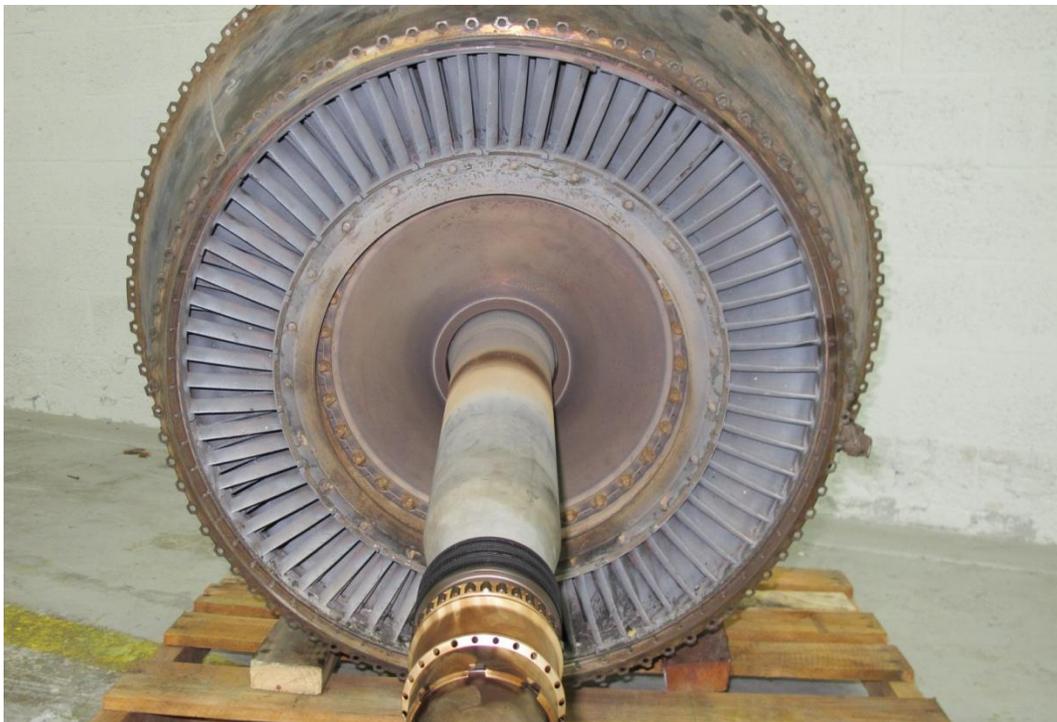
Looking through the LPT stage 2 vanes, the stage 2 turbine blades were visible. All the stage 2 turbine blades were present and appeared undamaged and straight. The stage 2 blade and vane airfoils visible exhibited a coating of light gray ash. The LPT stage 4 blades were all present, straight, in good condition, and no trailing edge damage was noted **(PHOTO 43)**. There were no indications of rub on the stage 4 blade tip shroud or outer air seal to the extent that could be observed in the assembled condition. Melted aluminium had pooled and subsequently solidified around the stage 4 turbine blades at the 6 o'clock position. Looking through the LPT stage 4 blades, the stage 4 vanes were visible. All the stage 4 turbine vanes were present and appeared undamaged. All the No. 6 bearing rollers were present, shiny, and secured in their cage which was also intact. The No. 6 bearing spun freely and smoothly when turned by hand. The No. 6 bearing carbon seal was present and intact. All the LPT disk tie-rods were present, and the tie-rods were secure.

PHOTO 41-LPT STAGE 2 VANES

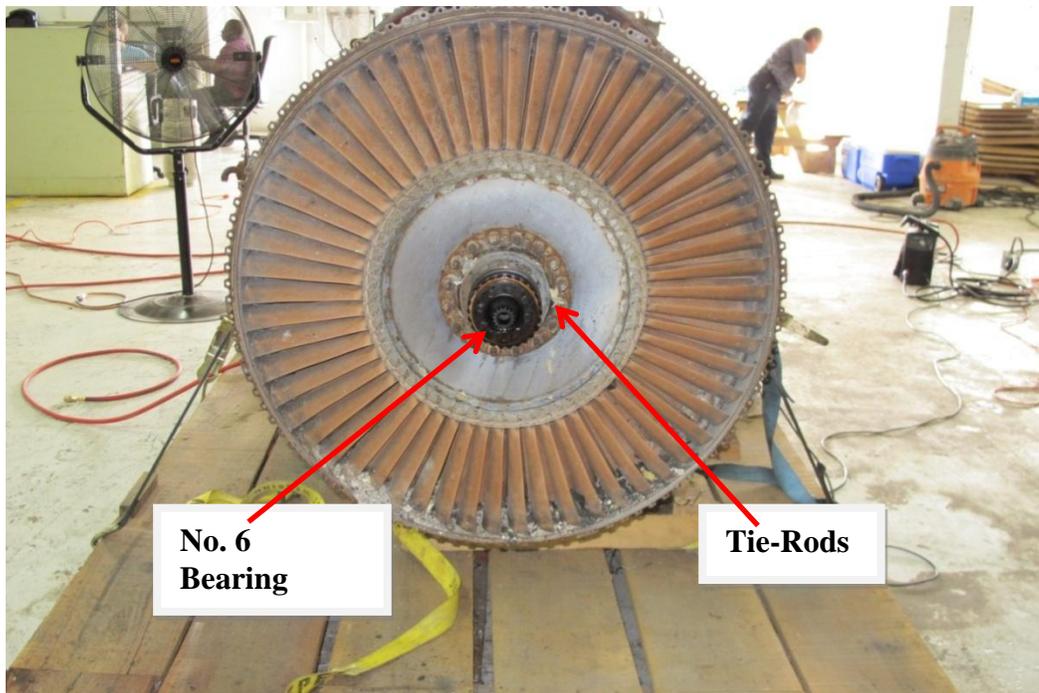
PHOTO 43-LPT STAGE 4 BLADES- GOOD CONDITION

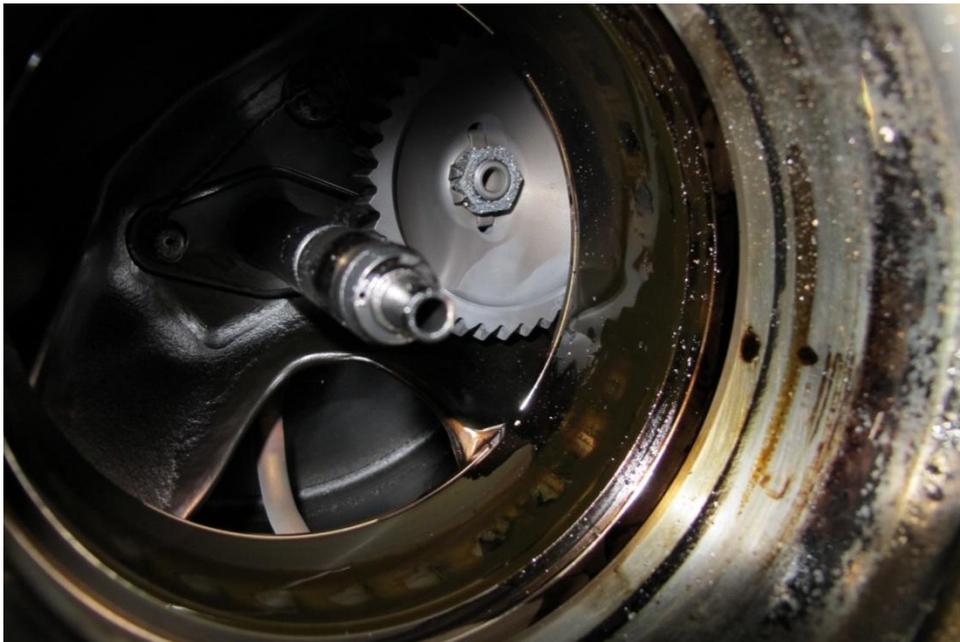
The No. 6 bearing compartment was undamaged and essentially dry and matte black in color with only a small amount of residue oil remaining (**PHOTO 44**). The residual oil was dark in color but did not have an acrid odor. The scavenge pump gear was dry and unable to be turned by hand. Oil staining was noted on the No. 6 bearing carbon seal land and the No. 6 bearing outer race.

PHOTO 44-No. 6 BEARING COMPARTMENT
