AIRCRAFT ACCIDENT REPORT

DANA/2012/06/03/F

Accident Investigation Bureau

**Report on the Accident to
DANA AIRLINES NIGERIA LIMITED
Boeing MD-83 aircraft with registration 5N-RAM
which occurred at Iju-Ishaga Area of Lagos State,
Nigeria
On 3rd June 2012**

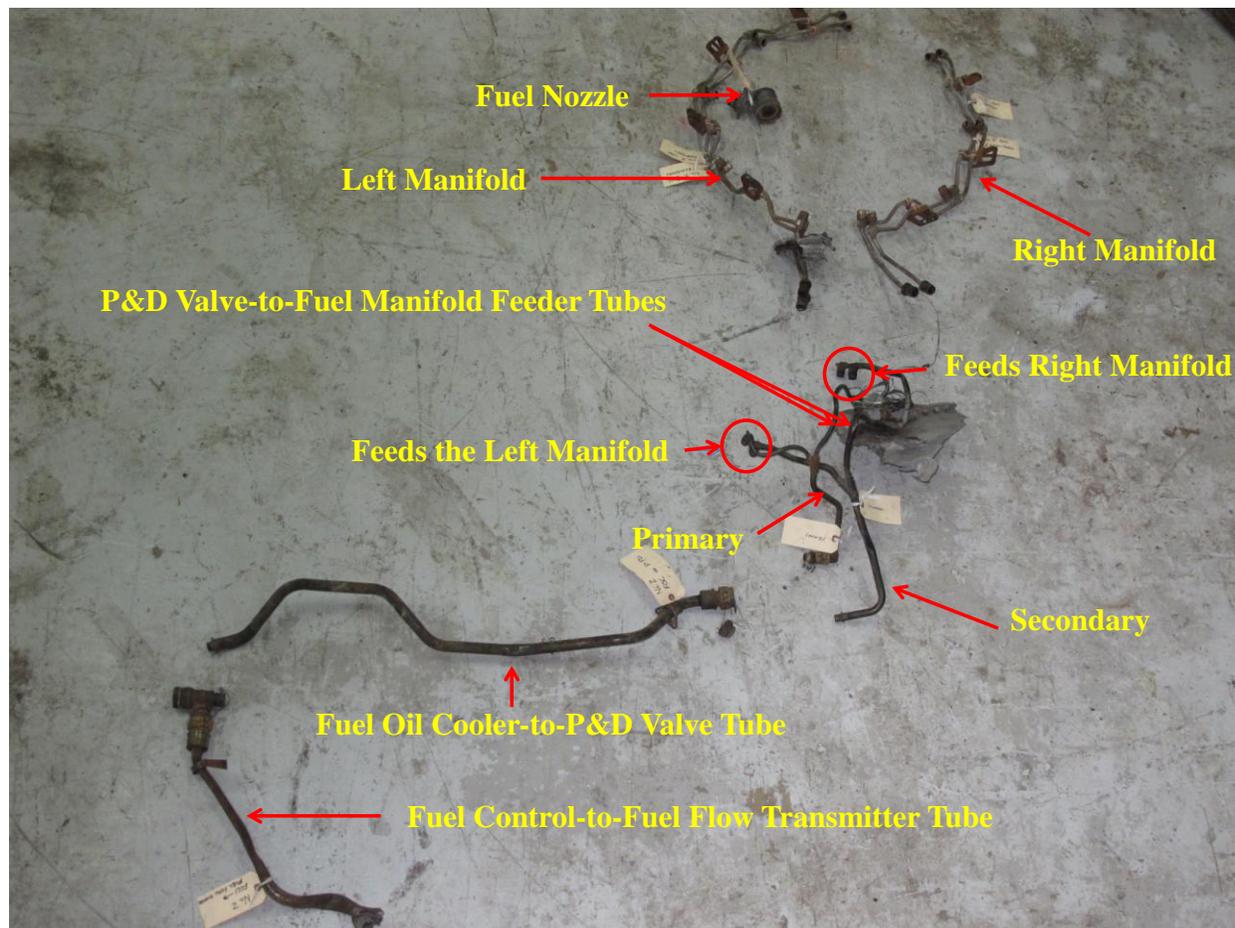
The fuel control unit-to-fuel flow transmitter line was flattened and bent over a majority of its length but was not collapsed to the point of complete blockage. No line breaches were noted. A piece of melted fuel control housing flange was still attached to the fuel control unit end of the line. No obstructions were observed during a visual inspection into both ends of the tube.

The fuel oil cooler-to- P&D valve line had two dents, one at the oil cooler attachment end and the other at approximately the mid-span. The line was not collapsed, no breaches were present, and no obstructions were observed during a visual inspection into both ends.

The primary fuel flow feeder line that connects the P&D valve to the fuel flow manifolds had multiple dents downstream of the junctions between the left and right manifolds. The P&D valve end B-nut and fitting were still present. No obstructions were observed during a visual inspection into both ends. The secondary fuel flow feeder line that connects to the right hand manifold was collapsed and bent downstream of the junction, neither of which completely blocked flow. The P&D valve end B-nut and fitting on the secondary line were not present.

The right-hand primary and secondary manifold supply tubes were bent at the No. 5 fittings. Similar damage was noted on the left-hand primary and secondary manifold supply tube at the No. 6 fittings. Neither of these bends completely obstructed flow. The left hand primary manifold also had a circumferential crack just outboard of the fan duct pass through. Visual examination did not identify any blockages looking into the open ends of the tubes.

PHOTO 45-FUEL SYSTEM TUBING

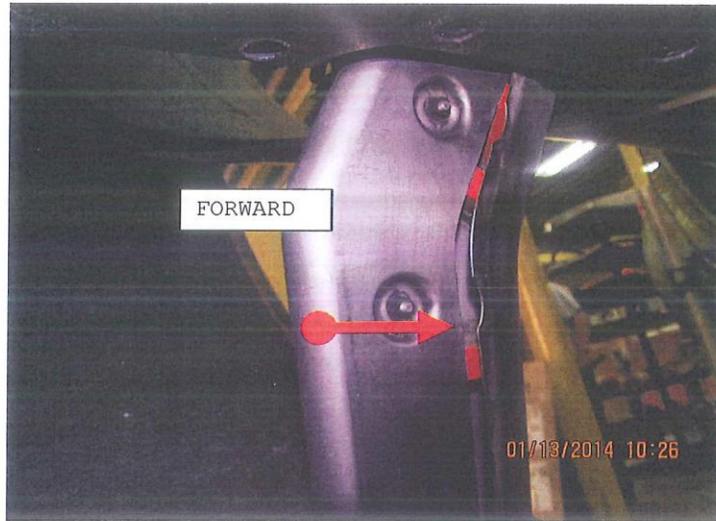
Upon removal of the fan discharge ducts it is noted that the R/H fuel manifold inlet fairing is improperly installed due to lack of engagement of the front and rear sections on the inboard side. Image 1 shows assembly as installed on engine. Image 2 shows assembly as removed from engine.

Image 1: Fuel manifold inlet tube fairing not engaged at split-line

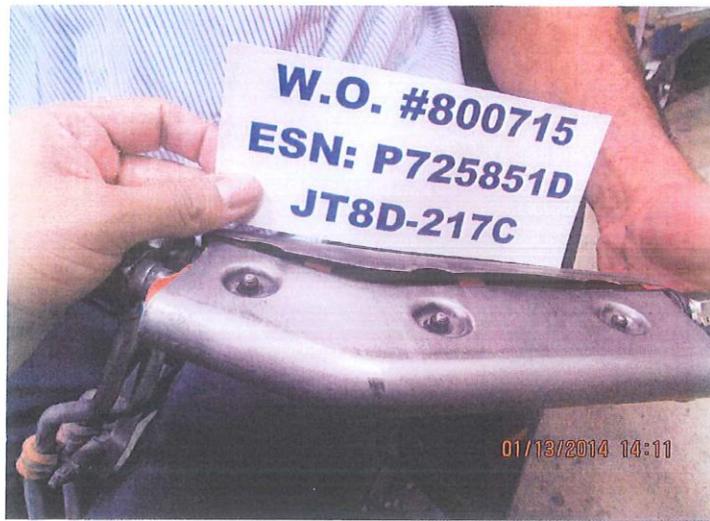
Image 2: Fuel manifold assembly as removed from engine

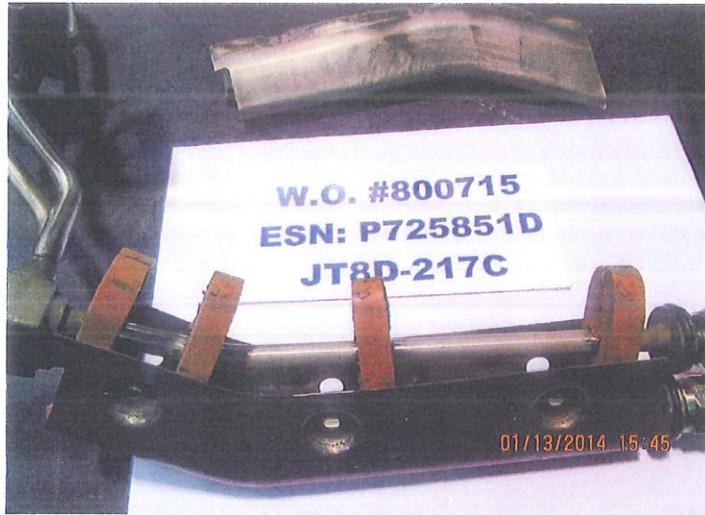
The R/H fuel manifold assembly shows a fracture on the secondary fuel inlet tube, No. 5 fuel nozzle at 5 o'clock position. The secondary fuel manifold inlet tube is liberated adjacent to the No. 5 fuel nozzle coupling location. Images 3 and 4 show fuel manifold assembly as installed on engine. Images 5, 6, 7, 8, 9, 10 and 11 show fuel manifold assembly as removed from engine. Referencing SB6452, page 3, this condition can be caused by thermal expansion resulting in high stresses. Also, installation of distorted manifolds and incorrect shimming of the manifold during installation can aggravate the condition. It is noted that fuel manifold assembly is pre-SB6452 (to provide secondary fuel manifold assemblies fabricated with new tube material, which have a significantly greater fatigue life).

Image 7: R/H fuel manifold assembly, aft fairing removed

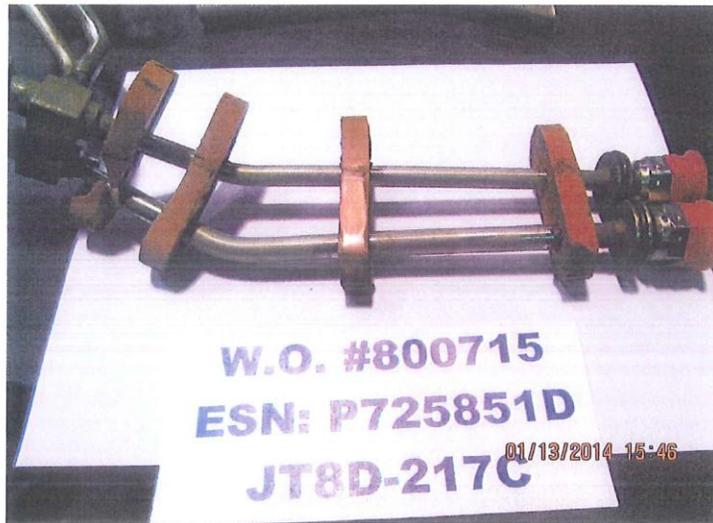
Image 8: R/H fuel manifold assembly, forward and aft fairing removed

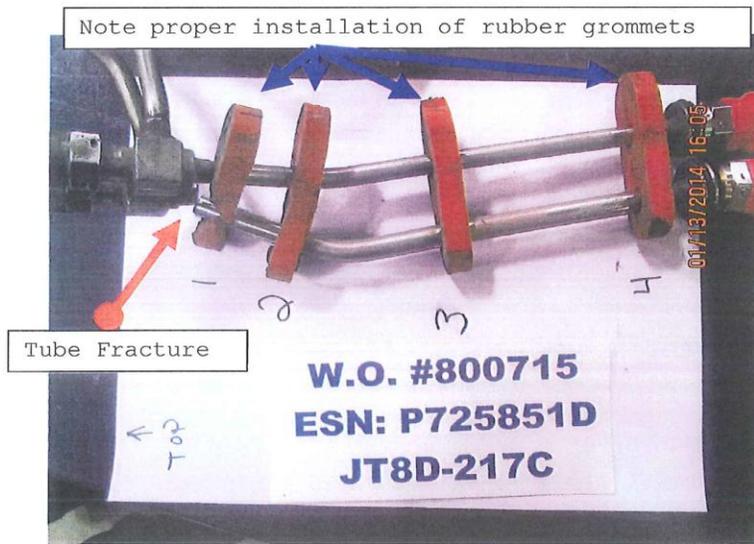
Image 10: R/H fuel manifold assembly fuel inlet tubes as exposed without fairings

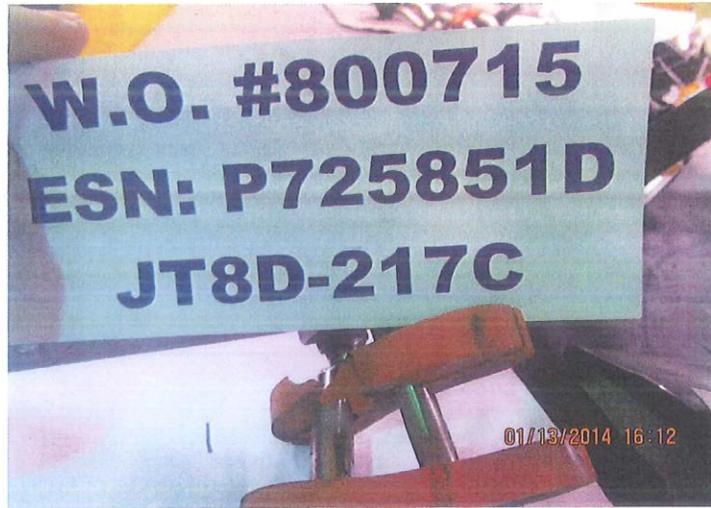
Image 11: R/H fuel manifold assembly fuel inlet tubes

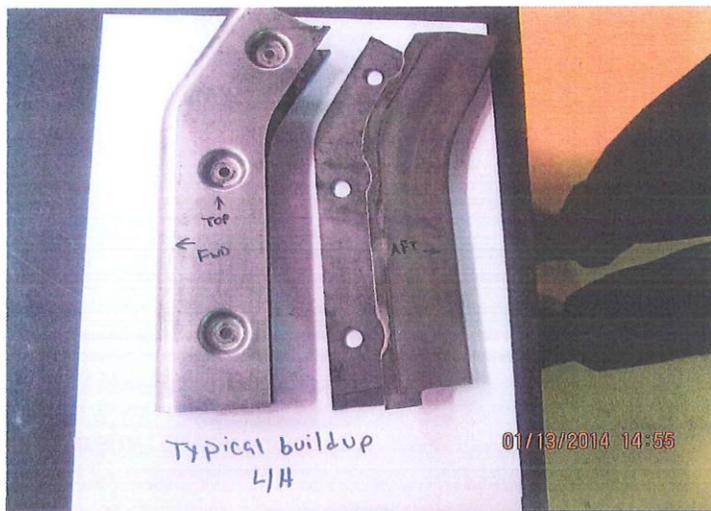
Images 12, 13, 14, 15, 16 and 17 show typical assembly of fairing assemblies with grommets.

Image 12: Typical assembly procedure of L/H fairing

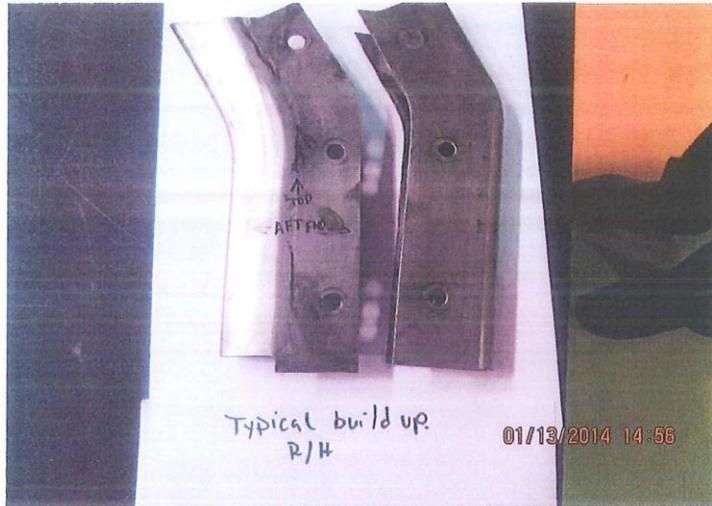
Image 13: Typical assembly procedure of R/H fairing

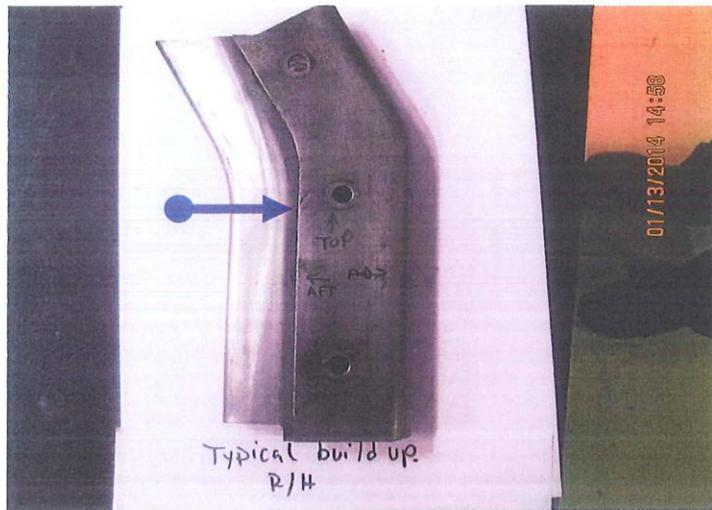
Image 14: Typical assembly, note proper engagement of forward and aft fairing

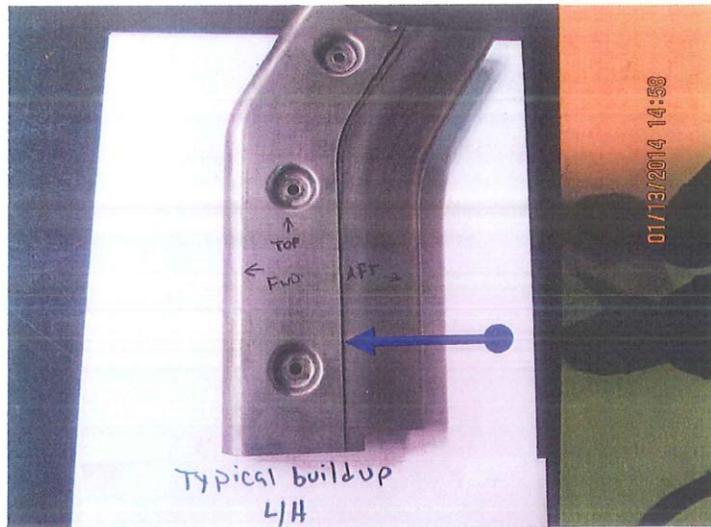
Image 15: Note proper engagement of forward and aft fairings

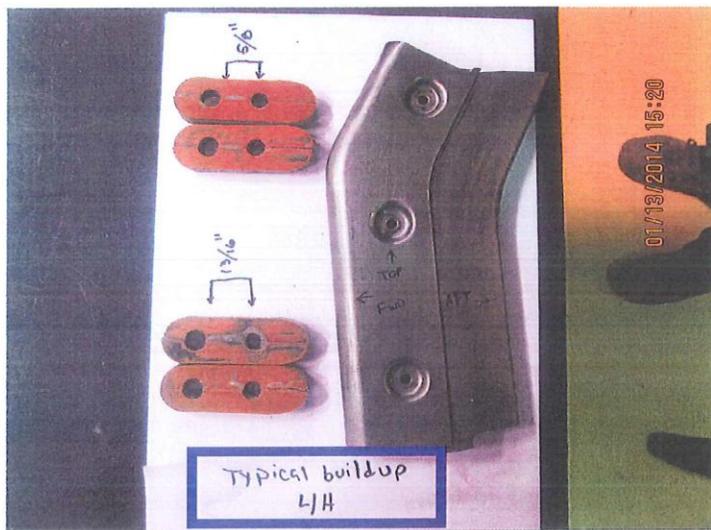
Image 15: Note distance of inlet tube holes in grommets for proper installation sequence

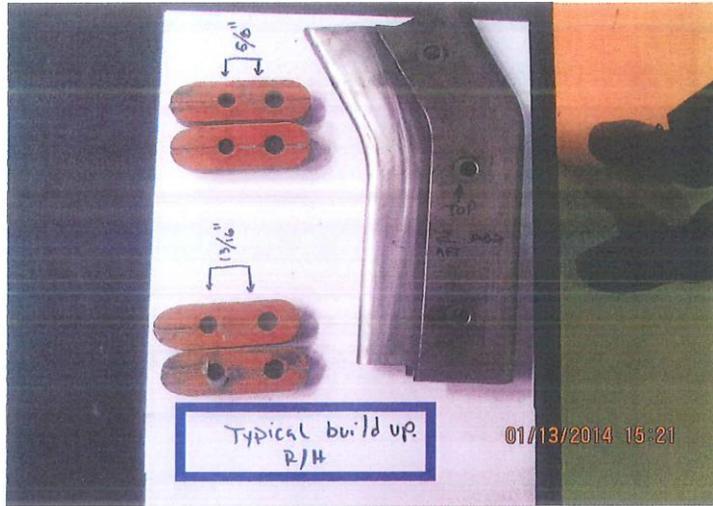
Image 17: Note distance of inlet tube holes in grommets for proper installation sequence

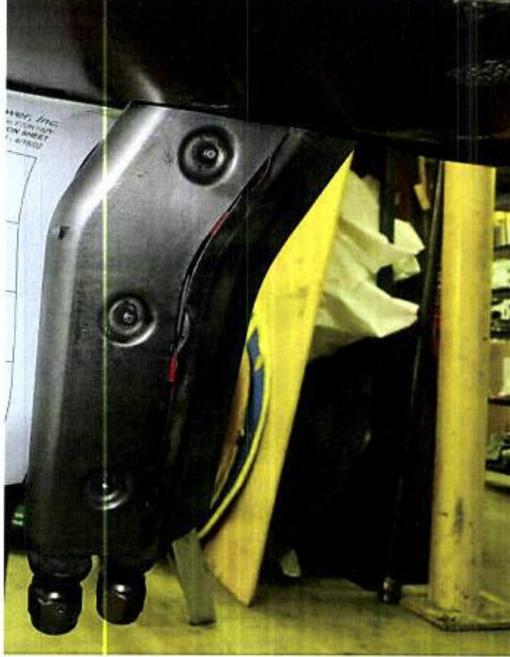
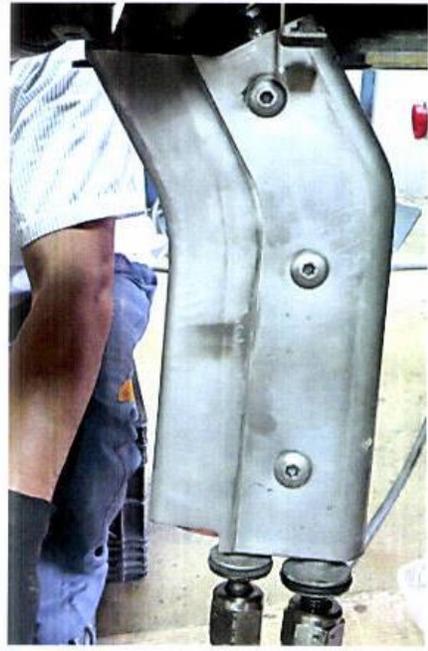
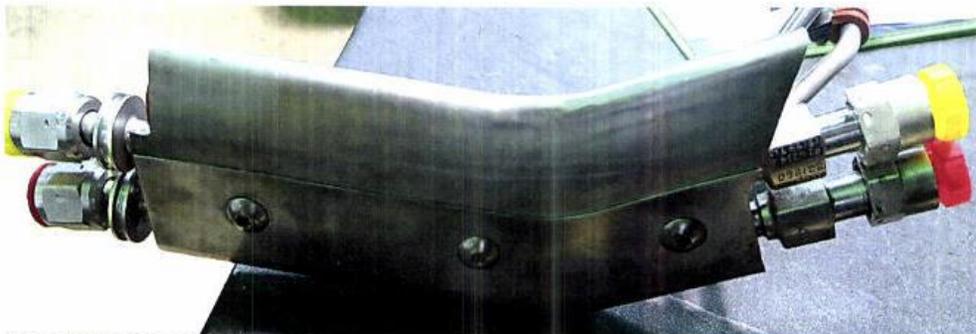
TOP LEFT INCORRECTLY FITTED; TOP RIGHT/BOTTOM – CORRECT INSTALLATION
