# Air Accident Investigation Sector

AAIS Case N° AIFN/0015/2016

## Failure of the Left Wing Landing Gear to Extend

Make and Model: Airbus A380-861

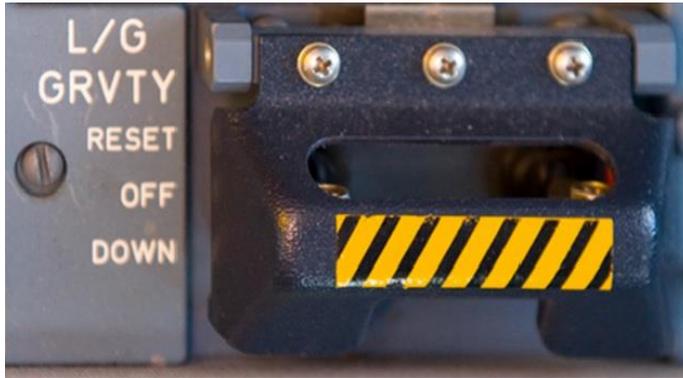
Figure 1. Landing gear gravity extension switches

The landing gear extension and retraction system consists of a normal gear extension system, and an independent free fall system for emergency operation (figure 1).

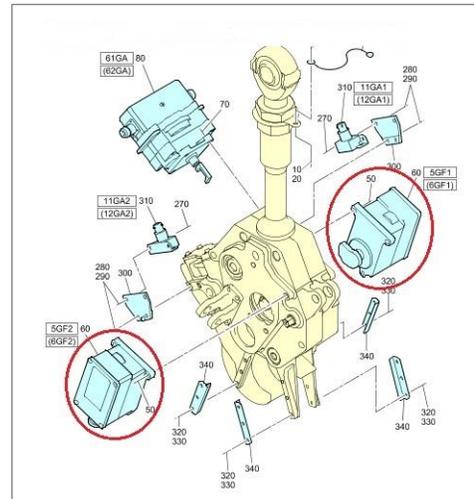
Figure 2. Emergency unlock actuators

The independent free fall, or gravity fall system, does not require hydraulic actuation and is controlled by two dedicated free fall control modules (FFCM). Each of these modules provides the emergency unlock actuators (EUA) (figure 2), located on the uplock assembly, with independent electrical power to unlock the landing gear. The landing gear doors will remain open when this system is used.

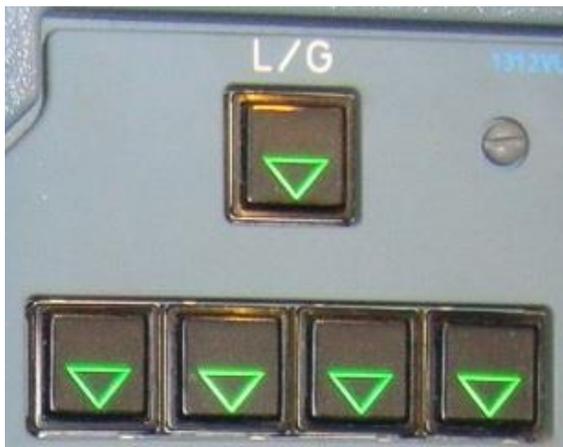
Figure 3. Aircraft landing gear indication

When the landing gear handle is selected down, the appropriate landing gear triangular indicator will illuminate when the relevant gear is down and locked (figures 3 and 4). If a landing gear is not down and locked the appropriate UNLKD sign will remain illuminated red with no green triangle (figures 5 and 6).

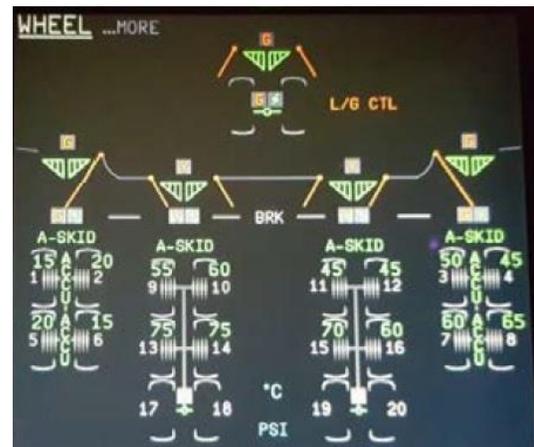
Figure 4. System Display/Wheel page

Additionally, an aural warning, a master warning light, and a L/G GEAR NOT LOCKED DOWN warning on the Engine Warning Display (E/W), alert the flight crew to the unsafe landing gear status. The wheel page on the Systems Display (SD) shows the configuration of the landing gear and the respective doors. (Figures 3 and 4).
