1. Report No. NTSB-AAR-77-1		2. Government Accession No.		3. Recipient's Catalog No.	
4. Title and Subtitle Aircraft Accident Report -- American Airlines, Inc., Boeing 727-95, N1963, St. Thomas, Virgin Islands, April 27, 1976		5. Report Date December 16, 1976		6. Performing Organization Code

AIRCRAFT ACCIDENT REPORT

AMERICAN AIR LINES, INC.  
BOEING 727-95, N1963  
ST. THOMAS, VIRGIN ISLANDS  
APRIL 27, 1976

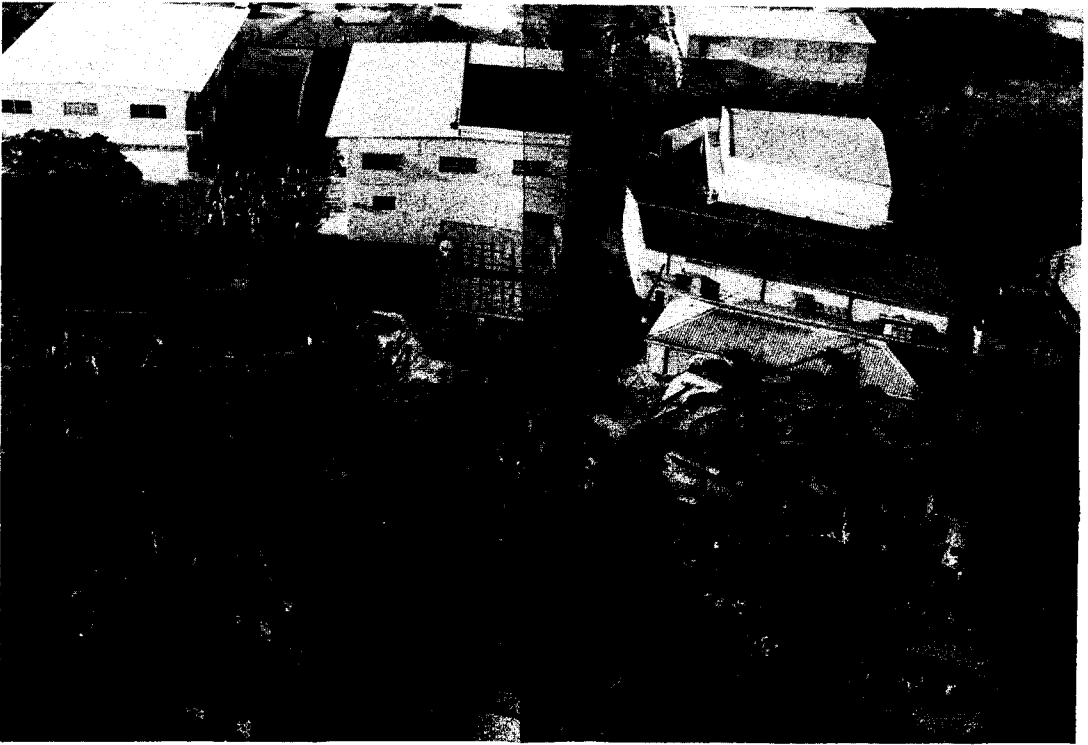
WRECKAGE DISTRIBUTION CHART  
AMERICAN AIRLINES, BOEING 727-N1963  
HARRY S TRUMAN AIRPORT  
CHARLOTTE AMALIE, ST. THOMAS, VIRGIN ISLANDS  
APRIL 27, 1976

The gasoline station's fuel-pump island and an automobile were destroyed. The rum warehouse and the gasoline station were extensively damaged by impact and fire.
