ACCIDENTS INVESTIGATION BRANCH

Boeing 707 321C G-BEBP

**Report on the accident near Lusaka International
Airport, Zambia, on 14 May 1977**

Accidents Investigation Branch
Aircraft Accident Report No. 9/78
(EW/A267)

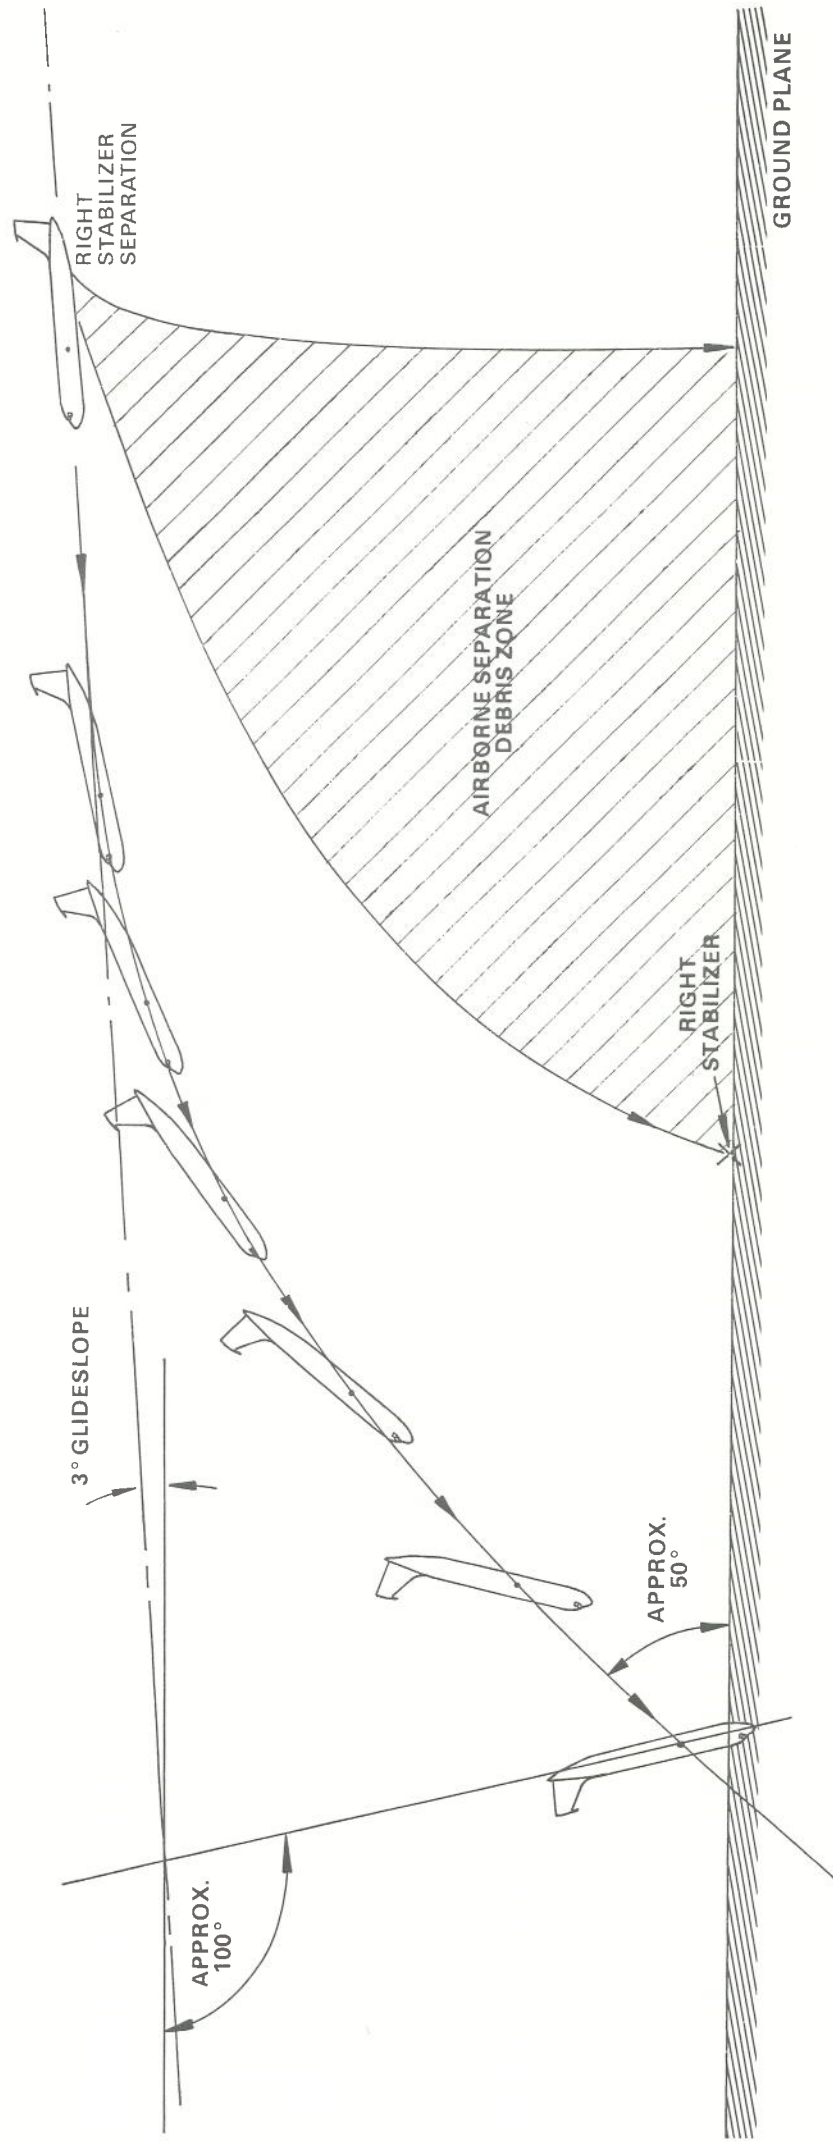
Figure 1 WRECKAGE PLOT

The wreckage of G-BEBP was confined to two relatively small and separate areas (see figure 1). The first area contained the complete right horizontal stabilizer together with some small fragments of structure from the rear fuselage adjacent to the empennage and from the inboard end of the right horizontal stabilizer.

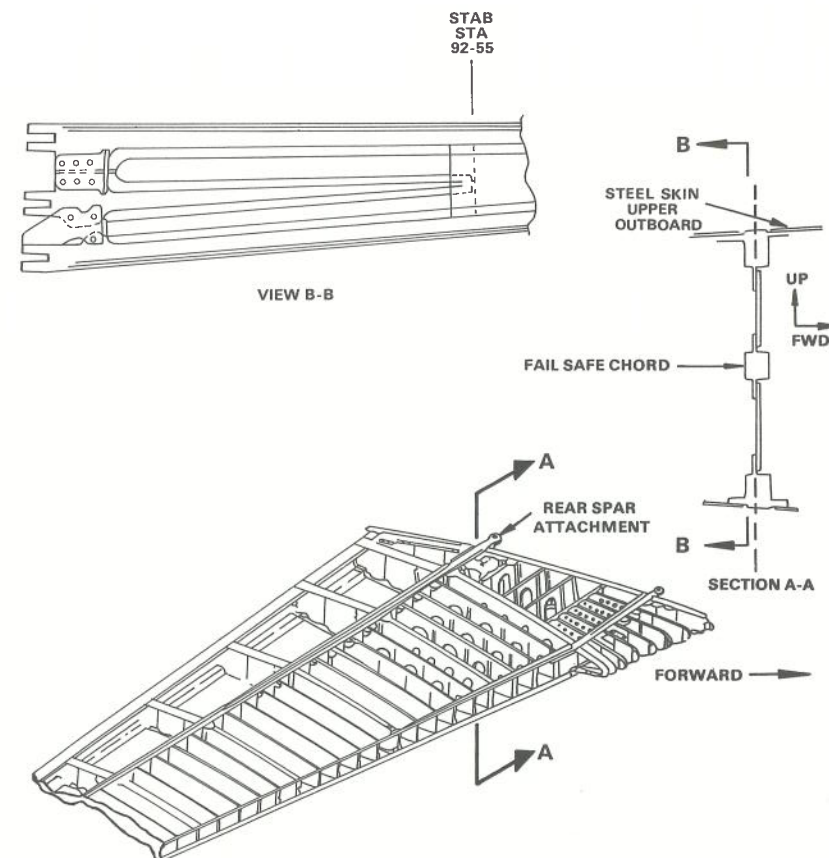
Figure 13a
BOEING 707-100 SERIES/720 SERIES.
HORIZONTAL STABILIZER STRUCTURE

The Boeing 707 family of aircraft began with the KC 135 military transport and 100 series airliner. A small number of 100 series derivatives known as the 200 series were also produced. The horizontal stabilizers on each of these variants were identical and had rear spars of 2 chord layout (see figure 13a). The failsafe capability of these stabilizers was demonstrated for the purpose of certification by dynamically failing a special top chord attachment pin during a ground test programme so allowing the front spar structure to carry the bending loads and transfer them to the centre section. The manufacturers also carried out a stabilizer fatigue test to investigate the sensitivity of the structure to fatigue damage. The 100 series was subsequently developed into the 720 series which retained the original 100 series type of stabilizer.

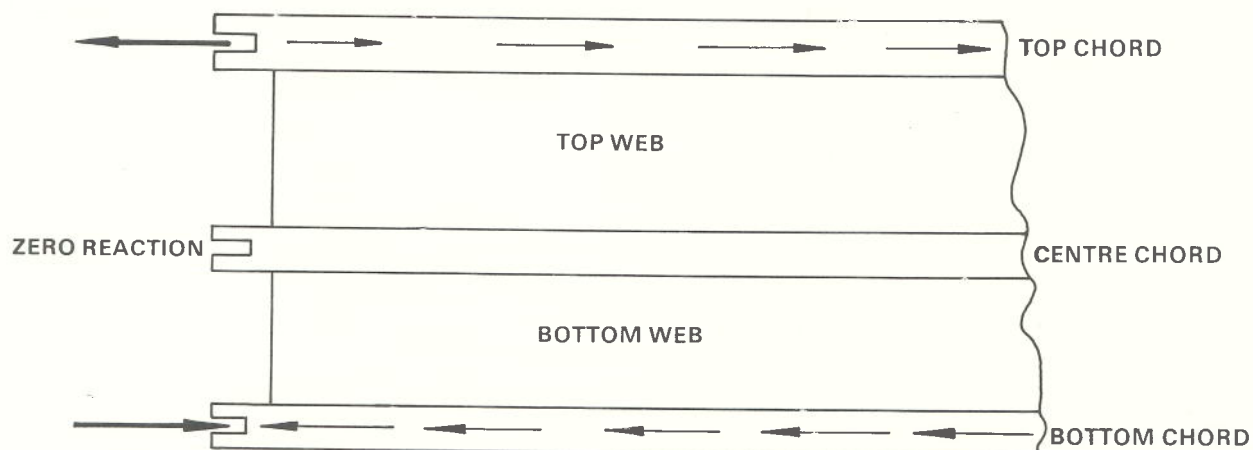
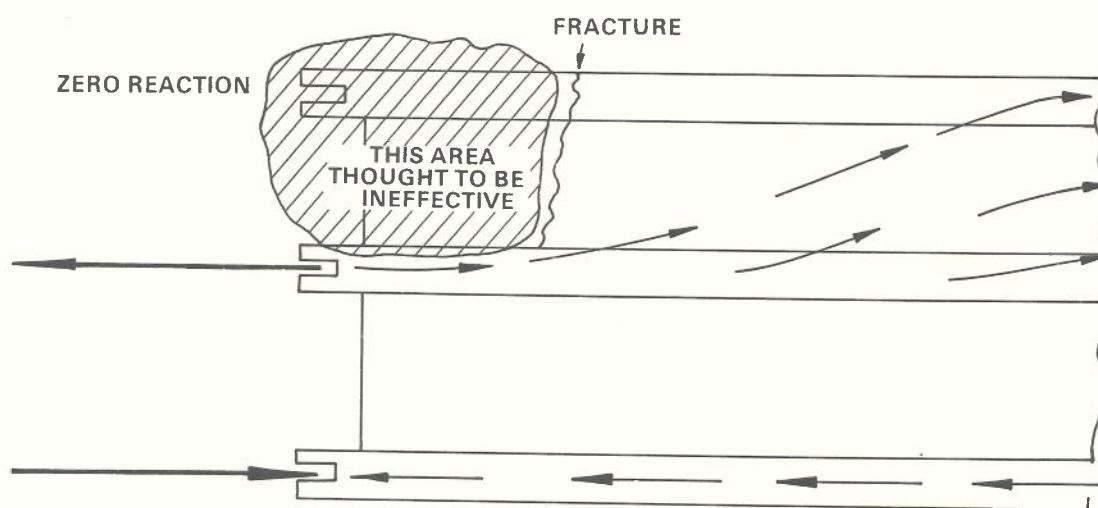
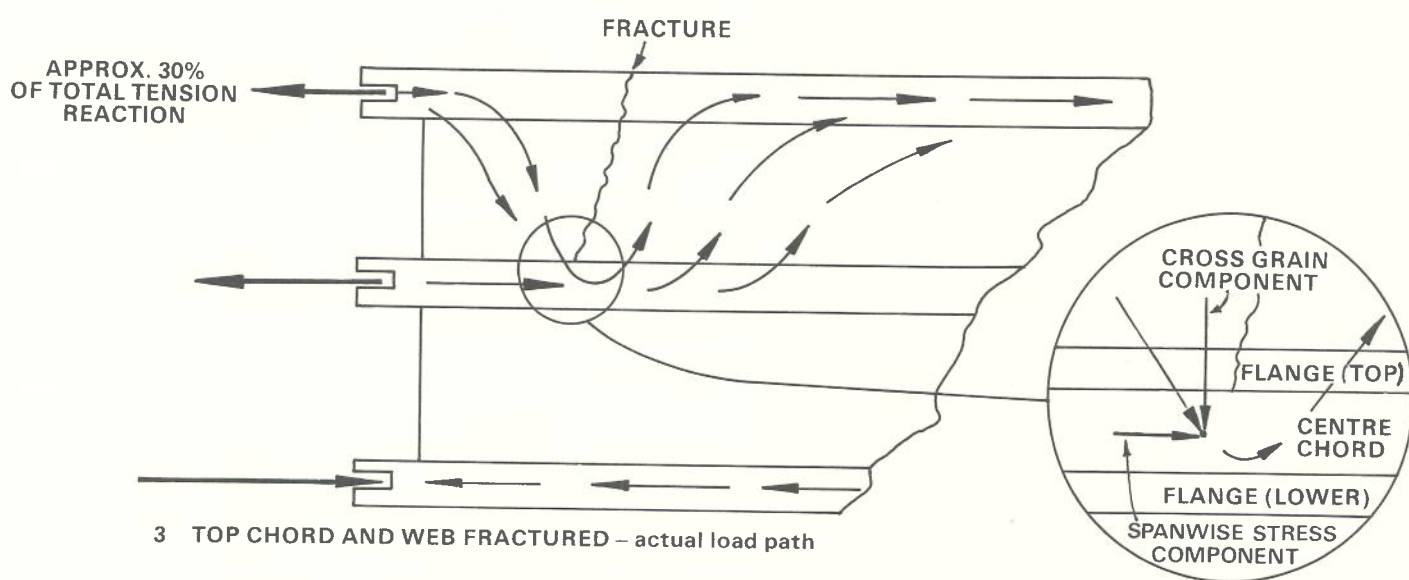
Figure 20 IDEALIZED LOAD PATHS IN REAR SPAR
(shear loads omitted)

An almost identical approach was adopted in the case of the 300 series stabilizer with a top lug failure being considered the most critical, and service experience has since shown the lug areas to be potential failure points. The designers appear to have been conscious of the need to cater for a failure at this point, (ie inboard of the closure rib). This concern is reflected in the design of the shear plates (see figure 13b) between the top and centre chords just inboard of the closure rib, which are far stiffer than the normal transfer of shear load to the bottom chord terminal fitting dictates. The excess load capacity in these shear plates was clearly intended to transfer the loads from the top chord to the centre chord terminal fitting in the event of a lug type failure. Care was also taken to ensure that the centre chord and centre chord terminal pin would not be damaged by fatigue during normal service. This was achieved by locating the centre chord on the rear spar neutral axis and by making the terminal pin a loose fit compared to the top and bottom chord pins, thus ensuring that the centre chord assembly was not loaded under normal conditions.

1 STRUCTURE INTACT – centre chord carries no load

2 TOP CHORD AND WEB FRACTURED – load path assumed during initial analysis

3 TOP CHORD AND WEB FRACTURED – actual load path
