DEPARTMENT OF TRADE

**Report on the accident to
BAe HS 748 G-BEKF at
Sumburgh Airport, Shetland Islands,
on 31 July 1979**

Civil Aircraft Accident Report No 1/81 (EW/C671)

<i>Owner and Operator:</i>	Dan-Air Services Limited
<i>Aircraft: Type:</i>	British Aerospace HS 748 Series 1
<i>Model:</i>	105
<i>Nationality:</i>	British
<i>Registration:</i>	G-BEKF
<i>Place of Accident:</i>	Sumburgh Airport, Shetland Islands Latitude 59°53'N Longitude 01°18'W
<i>Date and Time:</i>	31 July 1979, at 1601 hrs
	All times in this report are GMT

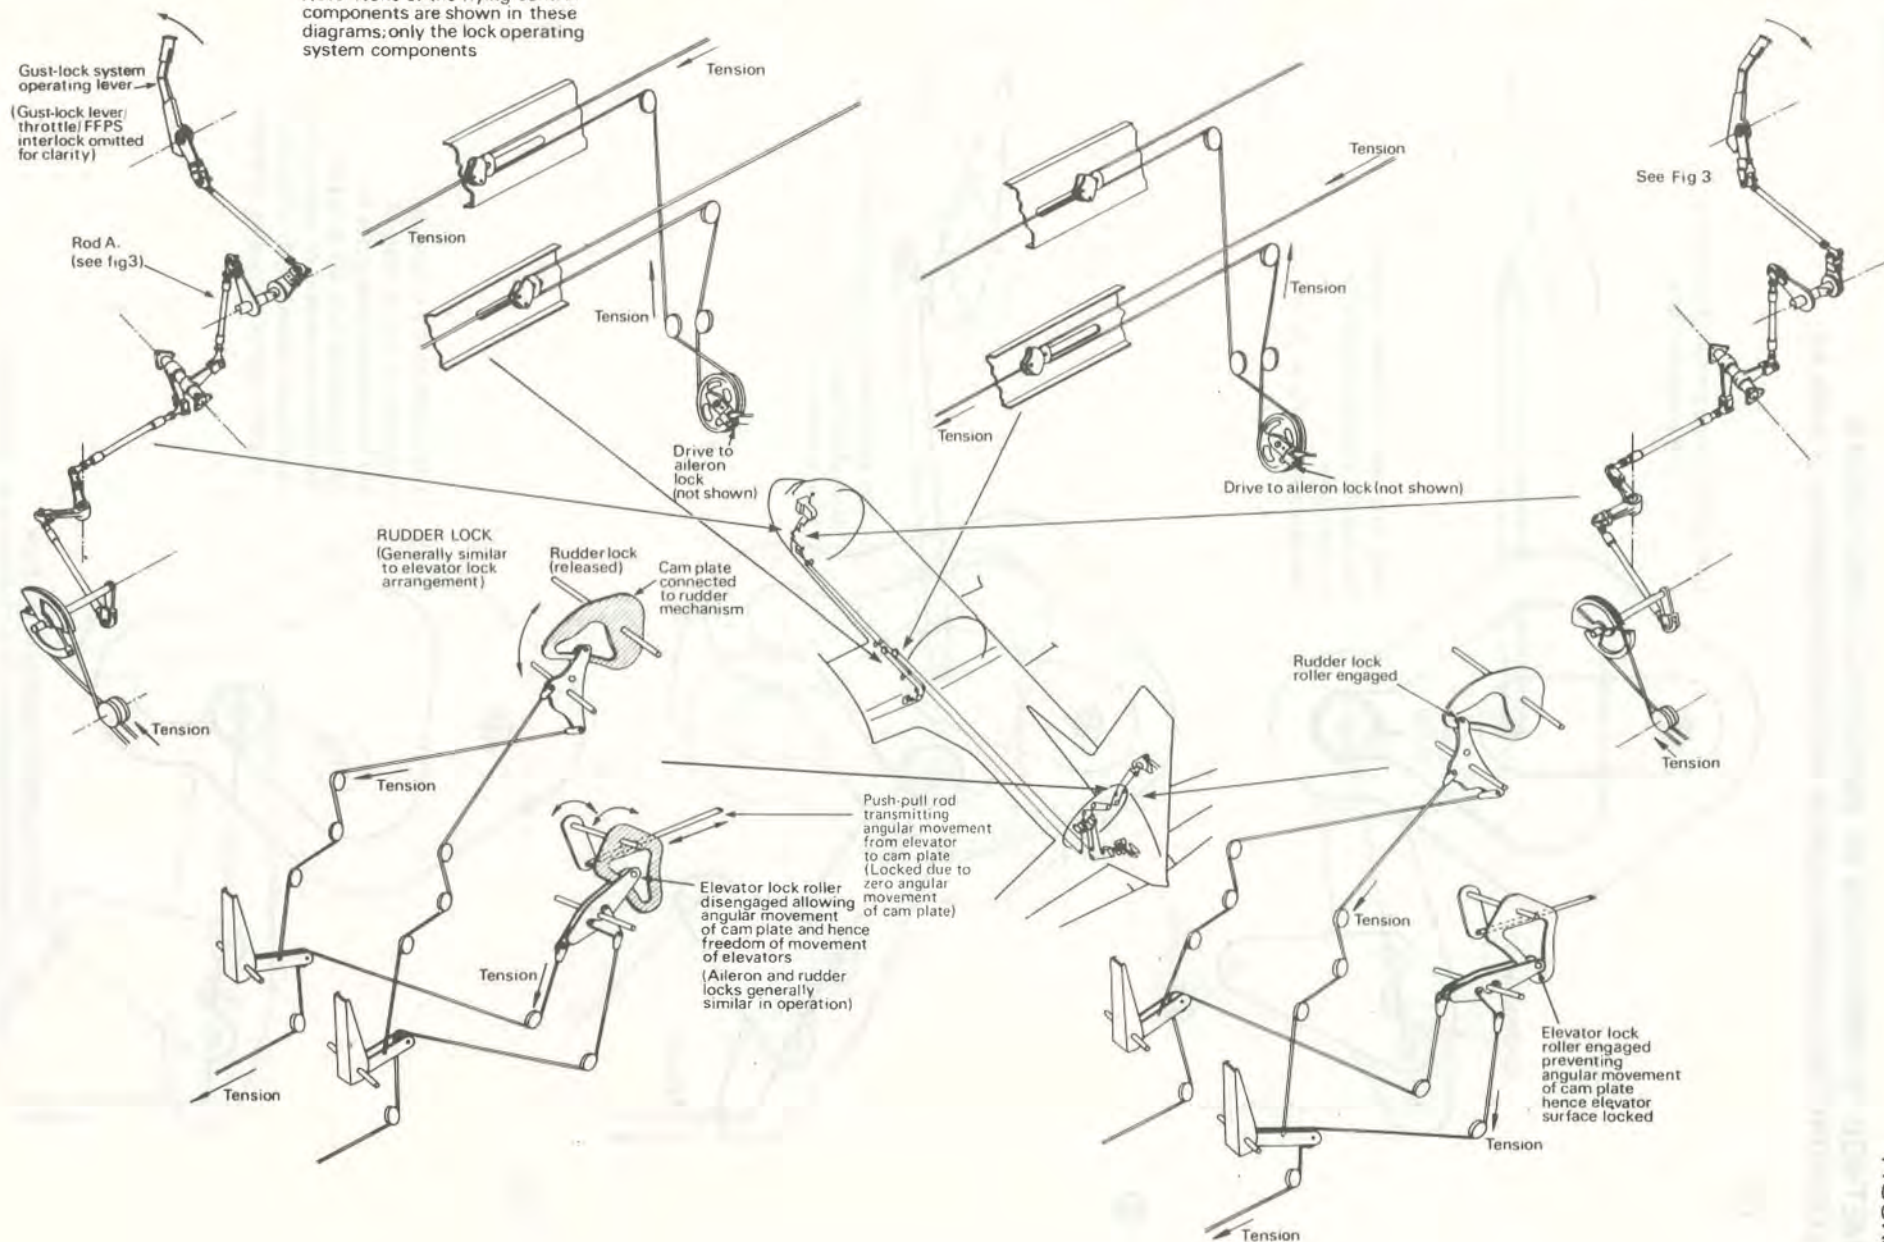
FIGURE 1

In normal service the gate plate is covered by a gate seal plate and the throttles, HP cock levers, FFPS lever and gust-lock lever protrude through rubber seals situated around the slots in the seal plate. Angular movement of the gust-lock lever is transmitted to three control locks by a mechanism shown in figure 1.

CONTROL LOCK OPERATING SYSTEM IN LOCKED POSITION

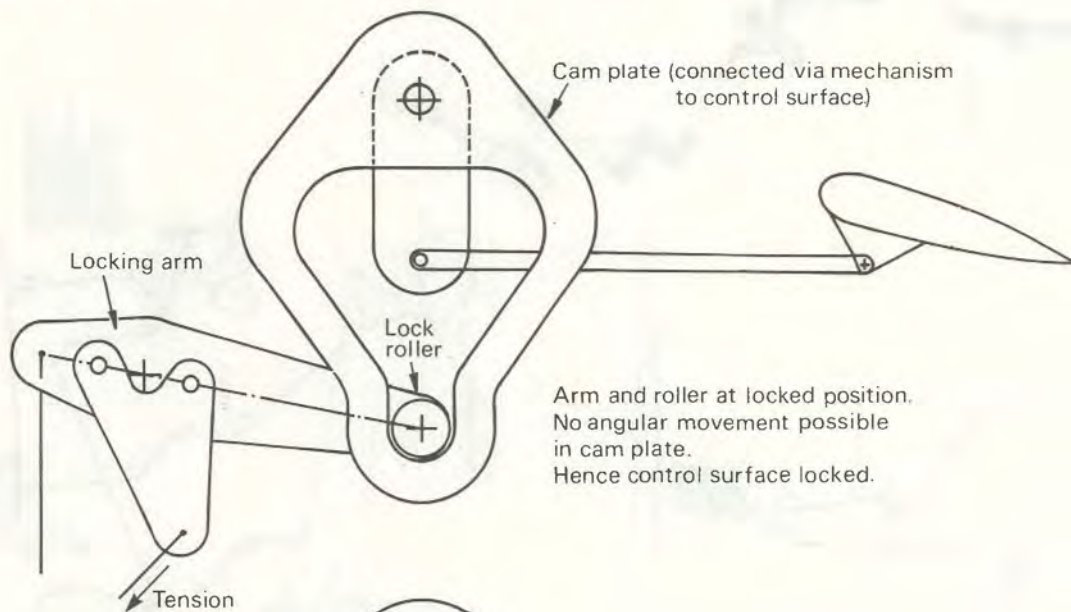
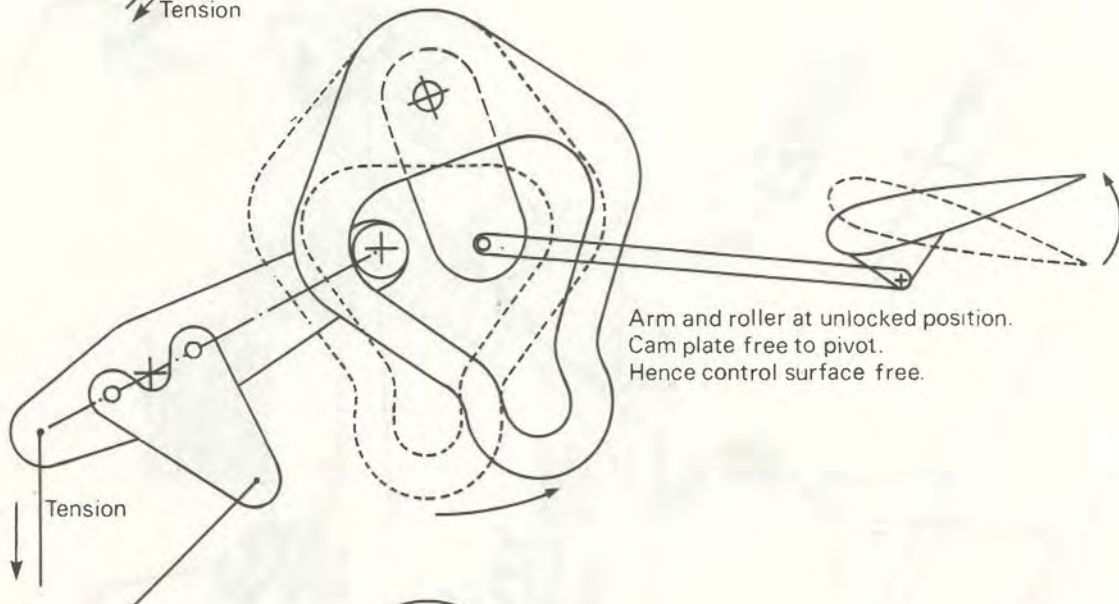
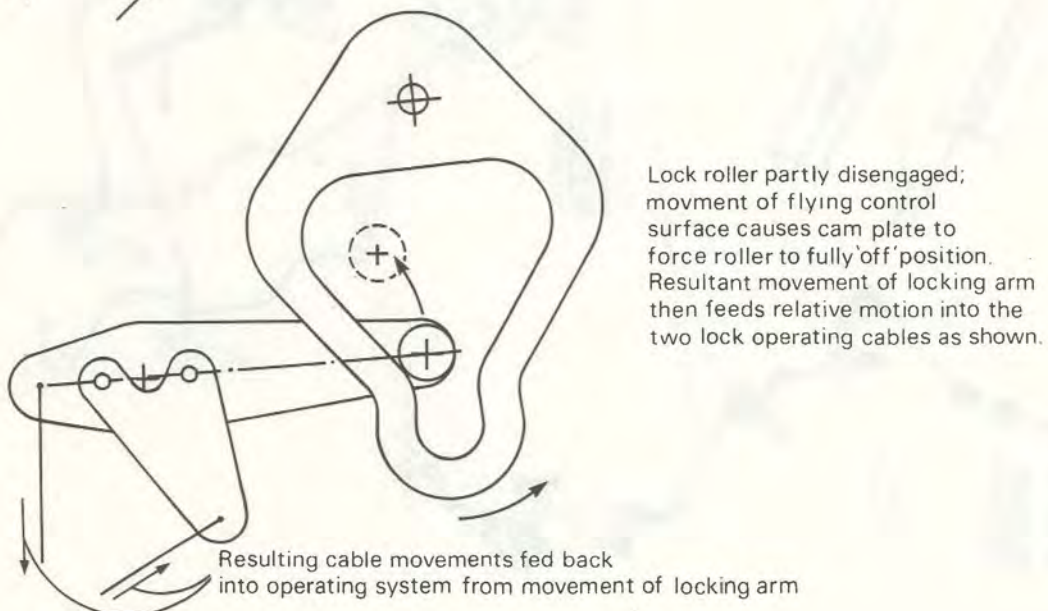
FIGURE 2

Subsequently, further attempts to reproduce this phenomenon were carried out. It was found possible to repeat it in some, but not all, cases. The main factor that appeared to affect the repeatability of this effect was the initial position taken up by each of the lock rollers (see figure 2) when the gust-lock lever was moved to the position approximately 30% of travel from the unlocked detent. Such forward movement of the lever caused the individual locks to move away from the fully locked positions. However, it was found that the sequence of movement of the locks is not repeatable and that the relationship between lock position and lever position is only uniquely defined when the system is fully locked or fully unlocked. Thus, on some occasions all three locks will become free nearly simultaneously during forward movement of the gust-lock lever, while on others one lock may move to the fully disengaged position, or nearly so, before either of the other locks begins to disengage.

METHOD OF OPERATION OF INDIVIDUAL GUST-LOCKS
(ELEVATOR LOCK SHOWN,AILERON AND RUDDER GENERALLY SIMILAR)

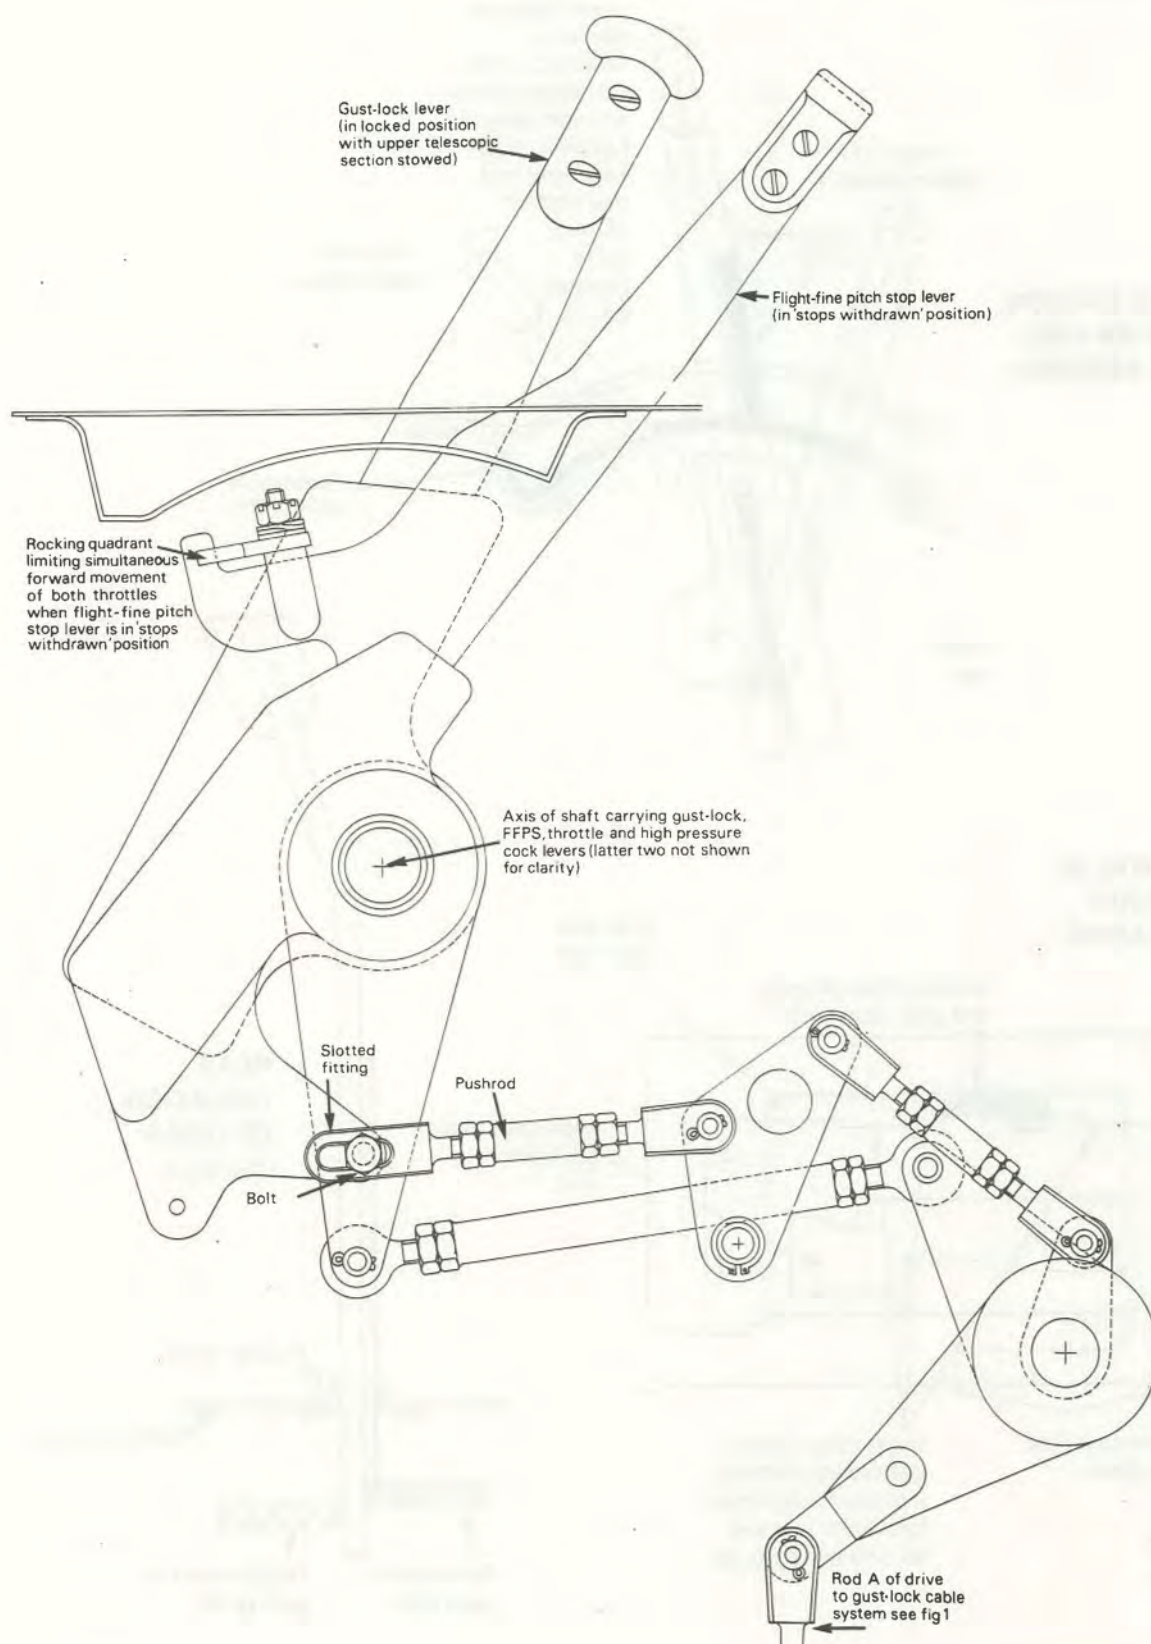
FIGURE 3

ever the FFPS withdrawal lever is prevented from moving to the 'stops engaged' position by the gust-lock lever interlock, forward movement of the two throttles is also limited (see photograph at plate 4) by a rocking quadrant which permits only one throttle to be fully opened at a time. Thus with a properly adjusted system it is not possible to achieve more than taxiing power on both engines simultaneously until the gust-lock lever is moved away from the 'controls locked' position. The design intention was that the interlock system should be the primary safeguard reminding pilots to disengage the gust-locks by preventing take-off with the locks engaged.

THROTTLE, FLIGHT-FINE-PITCH STOP GUST-LOCK INTERLOCK MECHANISM IN CONTROL CONSOLE
(Throttles omitted for clarity)

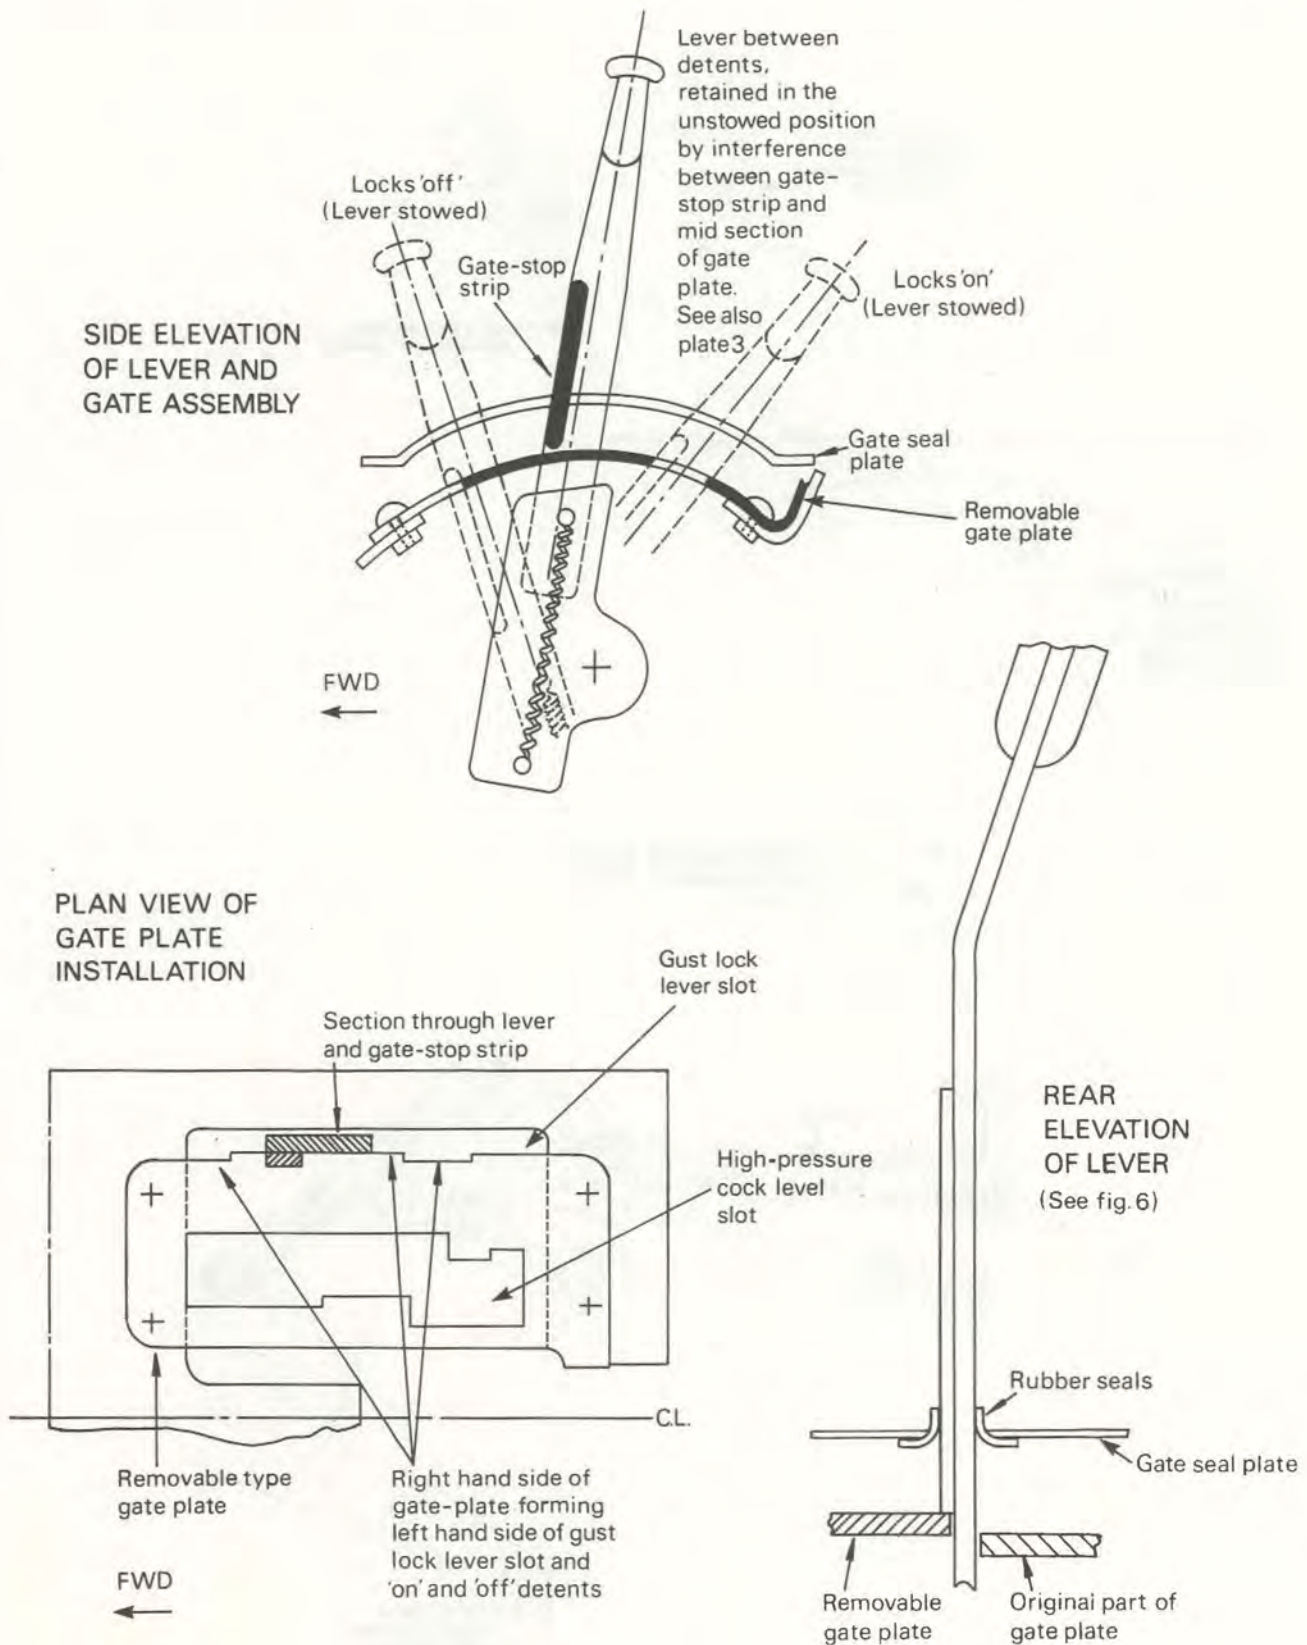
FIGURE 4

The upper section of the lever has attached to it a rectangular section strip, termed the gate-stop strip, which engages with one of two detents (known as the 'on' and 'off' detents) situated in the console at the 'controls locked' and 'controls unlocked' ends of the lever's range respectively (see figures 4 and 6 and photograph at plate 3).

ARRANGEMENT OF GUST-LOCK LEVER
AND GATE PLATE IN CONTROL CONSOLE (Recent production modification standard)

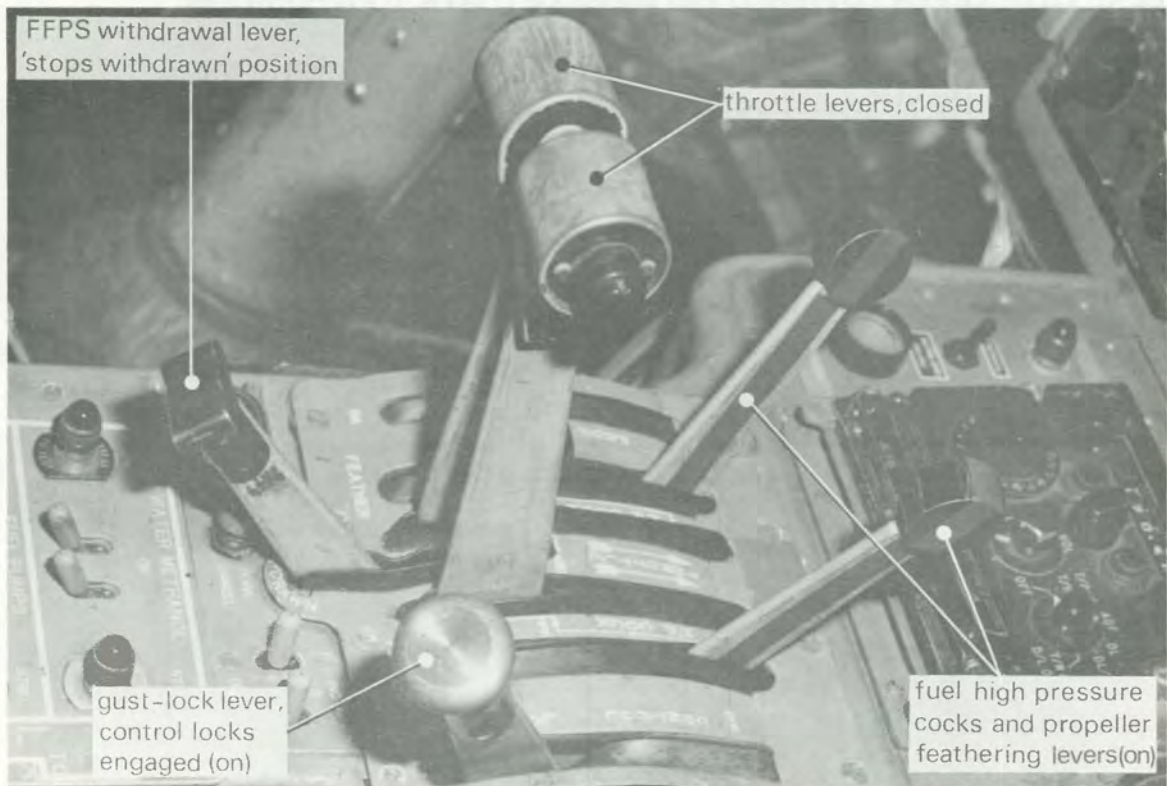
Plate1

Photographs at plates 1 and 2 show the relative positions on the control console of the throttles, high pressure (HP) cocks, gust-lock lever and FFPS withdrawal lever. The gust-lock lever is pivoted about a lateral axis in the centre console of the cockpit so that full backward movement causes all three control locks to engage, while full forward movement caused them to disengage (see also figures 1 and 2).

Cockpit controls-centre pedestal

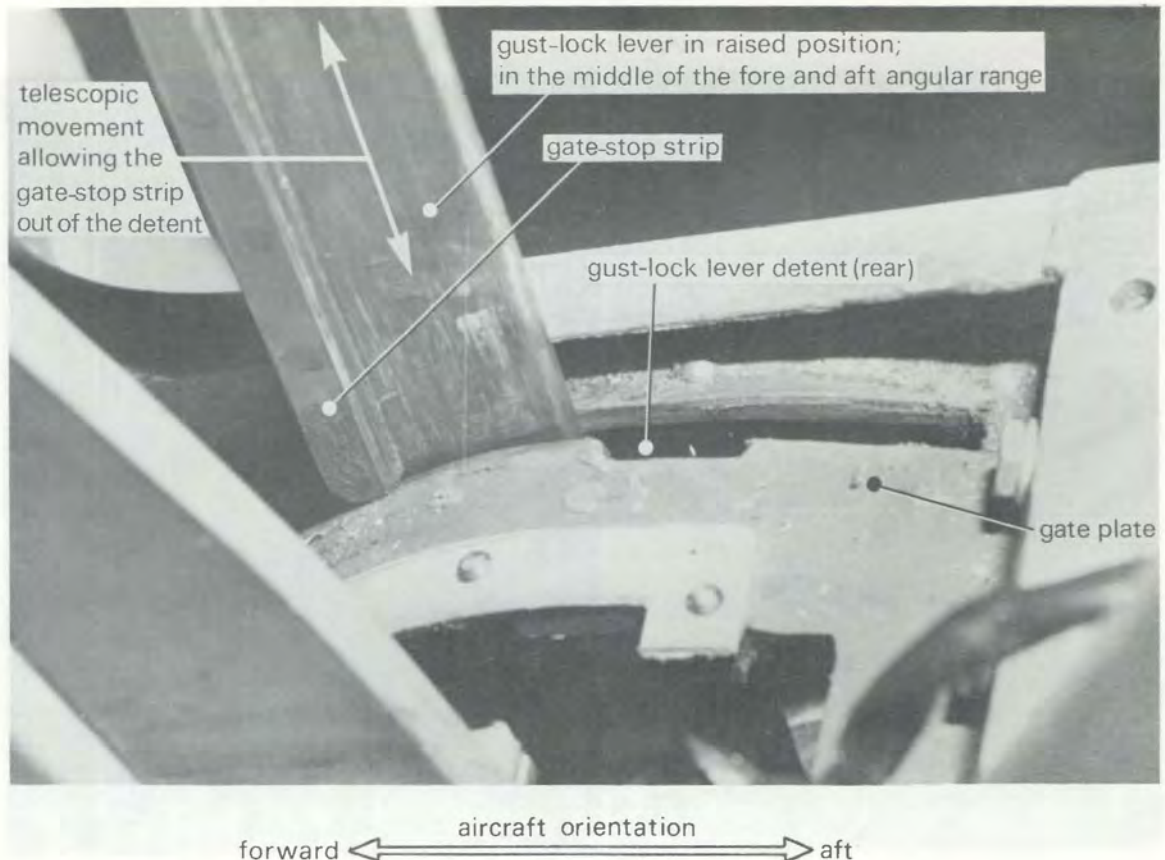
Plate 3 : gate seal plate removed

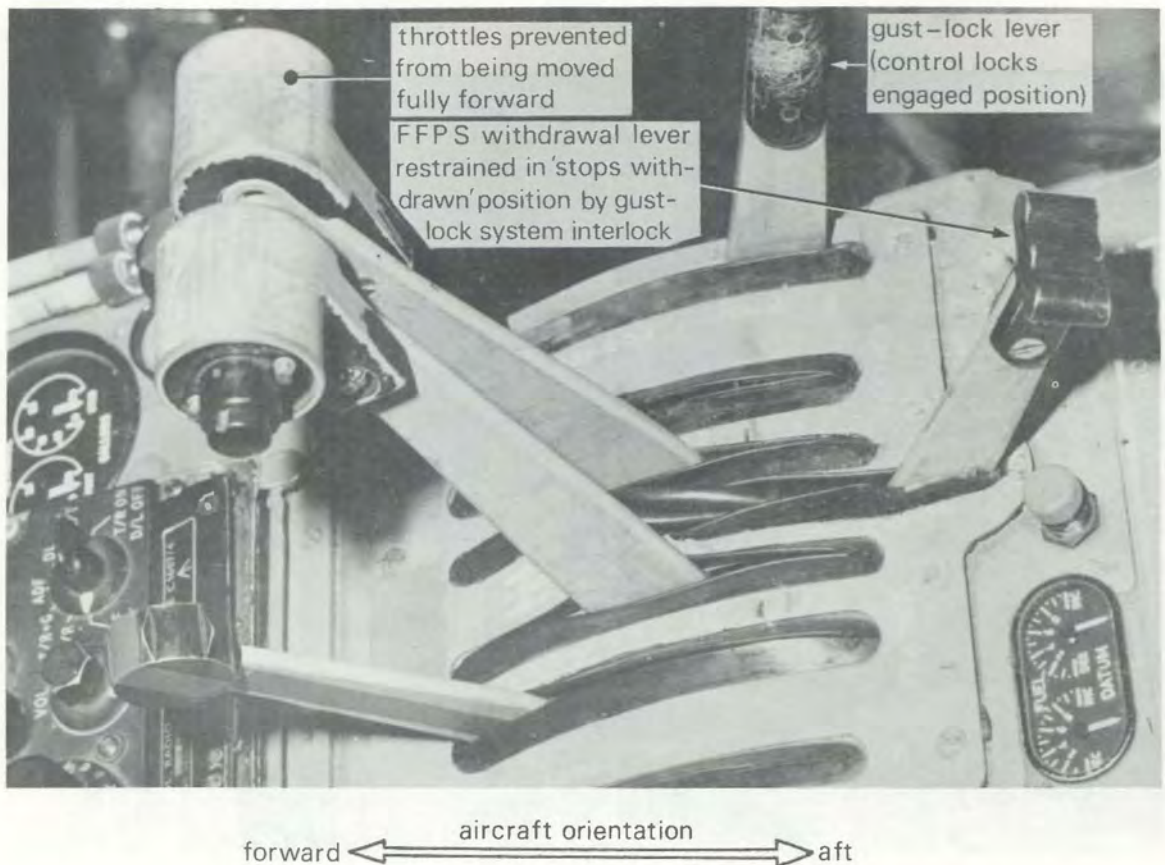
Plate 4 : throttle position when baulked by the interlock
