# **NATIONAL TRANSPORTATION SAFETY BOARD**

## **AIRCRAFT ACCIDENT REPORT**

**SCANDINAVIAN AIRLINES SYSTEM  
FLIGHT 901**

**FEBRUARY 28, 1984**

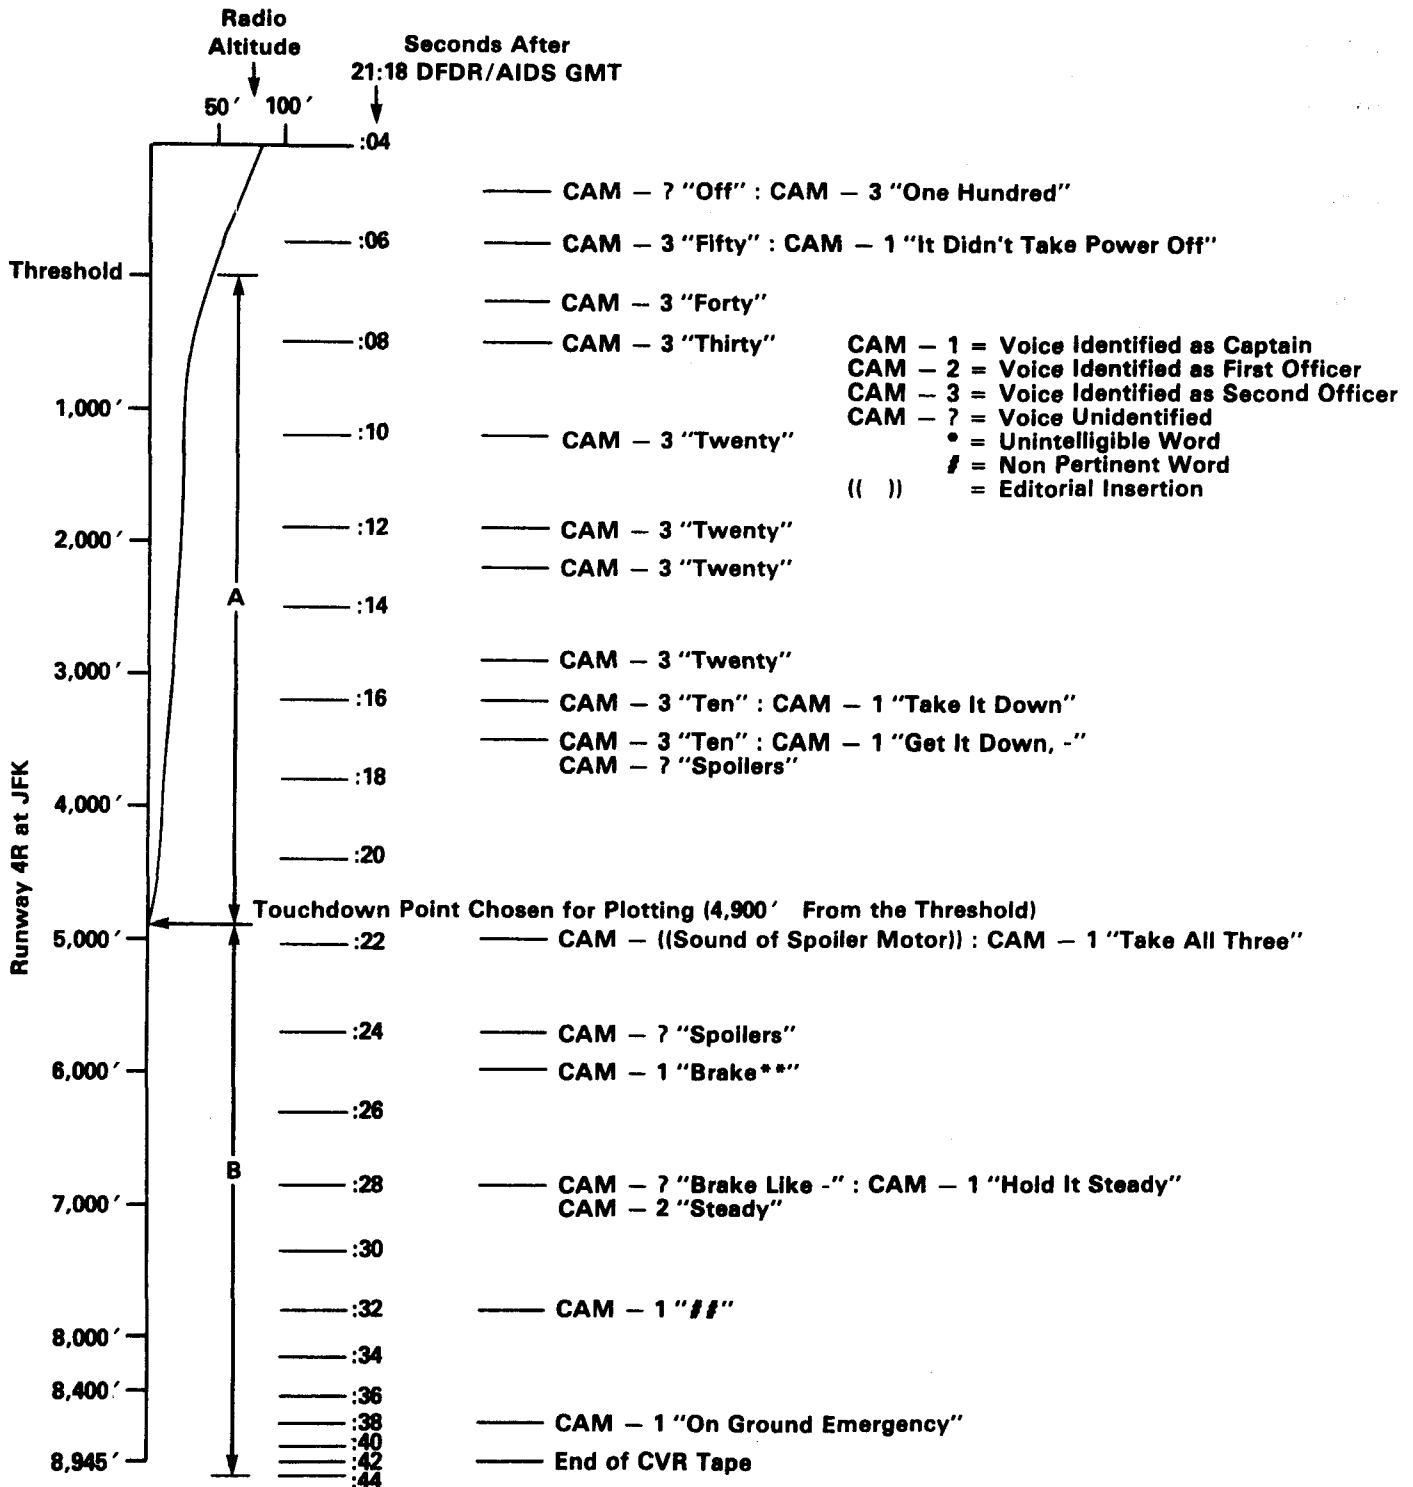
"A" Distance Is Based on AIDS INS Ground Speed Integration From the Middle Marker to Touchdown.

"B" Distance Is Based on the DFDR Longitudinal Acceleration Integration From the Assumed Time of Impact Back to the Time of Touchdown. This Distance Is Anchored at One End to the Approximate Final Position of the Aircraft.
