ACCIDENTS INVESTIGATION DIVISION

Civil Aviation Department
Hong Kong

Report on the accident to
Hawker Siddeley Trident 2E B-2218
at Hong Kong International Airport
on 31 August 1988

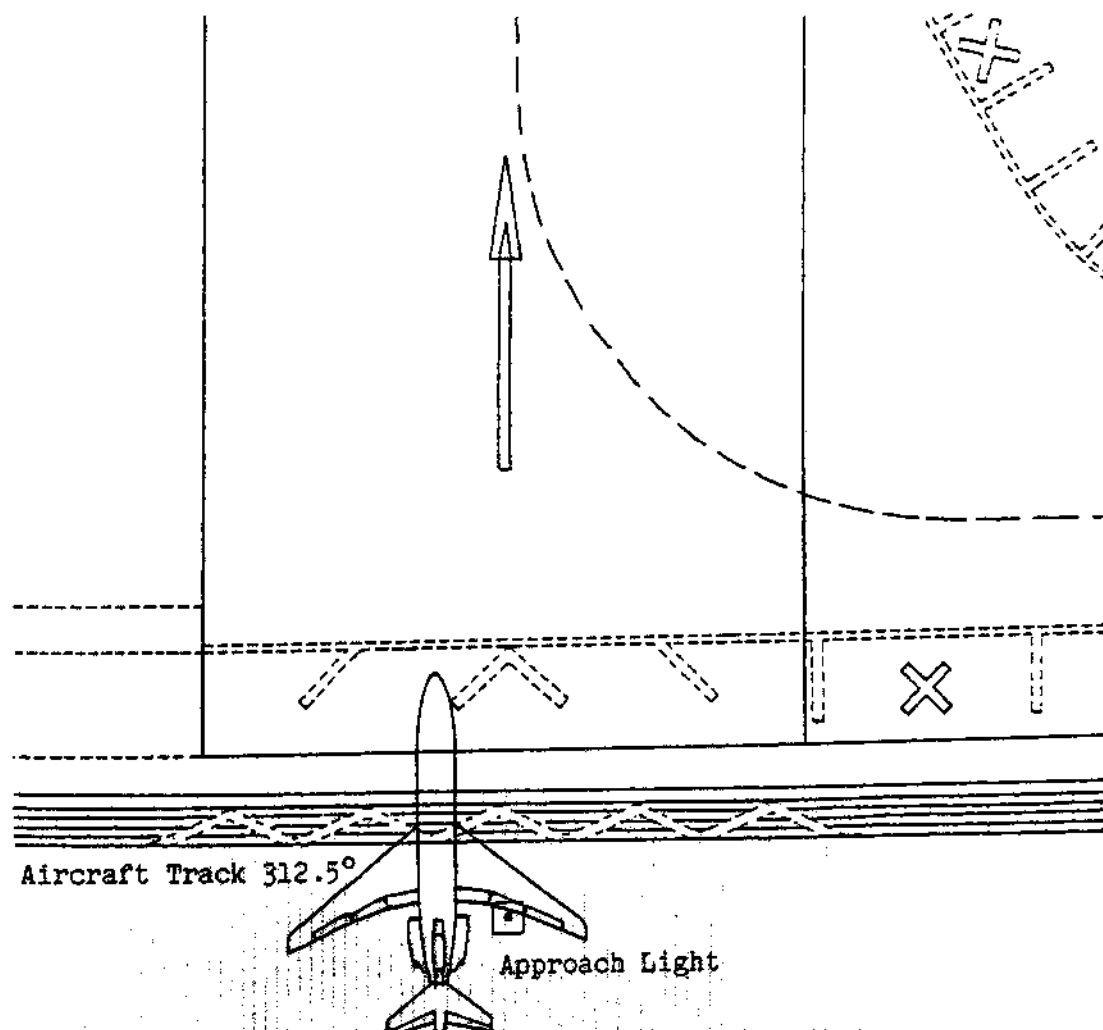
Plan

From the disposition of the contact marks of the right main gear tyres on the facing edge of the sea wall, and the left main gear tyres on the paved undershot surface, a roll attitude at impact of five degrees right wing low was determined. The precise pitch attitude of the aircraft at this time could not be determined from either the ground witness marks or the UFDR. However by manipulation of scale drawings it seems probable that at all likely pitch attitudes the aircraft was descending. This view is supported by the fact that the aircraft failed to strike the single crossbar light structure immediately before the approach light that was hit. Appendix 8 depicts the impact sequence and shows the wreckage distribution.

Wreckage Distribution and Impact Sequence
