PB92-910402  
NTSB/AAR-92/02  
(SUPERSEDES NTSB/AAR-90/01)

## AIRCRAFT ACCIDENT REPORT

EXPLOSIVE DECOMPRESSION--  
LOSS OF CARGO DOOR IN FLIGHT  
UNITED AIRLINES FLIGHT 811  
BOEING 747-122, N4713U  
HONOLULU, HAWAII  
FEBRUARY 24, 1989

**Abstract:** This report explains the explosive decompression resulting from the loss of a cargo door in flight on United Airlines flight 811, a Boeing 747-122, near Honolulu, Hawaii, on February 24, 1989. The safety issues discussed in the report are the design and certification of the B-747 cargo doors, the operation and maintenance to assure the continuing airworthiness of the doors, and emergency response. Recommendations concerning these issues were made to the Federal Aviation Administration, the State of Hawaii, and the U.S. Department of Defense.

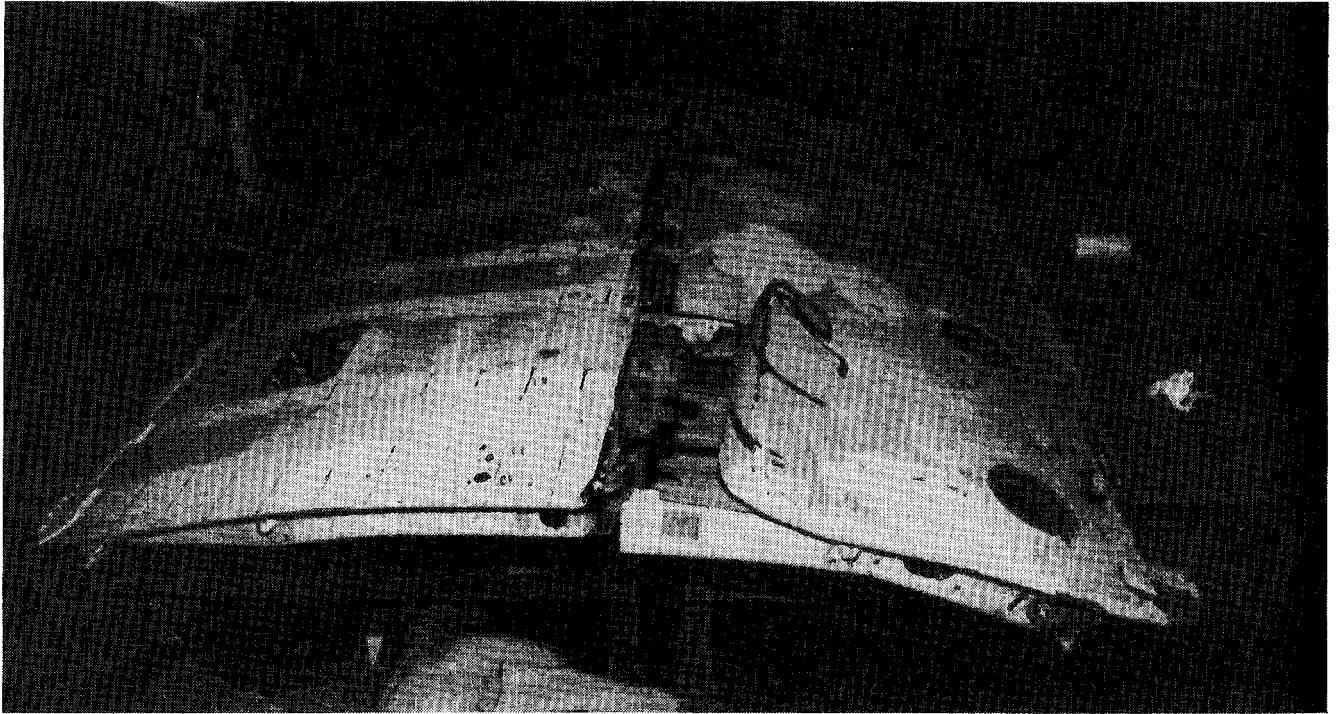
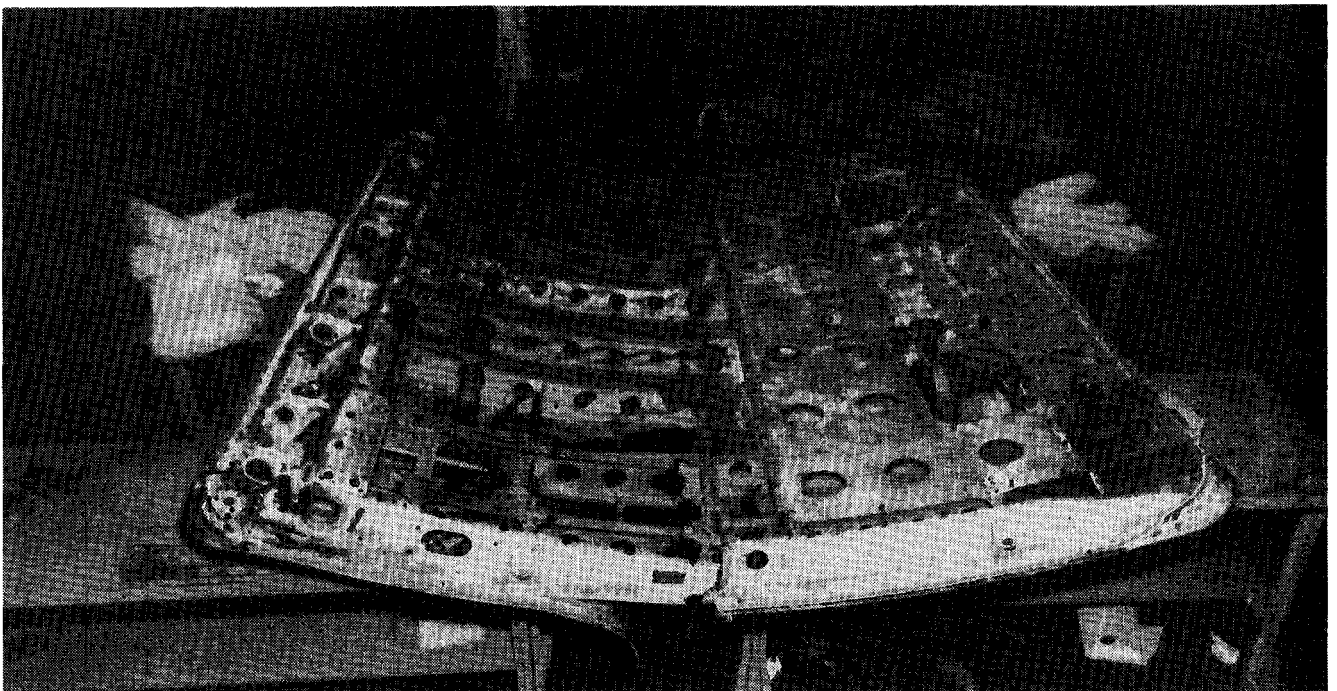
piece mated to the lower door piece.<sup>2</sup> Several areas of the upper door skin along the longitudinal fracture were bent back. In addition, a large area of lower door skin between frame 6 and the aft door edge had peeled downward from the fracture line. The two door pieces are shown together in Figures 9 and 10. Examinations of the fracture surfaces of the skin and frames revealed no evidence of pre-existing cracks. All fractures were typical of overstress separation.

Figures 9 and 10.--Exterior [top photo] and interior [bottom photo] views of cargo doors after removal of pull-in hooks, latch cams, lock sectors, and actuators.

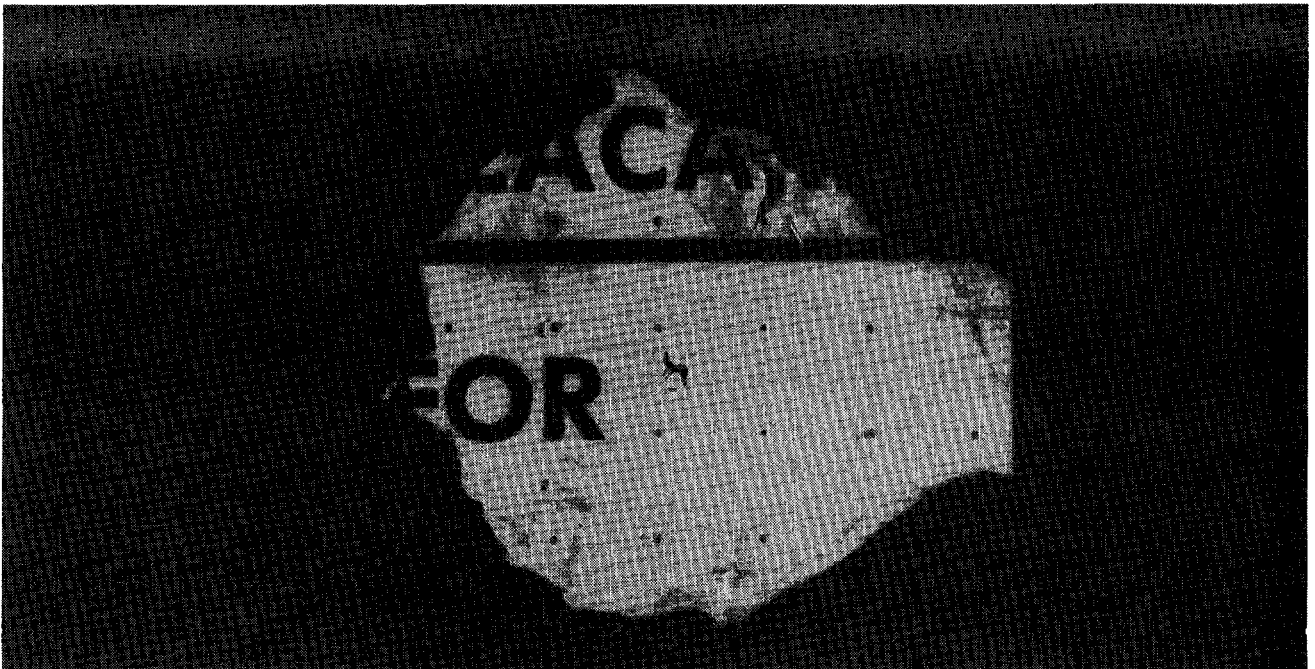
Figure 12.--Decal over latch actuator manual drive port  
(2X Magnification).

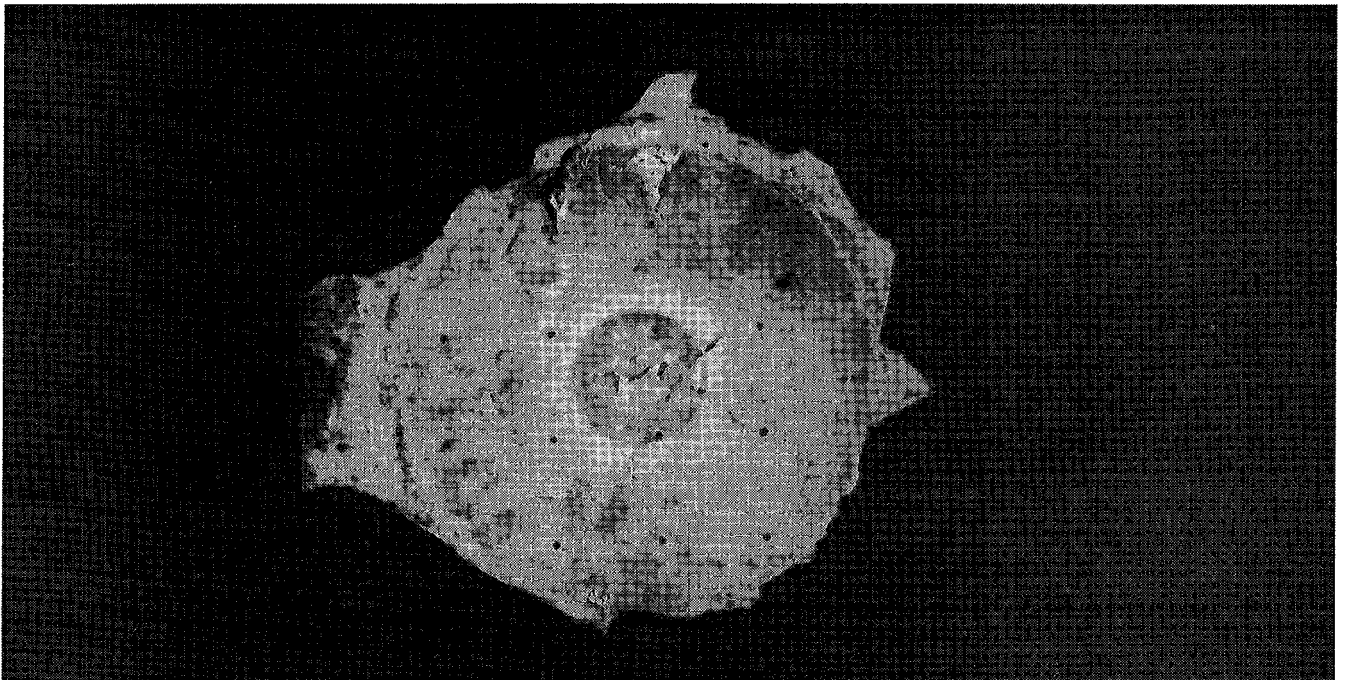
Figure 13.--Underside of decal piece (2X Magnification).

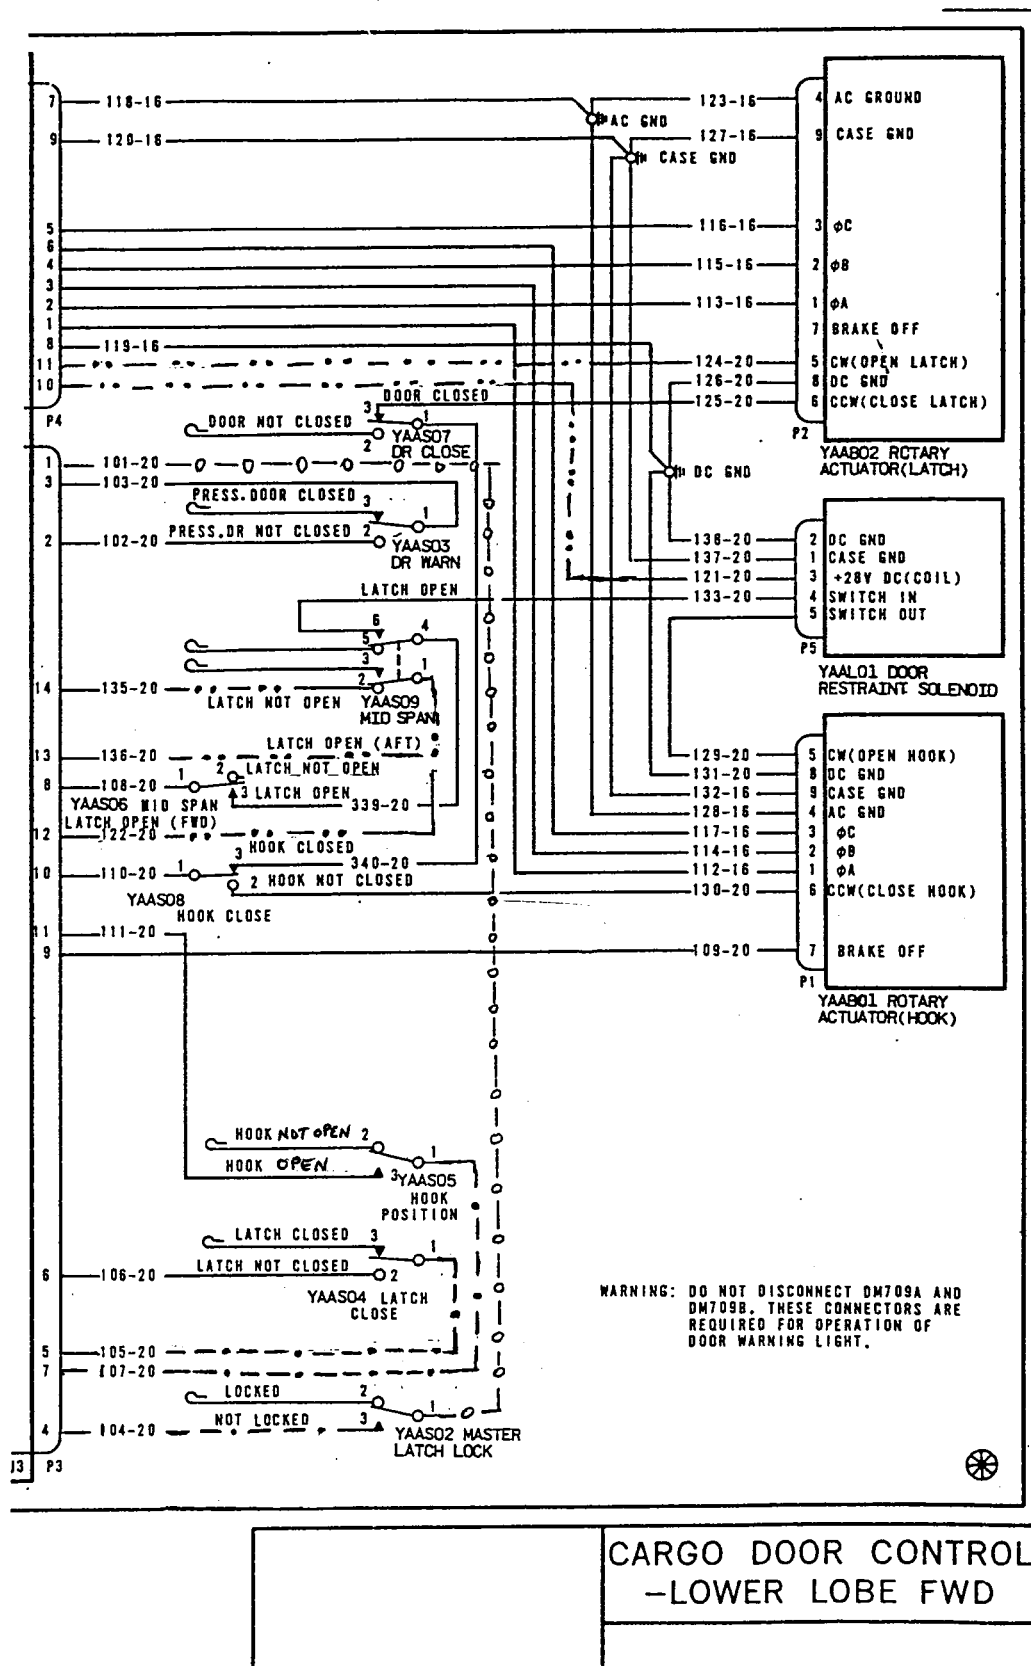
Figure 17.--Diagram of cargo door electrical circuitry.

Conductive contact of (-o-o-o-o) or (---.---.---) coded wire with (-.---.---) coded wire could potentially result in providing a 28VDC circuit path to the latch actuator open circuit. Direct wire-to-wire paths are coded in Figure 17 as defined above. The two-wire short circuit paths are identified as wire pairs consisting of wire 101-20 shorting with any of the following wires; 108-20, 121-20, 122-20, 124-20, 135-20, or 136-20.

If the S2 master latch lock switch fails in the "Not Locked" position, there are additional wire pairs that provide short circuit paths. These are coded in Figure 17 as (---.---.---) to (-.---.---) wire pairs.
