**THE AIRCRAFT ACCIDENT INVESTIGATION BOARD / NORWAY**

**HAV 02/93**

**REPORT ON THE CONVAIR 340/580 LN-PAA AIRCRAFT  
ACCIDENT NORTH OF HIRTSHALS, DENMARK, ON  
SEPTEMBER 8, 1989**

**SUBMITTED FEBRUARY 1993**

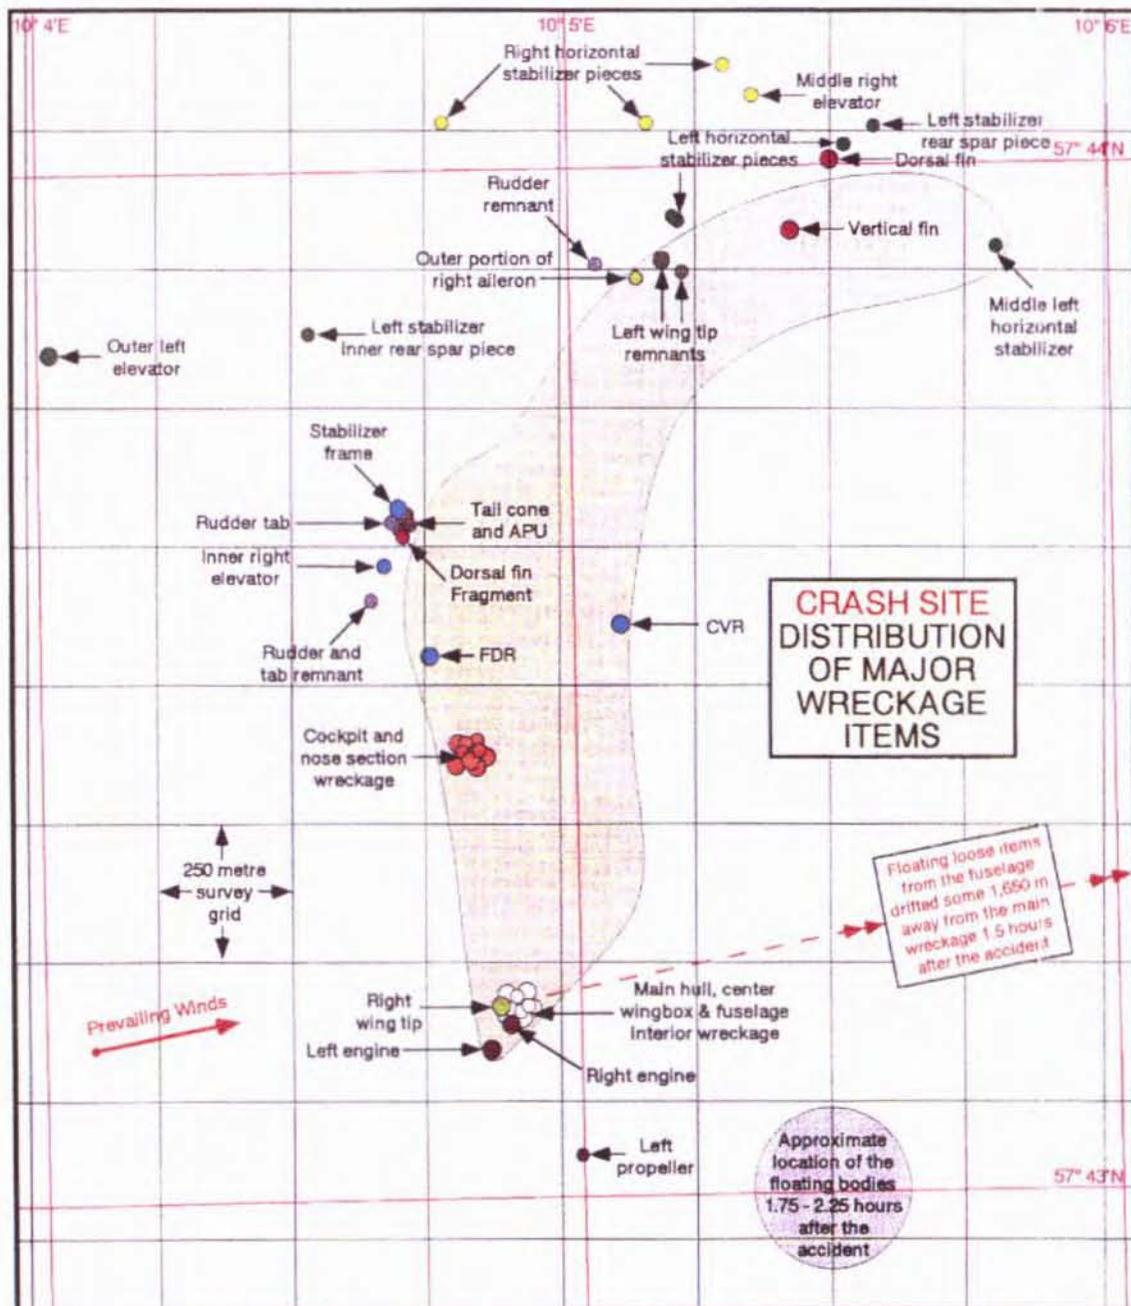
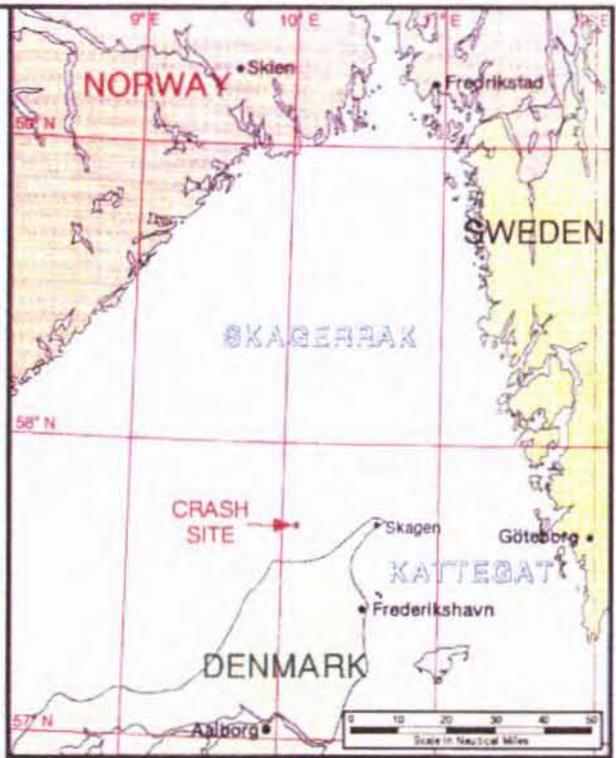
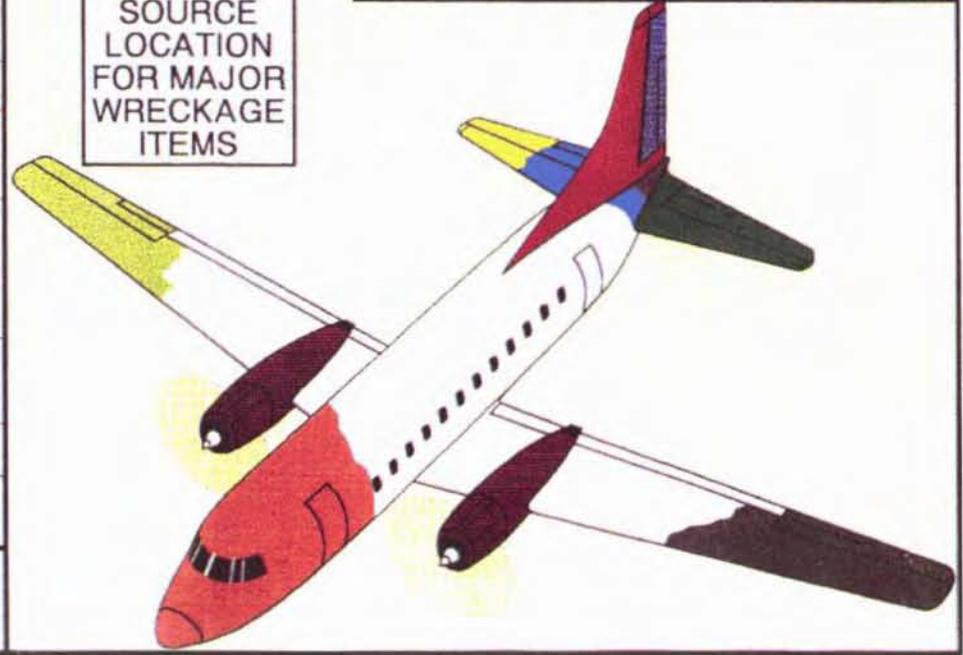
FIG. 2

1.12.1.1 The site of the accident was at sea, approximately 10 nm north of Hirtshals (figure 2). The location of the start of the search was based on radar information received and on the position of floating victims and wreckage. A side-scanning sonar was used to search the sea bed. Approximately 52 km<sup>2</sup> of the sea bed was searched with 100% overlapping. The area where the wreckage was found was limited to approximately 12.5 km<sup>2</sup>. The main wreckage area covered approximately 3 km<sup>2</sup>.

1.12.1.2.6 After the salvaging operation had been completed the positions of the wreckage parts were plotted on suitable maps. The positions of the essential parts are shown in figure 2.

1.12.2 The AAIB/N knew of a research project carried out at the Cranfield Institute of Technology in England, entitled "Trajectories of Falling Parts following In-Flight Break-up". The LN-PAA data were sent to the project leader for evaluation. The result of this work was there were no clear signs of the aircraft having completely broken up before impact with the water. However, there were data that could point to a partial break-up, most likely in the altitude range of 5,000 - 10,000 ft. One of the main points of argument was that the pattern registered on the seabed

**WRECKAGE DISTRIBUTION ANALYSIS PARTNAIR CONVAIR 580, LN-PAA**

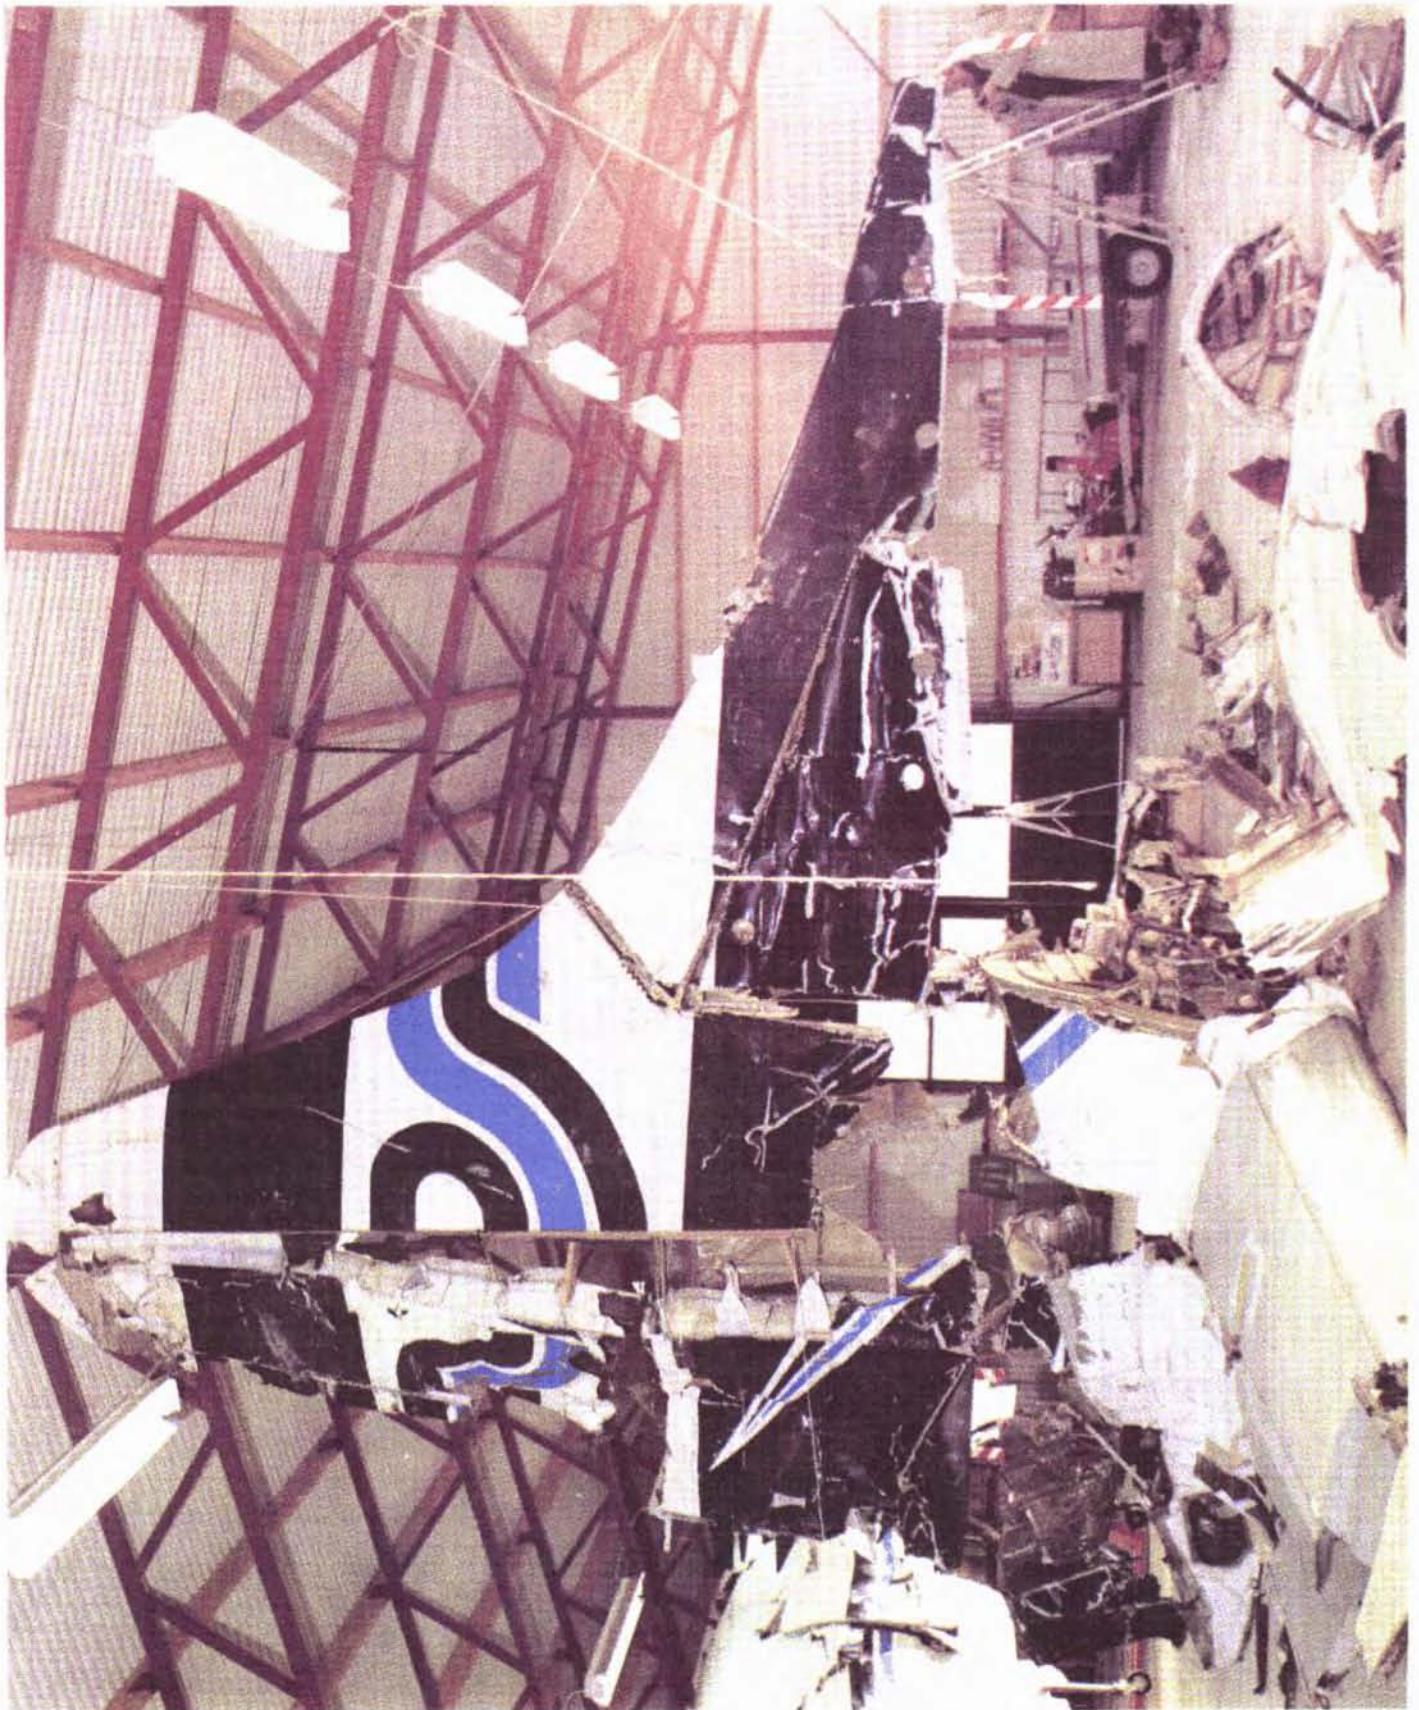
PHOTO (FOTO) 7

RIGHT SIDE OF THE TAILSECTION  
(HØYRE SIDE AV HALESEKSJONEN)

- tail cone with the APU
- rear section of the fuselage, from the front part of the horizontal stabiliser to the tail cone, including the inner part of the right horizontal stabiliser (photos 7 - 10)

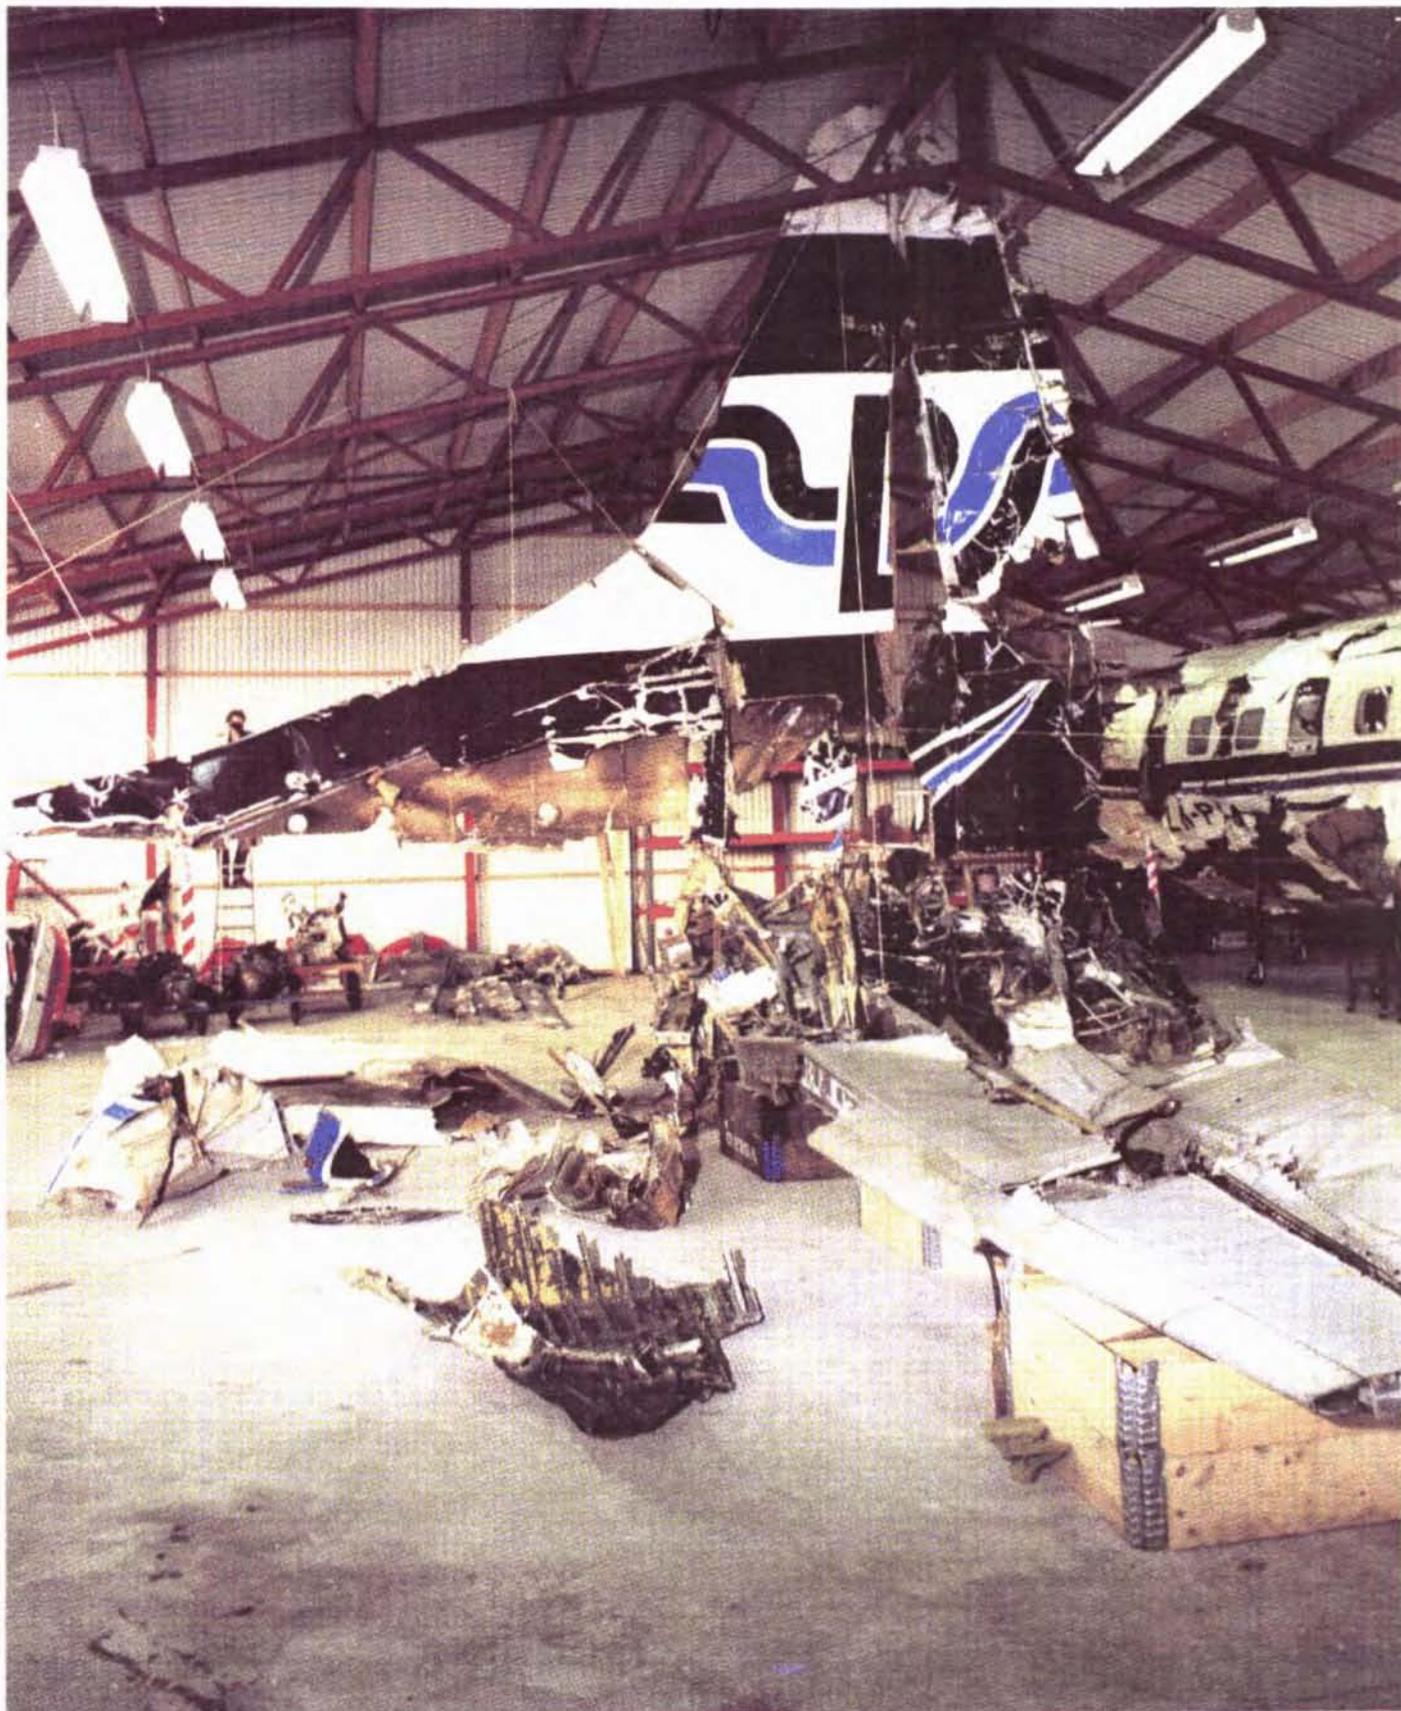
PHOTO (FOTO) 8

LEFT SIDE OF THE TAILSECTION  
(VENSTRE SIDE AV HALESEKSJONEN)

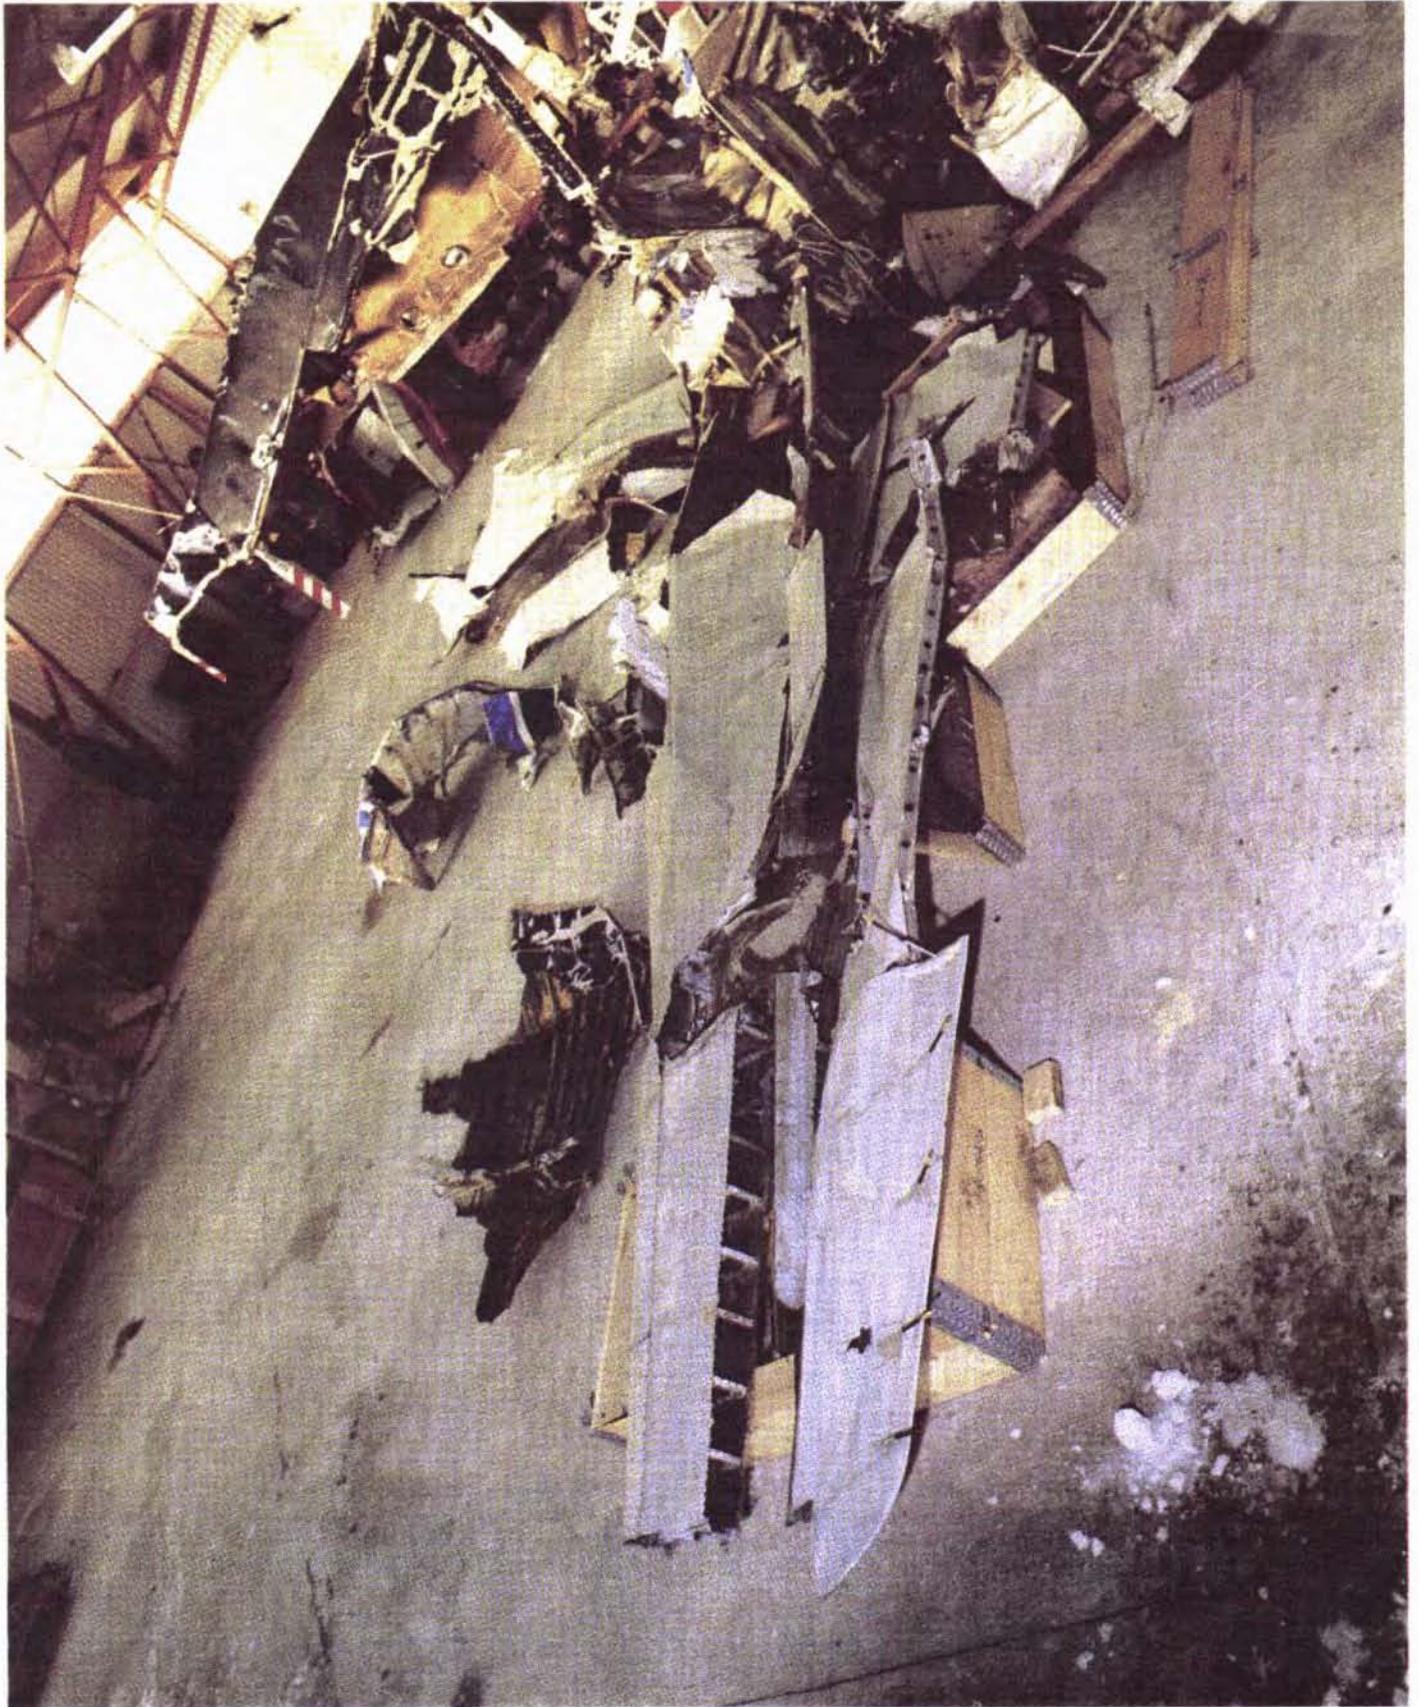
PHOTO (FOTO) 9

LEFT TAILPLANE INCLUDING ELEVATOR  
(VENSTRE HALEFLATE M/HØYDEROR)

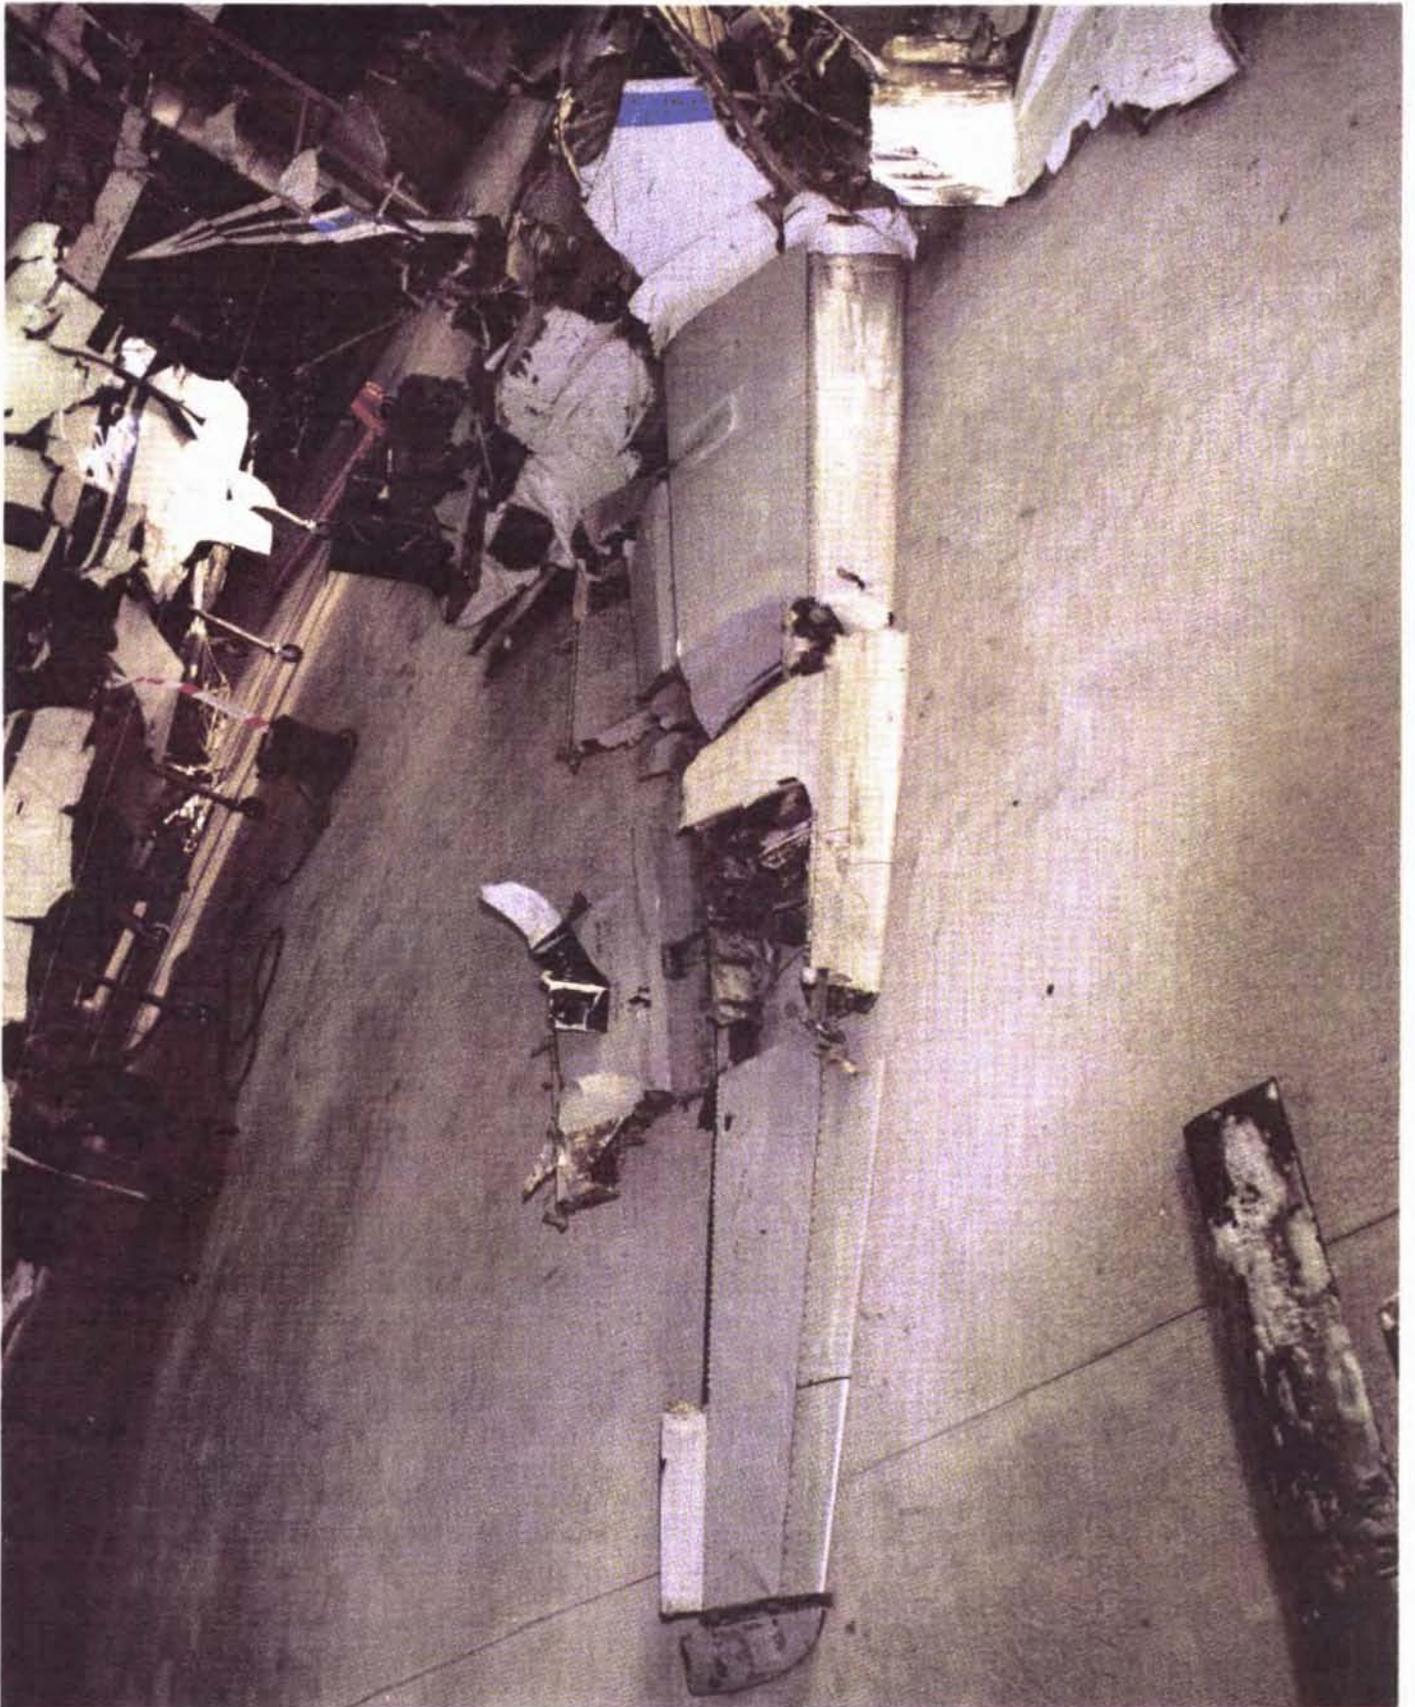
PHOTO (FOTO) 10

RIGHT TAILPLANE WITH PIECES OF ELEVATOR  
(HØYRE HALEFLATE M/RESTER AV HØYDERØR)

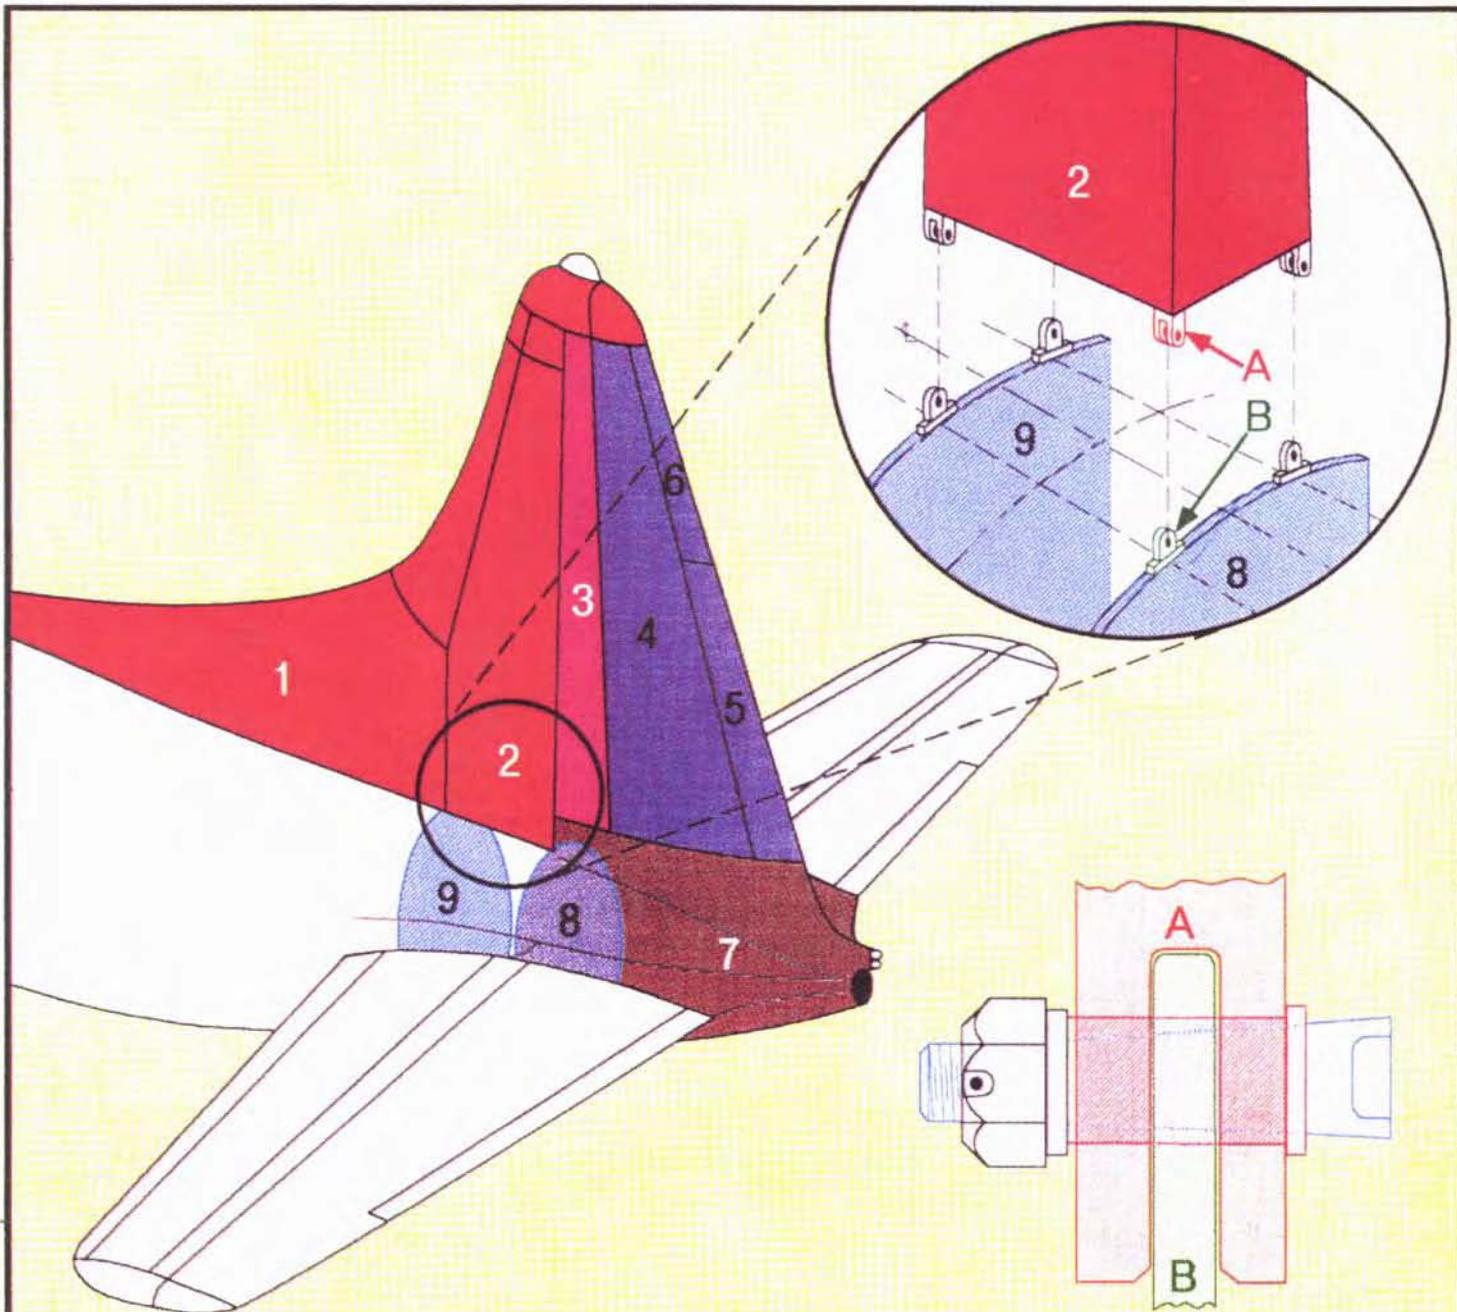
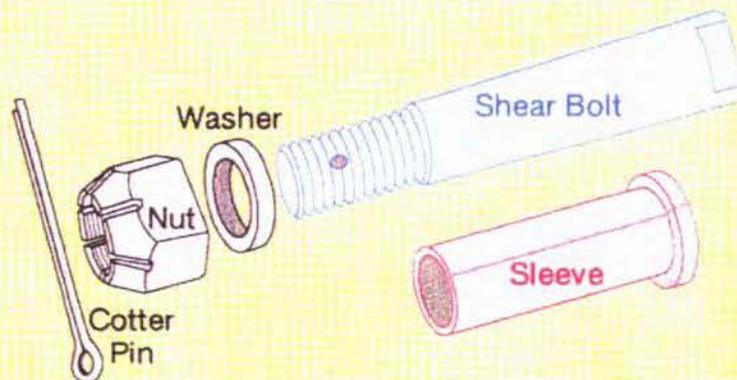
**FIG. 3**

bracket had two lugs fitted on either side of a steel bracket lug (figure 3). Both types of brackets may be equipped with inside steel bushings. On this aircraft only the aluminum brackets were fitted with such bushings. The fastening bolt consisted of a conical steel pin with a matching steel sleeve. The inside of the sleeve had a conical shape corresponding to that of the pin. The external shape was cylindrical. In addition, the sleeve had a longitudinal slit facilitating expansion when the pin was drawn into the sleeve. The purpose of this design was to provide a tight fitting for the attachment, thereby eliminating all movement when connecting the fin to the fuselage.

**TAIL & FIN ATTACHMENT SKETCH  
PARTNAIR CONVAIR 580, LN-PAA**

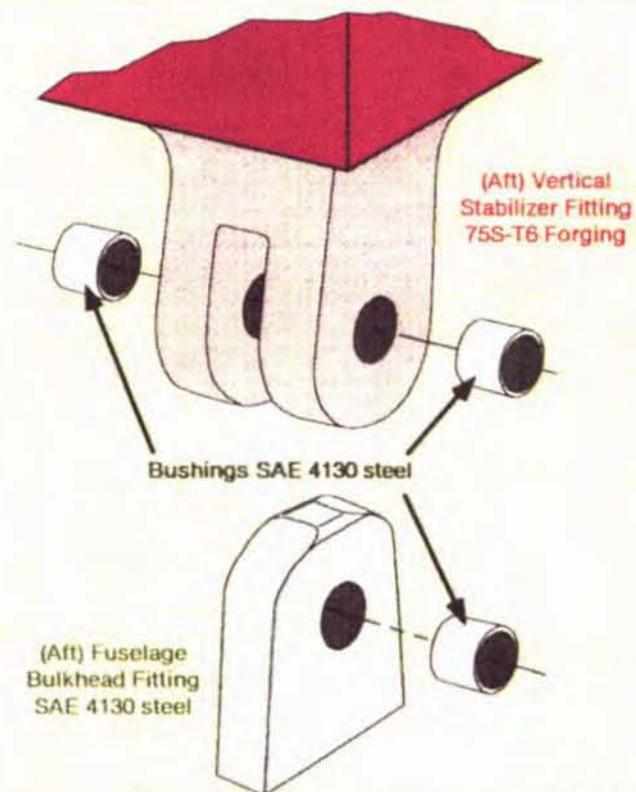
**FIG. 4**

Later examinations by AIR also revealed that the two front attachment pins, as well as their respective sleeves, did not satisfy the specifications. The hardness was between 200 and 230 (HV5). A hardness of 200 - 230 corresponds to a tensile strength of approximately 100,000 psi. Convair's specification for hardness corresponds to a tensile strength of 160,000 to 180,000 psi.

A check carried out on the bushings installed in the aluminum lugs on the rear right-hand attachment bracket showed a considerable discrepancy between the dimensions in the front and rear bushings. The difference between the outer diameters was approximately 0.013 inches while the difference between the inner diameters was approximately 0.018 inches (figure 4). In the production of these bushings the maximum allowable deviation is 0.001 inches.

**VERTICAL STABILIZER BUSHING & SLEEVE DIMENSIONS & SPECIFICATIONS SKETCH; PARTNAIR CONVAIR 580, LN-PAA**

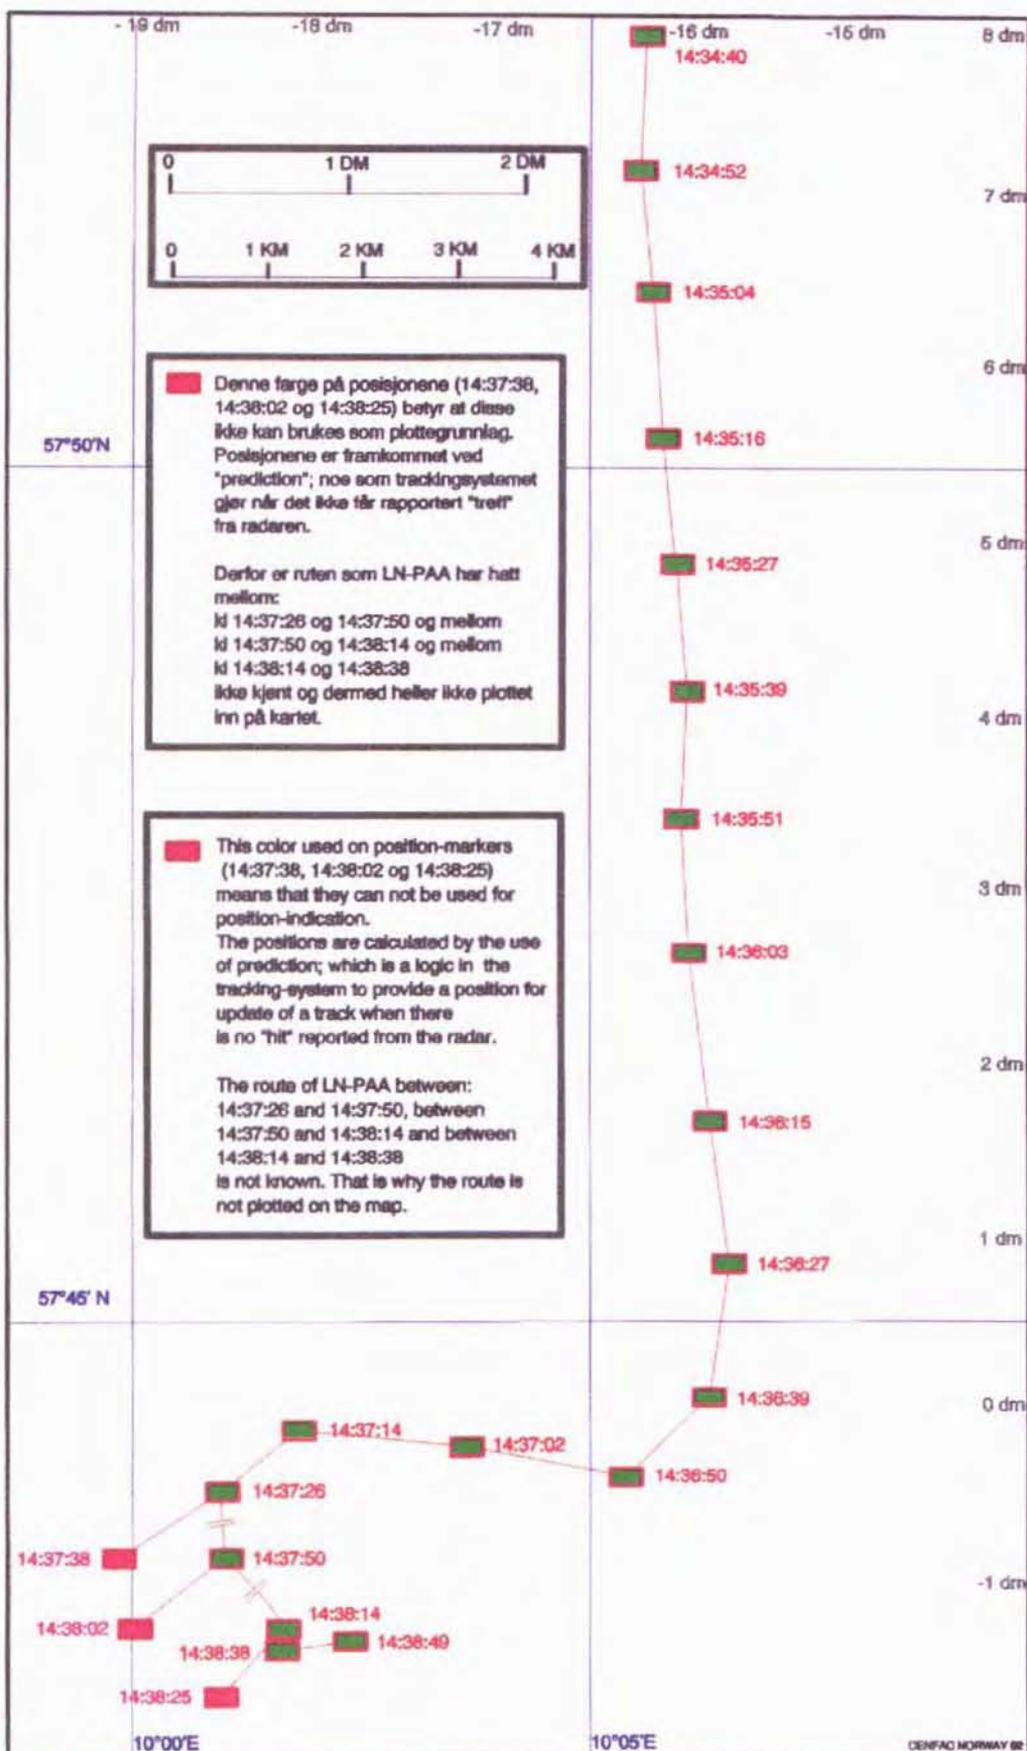
FIG. 6

been any wider, as figure 6 shows, owing to the characteristics of the radar system. The last recording of acceptable quality was made at 1438:49 hrs. The last recording by AWACS was made at 1438:08 hrs. At 1437:43 Swedish radar monitored LN-PAA for the last time. The radar recording ended abruptly on the Swedish radar screen, which, according to Swedish experts, indicated a steep descent.

According to the Norwegian system consultant, the monitoring of the aircraft track by Skagen radar was the most accurate. The Board therefore chose to go by Skagen radar's recordings (figure 6).

Plot based on Skagen radar.

From 1428:00 hrs to 1432:36 hrs there were several recordings of 21,900 ft. Twenty seconds later the mode C recording was 21,800 ft. There was a subsequent interval until 1438:03 hrs, when the final recording was made. The altitude of the aircraft was then given as 11,200 ft.

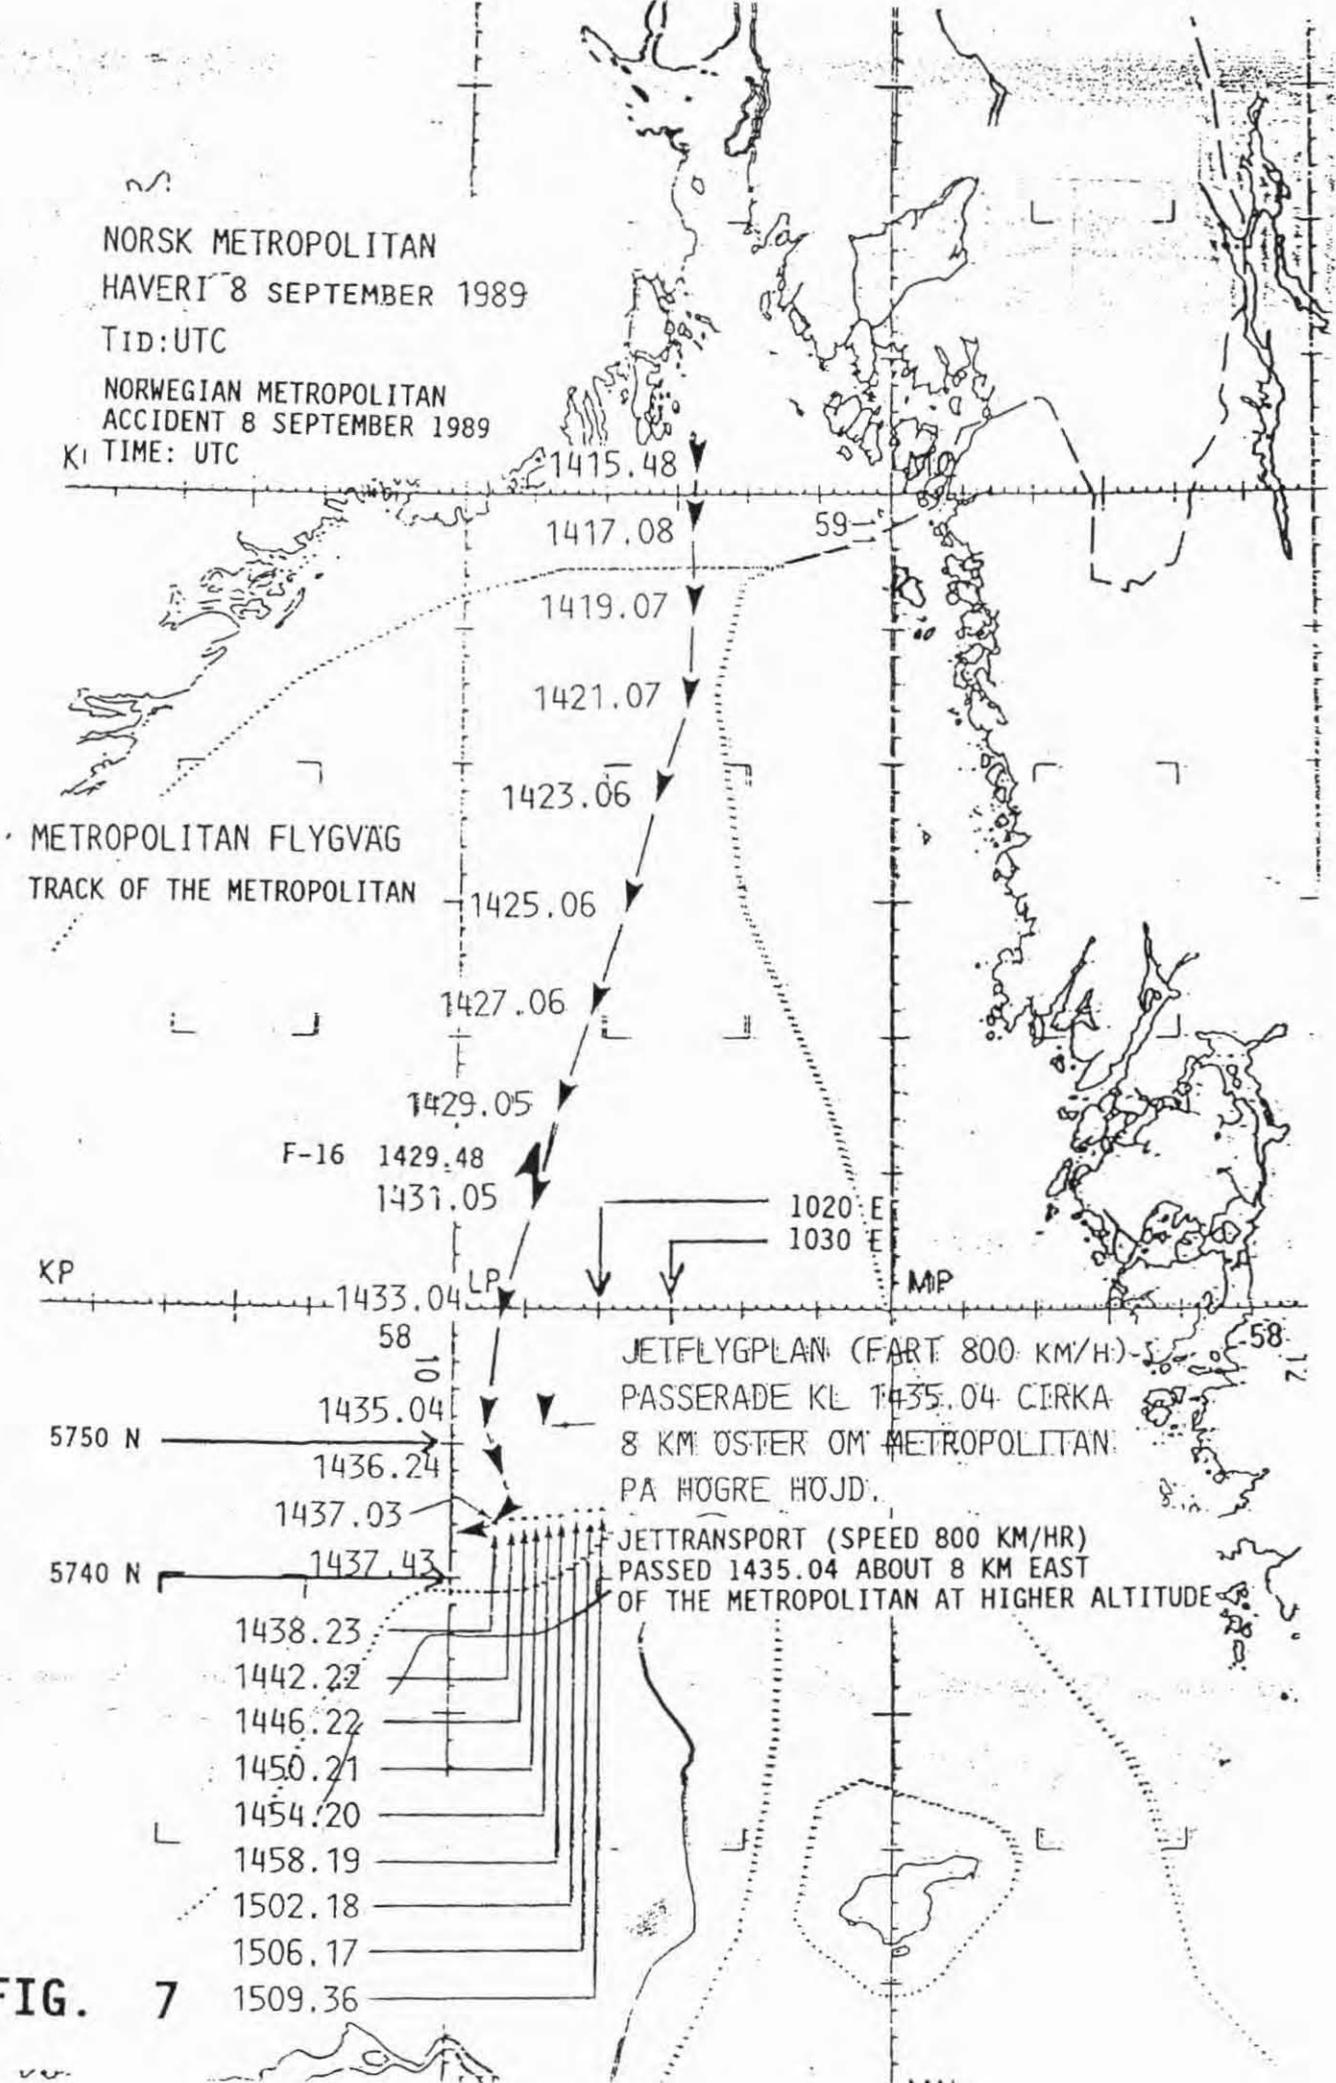
FIG. 7

- 1.17.3.13 Swedish radar recordings after 1638:23 hrs (figure 7)

The AAIB/N placed emphasis on trying to determine what exactly Swedish radar had recorded once the PAR 394 radar hits had disappeared. The line of thought was that the

object must have been small and very light. It must also have excellent radar reflection properties. The object was recorded for 2,473 secs (41 mins and 13 secs) from a minimum height of 5,000 m until it disappeared at a height of 400 m. This corresponds to a minimum sink rate of 1.86 m/s. Since the radar hit of the object could have been blocked by the radar hit of the aircraft, the maximum possible height could have been 21,100 ft (6,431 m). This corresponds to a maximum altitude loss of 6,031 m during the same time span. The maximum possible sink rate was thus 2.4 m/s. Both maximum and minimum values pointed to the fact that the object must have been very light. Owing to the characteristics of the radar signal the experts judged the object to be quite small.
