**THE AIRCRAFT ACCIDENT INVESTIGATION BOARD / NORWAY**

**HAV 02/93**

**REPORT ON THE CONVAIR 340/580 LN-PAA AIRCRAFT  
ACCIDENT NORTH OF HIRTSHALS, DENMARK, ON  
SEPTEMBER 8, 1989**

**SUBMITTED FEBRUARY 1993**

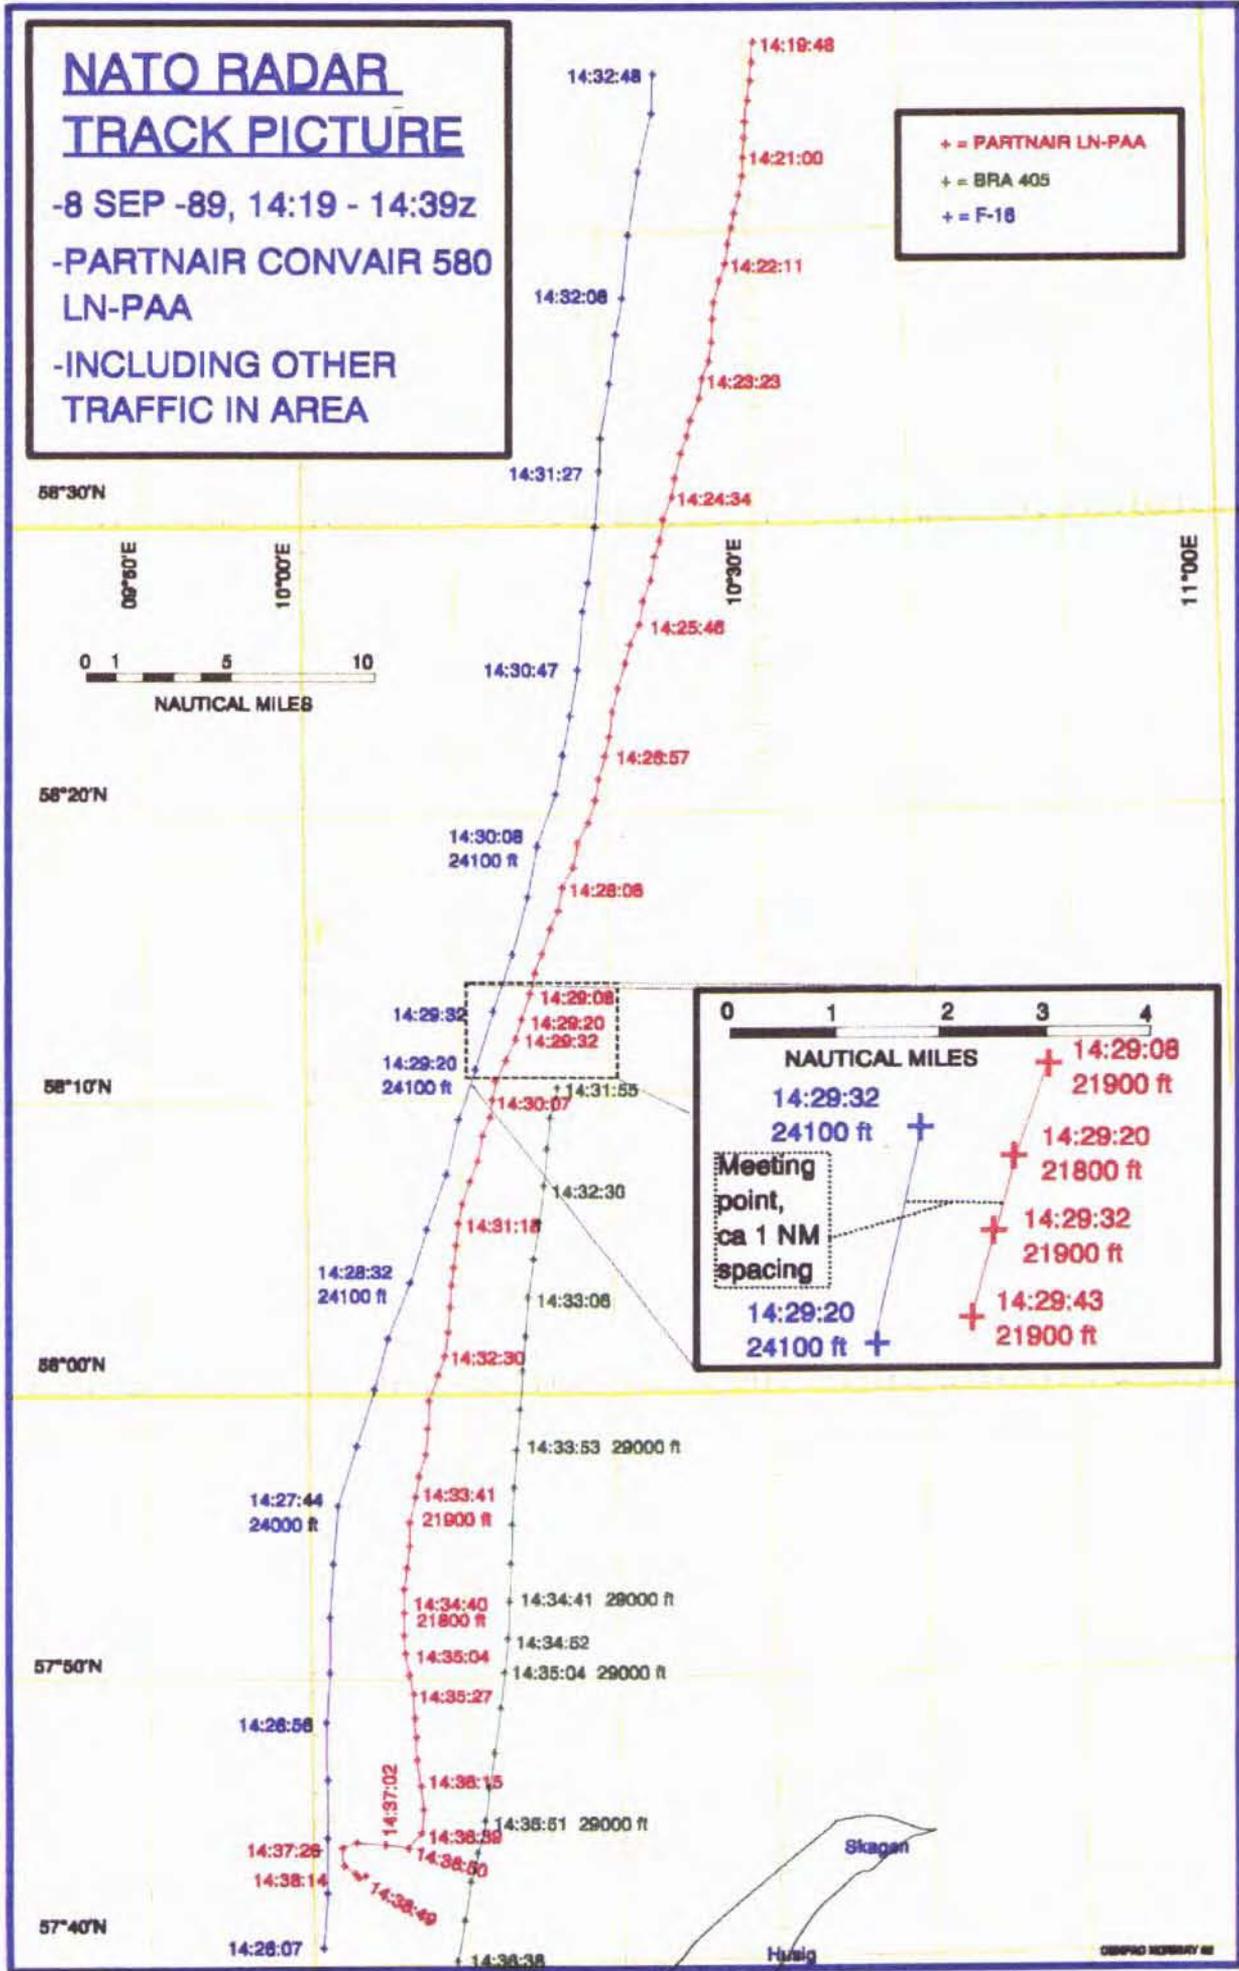
FIG. 8

- 1.17.4.1 In addition to LN-PAA, other air traffic in nearby airspace consisted of a B-737 Braathens SAFE passenger flight (Flight No. BRA 405) en route from Fornebu to Billund and a Norwegian F-16 fighter aircraft en route from Aalborg to Rygge under civilian air traffic control. The two aircraft had established their respective cruising levels when they passed LN-PAA. LN-PAA maintained FL 220, BRA 405 maintained FL 290 and the F-16 maintained FL 240. According to radar information, all the aircraft were identified as friendly, i.e. known traffic (figure 8).

-8 SEP -89, 14:19 - 14:39z  
 -PARTNAIR CONVAIR 580 LN-PAA  
 -INCLUDING OTHER TRAFFIC IN AREA

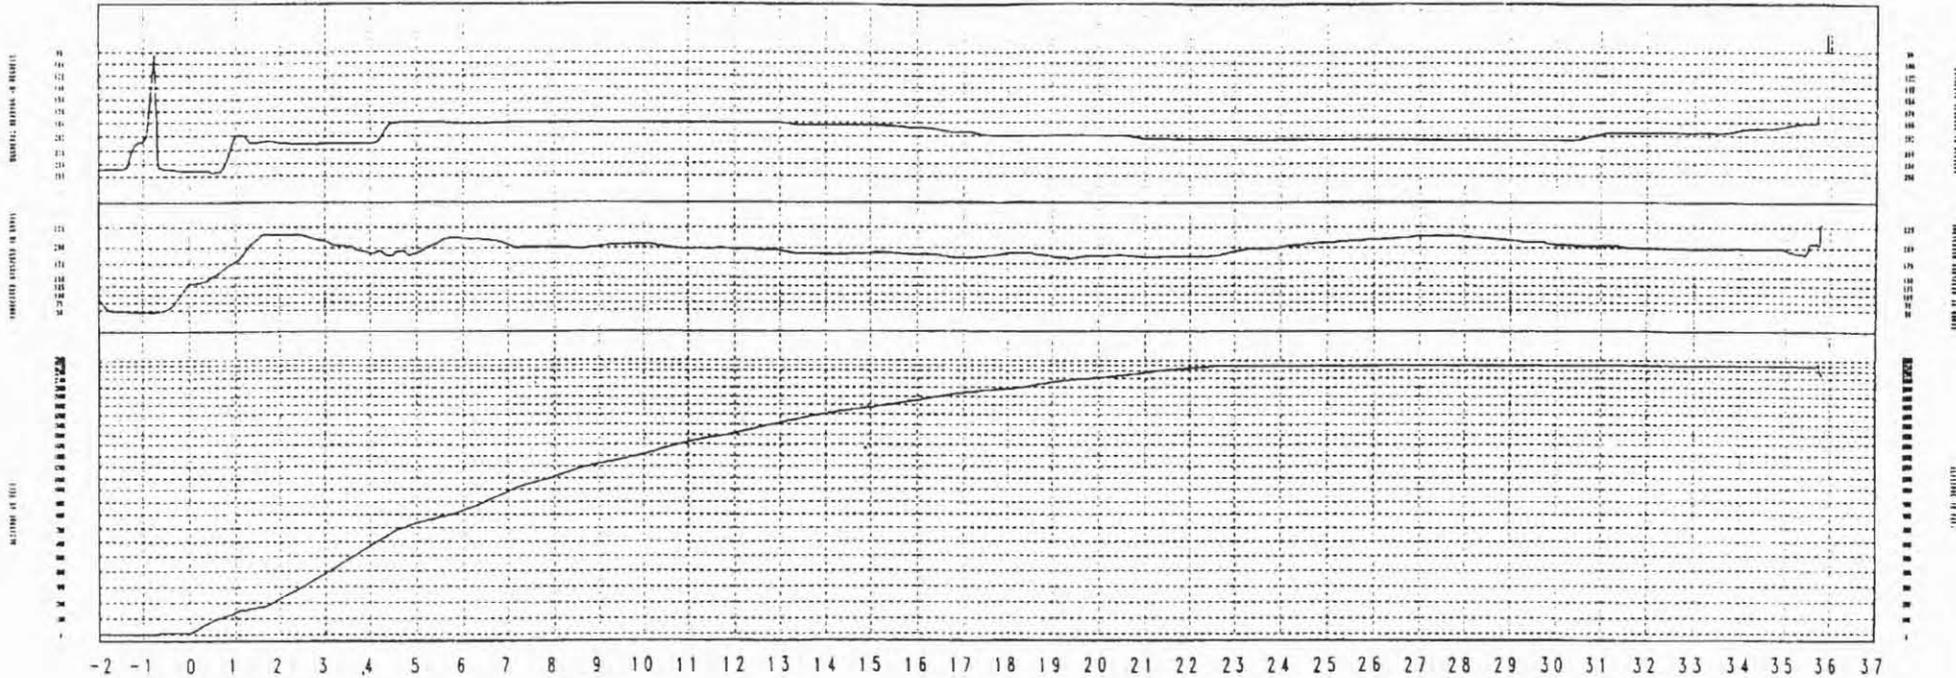
Complete FDR Readout for the accident flight, Convair 580, LN-PAA.

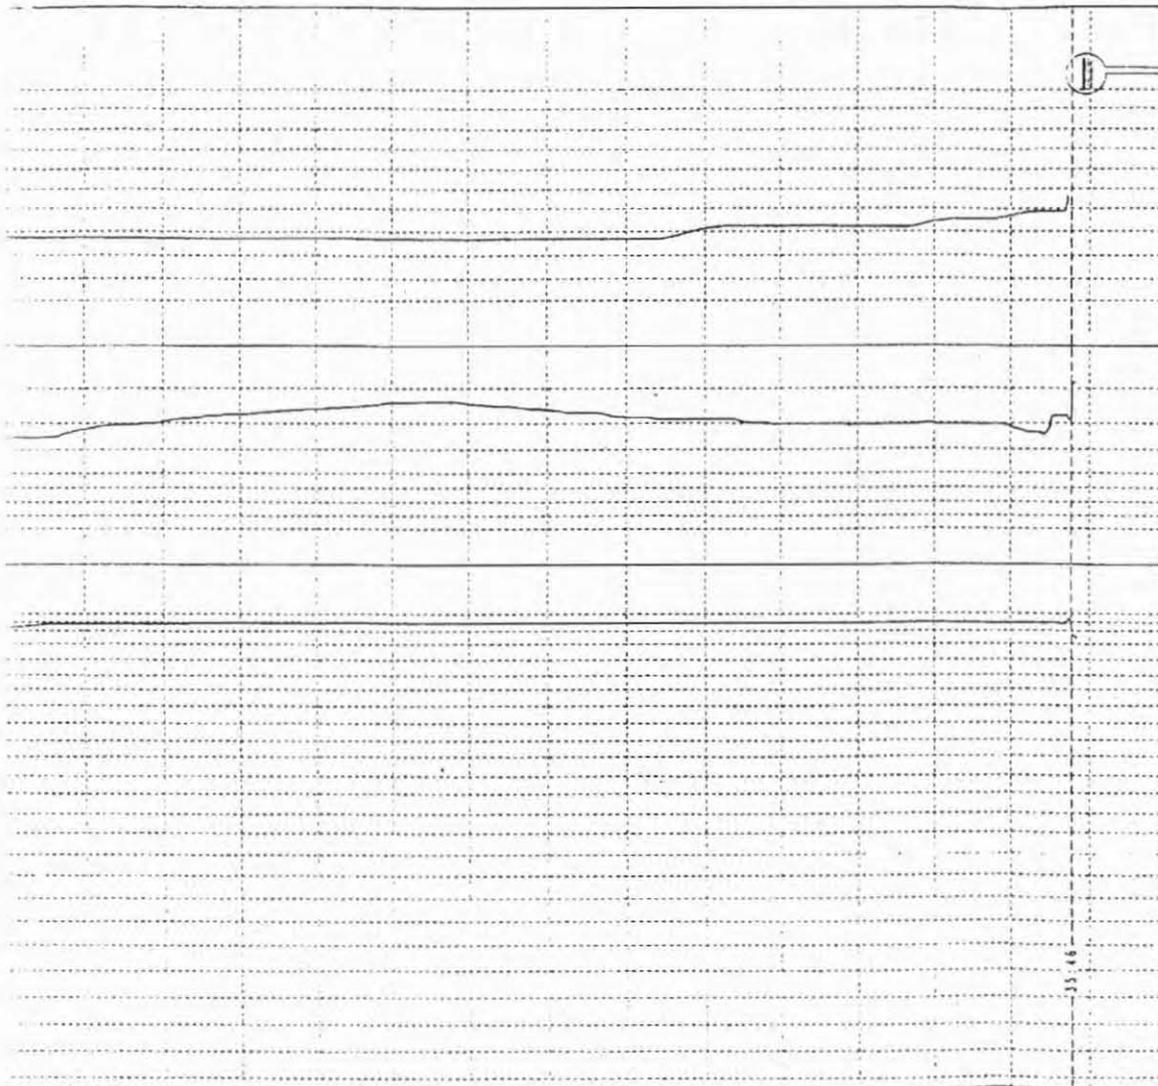
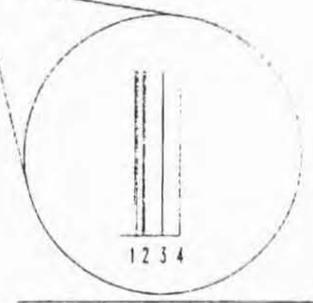
Trip/Date On/Off Event Markers	
1	35:54.0
2	35:55.2
3	35:57.9
4	36:00.6

FDR Readout showing electrical event markers at the end of the accident flight, Convaair 580, LN-PAA.
