AIRCRAFT ACCIDENT REPORT 1/95

# **ACCIDENTS INVESTIGATION DIVISION**

**Report on the accident to  
Boeing 747-409B B-165  
at Hong Kong International Airport  
on 4 November 1993**

**Hong Kong  
August 1995**

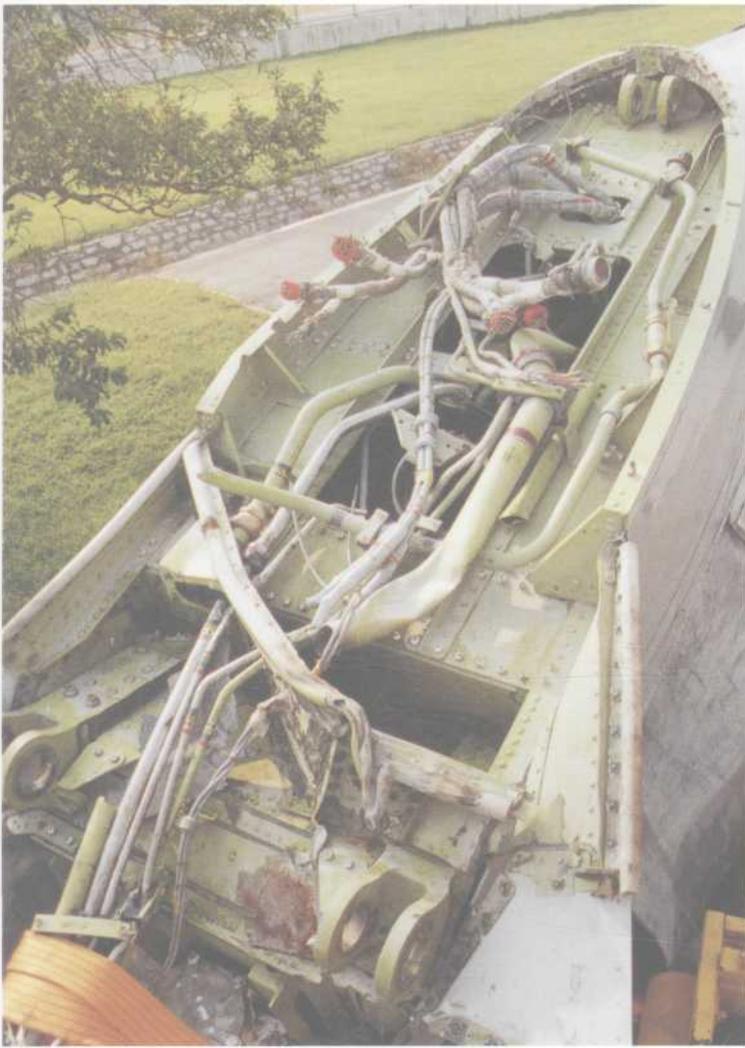
**ENGINE No 3**

No 4 engine details showing effect of engine rear mount deformation due to strike on sea wall. Fan and turbine exit areas for engine No 3 are also shown, which identify no evidence of pre-impact damage and stowed thrust reverse blocker doors. All engines were similar in this respect.

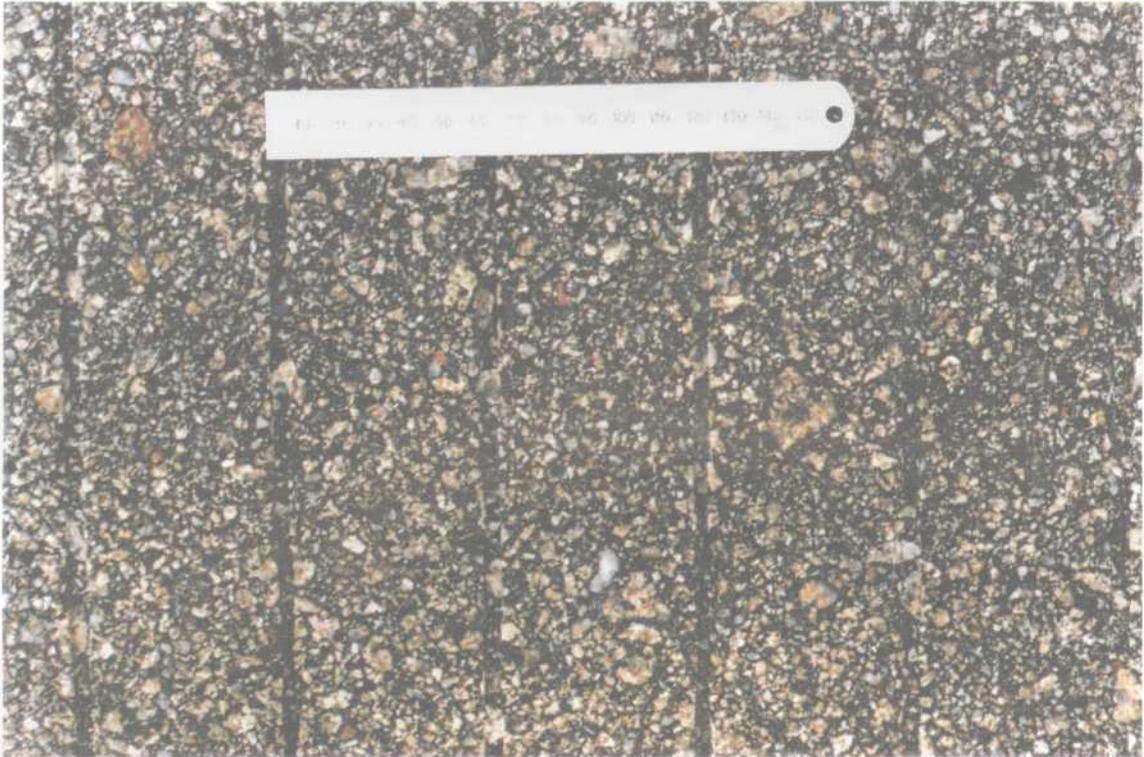
**Fig 2 Close-up of rubber contaminated grooved asphalt surface**

2.1 Runway 13/31 is 3393 metres long and 61 metres wide. The surface is grooved asphalt with groove size 3mm x 3mm at a 60mm pitch. Figs 2 and 3 are close-ups of typical areas of the grooved surface close to the centreline.

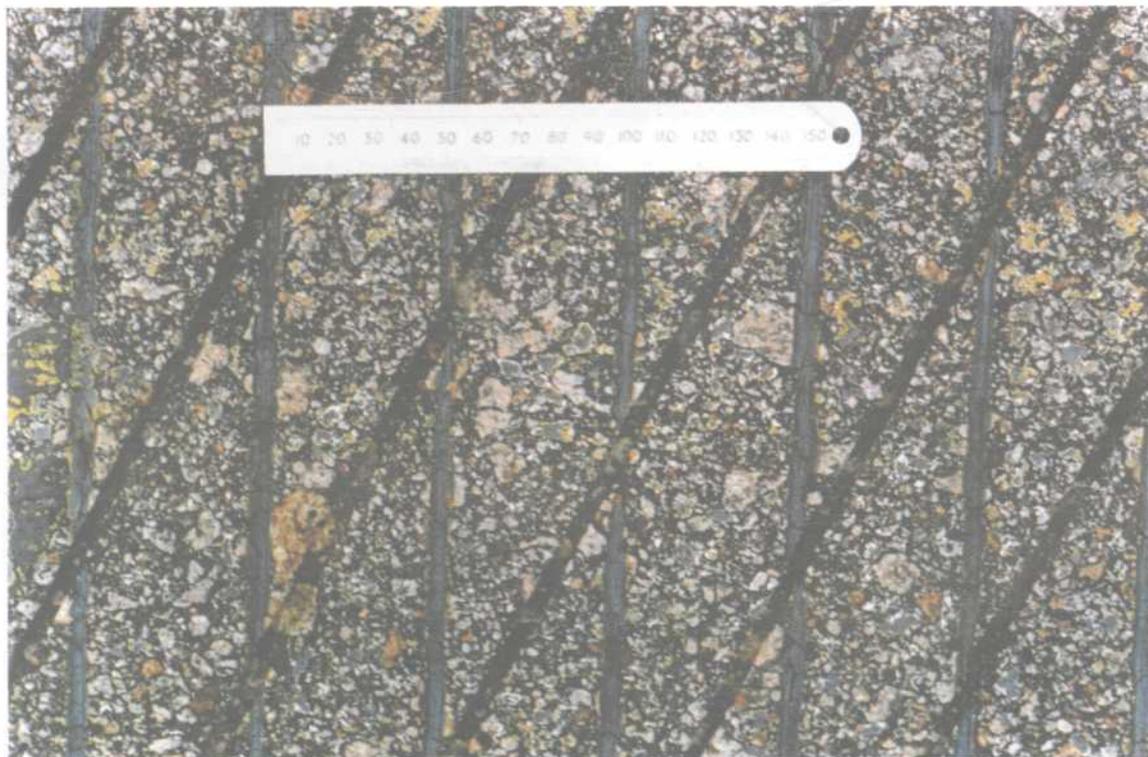
**Fig 7 Close-up of worn grooves**

2.2 During runway construction the groove width was specified to be between 4.5mm and 6.5mm. The majority of the grooving appears to be at the lower width and in some cases (Fig 6) was even lower than this. Similarly, though the groove spacing was specified to be between 50mm and 60mm, the majority was at the wider spacing. The effect of the grooving is diminished where rubber is deposited, causing a narrowing of the grooves. Some grooves have lost their sharp edges, Fig 7.

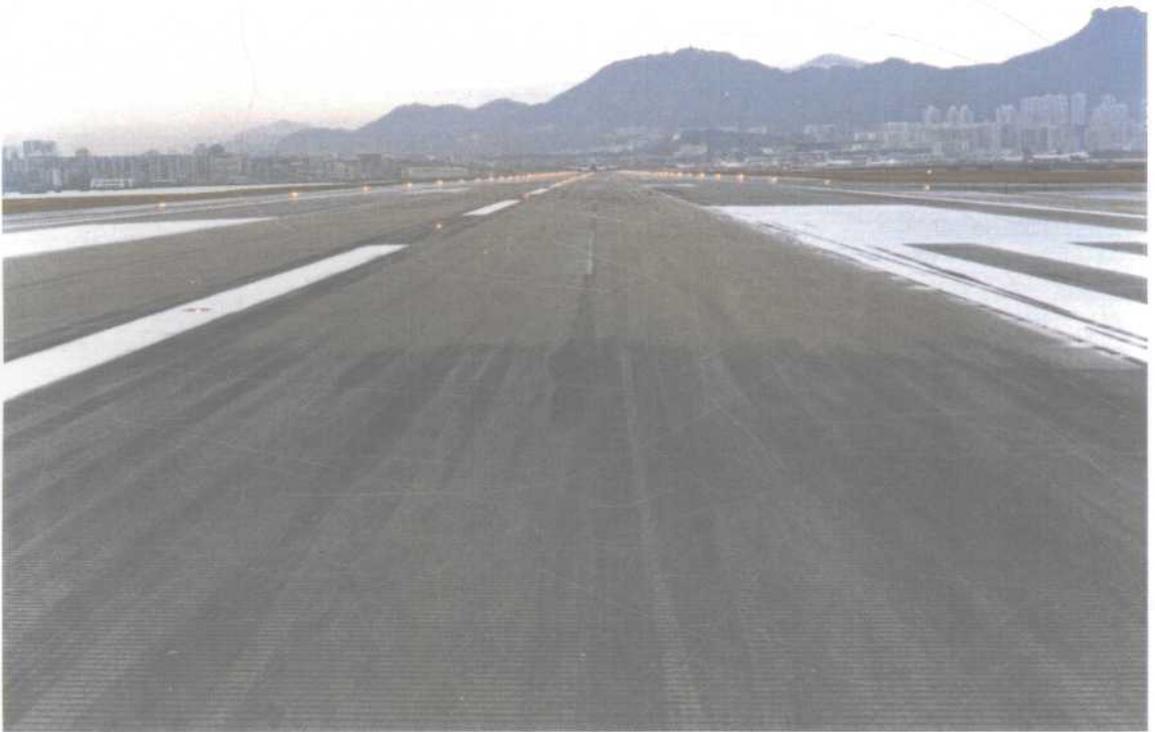
**Fig 8 Cross grooving near the 31 threshold**

The run speed was 65km/h (40mph) with 0.5mm water depth beneath the tyres. Across the piano keys the friction value dropped below 0.10 followed by a rapid rise to 0.78 across the 50m of the diagonally grooved asphalt, Fig 8 reducing slightly to 0.70 on the final 100m of grooved concrete.

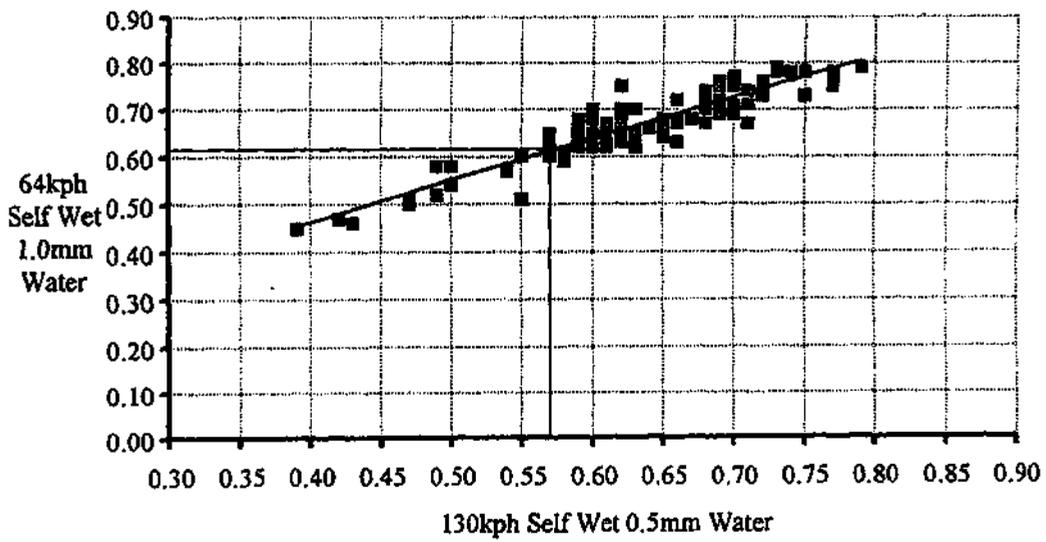
b) Comparison of 130km/h (80mph) at 0.5mm water depth and 64km/h (40mph) results at 1.0mm water depth
