AIRCRAFT ACCIDENT REPORT

In-flight Breakup Over the Atlantic Ocean
Trans World Airlines Flight 800
Boeing 747-131, N93119
Near East Moriches, New York
July 17, 1996

**NTSB/AAR-00/03
DCA96MA070
PB2000-910403
Notation 6788G
Adopted August 23, 2000**

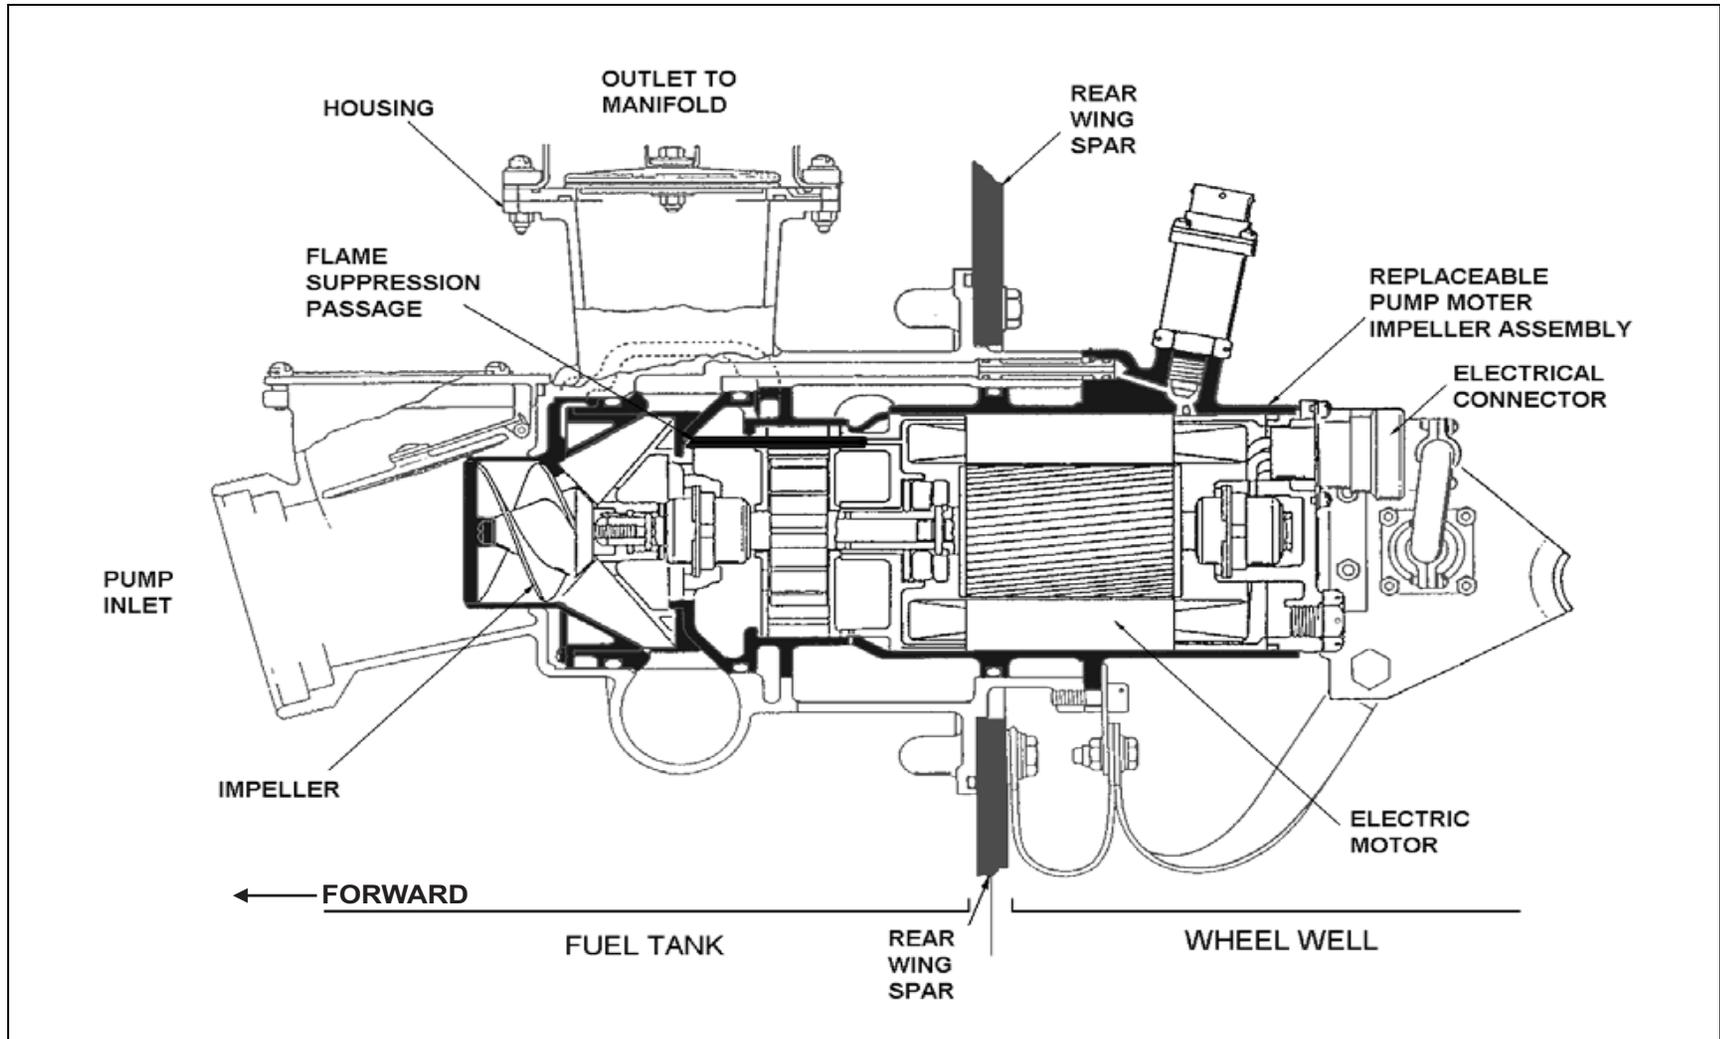
¹⁴⁷ Similar, but extensively deeper rubbing damage was found in jettison/override pumps in the Philippine Airlines 737 that had a CWT explosion on May 11, 1990. The Safety Board conducted tests for 2 weeks to determine whether galling between aluminum surfaces within the pump could have ignited flammable vapors. The investigative group was not able to ignite flammable vapors by impeller rubbing or by other types of contact between internal fuel pump components.

Figure 23. A diagram of a jettison/override fuel pump.

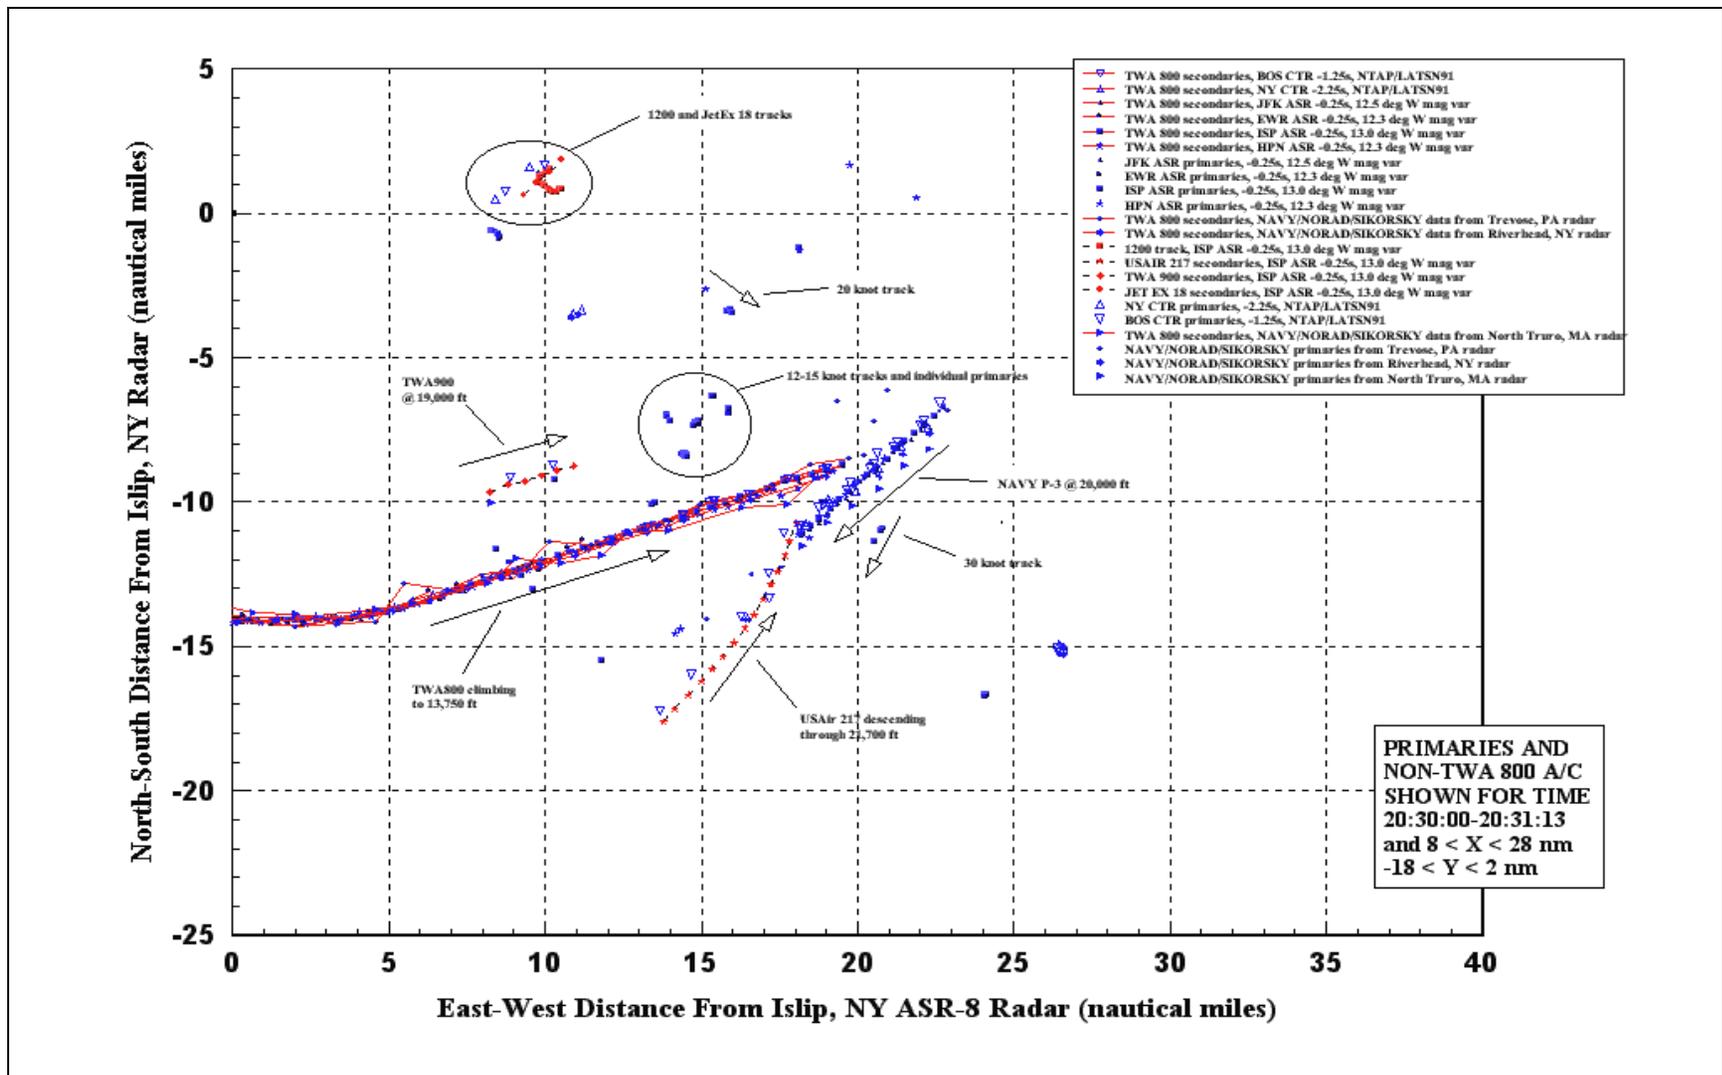
Examination of the radar data showed the following vehicle and/or object tracks within 10 nm of TWA flight 800 just before the accident (see figure 25):

Figure 25. Radar data showing vehicle and/or object tracks within 10 nm of TWA flight 800 just before the accident.

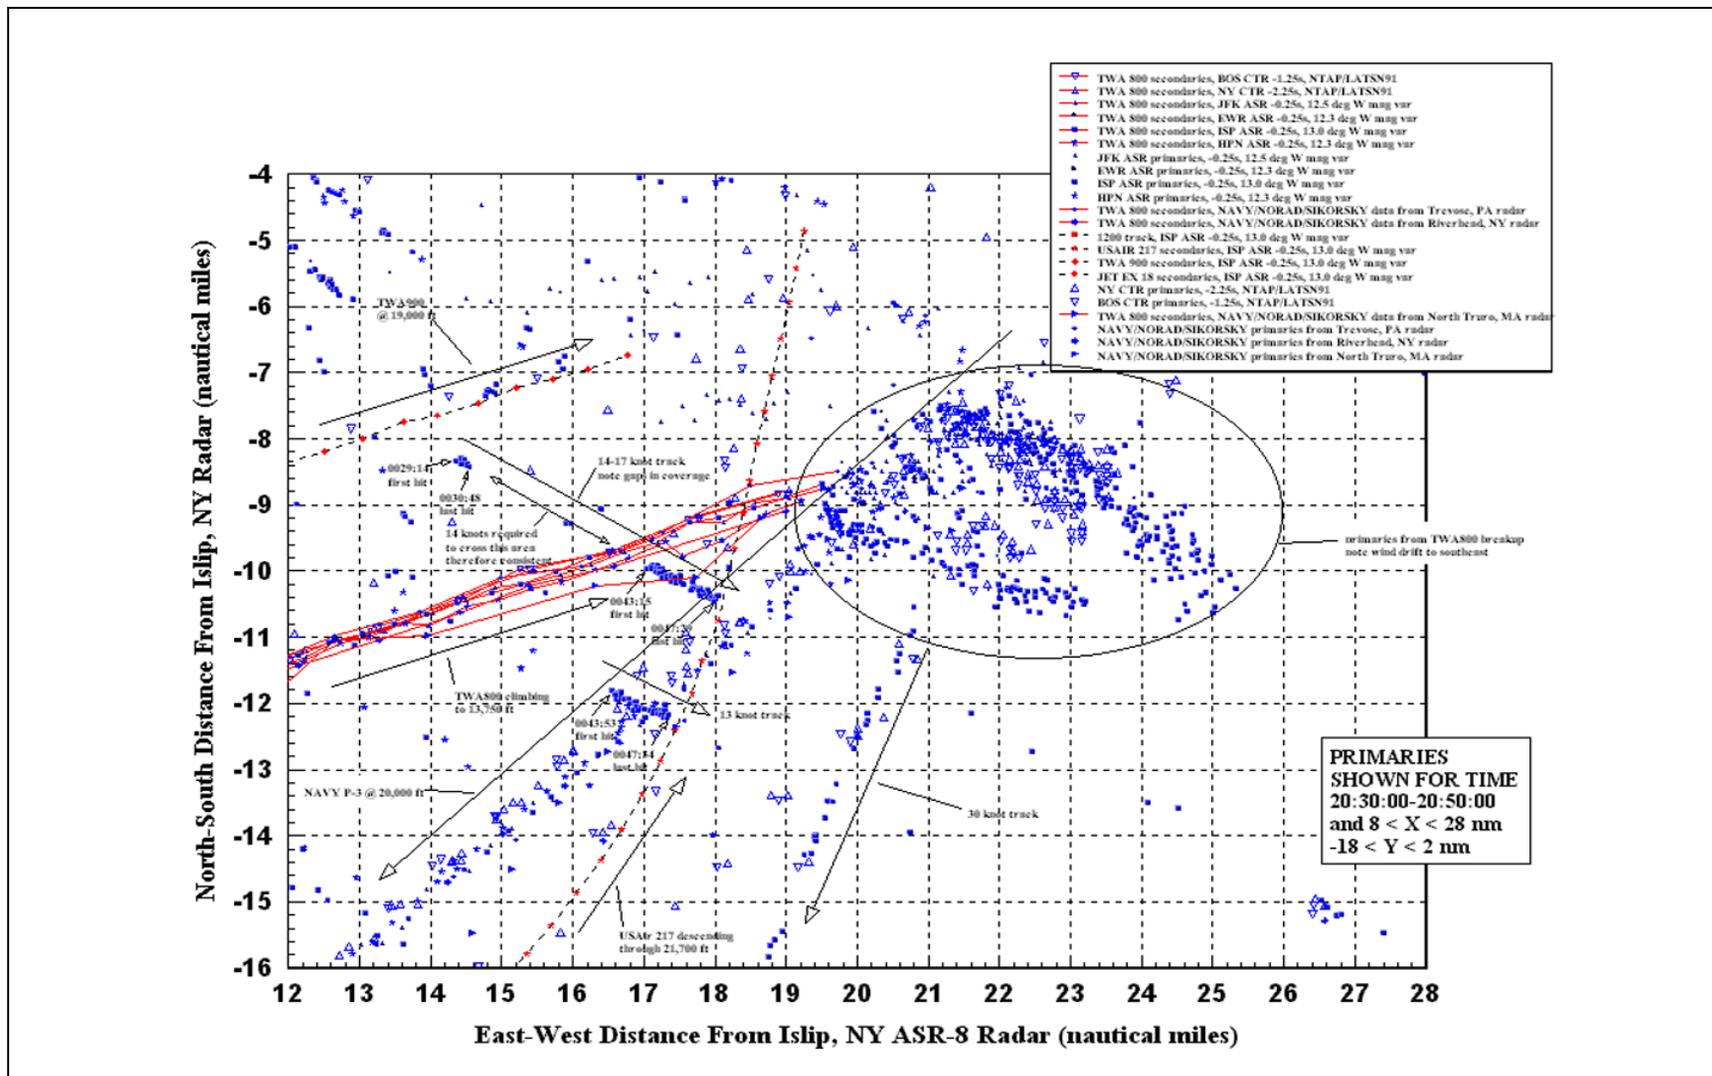
The Safety Board's examination of all of the available radar data revealed no sequence of primary or secondary radar returns that intersected TWA flight 800's position at any time, nor did it reveal any radar returns consistent with a missile or other projectile traveling toward the accident airplane. No secondary radar returns were received from TWA flight 800 after 2031:12; however, after 2031:12, numerous new primary radar returns appeared near the accident airplane's last recorded radar position, some of which were visible for up to 20 minutes after the last secondary radar return was received from the accident airplane. The primary radar returns that appeared near the accident airplane after 2031:12 were recorded largely in two areas of dense concentration, located about 1 to 1 1/2 miles east-northeast and 1 1/2 to 2 1/2 miles northeast of the last secondary radar return, respectively (see figure 26).

Figure 26. Primary radar returns that appeared near the accident airplane after 2031:12.

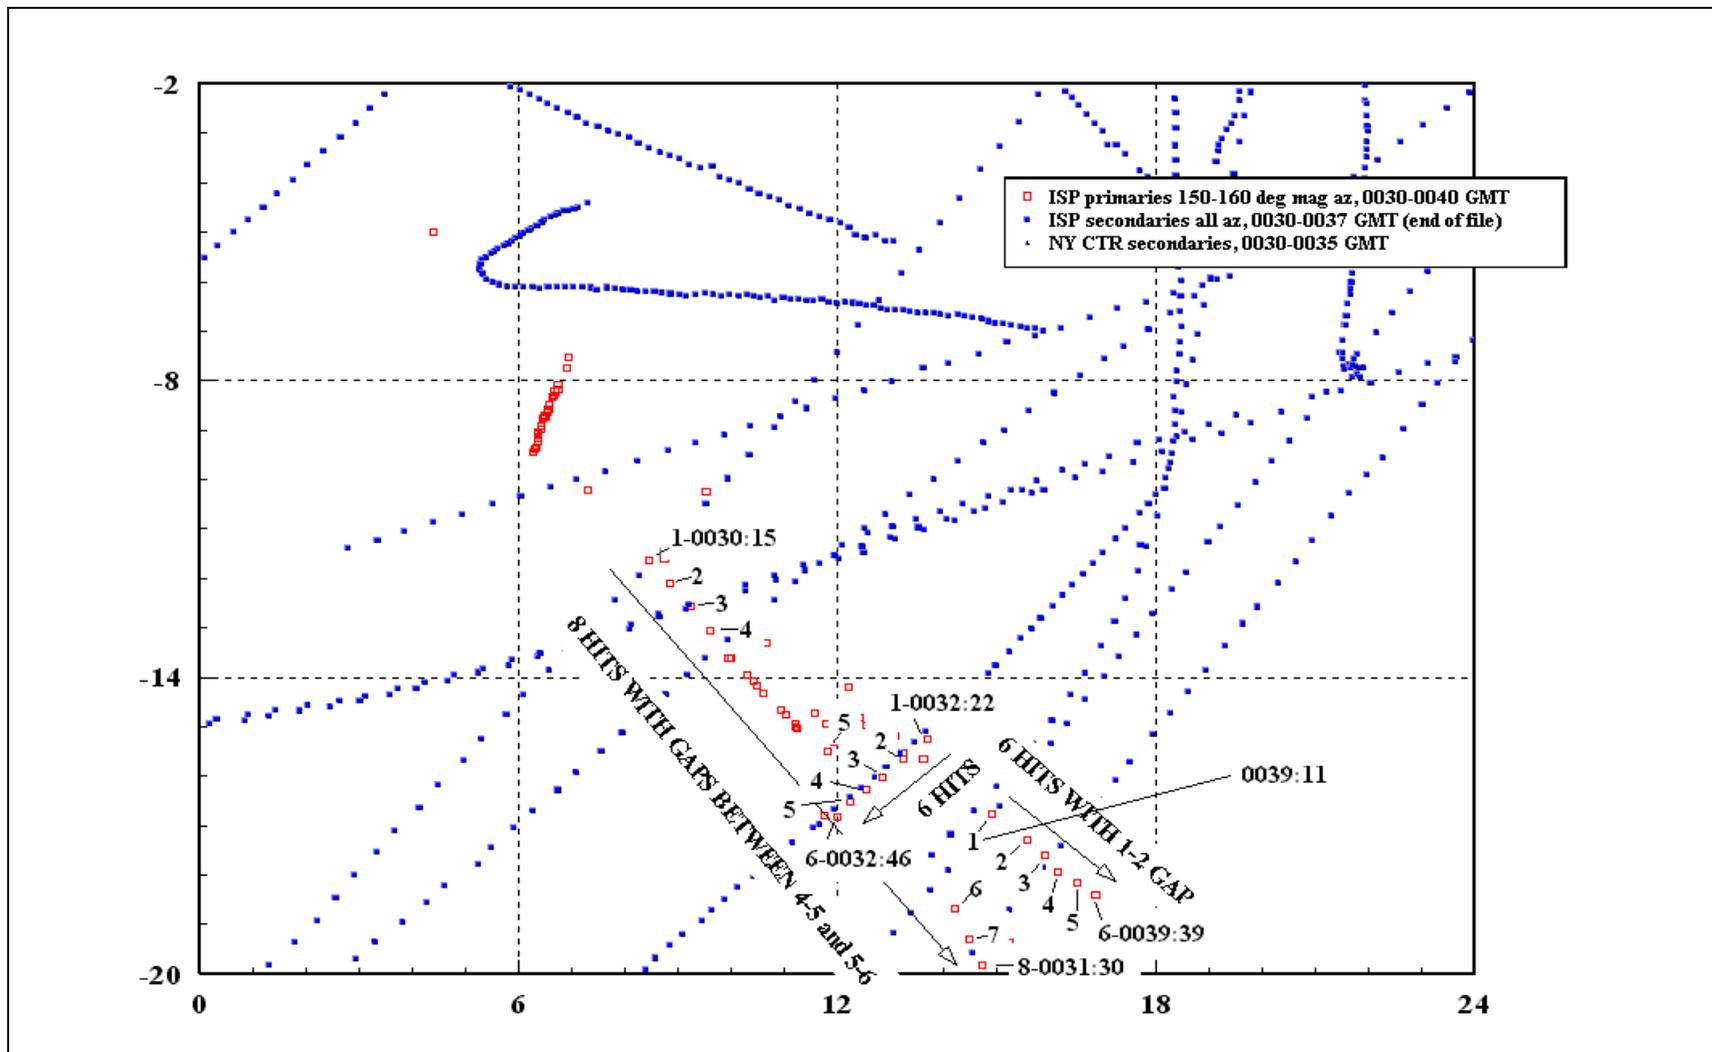
The Islip, New York, radar data showed one particular sequence of eight primary radar returns about the time of the accident (see figure 27) that warranted further review. On the basis of the times of and distances between these primary radar returns, the target appeared to be moving away from TWA flight 800's position at a ground speed of more than 400 knots. The first of the eight radar returns was recorded at 2030:15, more than 6 nm southeast of the accident airplane. The last of these returns was recorded at 2031:30 (18 seconds after TWA flight 800's last secondary return), about 15 miles southeast of TWA flight 800.

Figure 27. Sequence of eight primary radar returns recorded by the Islip, New York, radar site about the time of the accident.

Although most of the radar systems from which the Safety Board obtained data were capable of recording radar targets in the geographic area in which these primary radar returns were recorded, this sequence of eight primary radar returns was only observed in the data from the Islip radar site. Further examination of the returns recorded in that geographic area by the Islip site between about 2030 and 2040 revealed two additional sequences of primary radar tracks with apparent ground speeds greater than 300 knots. One of these sequences indicated a radar target movement away from TWA flight 800 to the southeast, whereas the other sequence indicated a target movement away from TWA flight 800 to the southwest.

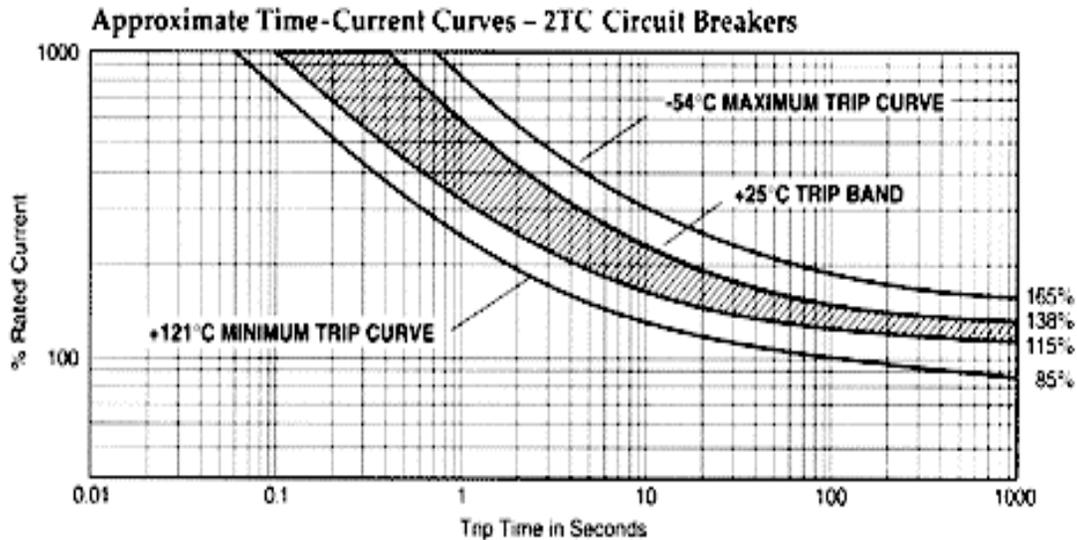
shows a “trip-curve” chart for a typical circuit breaker (excerpted from Texas Instruments Klixon® specification), which depicts the relationship between the amount of current that can pass through a circuit breaker and the amount of time until the circuit breaker opens.

Figure 34. A trip-curve chart for a typical circuit breaker (excerpted from Texas Instruments Klixon® specification).

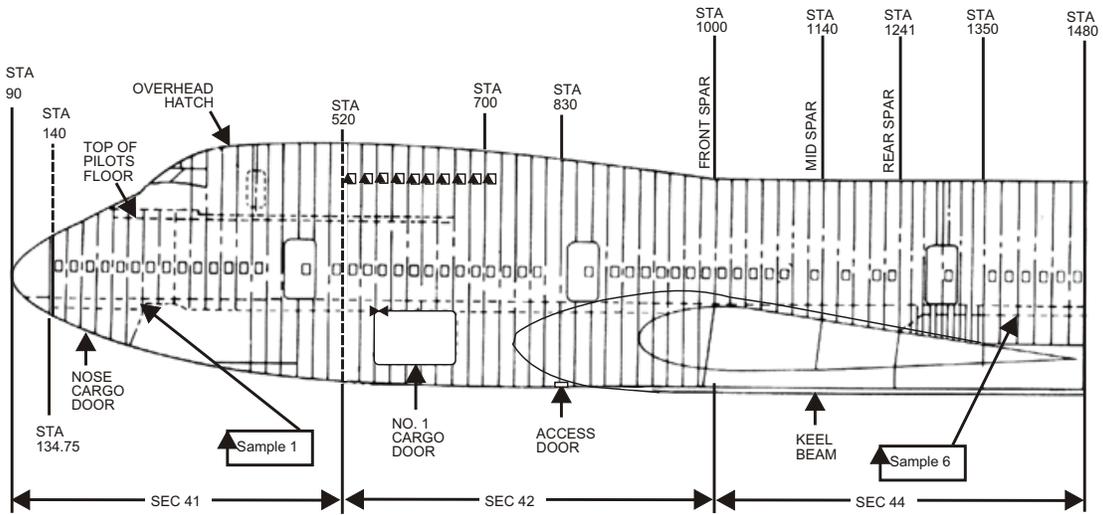
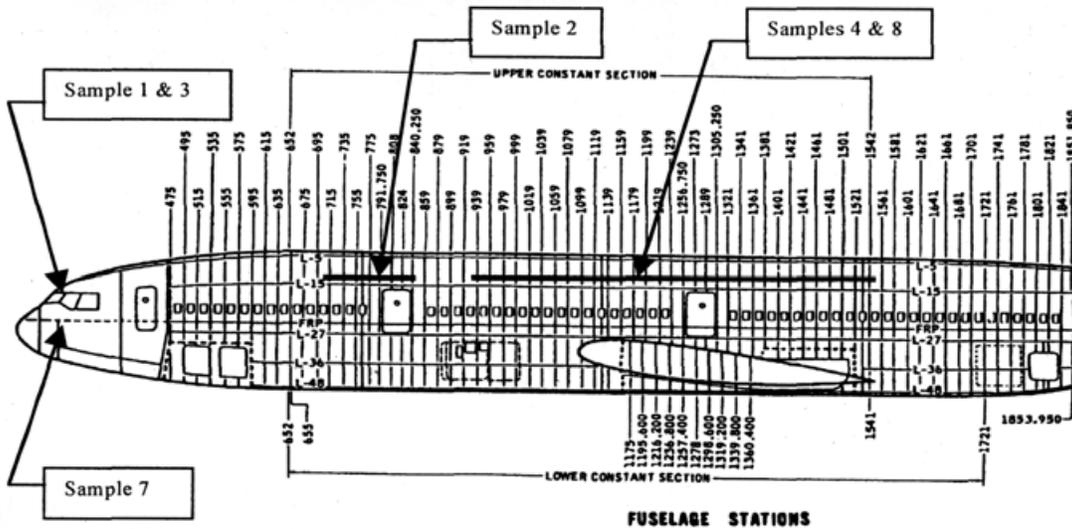
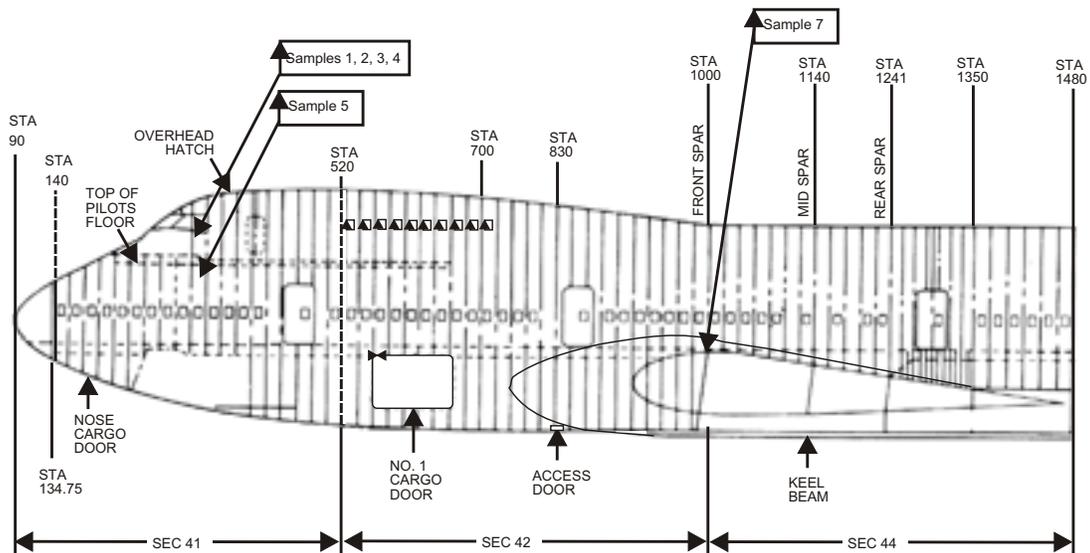
Figure 35a. Sample origination locations for the 747 manufactured in 1970.

Figure 35b. Sample origination locations for the DC-10 manufactured in 1973.

Figure 35c. Sample origination locations for the 747 manufactured in 1973.

4. The weak point in this wire type appears to be the lack of ability to maintain physical and electrical integrity during extended elevated thermal exposure with mechanical stress. As the wire ages, there is an increased risk of dielectric problems [breakdown of wire insulation integrity], mechanical damage and loss of electrical integrity.
5. No wire was submitted that was exposed to high levels of environmental exposure (such as wires from wheel wells, wing leading edges, etc.). Wire from these areas, would be expected to perform worse than the wire submitted. [See figures 35a, 35b, and 35c for sample locations.]

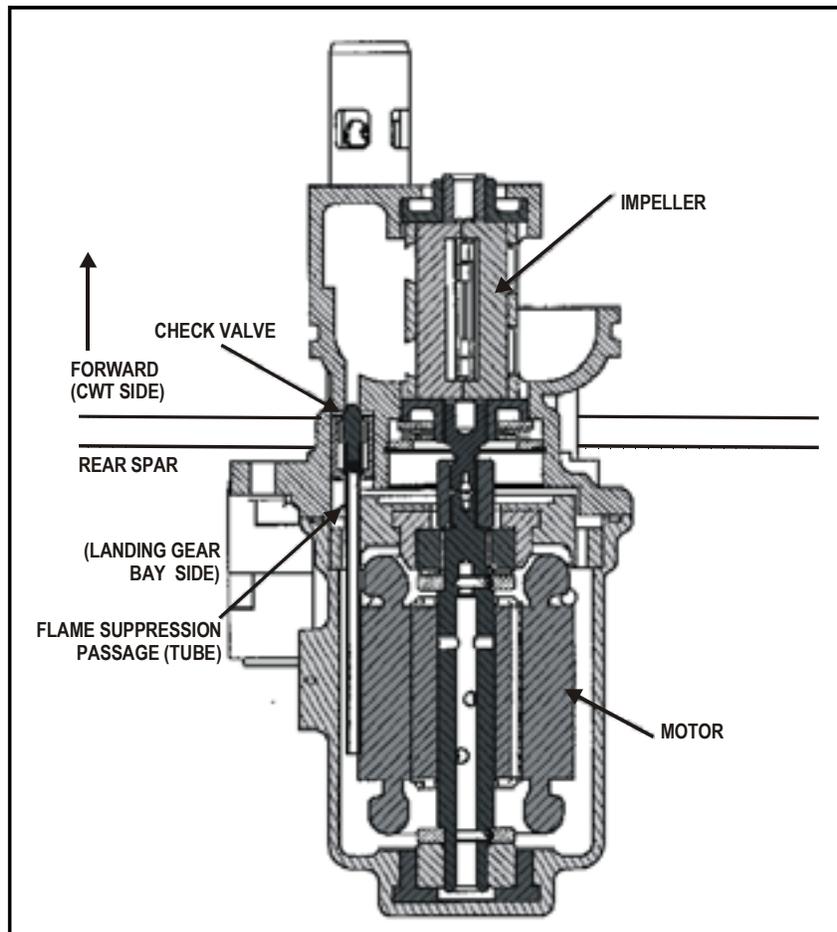
contained multiple explosions that were intentionally ignited within the pump motor cavity, preventing the ignition from transferring to the fuel tank. (Figure 37 is a diagram of a scavenge pump.) Because the Board became aware of instances in which the flame arrestor tube was broken or missing, investigators also conducted a series of tests to determine whether the scavenge pump motor housing would contain explosions with only one of the flame suppression system components (either the flame arrestor tube or the check valve) functioning. In all tests, the scavenge pump housing contained the explosions, and the explosive atmosphere surrounding the test pump did not ignite.

During its postaccident examination of other transport-category airplanes, the Safety Board observed that components in the electrical connector on a scavenge pump in a retired 747 were deteriorated. (Boeing ASBs 747-28A2194 and 747-28A0043, both dated January 18, 1996, “encouraged” operators to inspect for degradation in connectors.) Investigators observed that several scavenge pump electrical connectors had been manufactured of a material that degraded with long-term exposure to fuel. Boeing provided the Board with a service history for the 747 scavenge pump for the 10 years preceding the accident. When queried about the brevity of this history, Boeing indicated that most operators did not return the scavenge pumps to the manufacturer for overhaul.

Figure 37. A diagram of a scavenge pump.

As a result of these findings, Boeing issued ASB 747-28A2206, dated September 25, 1997, and AD 97-25-06, effective December 16, 1997. AD 97-25-06 contained the following summary:

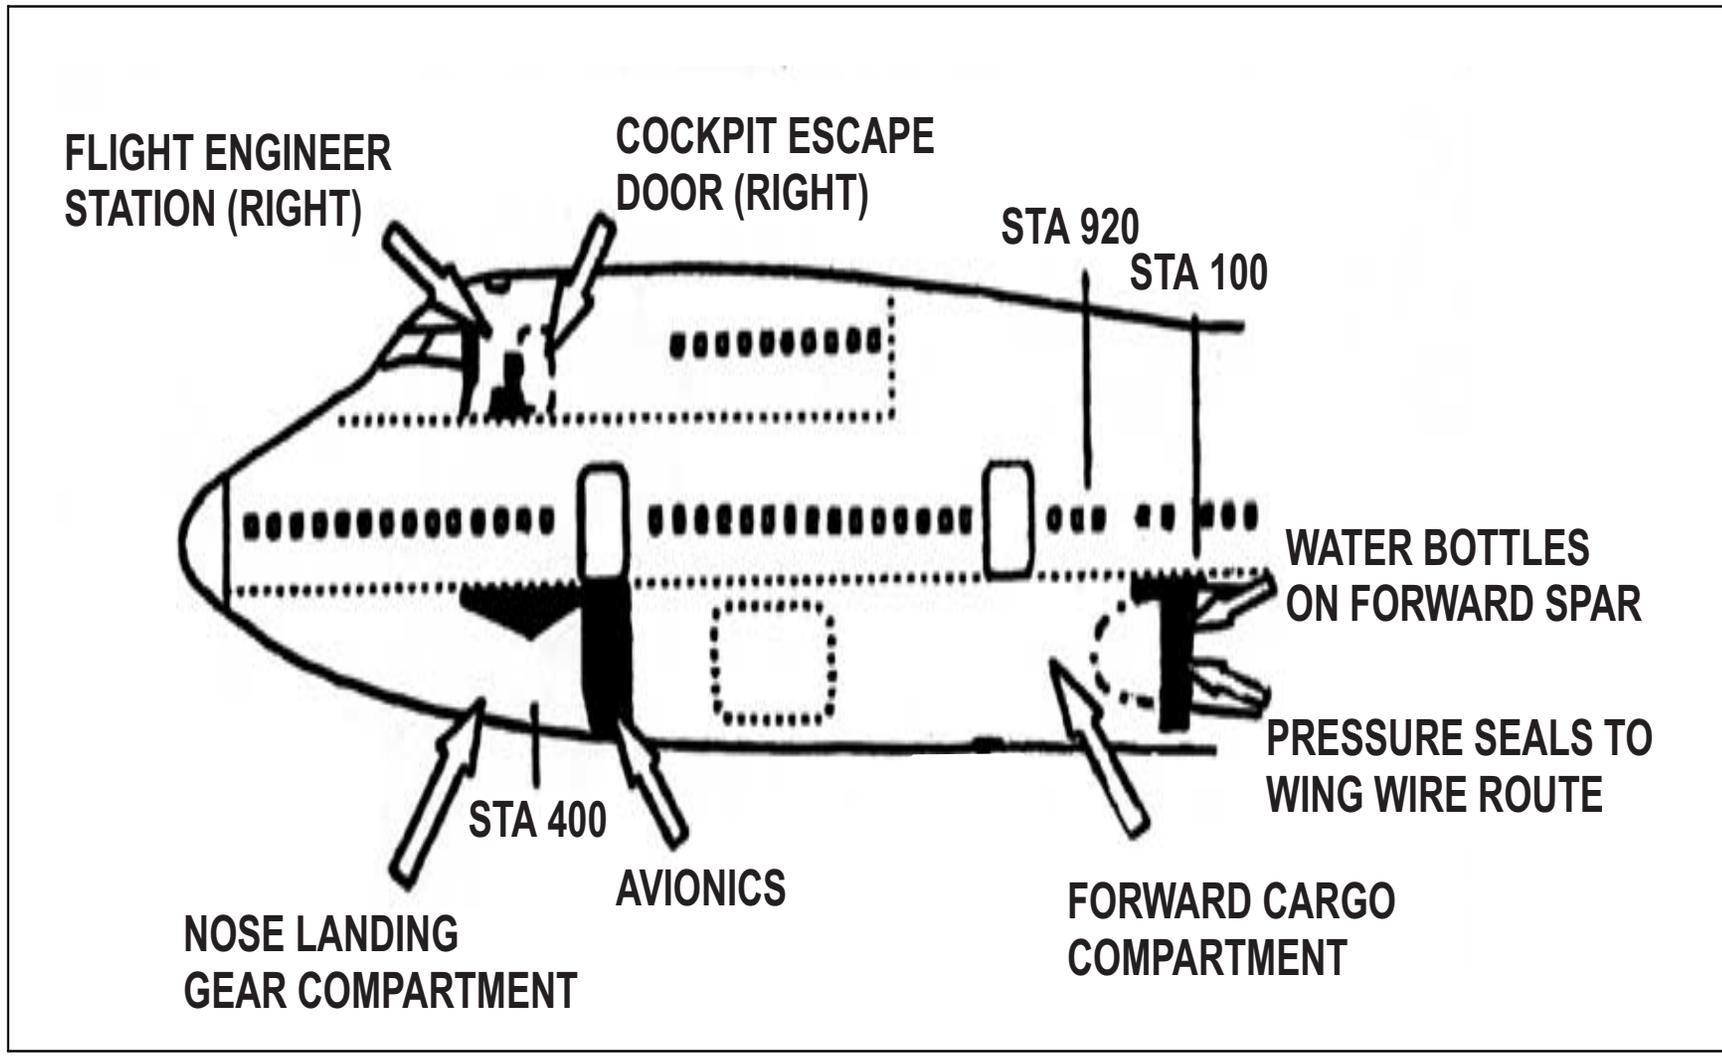
water bottles in the forward cargo compartment, and the pressure seal-to-wing wire route.³⁷⁸ Figure 38 shows the areas typically inspected on 747 airplanes.

Figure 38. Diagram showing the areas typically inspected on 747 airplanes.

In one airplane (its last known flight was in January 1997), wires in the raceway over the CWT were not bundled (as indicated by Boeing's PIs) but were randomly laid in a tray, such that individual wires crossed from one side of the tray to the other. Higher-voltage generator and galley power cables were clamped to the adjacent structure (not routed in the tray). Inspection of the inside of this airplane's CWT revealed the following: the scavenge pump inlet screen contained a nearly 1-inch-long uninsulated wire fragment, a vertically routed FQIS wire was chafed where it contacted a horizontal structural flange, and a horizontally routed FQIS wire was chafed where it contacted a vertical row of rivets between two supporting clamps. Examination of this airplane's CWT fuel quantity probes by the AFRL experts revealed sulfide deposits on the bare wire ends and terminal sleeves, and some of the wires were loose under the clamps; two of the wires exhibited striation marks that resembled jaw marks of a wire stripping tool.

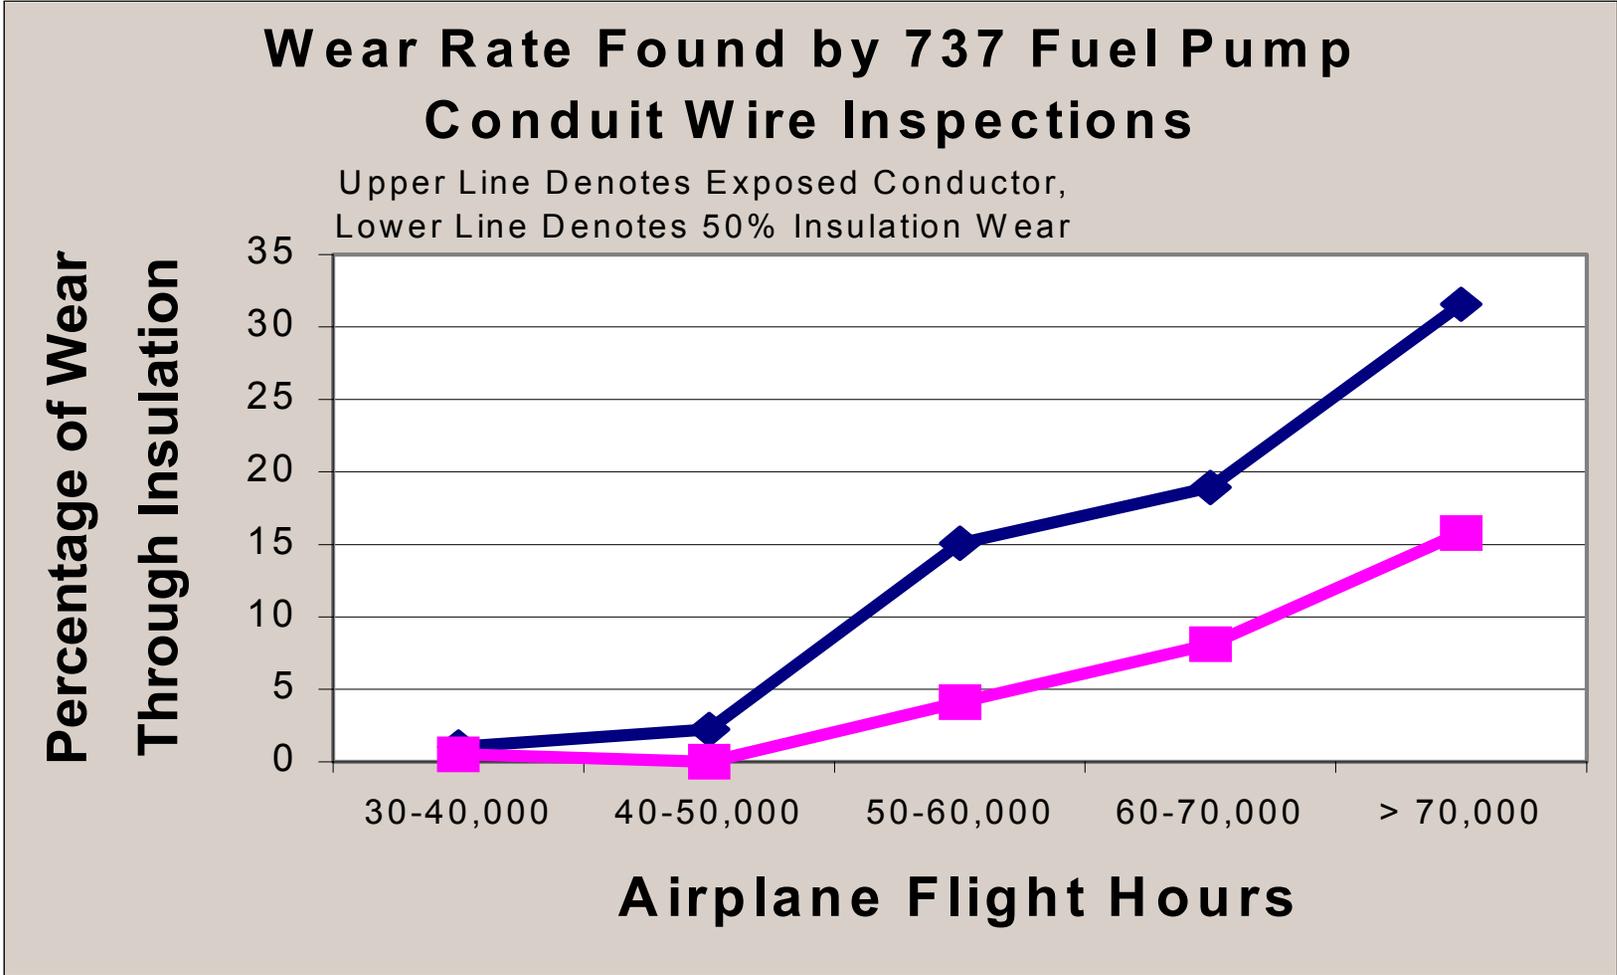
conduits, on May 10, 1998; (2) AD 98-11-52, which revised the flight-hour requirement outlined in AD T98-11-51 to include airplanes with more than 40,000 flight hours, on June 24, 1998; and (3) AD 99-21-15, which further revised the flight-hour requirement outlined in AD T98-11-51 to include airplanes with more than 20,000 flight hours, on October 8, 1999. Figure 39 shows the 737 fuel pump conduit wear rate that was identified by the FAA during representative 500 wire inspections.⁴¹² Similar data for 747 inspection results were not released.

Figure 39. A chart showing the 737 fuel pump conduit wear rate that was identified by the FAA during representative 500 wire inspections.

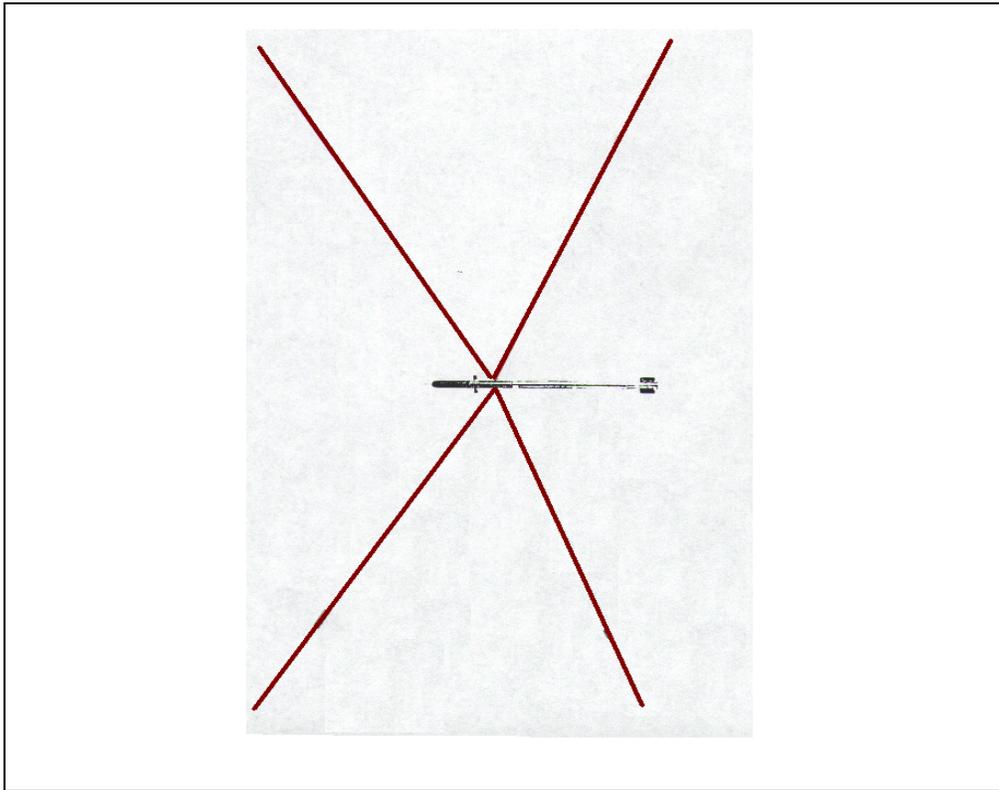
According to the MSIC, warhead detonation typically results in about 1,000 fragments of various sizes, with an average mass of less than 10 grains (0.0229 ounce), and a mass as large as 40 grains (0.0916 ounce) in the pattern shown in figure 43. MSIC reported that warhead fragments could have an initial velocity of up to 9,000 fps. Data obtained from the SURVIAC indicated that 10- and 40-grain fragments would require velocities of 3,500 fps and 2,000 fps, respectively, to penetrate the CWT if they impacted the bottom of the CWT at a right angle. Using the initial speed and speed decay rate for the warhead fragments, the Safety Board calculated that a detonation would have to occur 40 feet or less below the airplane's CWT for a fragment to retain sufficient velocity to penetrate the CWT.

Figure 43. Diagram of warhead detonation fragment pattern.

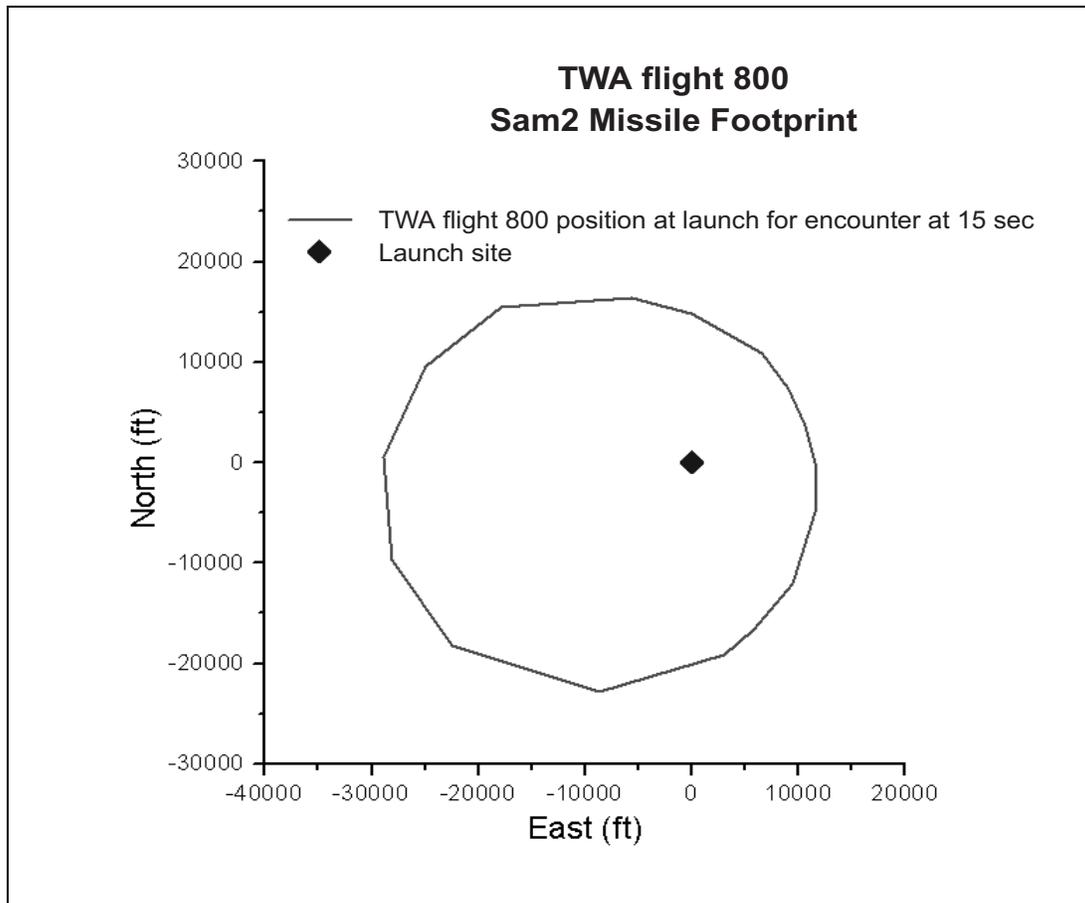
The Safety Board's computer simulations (using this missile performance data and taking into account the winds at the time of the accident) showed that the locations on the surface from which a missile launched at TWA flight 800 would result in selfdestruction within 40 feet of the airplane were extremely limited. Figure 44 shows airplane locations at which, if a high-performance missile were launched at the airplane, the missile would selfdestruct within 40 feet of the airplane. Note that, at the scale shown, the launch area that would result in a selfdestruction within 40 feet of the airplane is not as wide as the line showing the 15-second perimeter in this figure.

Figure 44. Diagram showing airplane and missile launch site locations that could result in missile selfdestruct within 40 feet of the plane.

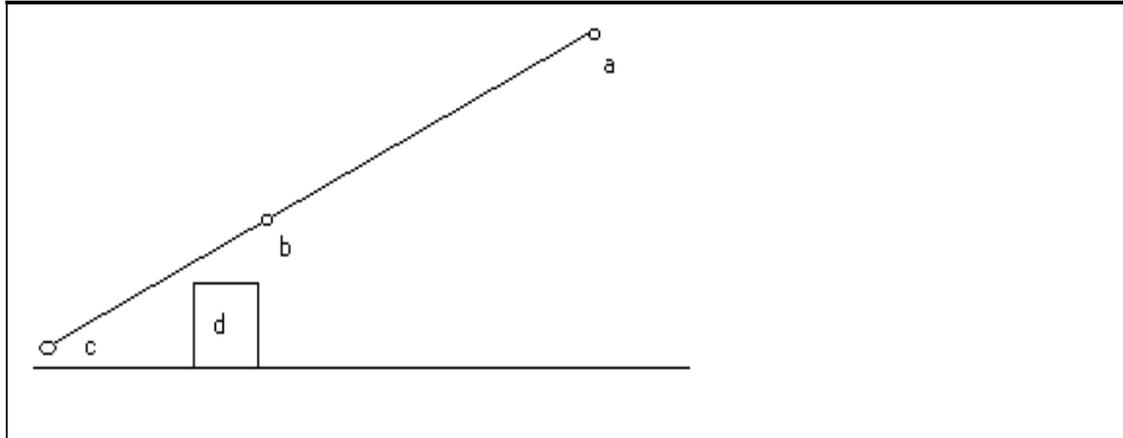
It should also be noted that witnesses observing the accident from Long Island would have been viewing it against a featureless background and, therefore, would have had few, if any, depth perception cues. Consequently, because of the tendency to perceive more distant objects as being about the same distance away as intervening objects (the equidistance tendency), the streak of light could have appeared closer to them than it actually was. The equidistance tendency is illustrated in figure 45, which depicts a person at point “c” observing an object at point “a” that appears at point “b” at the same perceptual distance as an intervening building at point “d.”

Figure 45. A graphical illustration of the equidistance tendency.

in the sky than it actually was, which explains why the streak of light may have been reported by some witnesses as having originated at the surface of the earth. It should be noted that almost all of the witnesses who reported that the streak of light originated at the surface viewed the streak of light on the far side of intervening terrain features, such as houses or the barrier island. These witnesses would have perceived the streak of light to be about the same distance as the intervening object because the elevation angle of the object would have been perceptually reduced.

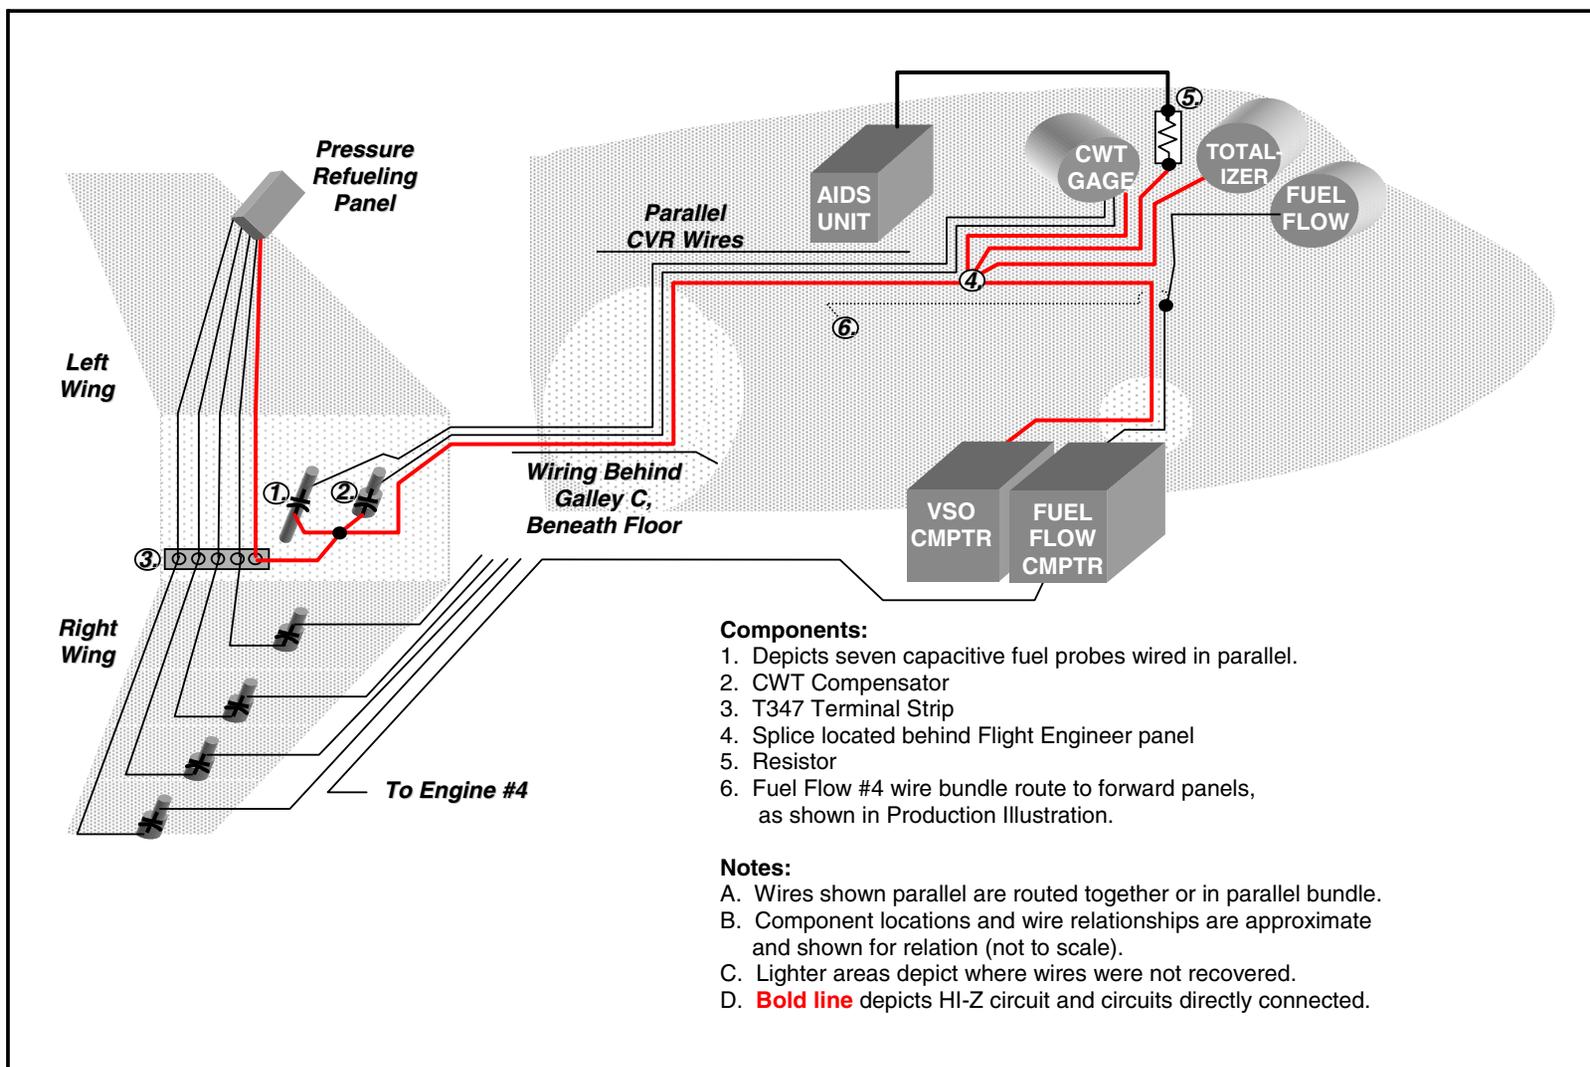
The CWT FQIS wiring in the 747 terminates at common connectors with the fuel quantity indicator, the totalizer gauge, the airborne integrated data system (AIDS), the volumetric shutoff (VSO), and the left wing refueling station; each of these connectors also includes terminating wires from circuits that carry 115 volts.⁶⁰⁵ (See figure 46.) Short circuits in connectors have caused incidents in the past. For example, an October 22, 1995, incident involving roll/yaw oscillations on a 737 near Manchester, England, was attributed to a short circuit in the rudder circuitry of the incident airplane that resulted from lavatory fluid bridging the pins within an electrical conductor.

Figure 46. Diagram of the center wing tank fuel quantity indication system wiring on the 747 and its common connectors.
