PB97-910403
NTSB/AAR-97/03
NYC97MA005

AIRCRAFT ACCIDENT REPORT

DESCENT BELOW VISUAL GLIDEPATH
AND COLLISION WITH TERRAIN
DELTA AIR LINES FLIGHT 554
MCDONNELL DOUGLAS MD-88, N914DL
LAGUARDIA AIRPORT, NEW YORK
OCTOBER 19, 1996

**Adopted: August 25, 1997
Notation 6785B**

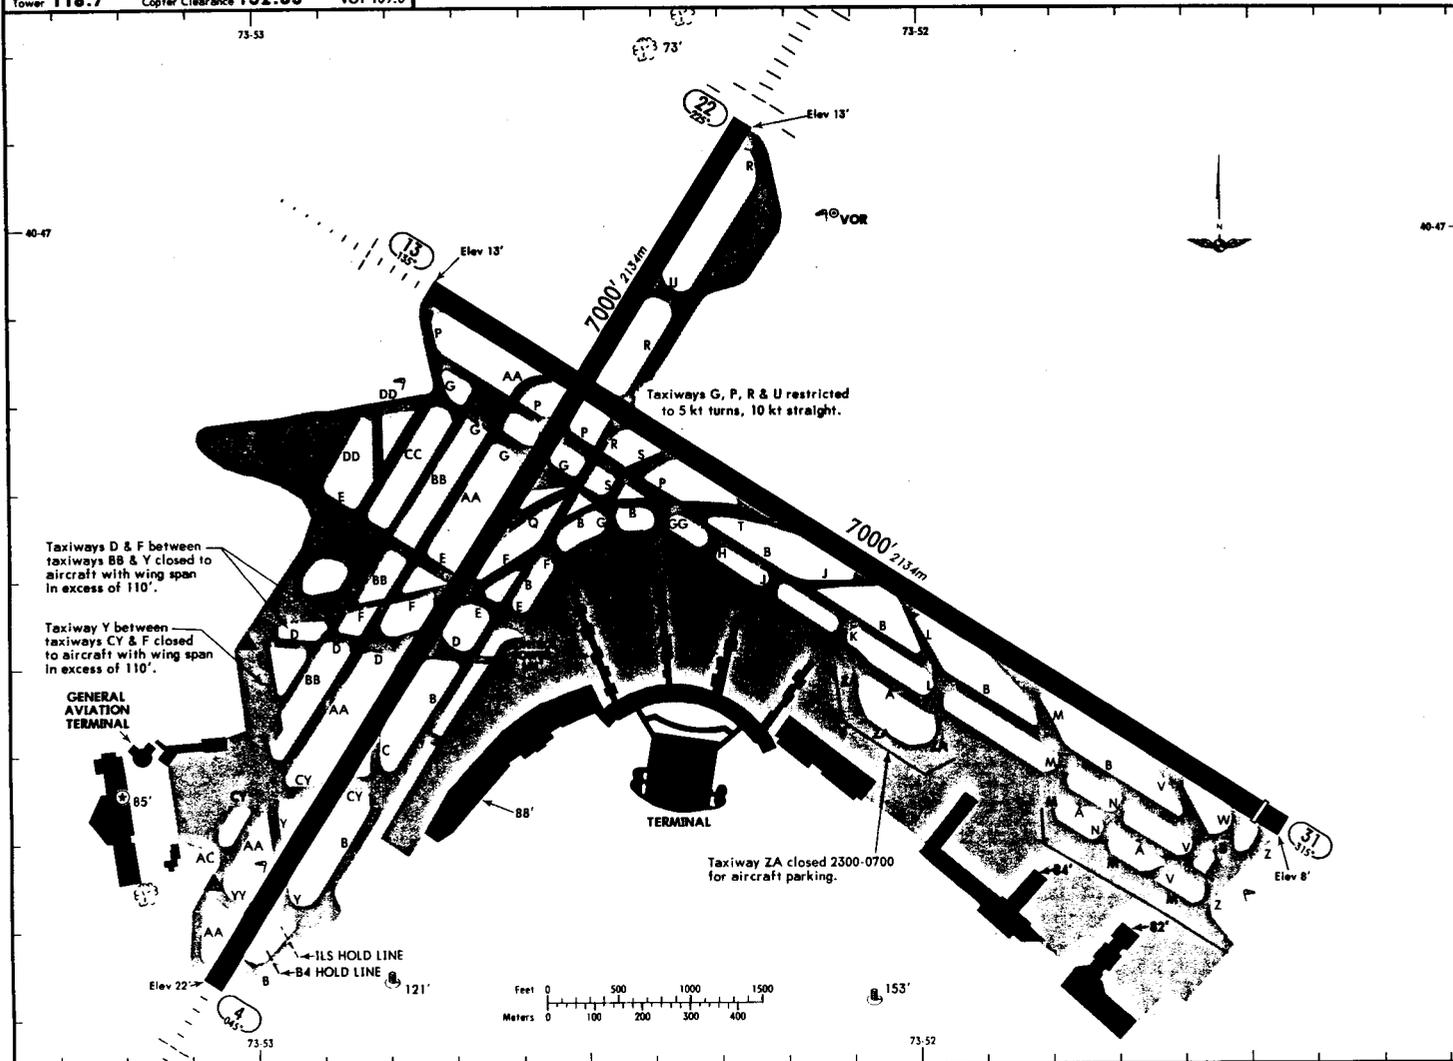
Figure 3—Diagram of LaGuardia Airport
(Reproduced with permission of Jeppesen Sanderson, Inc.)

LaGuardia Airport is located in Flushing, New York, and has an airport elevation of 22 feet.³⁰ The airport is served by runway 4/22, which is oriented north-northeast/south-southwest and runway 13/31, which is oriented northwest/southeast. The runways are 7,000 feet long and 150 feet wide, grooved paved surfaces, and constructed of asphalt and concrete. The approach ends of runway 22 and runway 13 extend on an elevated deck above the Rikers Channel portion of Flushing Bay. The extended portion of the runways is constructed of asphalt and concrete laid out on steel piers, the approach end of which is covered by orange and white plywood panels that extend vertically toward the water. Runways 22 and 13 are equipped with approach lighting systems built on stanchions and accessible by catwalks, which extend farther into the bay from the end of the runway deck. During postaccident interviews, the LaGuardia airport manager stated that the airport "[does] a lot in a small area,³¹ [but we] feel the physical constraints of its size." Refer to figure 3, "Diagram of LaGuardia Airport."
