Aircraft Accident Report

SILKAIR FLIGHT MI 185

BOEING B737-300

19 DECEMBER 1997

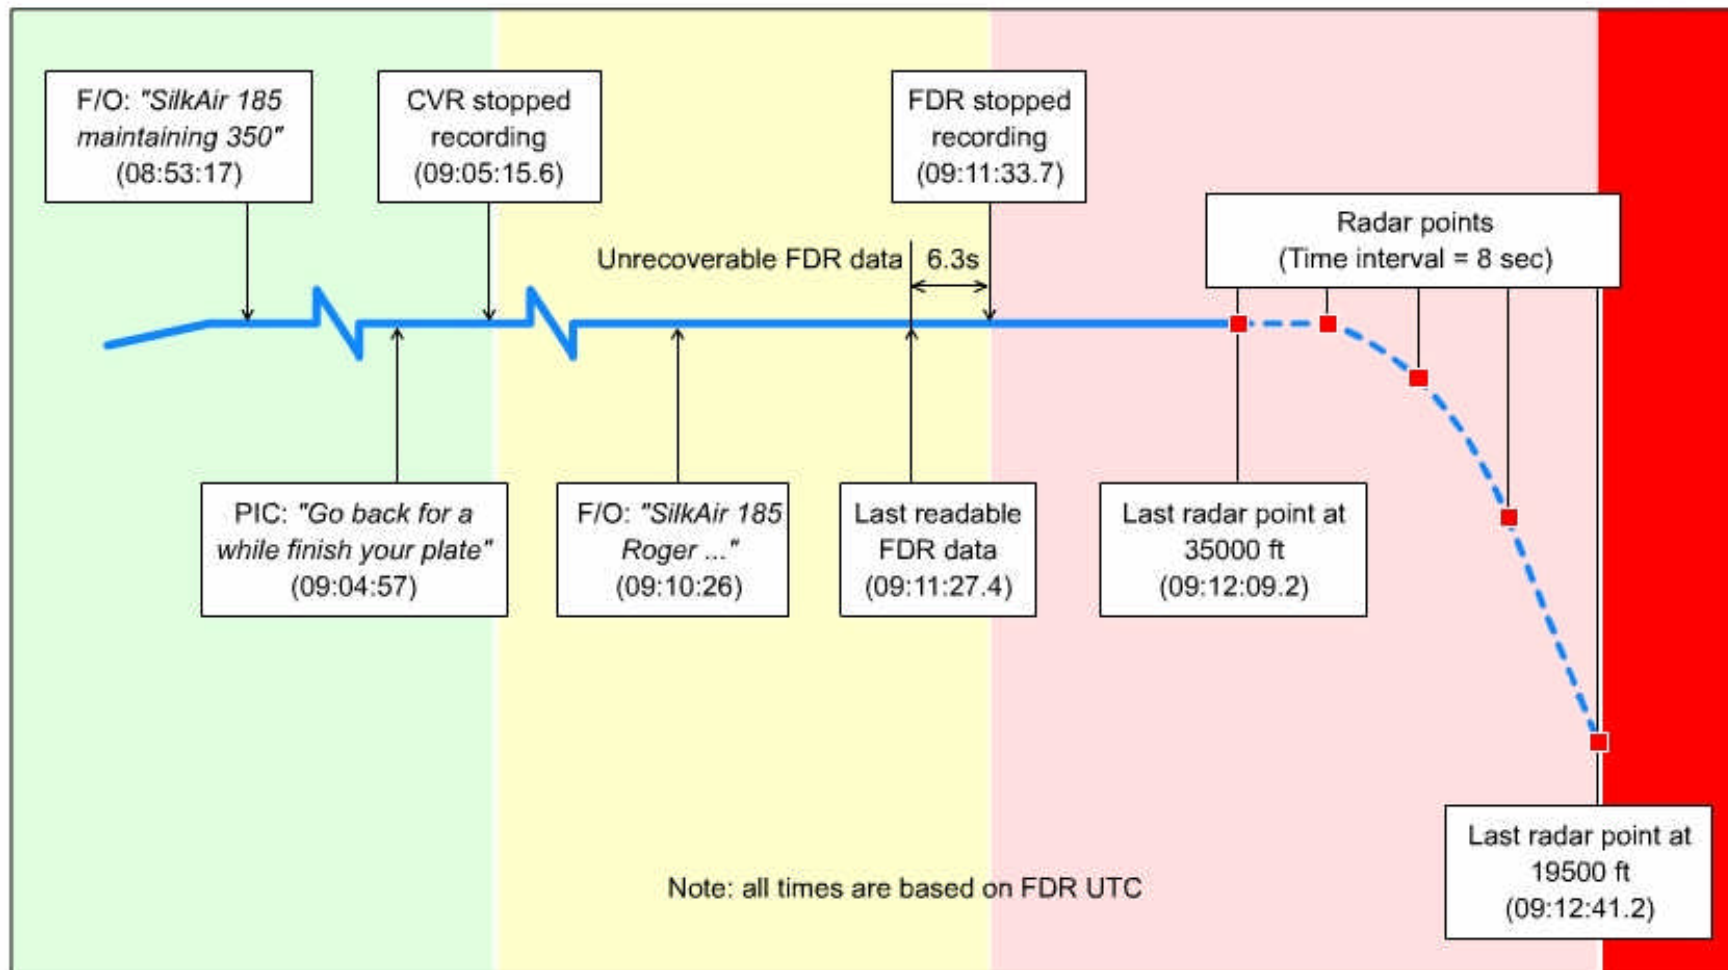
Figure 2 - Sequence of Events

The FDR stopped recording at 09:11:33.7, or 6 minutes and 18.1 seconds after the CVR stoppage, and approximately 35.5 seconds before the aircraft started its descent, see Section 1.11.1 and Figure 2. Data recorded by the FDR indicates that the flight was normal until the FDR stoppage time. It was concluded that until the stoppage of the FDR, there were no indications of unusual disturbance (e.g. atmospheric turbulence, clear air turbulence, or jet stream upsets, etc.) or other events affecting the flight.

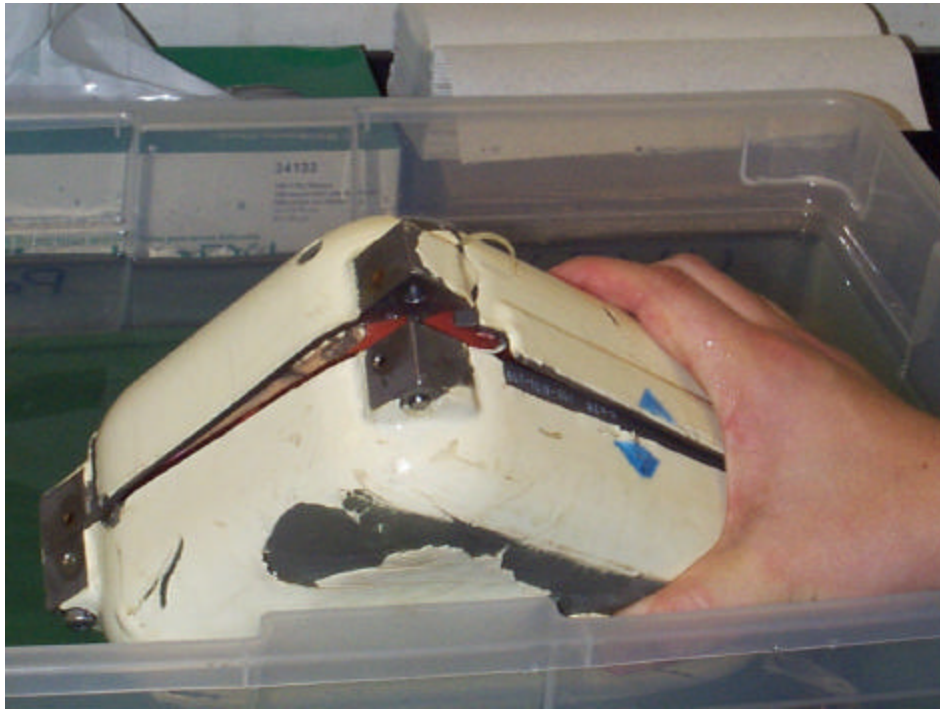
Figure 4.a Flight Data Recorder with an opening corner

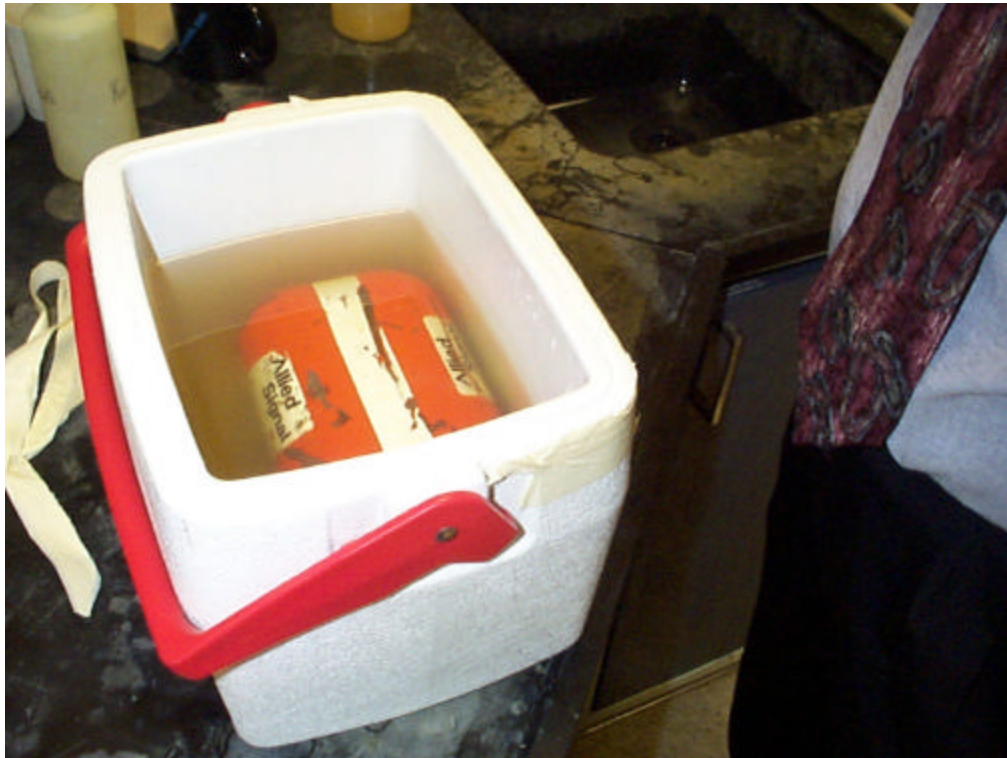
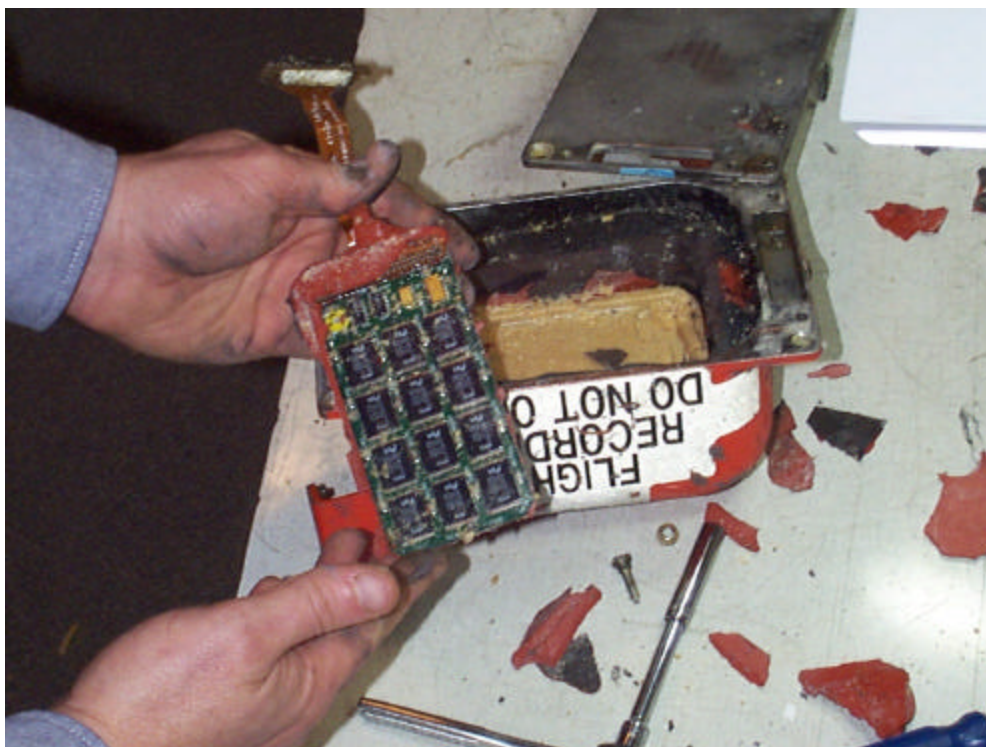
Figure 5.a Solid State CVR Module immersed in the river water

Figure 5.b Memory module of the Solid State CVR

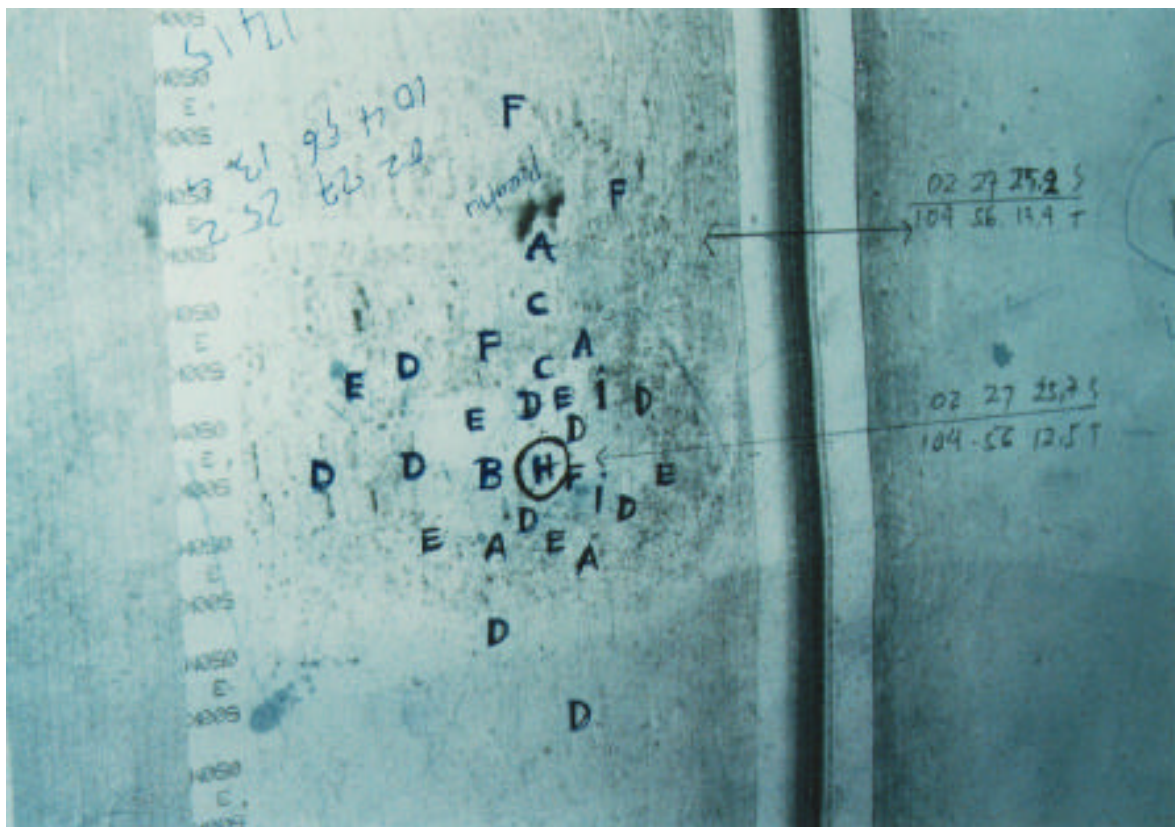
Figure 6.c Sonar photo of the debris distribution buried in the river bottom

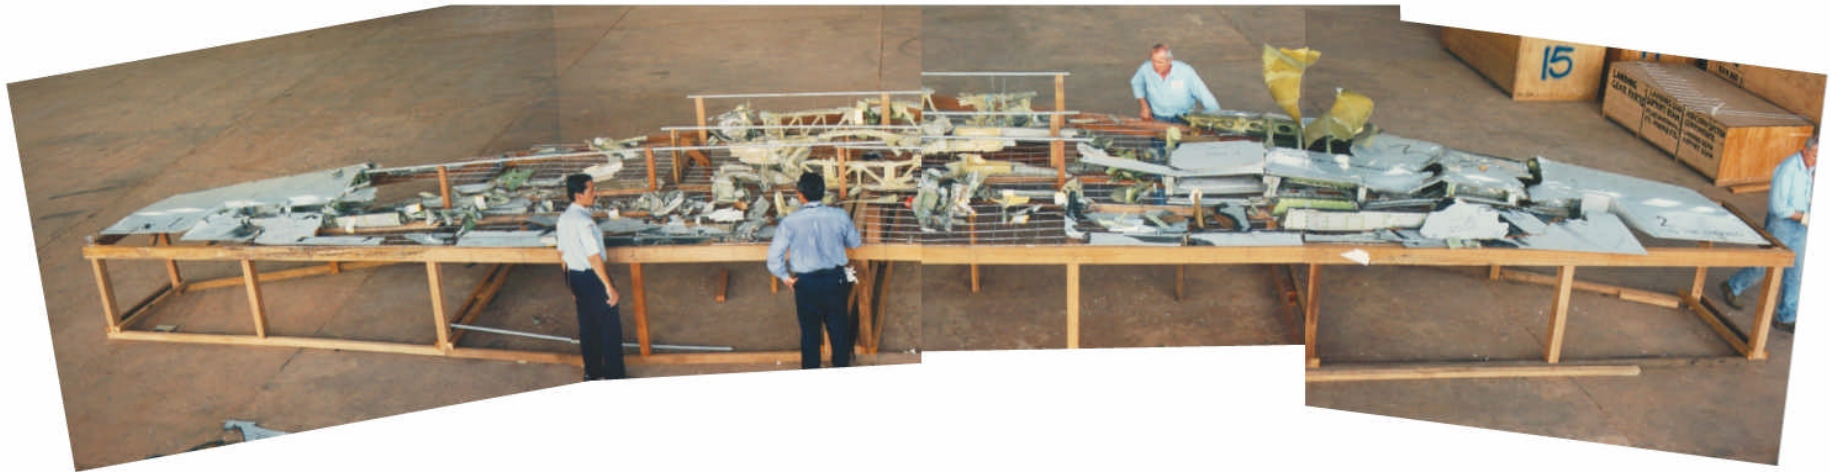
Figure 11 Picture of the reconstructed empennage

A wooden structure was constructed to mount parts of the horizontal stabilizer and elevators in their respective positions. The reconstruction facilitated documentation of the wreckage and the deformation of the pieces that had separated in-flight. The reconstruction work was done in a hangar in Curug near Jakarta, in March 1998. The reconstructed empennage is shown in Figure 11.

The parts of the horizontal stabilizer center section (“Texas Star”) were recovered in the river and were found broken due to impact, see Figure 11. In the recovered parts no evidence was found which could be attributed to fatigue failure.

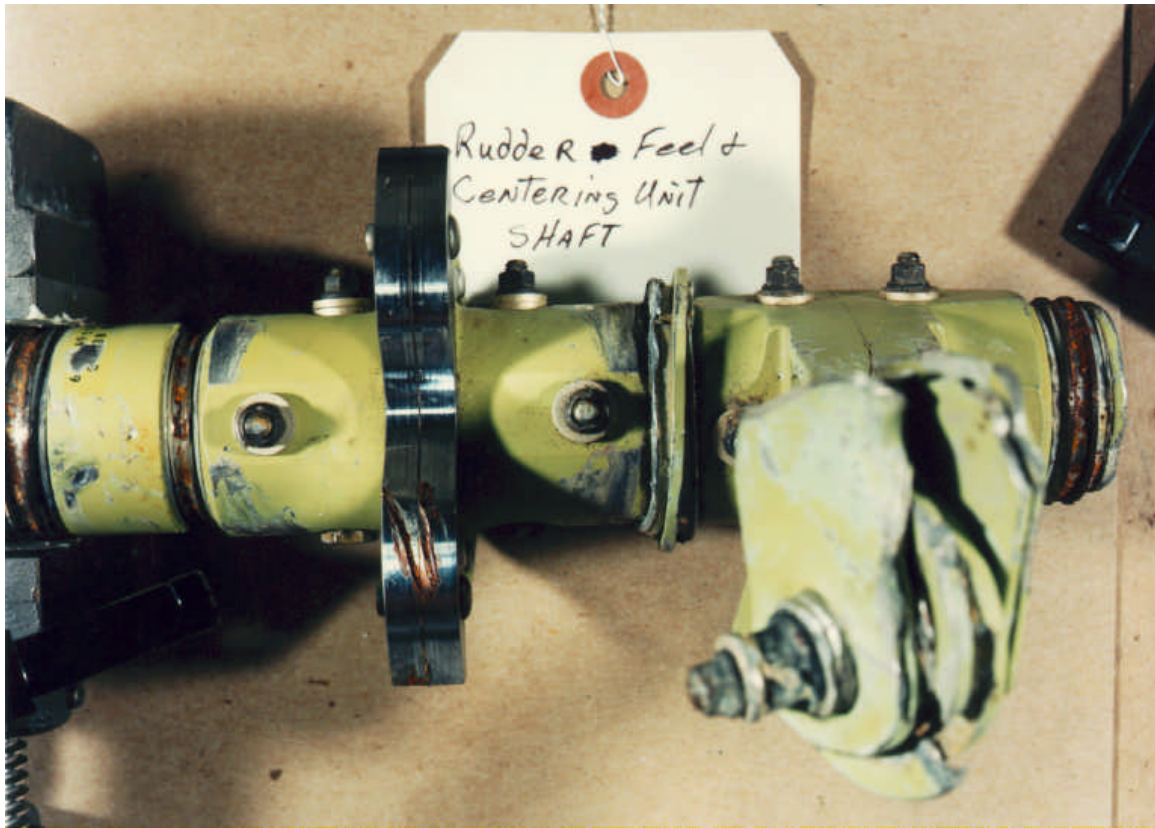
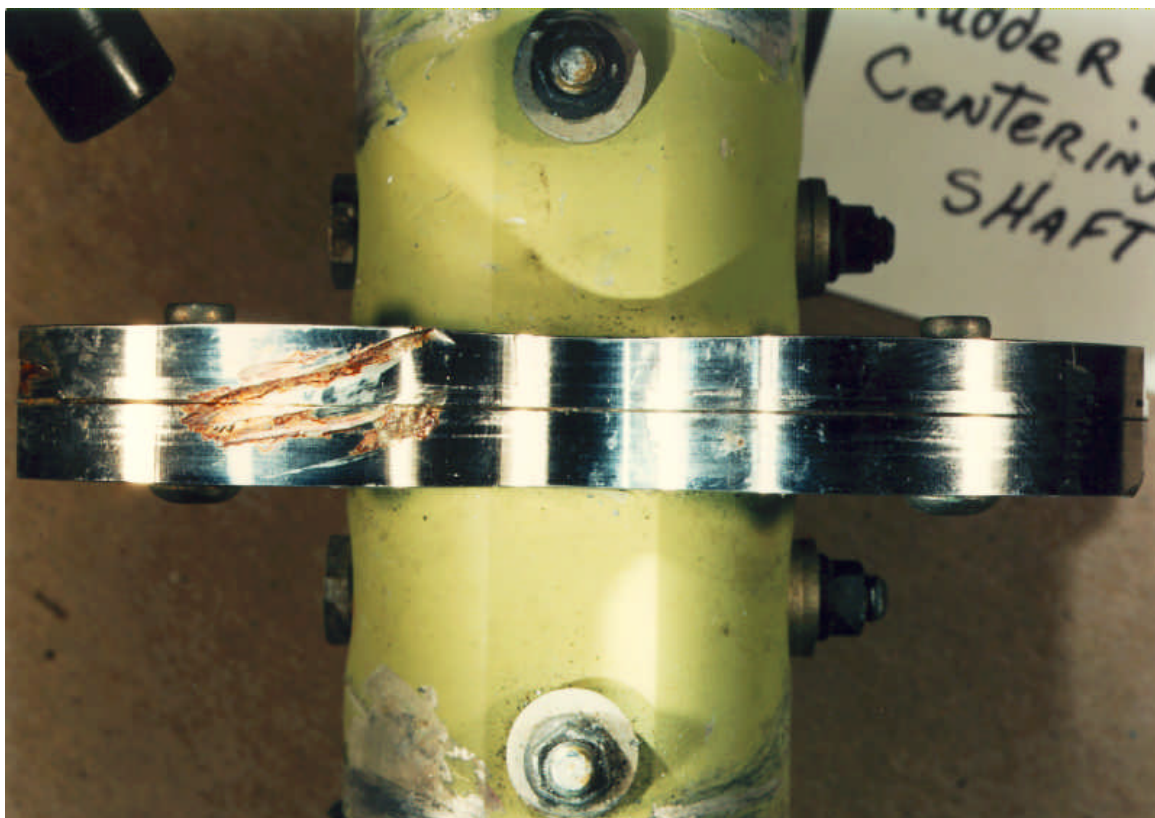
Figure 12 Picture of the impact marks at the cam feel centering unit

- d) The rudder trim actuator (*Item 14* in Appendix E) was found to be close to neutral.
- e) The cam of the feel and centering unit (*Item 22* in Appendix E) had impact marks indicating a left rudder deflection, (Figure 12).

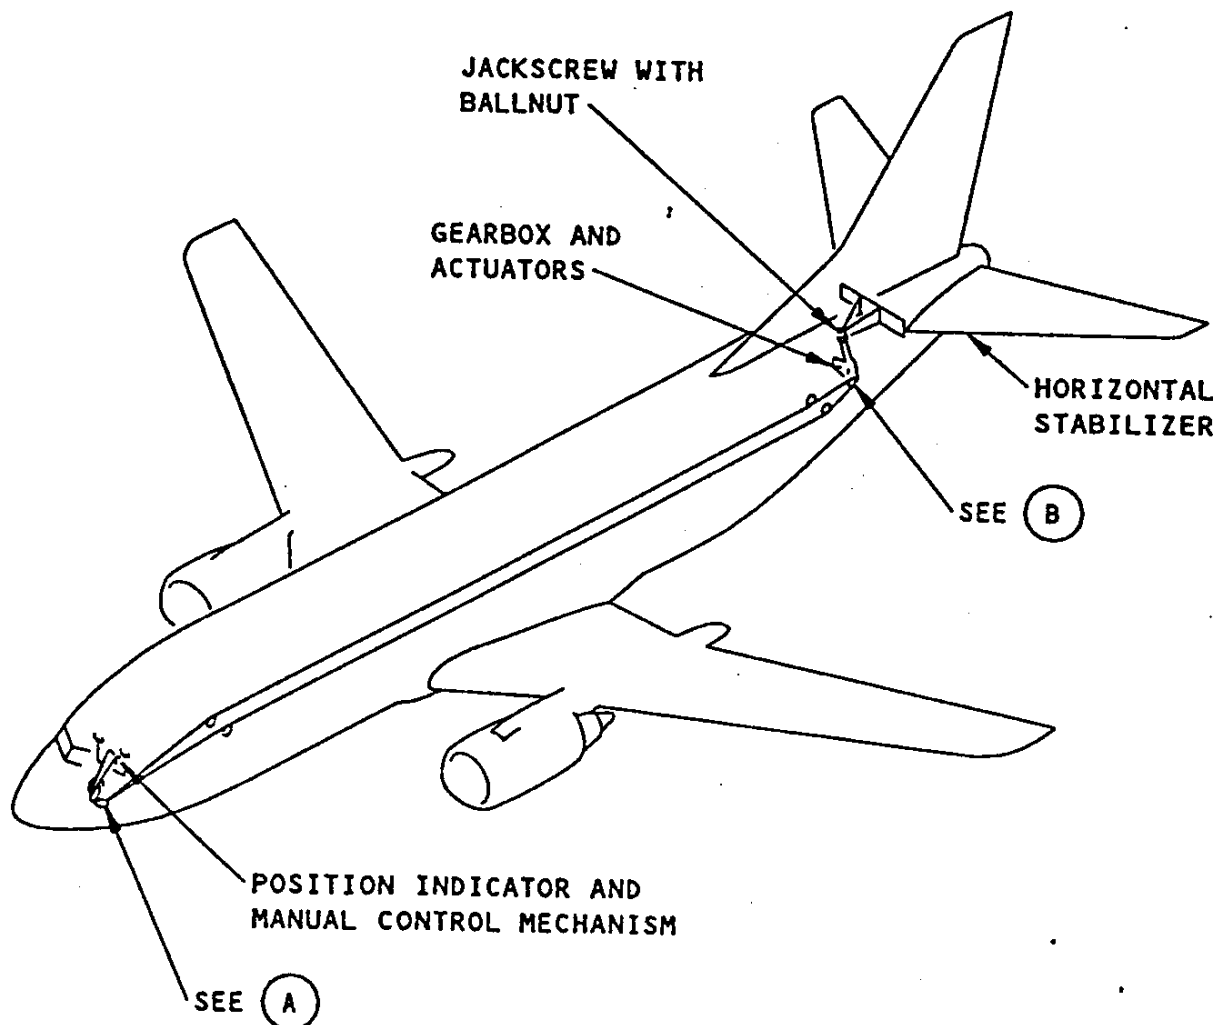
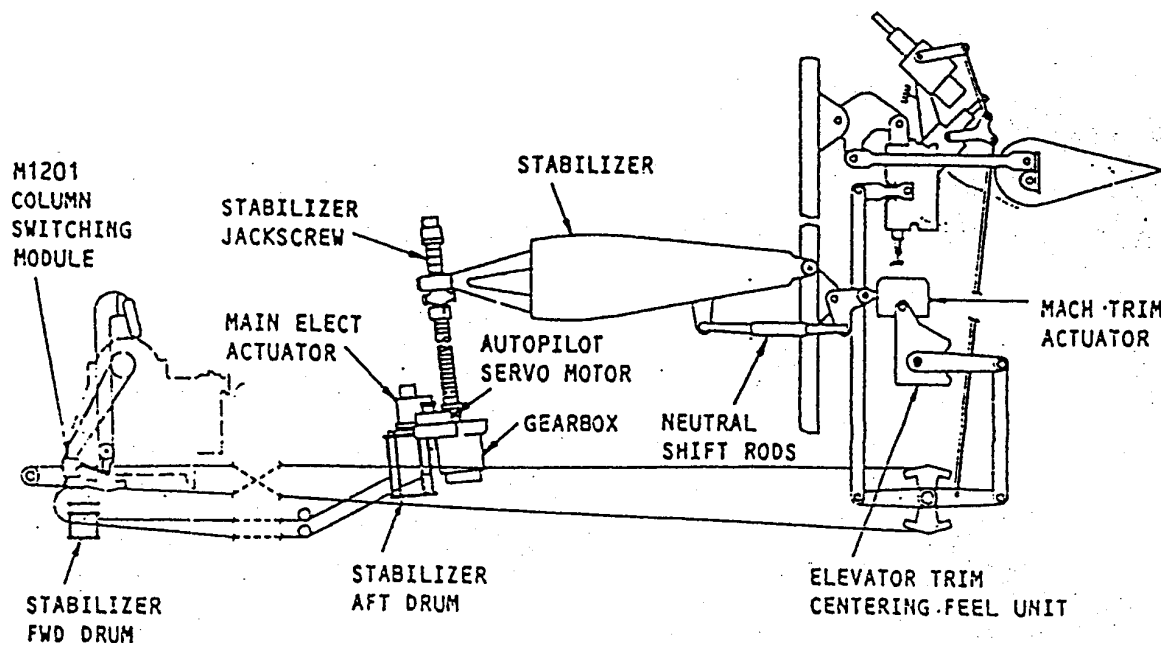
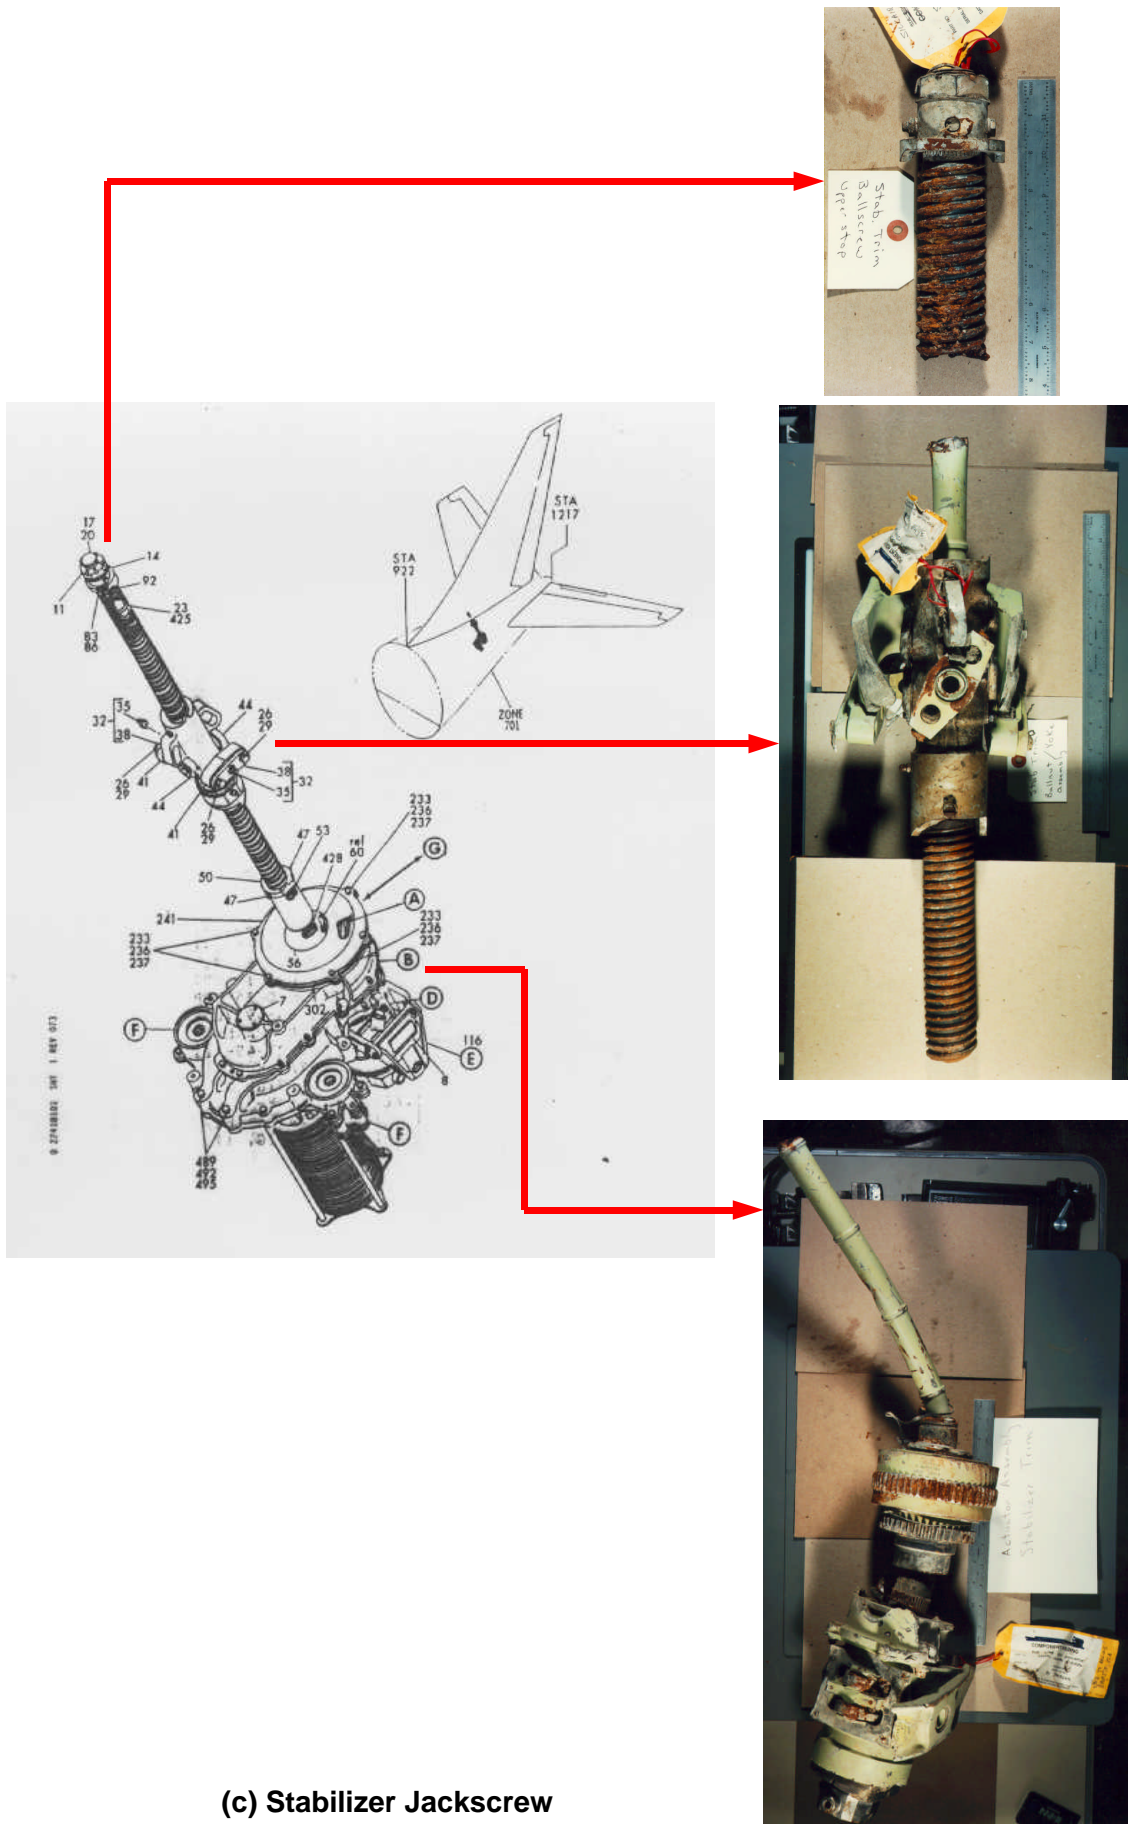
Figure 13 Horizontal Stabilizer Trim

- i) Horizontal stabilizer jackscrew (*Item 23* in Appendix E) – The pictures of the broken jackscrew are shown in Figure 13. The jackscrew ball-nut was found in a horizontal stabilizer trim position of 2.5 units, equivalent to 0.5 degree horizontal stabilizer

⁴ Relation between reading in units and deflection in degrees is given as follows: $x \text{ units} = x \text{ degrees} + 3$. According to the sign convention, deflection of horizontal stabilizer leading edge up means negative, and leading edge down means positive (see Figure 13).

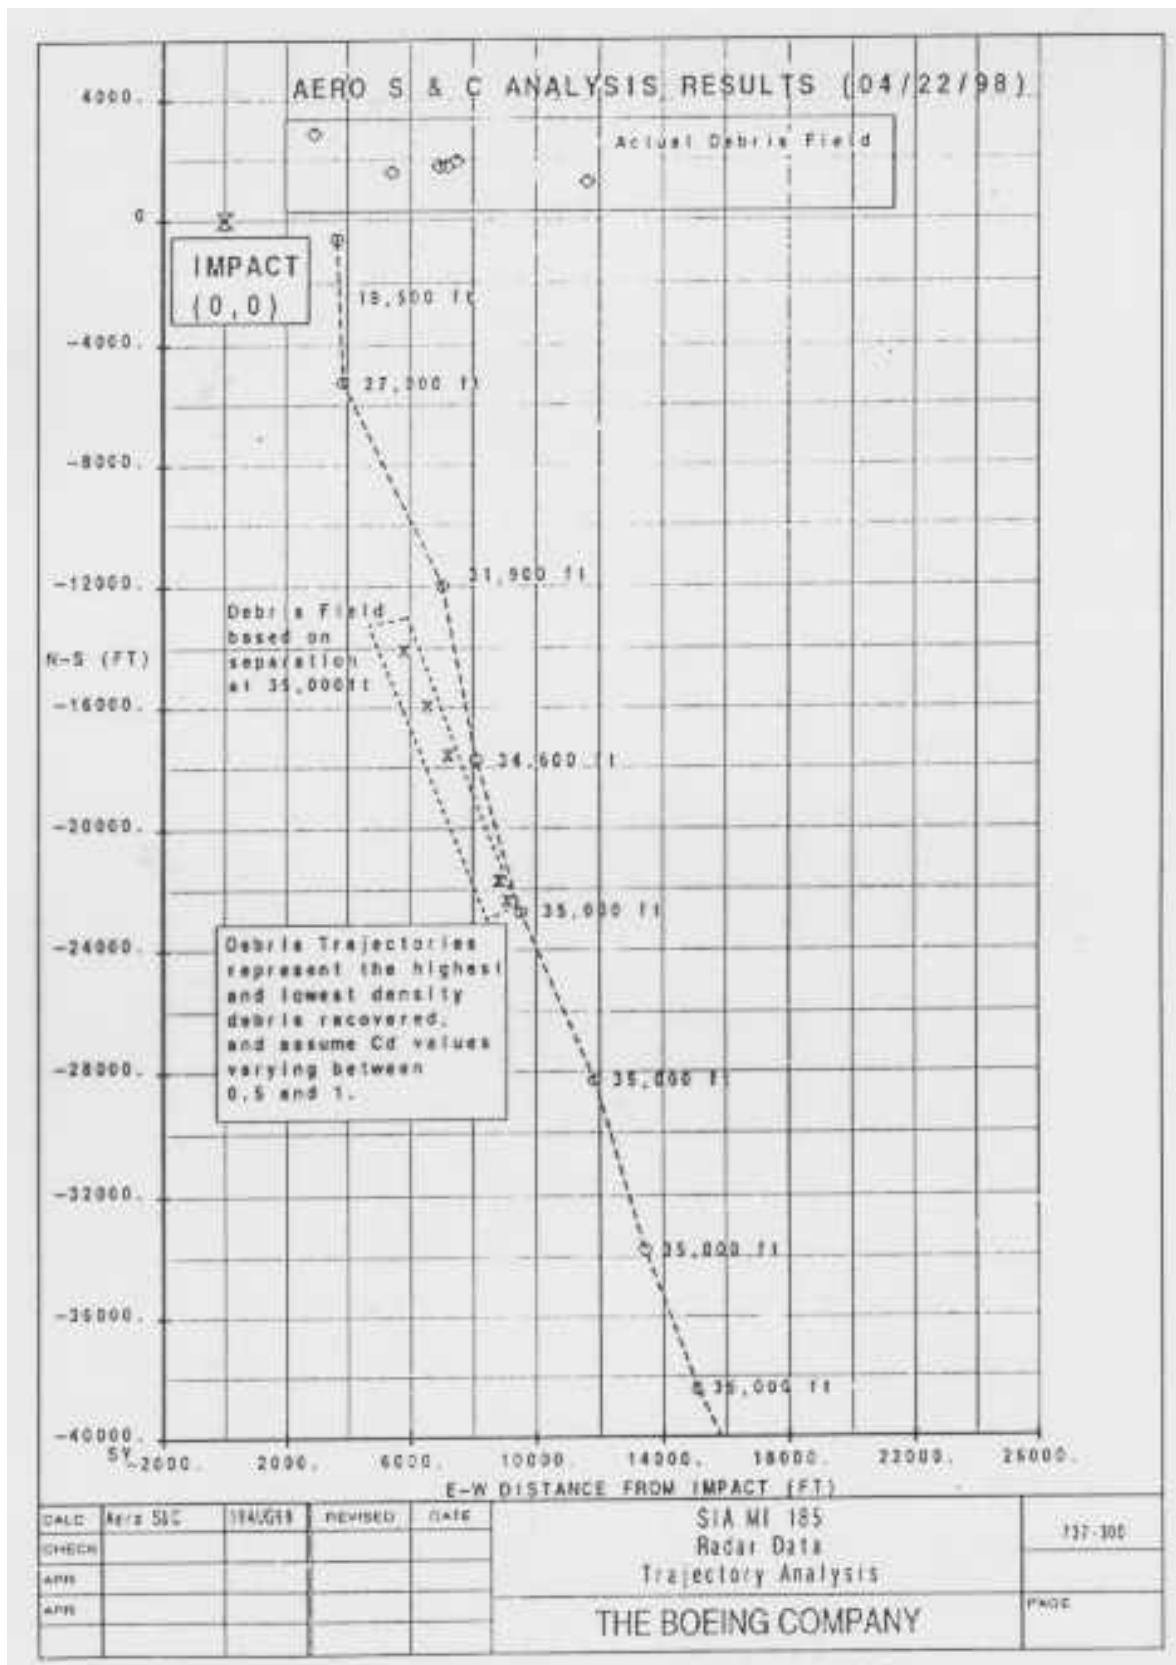
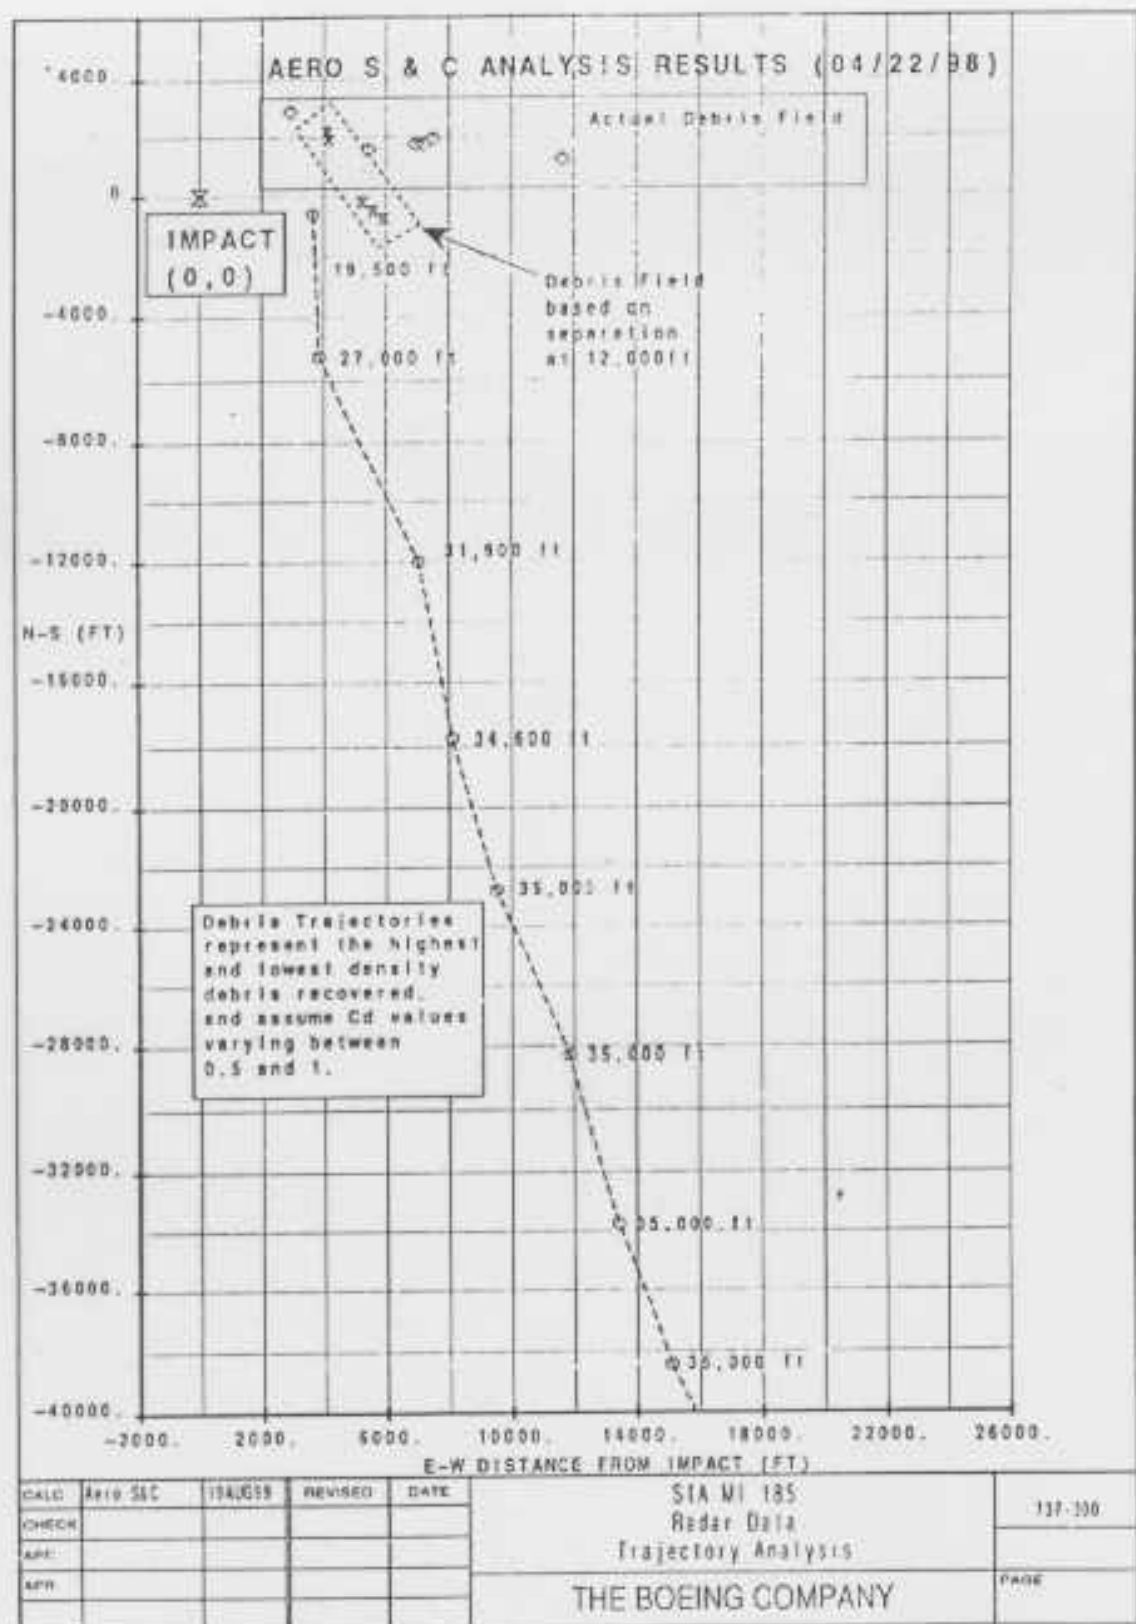
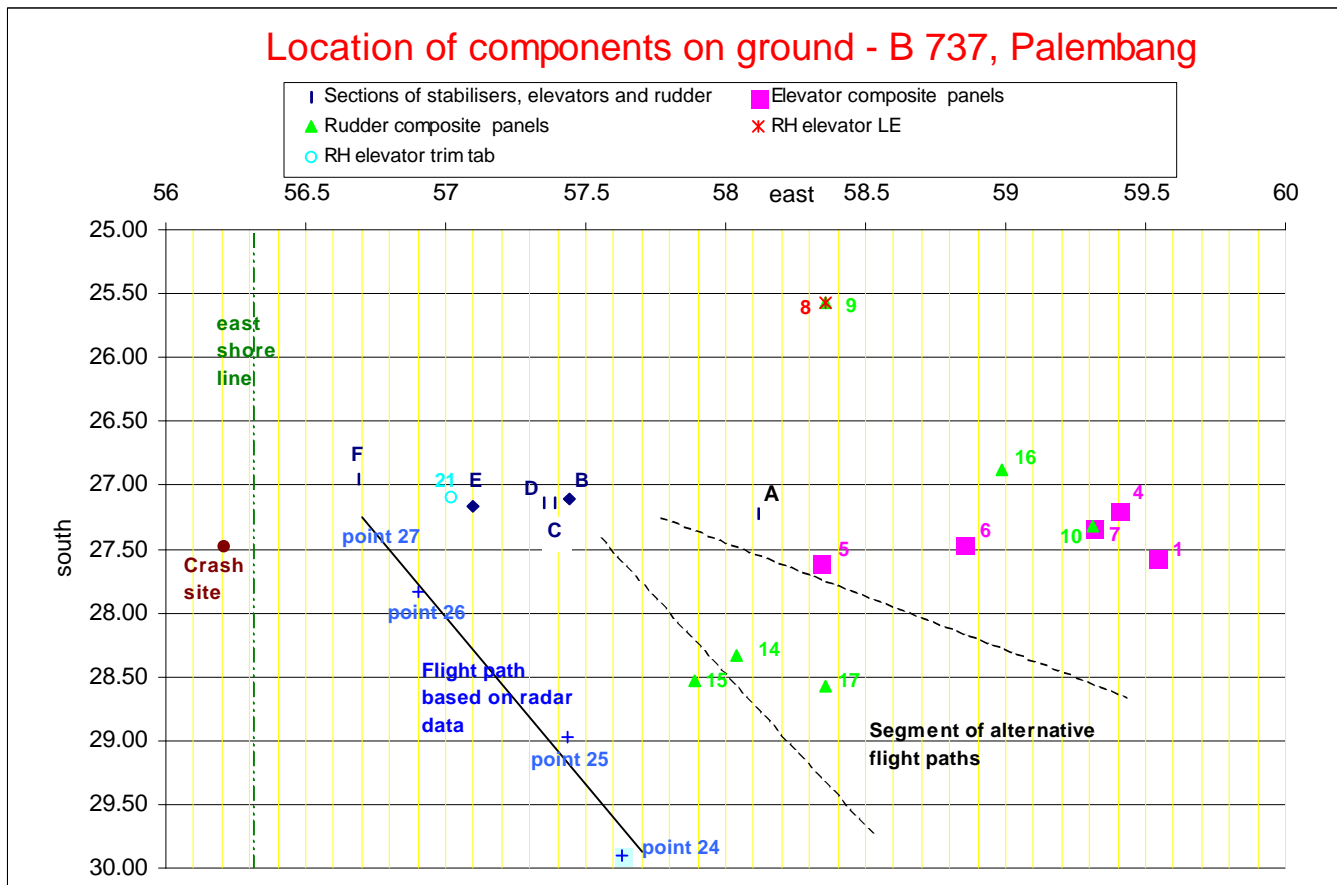
Figure 14 Diagram of debris distribution analysis

Both studies, see Figure 14, were based on the theory that the trajectory of a separated object was determined by its initial condition at the time of separation, such as mass, speed, heading, altitude and its aerodynamic characteristics as well as the wind direction.

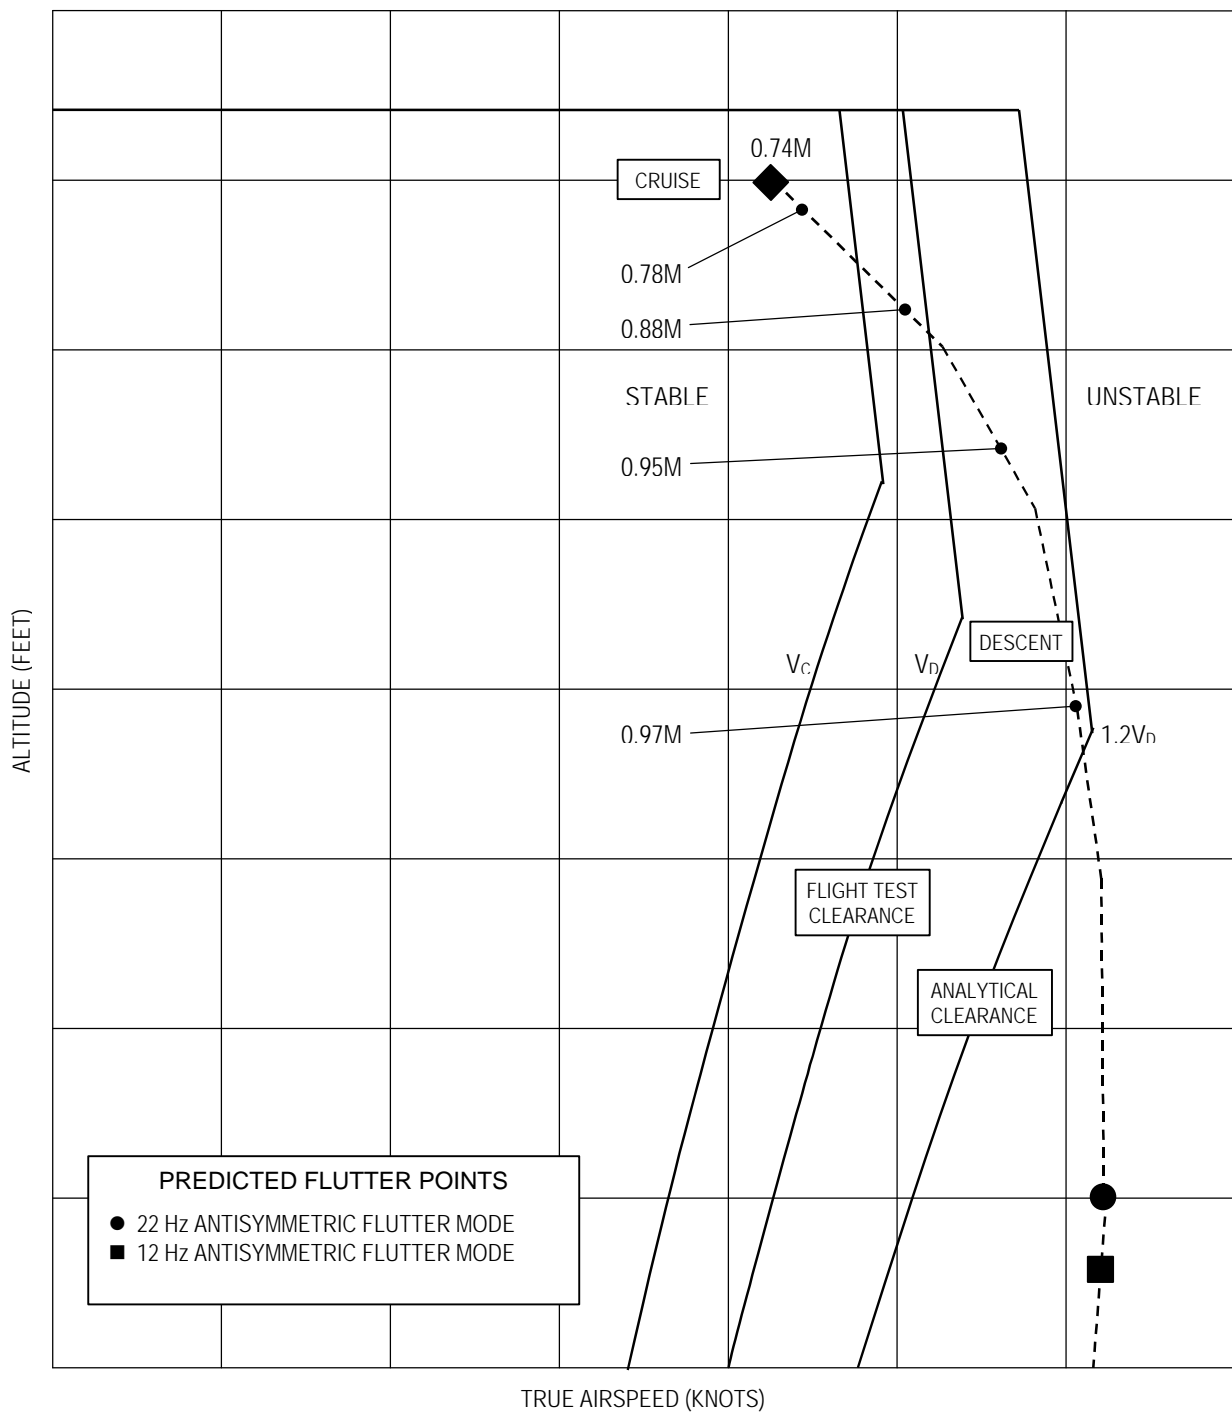
Figure 15 Diagram of Boeing B737 Flutter Flight Envelope

- During descent from 20,000 feet to ground impact
The applied static loads are less than the design ultimate load envelope and do not support separation of the empennage during the final descent below 20,000 feet. The estimated descent speed exceeded the 1.2 dive speed V_d analytical flutter clearance speed at approximately 18,000 feet altitude. An onset of an empennage 22 Hz anti-symmetrical flutter mode was calculated to occur later in the descent at approximately 5,000 feet altitude (570 equivalent airspeed in knots-KEAS). A lower frequency 12 Hz anti-symmetrical flutter mode was calculated to occur at approximately 3,000 feet altitude (600 KEAS), see Figure 15.

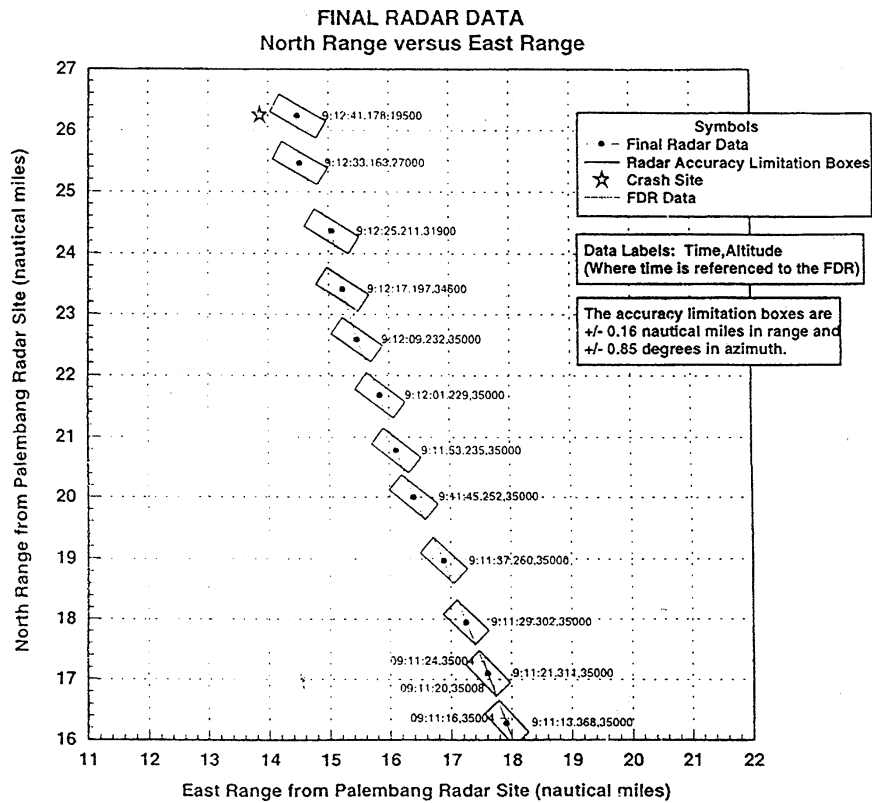
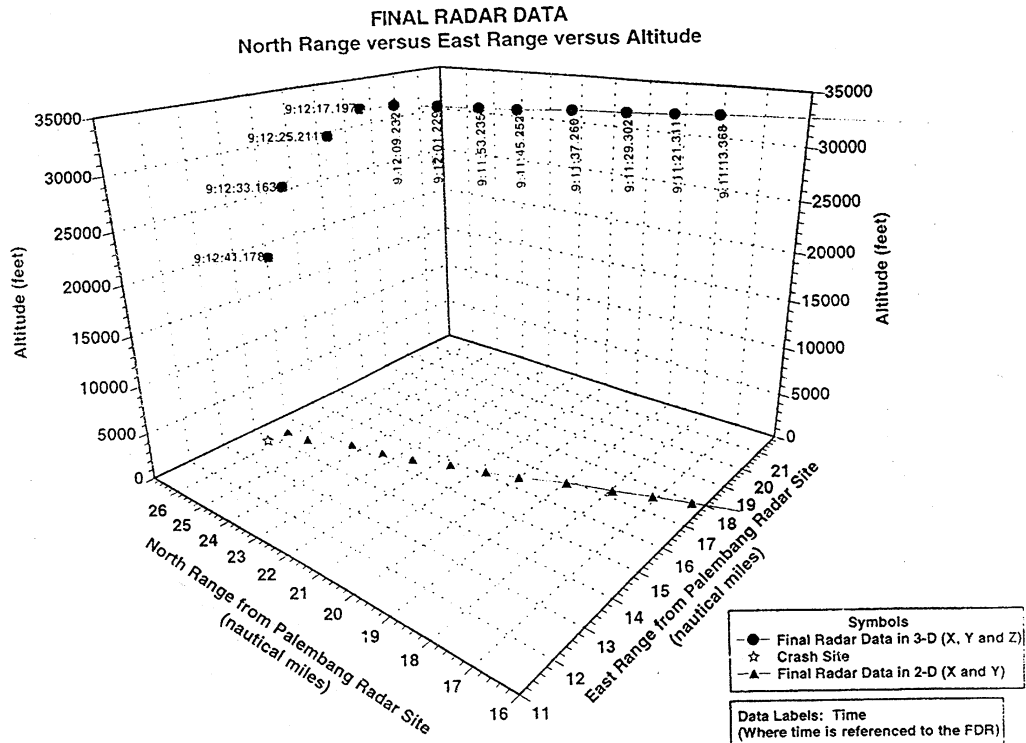
Figure 16 Corrected Radar Data

The radar data and information retrieved from the GUARDIAN system was further examined and corrected, by Boeing as well as NTSB, focusing particularly on the last twelve radar returns. Based on this final radar data, the aircraft flight path and its ground track projection was reconstructed, see [Reference 18] and (Figure 16).
