Aircraft Accident Report

**Loss of Control and Impact with Pacific
Ocean Alaska Airlines Flight 261
McDonnell Douglas MD-83, N963AS
About 2.7 Miles North of
Anacapa Island, California
January 31, 2000**

**NTSB/AAR-02/01
PB2002-910401
Notation 7263E
Adopted December 30, 2002**

The National Transportation Safety Board determines that the probable cause of this accident was a loss of airplane pitch control resulting from the in-flight failure of the horizontal stabilizer trim system jackscrew assembly's acme nut threads. The thread failure was caused by excessive wear resulting from Alaska Airlines' insufficient lubrication of the jackscrew assembly.

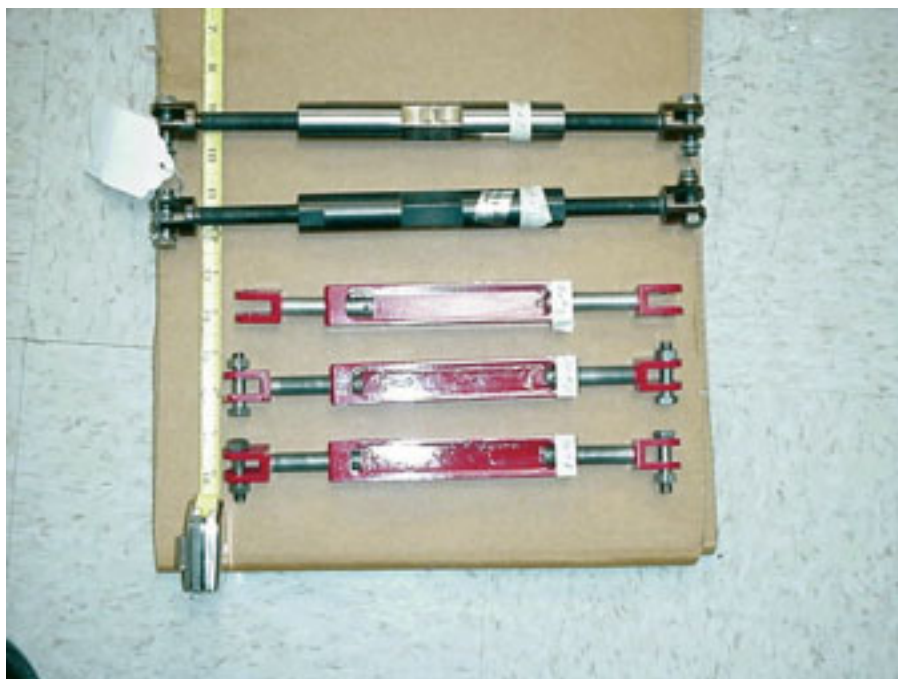
Figure 10. Two Alaska Airlines-fabricated restraining fixtures and three Boeing-manufactured fixtures.

During the investigation, Safety Board investigators conducted several on-wing end play checks using both restraining fixtures fabricated by Alaska Airlines⁹⁰ and those manufactured by Boeing. Examination of the restraining fixtures indicated that none of the fixtures manufactured by Alaska Airlines met Boeing’s engineering drawing requirements for the fixtures. During several of these tests, the restraining fixtures fabricated by Alaska Airlines yielded lower end play measurements than the measurements obtained using the Boeing-manufactured fixture.⁹¹ Figure 10 shows two of the restraining fixtures fabricated by Alaska Airlines and three of the fixtures manufactured by Boeing.

⁹¹ Discrepancies up to a maximum of about 0.005 inch were recorded.

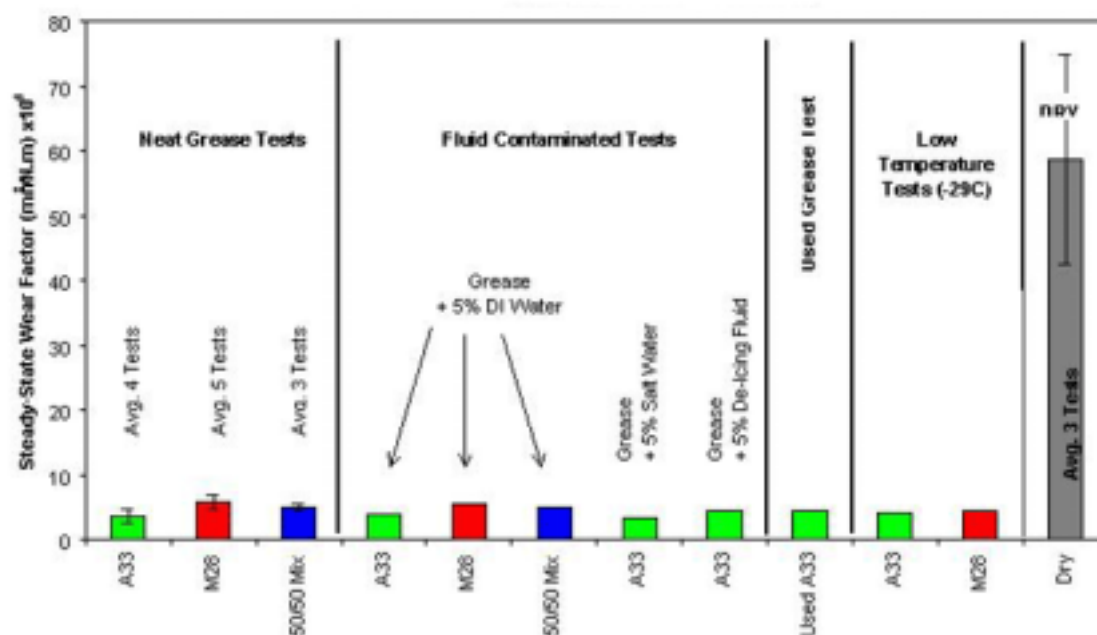
Figure 19. A summary of the results of the high-load wear tests, including the contamination and low-temperature tests.

The results of the wear tests showed that, in all ranges of contact pressure, lower wear rates were generated when Aeroshell 33 was used than when Mobilgrease 28 was used. Additionally, the effects of contamination, aging, and subzero temperature exposure were determined to have little effect on the lubricating effectiveness of Aeroshell 33. Only the tests run without any lubrication generated wear rates significantly higher than those generated when Mobilgrease 28 was used. In these cases, wear rates were seen to transition up to 10 times higher than those with equivalent conditions lubricated with Mobilgrease 28. Figure 19 shows a summary of the results of the high-load wear tests, including the contamination and low-temperature tests.
