AIRCRAFT ACCIDENT REPORT
ASC-AAR-02-04-001

**CRASHED ON A PARTIALLY
CLOSED RUNWAY DURING TAKEOFF
SINGAPORE AIRLINES FLIGHT 006
BOEING 747-400, 9V-SPK
CKS AIRPORT, TAOYUAN, TAIWAN
OCTOBER 31, 2000**

AVIATION SAFETY COUNCIL

Crashed on a Partially Closed Runway during Takeoff, Singapore Airlines Flight 006,
Boeing 747-400, 9V-SPK, CKS Airport, Taoyuan, Taiwan, October 31, 2000

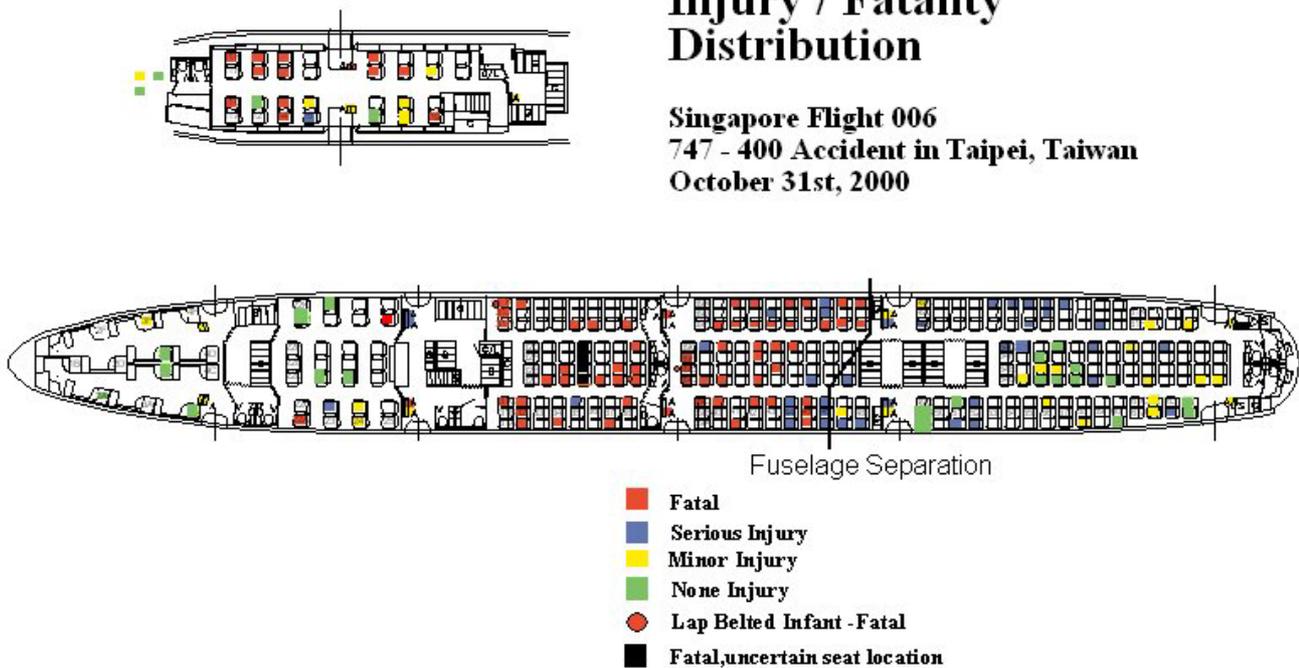
Figure 1.2-1 Injury/fatality distribution

The following diagram (Figure 1.2-1) shows the passenger seat positions and the severity of injuries that they sustained. The information on the passenger seat position was from the airline-seating plan and from interviews with passengers. Some passengers changed seats; therefore, Figure 1.2-1 might not accurately reflect the actual seating positions at the time of the accident.

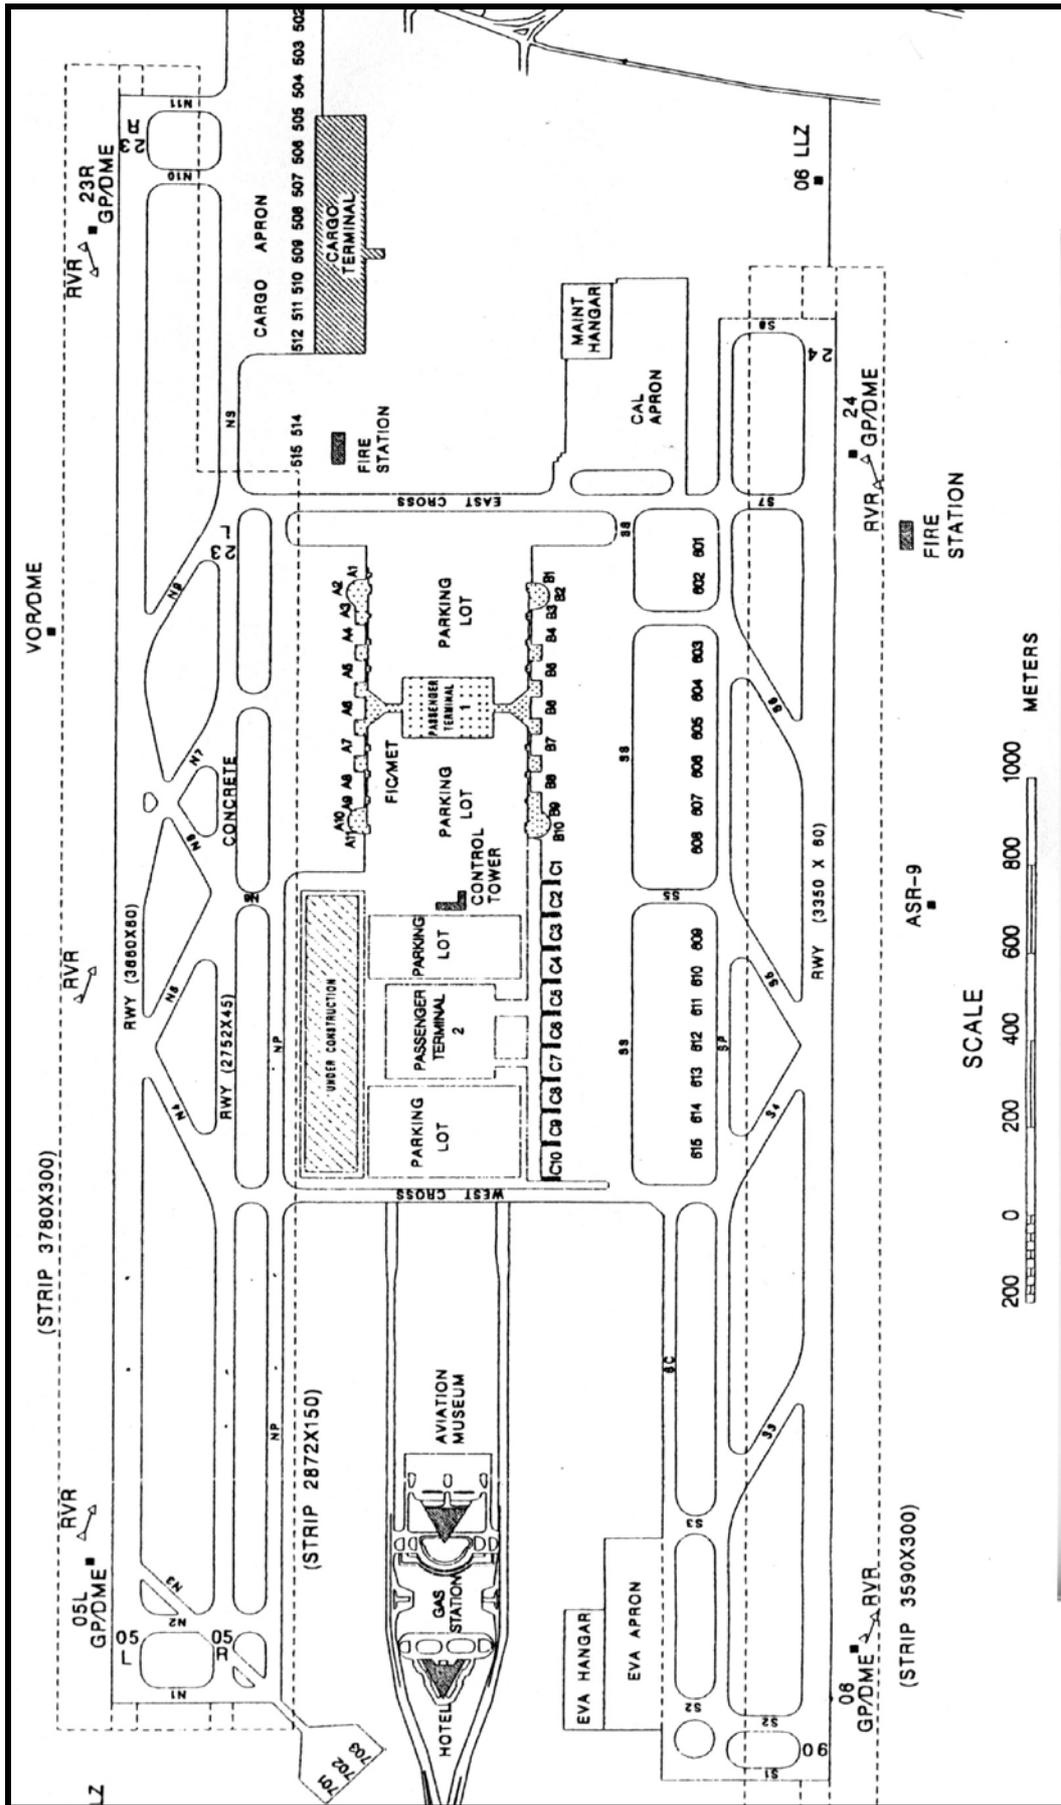
Figure 1.10-1 Layout of CKS Airport

According to the CAA officials, the CKS Airport Runway 05R had been planned to be re-designated as Taxiway NC. The re-designation schedule was postponed due to a material procurement delay. In the meantime, the pavement between Taxiway N4 and Taxiway N5 of Runway 05R was closed for repair. Runway 05R was still a runway with its remaining portion used for aircraft taxi operations at the time of SQ006 accident.

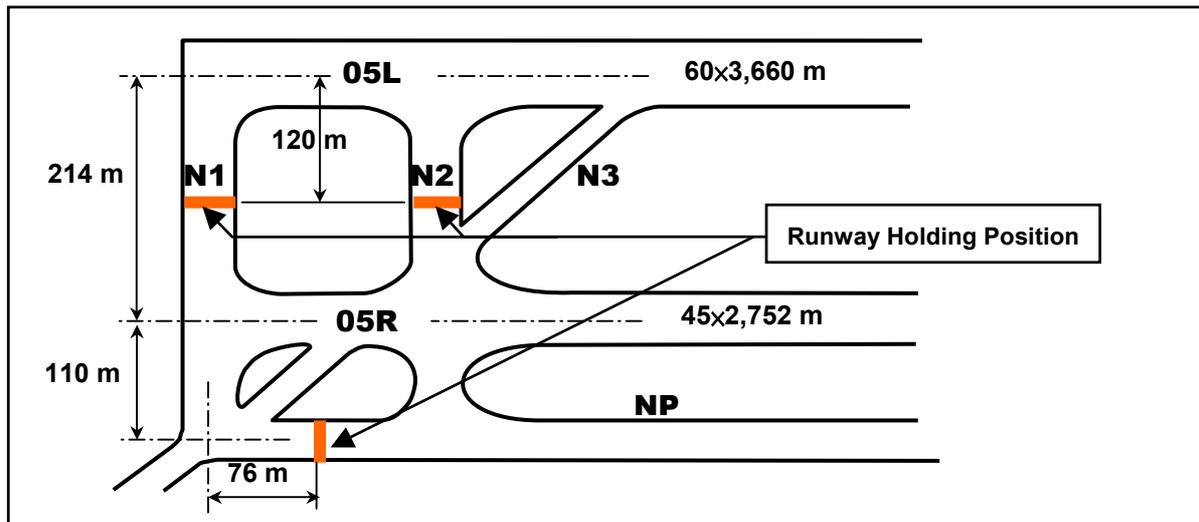
Figure 1.10-2 Distance of runway holding positions (not to scale)

A third runway holding position is located on Taxiway NP, 76 meters east of Taxiway N1 centerline. The locations of the runway holding positions and the actual marking are shown in the Figures 1.10-2

According to ICAO Annex 14, vol. 1 paragraph 3.11.6, Table 3-2, the minimum distance from the runway centerline to a runway holding position for a non-instrument / takeoff runway is 75 meters and for a runway serviced with a precision approach, the distance is 90 meters, or an appropriate distance necessary to protect the critical/sensitive areas of ILS/MLS. Standards and Recommendation for runway holding position marking are described in ICAO Annex 14, vol. 1, paragraph 5.2.9.2, 5.2.9.3 and 5.2.9.5 respectively.

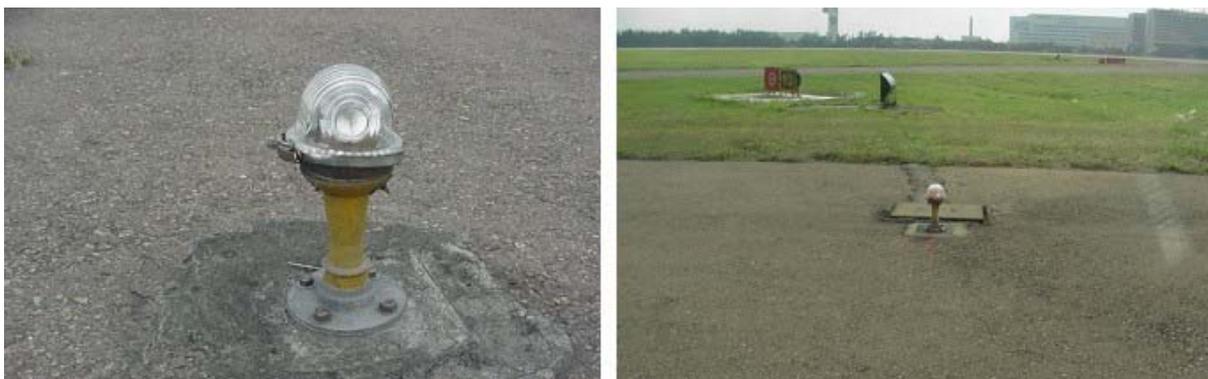
Figure 1.10.8 Runway 05R/23L edge lights

Runway edge lights (Omni direction with bi-directional converging lens) were provided for both Runway 05L/23R and Runway 05R/23L. These were spaced at between 55-60 meters apart. These lights were of identical make and model (Crouse Hinds L-862 elevated and L-852 inset, FAA specification). The lamps used on the elevated runway edge light fittings were found to be 6.6A/T4Q/CL/2PPF and Philips 6372/200W/6.6A/8L. Figure 1.10-8 shows the runway edge light installations at Runway 05R/23L.

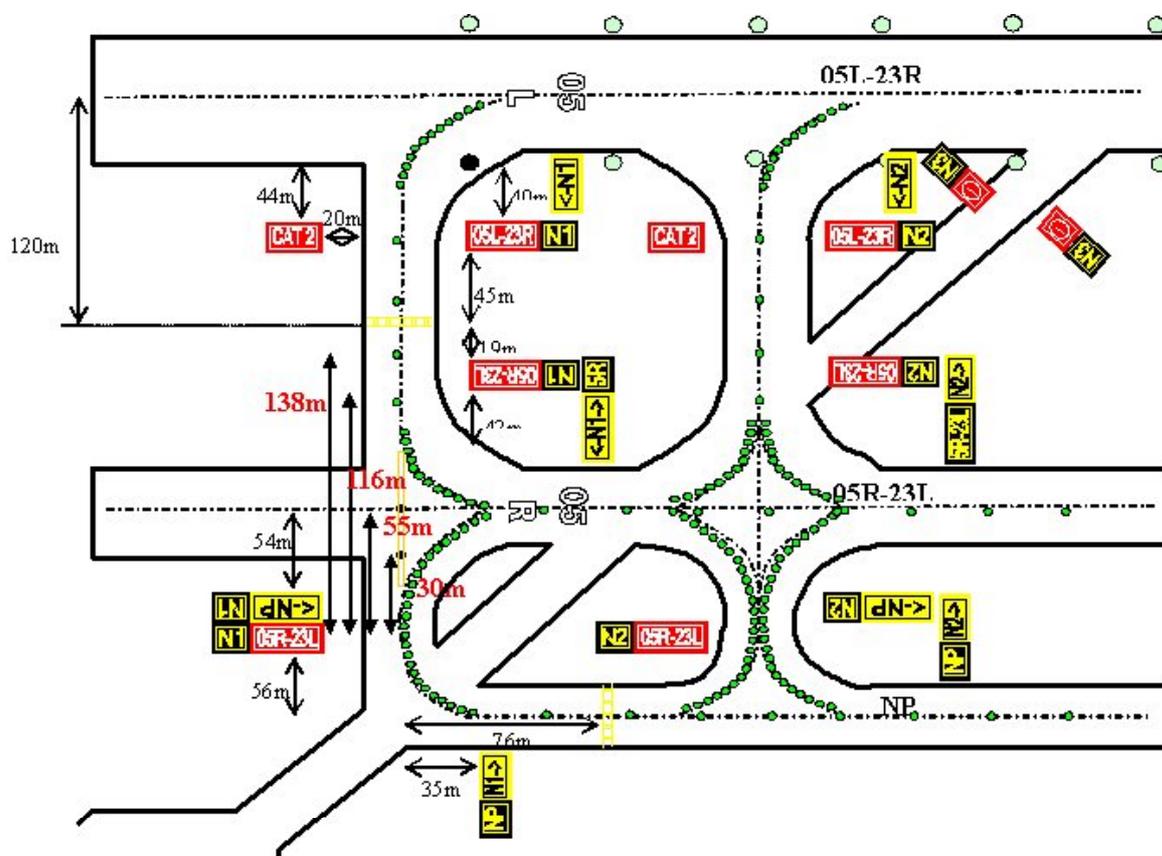
Figure 1.10-9 Taxiway N1 centerline lights spacing

There were no alternate green/yellow taxiway centerline lights on exit taxiways to demarcate the limits of the ILS sensitive area. For an aircraft taxiing along Taxiway NP, the spacing of the green taxiway centerline lights on the straight portion of Taxiway NP was 30 meters. As it turned right into Taxiway N1, the spacing of taxiway centerline lights along the curved section was 7.5 meters up to the point of tangency with the Taxiway N1 centerline. The taxiway centerline lights continued into Runway 05R with a spacing of 7.5 meters up to the point of tangency with the Runway 05R centerline. Beyond that, the spacing of green taxiway centerline lights was 30 meters along Runway 05R/23L. Along Taxiway N1 towards Runway 05L, there were four taxiway centerline lights along the straight segment of Taxiway N1 up to the Runway 05L holding position. These taxiway centerline lights were located at a distance of 30 meters, 55 meters and 116 meters and 138 meters respectively from the point of tangency (where the curved taxiway centerline marking from Taxiway NP meets Taxiway N1). (See Figure 1.10-9)

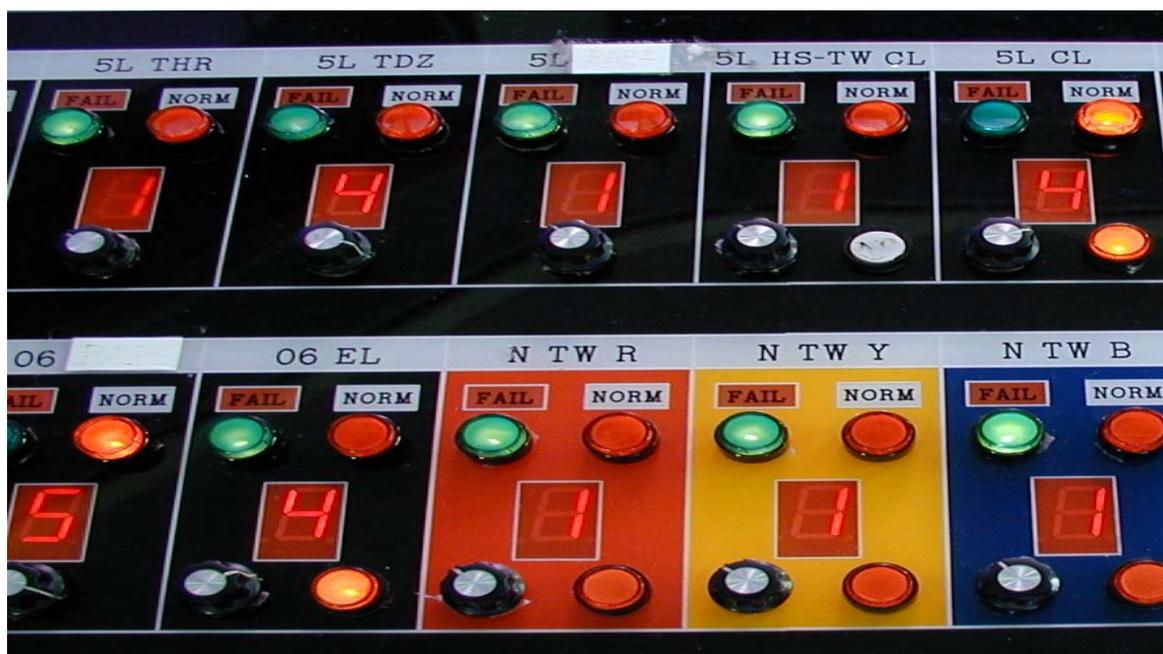
Figure 1.10-13 Airfield lighting control panel in the control tower

The CKS airfield runway and taxiway lighting was controlled from the Control Tower by individual pushbuttons. A knob was provided for each of the circuits to enable the selection of different intensity levels for the airfield lights. Figure 1.10-13 shows the airfield lighting control panel in the control tower.

The lighting system, when installed in 1979, met ICAO Annex 14 SARPs at that time for which light control interlocks were not specified; and although the interlock has since been addressed in revised SARPs, the lighting system at CKS Airport was not equipped with an interlocking device.

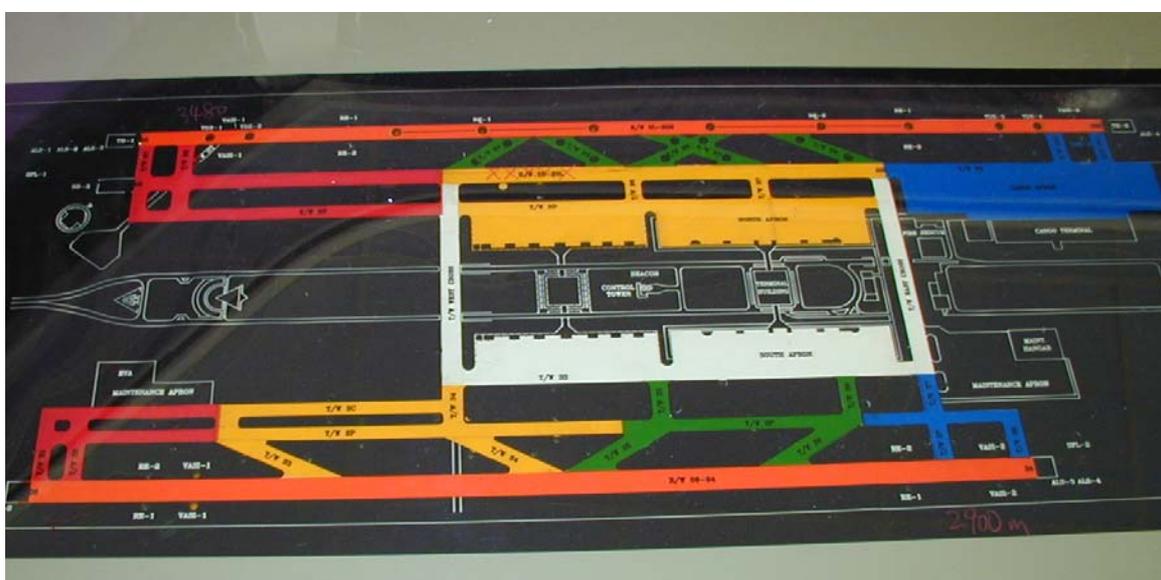
Figure 1.10-14 CKS airfield lighting layout

According to the CKS ATC procedures, no aircraft operations were permitted on Taxiway NP when Runway 05R/23L was being used for takeoff operations. Simultaneous use of the Runway 05R edge lights and the taxiway centerline lights on that runway was not permitted. Because the Runway 05R and taxiway lights did not have an interlock, the ATC ground controller and the tower controller would coordinate and manually select the appropriate lights for the specific operation being conducted on the runway. (See Figures 1.10.13 and 1.10.14 for airfield lighting control panel and layout)

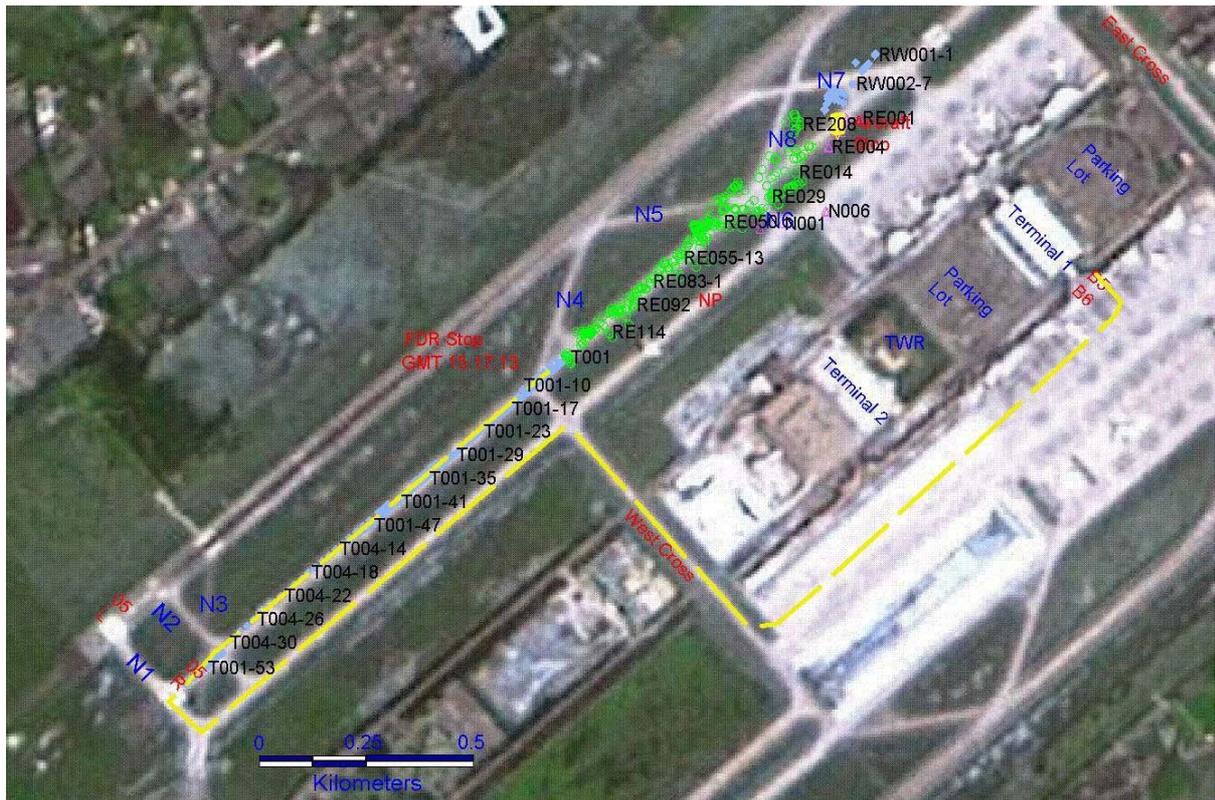
Figure 1.11-1 The combination of FDR data, site survey data, and the satellite map

Figure 1.11-1 shows the smoothed latitude and longitude position of the FDR data (yellow line), based on the related satellite image with respect to taxiways and runways. It also shows the ground scars and the wreckage distribution from the site survey.

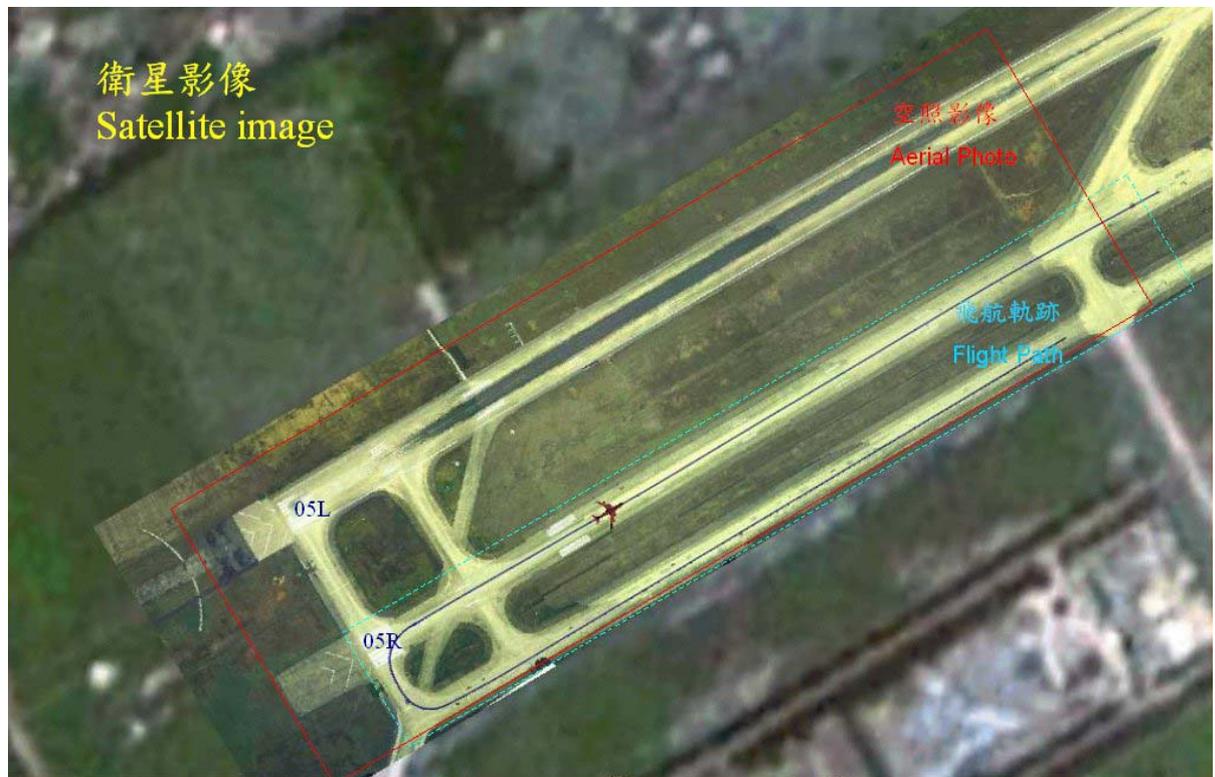
Figure 1.11-2 SQ006 superposition of flight path and digital map

The Safety Council combined the satellite map, CVR audio and FDR data to create a 3D animation using RAPS. Due to limitations of recorded latitude and longitude position, the Safety Council used the ground speed, magnetic heading, and drift angle to compute the ground track of the aircraft. The aerial photography was also used to correct the position of the aircraft's flight path (See Figure 1.11-2).

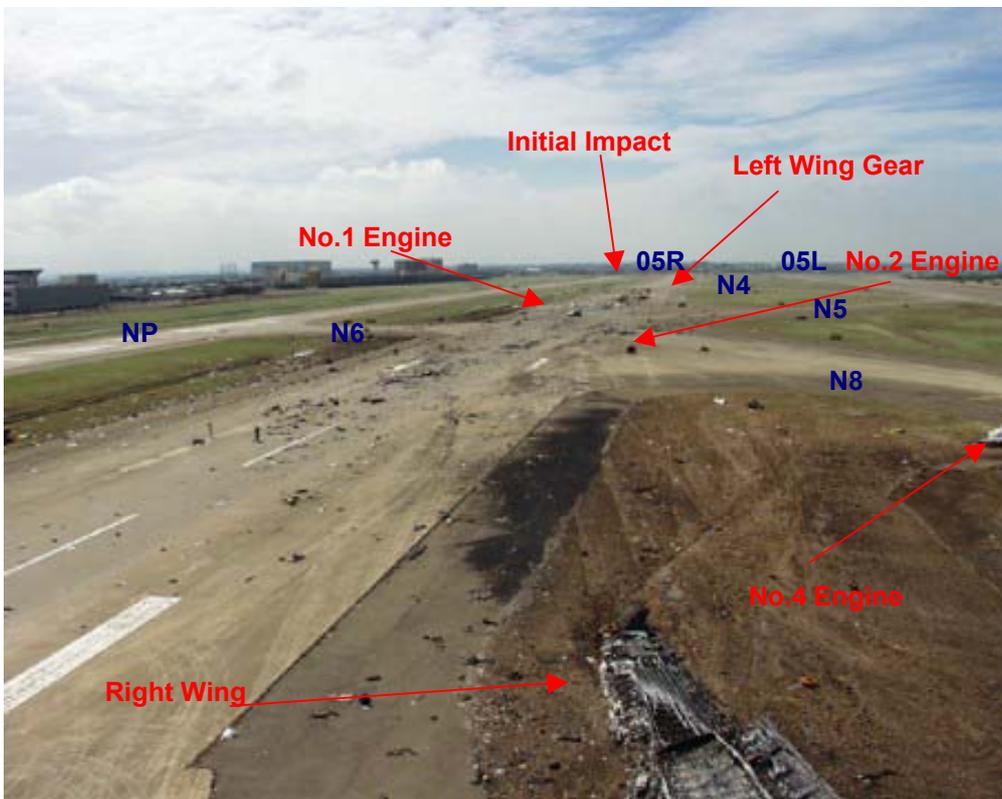
Figure 1.12-4 Wreckage distribution as seen opposite from the flight path

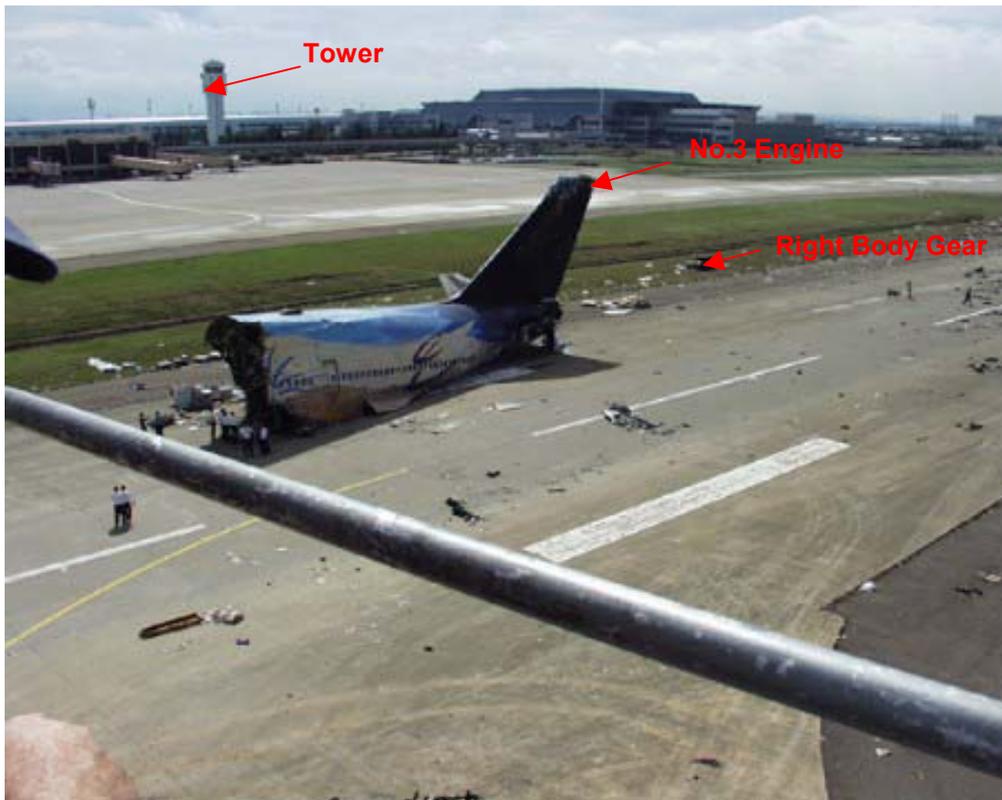
Figure 1.12-5 Wreckage distribution towards the end

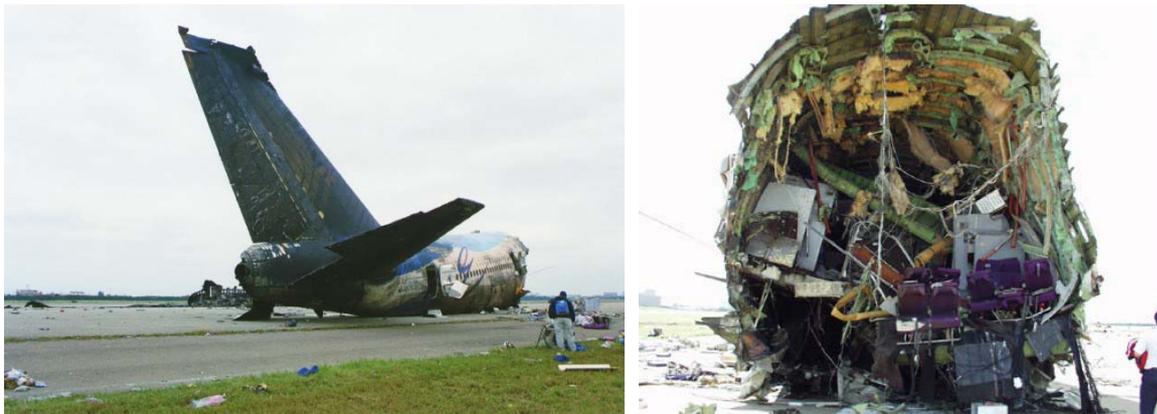
Figure 1.12-8 Aft portion of the aircraft

The vertical stabilizer was blackened by fire but was still attached to the fuselage. The upper portion had broken off.

There were no longitudinal scrape marks on the lower skin on Body Section 48.

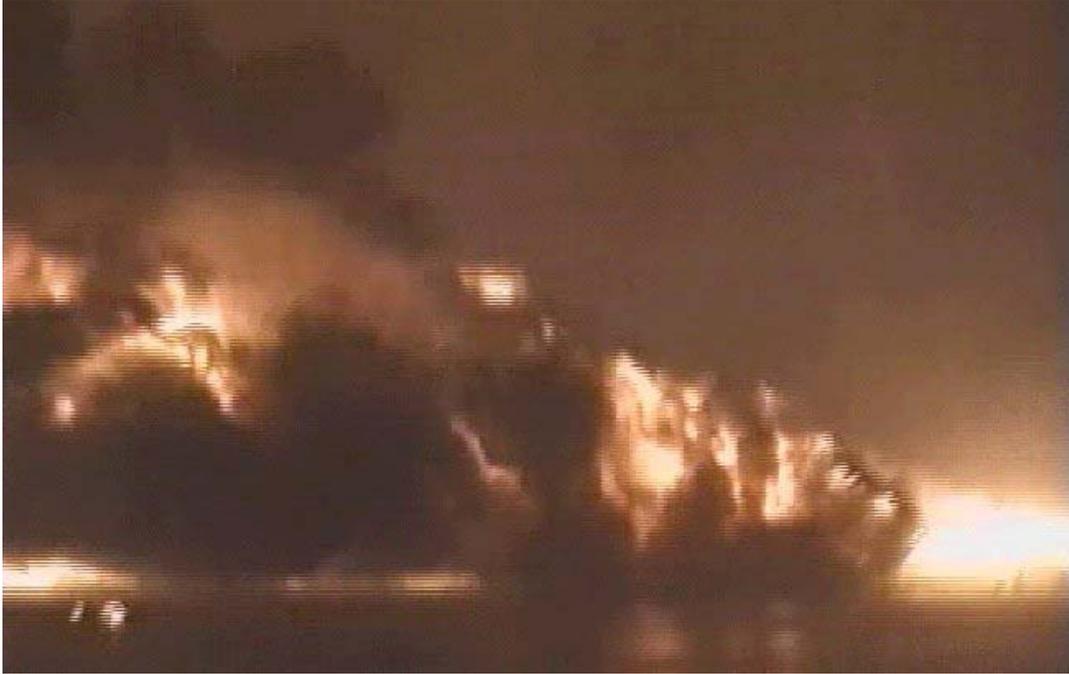
Figure 1.15-1 The heavy fire areas of the front fuselage about 30 seconds after the aircraft came to rest¹⁹

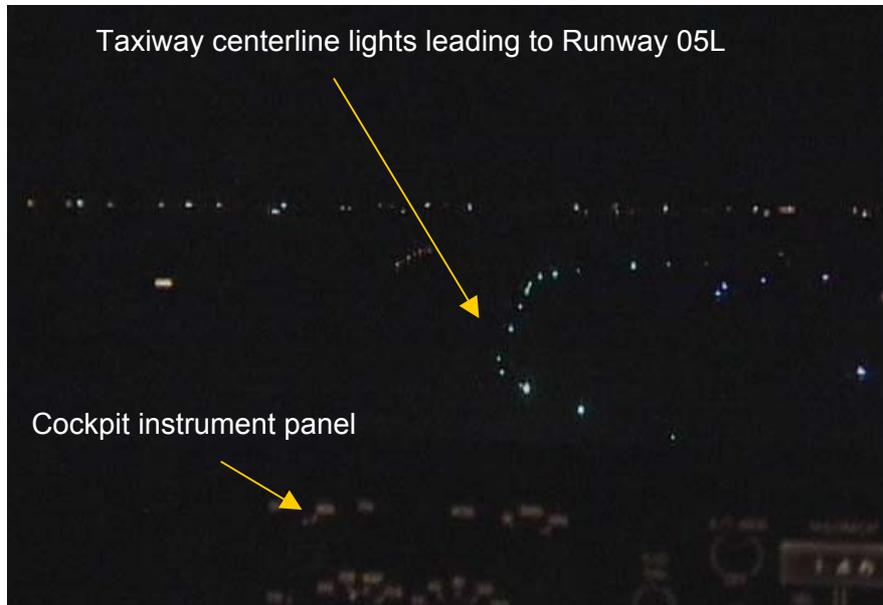
Figure 1.16-1 Taxiway centerline lights leading to Runway 05L (field of view from Boeing 747-400 cockpit-captain side)

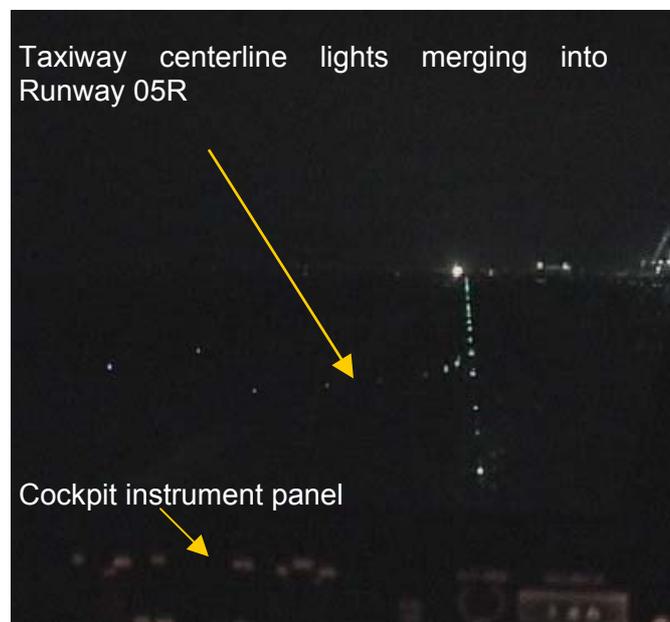
- (g) the taxiway centerline lights emanating from the left side of Runway 05R and merging into the Runway 05R centerline lights about 100 meters ahead of the runway threshold. (Figure 1.16-2)

Figure 1.16-2 Taxiway centerline lights merged onto Runway 05R from Taxiway N2 (field of view from Boeing 747-400 cockpit-captain side)

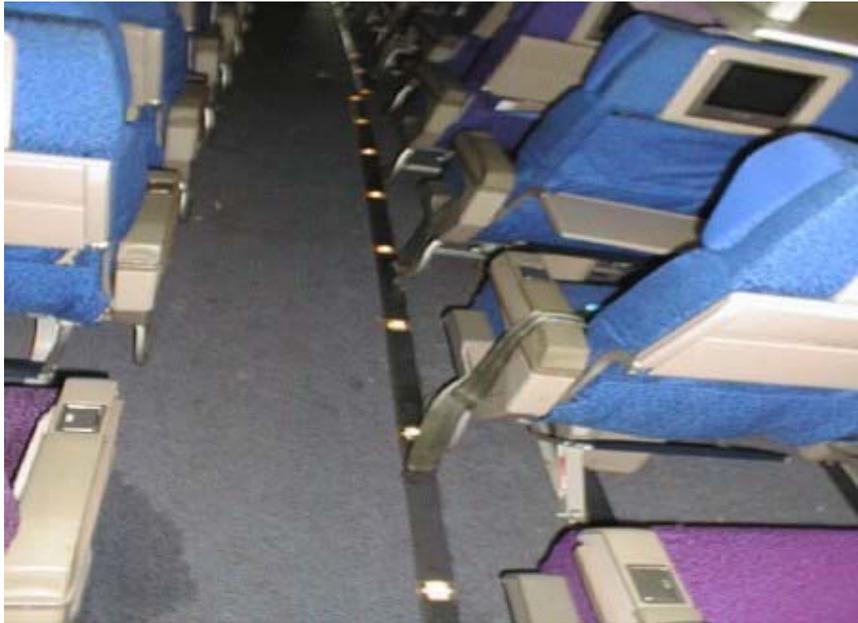
The battery packs were tested at the China Airlines workshop at CKS Airport to determine their state of charge following the accident. Each of the four packs was subjected to a 7 amp light load, as is used during functional testing of serviceable batteries. When each battery pack was connected to the load, the voltage across the terminals briefly rose to approximately 5.2 volts DC, and then dropped to less than 0.1 volts DC within 10 seconds. These readings are consistent with battery packs that are fully discharged. All four battery packs behaved the same way. Examination of the emergency lights, including the Passenger Emergency Evacuation Path Lighting System (PEEPLS) and the floor proximity emergency lighting system positioned between Doors 4 and 5 (Figure 1.16-3), revealed that all of the four battery packs were completely discharged.

Figure 1.16-3 Illuminated floor proximity lights in aft fuselage section during testing

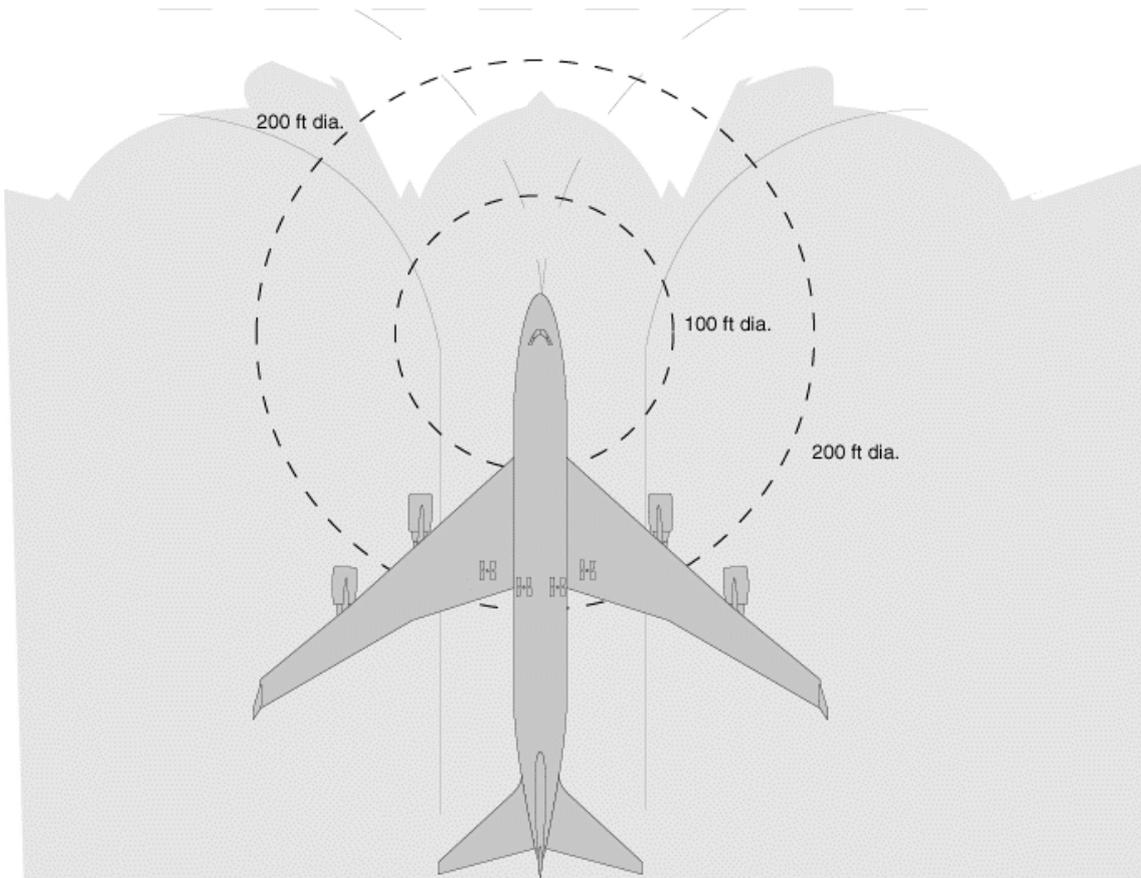
The study represented the view from a single point. The actual field of view will be better when the pilot moves his head. Figure 1.16-8 and 1.16-9 show the ground visibility from the field of view study.

Figure 1.16-8 The ground visibility for Captain and First Officer's eye reference points – wiper area only. The gray area represents the area not visible from Captain and First Officer's eye reference points. The concentric circles do not represent the perceptual range of the human eye.

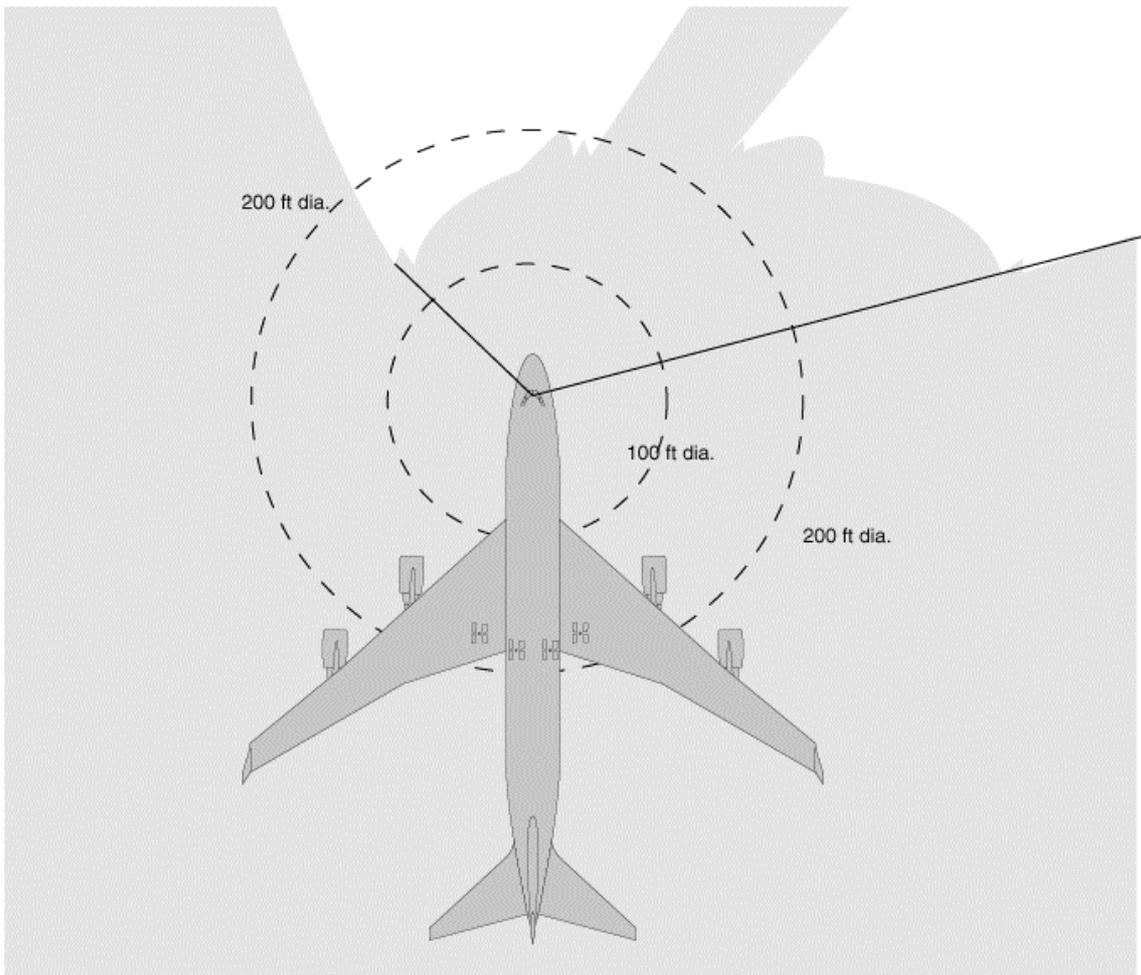
Figure 1.16-9 The ground visibility for Captain's eye reference points – wiper area only. The gray area represents the area not visible from Captain's eye reference points. The concentric circles do not represent the perceptual range of the human eye.

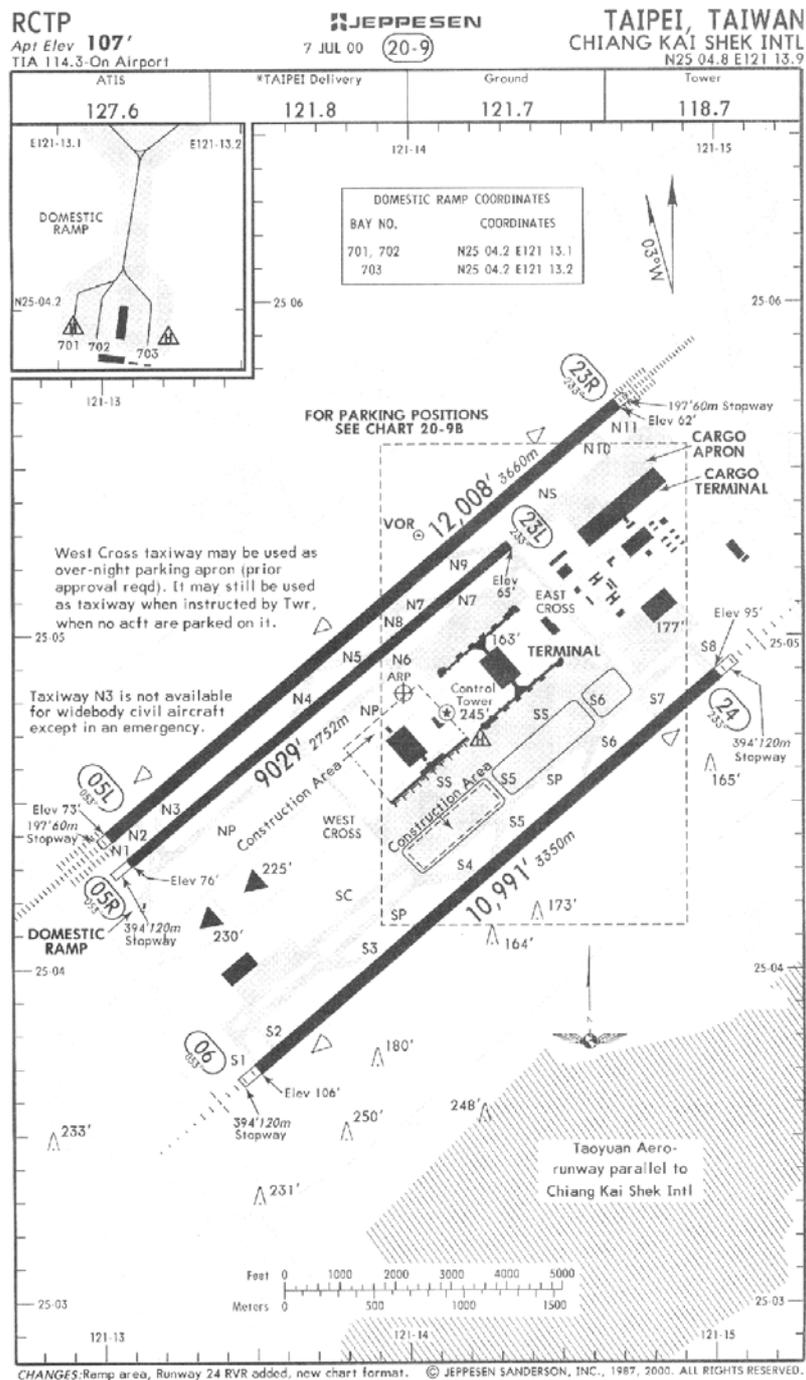
Figure 1.18-1 Jeppesen chart, dated "7 JUL 00" of CKS Airport

other 2 pilots all stated that the charts used on October 31, 2000, showed Runway 05R and 05L. Jeppesen chart, dated "7 JUL 00" of CKS Airport, reflects Runway 05R as a runway (Figure 1.18-1).

The Jeppesen chart provided to the flight crew did not include a yellow page supplement that contained information on the work in progress on Runway 05R.

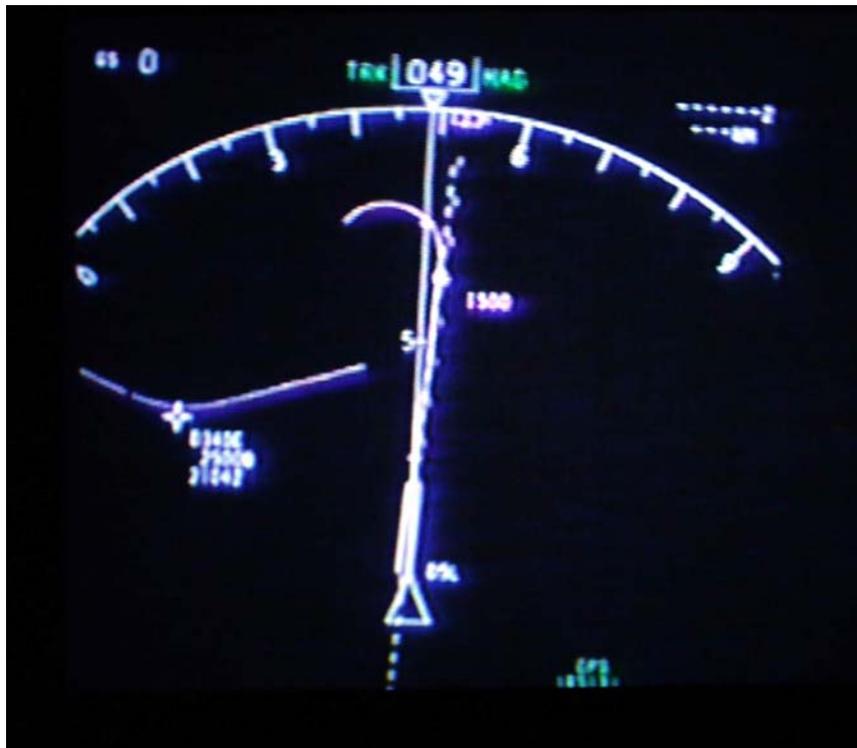
Figure 1.18-4 The display of the ND when the aircraft was lined up on Runway 05R

During the taxi route simulation on November 6, 2000, the simulation team had selected Runway 05L ILS frequency for departure. Consequently, the runway symbol for Runway 05L was displayed on the ND, and was labeled “05L.” Because the aircraft had lined up on Runway 05R, the aircraft symbol on the ND appeared on the right edge of the 05L runway symbol but the label “05L” remained unchanged. The investigation team was unable to determine what range had been set on the ND for

SQ006 prior to or on runway line-up. Figure 1.18-4 shows the ND when the aircraft was lined up on Runway 05R.

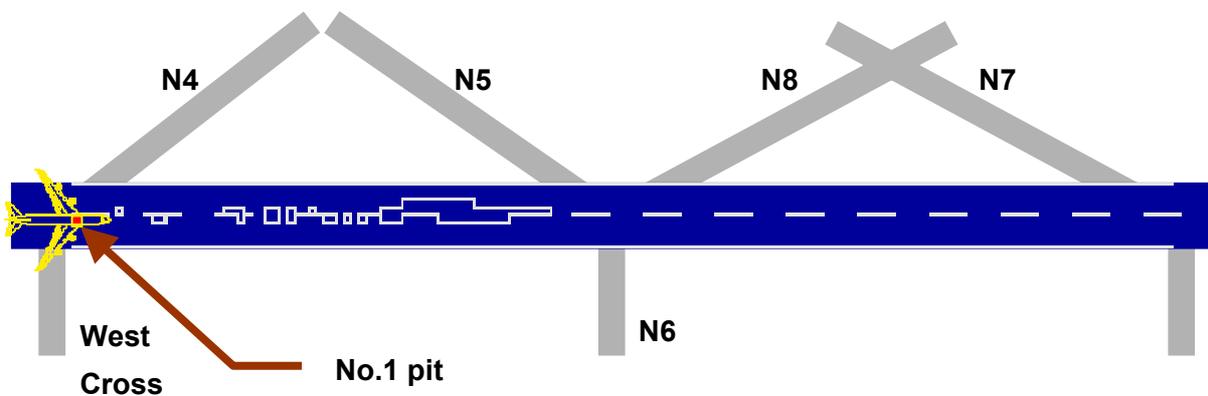
Figure 2.2-1 Structure failure sequence-1

1. The right body gear strut door (most likely the right side) impacted, and knocked over a jersey barrier. The left body gear traveled over pit #1 and the forward tires impacted the north edge of the pit, causing at least one tire to fail. (#1 pit as shown in red).

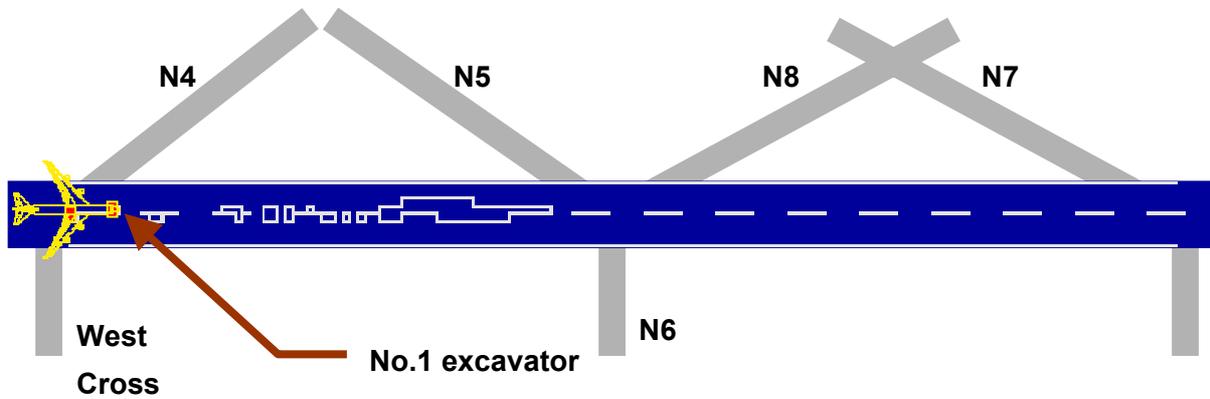
Figure 2.2-2 Structure failure sequence-2

- #1 excavator (as shown in red) rolled/progressed down the lower left side of fuselage and damaged the Main Equipment Center and lower left side of fuselage and damaged the avionics bays cargo holds, and other components located below the main passenger cabin floor.

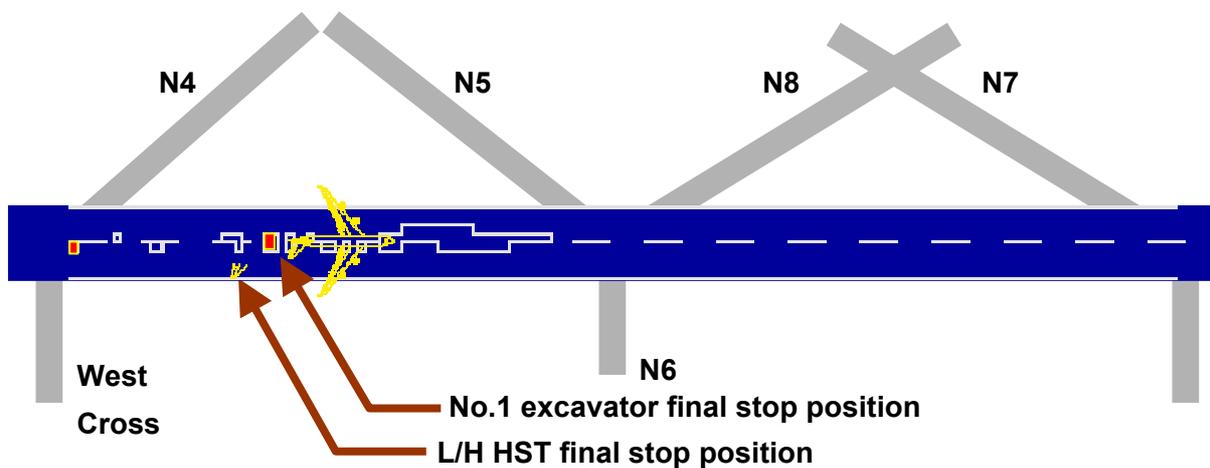
Figure 2.2-3 Structure failure sequence-3

- The #1 excavator impacted the stabilizer as it rolled out from underneath the aircraft. The bucket or other structure impacted the leading edge, subsequently causing the stabilizer to fail and compromising the stabilizer fuel.

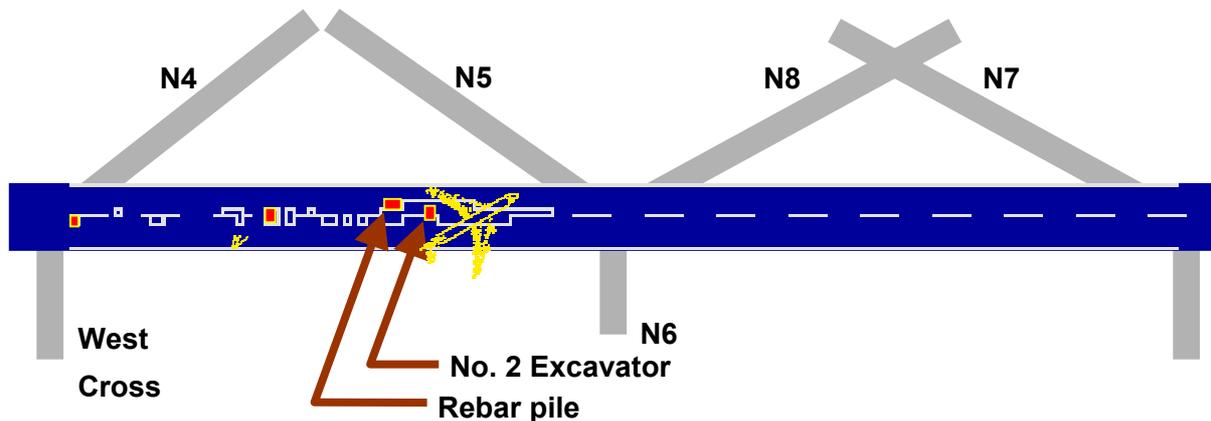
Figure 2.2-4 Structure failure sequence-4

- The #1 engines struck the pile of rebar beside pit #11 and the #2 engine struck the second excavator (shown in red) in pit #11, causing both to separate from the left wing. The impacts on the left side and asymmetric thrust began a counter-clockwise rotation of the fuselage. At about the same time, the #3 engine struck the ground, separated from the wing, and continued onward towards the terminal building.

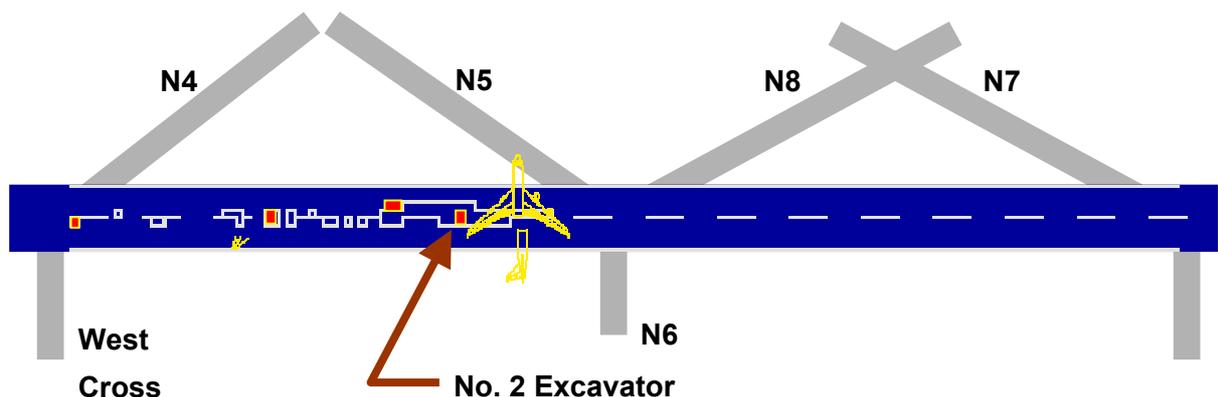
Figure 2.2-5 Structure failure sequence-5

- After striking 2 Steam Rollers (as shown in red), the aft fuselage most likely broke away from the front fuselage prior to Taxiway N6 and almost immediately rolled onto its left side. The grass besides the eastern runway showed signs of burning, beginning at approximately 1,430 feet from the first point of impact along with burnt cargo items.

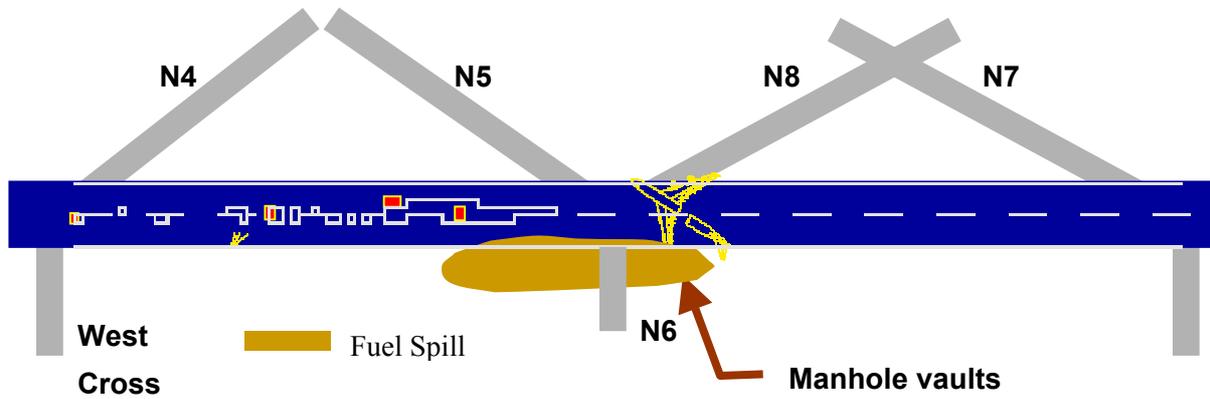
Figure 2.2-6 Structure failure sequence-6

- As the aircraft was traveling backwards and rotating counter clockwise, the outboard section of the left wing was sheared off after hitting the southern manhole vaults (as shown in red). This stopped the CCW rotation and caused the aircraft to continue along the path backwards. The grass besides the eastern runway showed signs of burning beginning at approximately 2,000 feet from the first point of impact.
