AIRCRAFT ACCIDENT REPORT
ASC-AAR-02-04-001

**CRASHED ON A PARTIALLY
CLOSED RUNWAY DURING TAKEOFF
SINGAPORE AIRLINES FLIGHT 006
BOEING 747-400, 9V-SPK
CKS AIRPORT, TAOYUAN, TAIWAN
OCTOBER 31, 2000**

AVIATION SAFETY COUNCIL

Crashed on a Partially Closed Runway during Takeoff, Singapore Airlines Flight 006,
Boeing 747-400, 9V-SPK, CKS Airport, Taoyuan, Taiwan, October 31, 2000

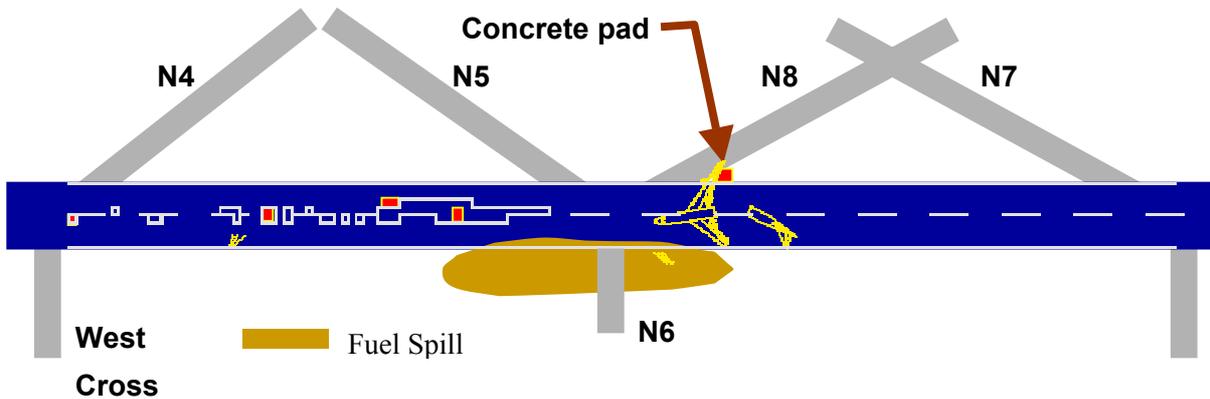
Figure 2.2-7 Structure failure sequence-7

- As the aircraft was traveling backwards, the #4 engine impacted the concrete pad (as shown in red), separating it from the right wing.

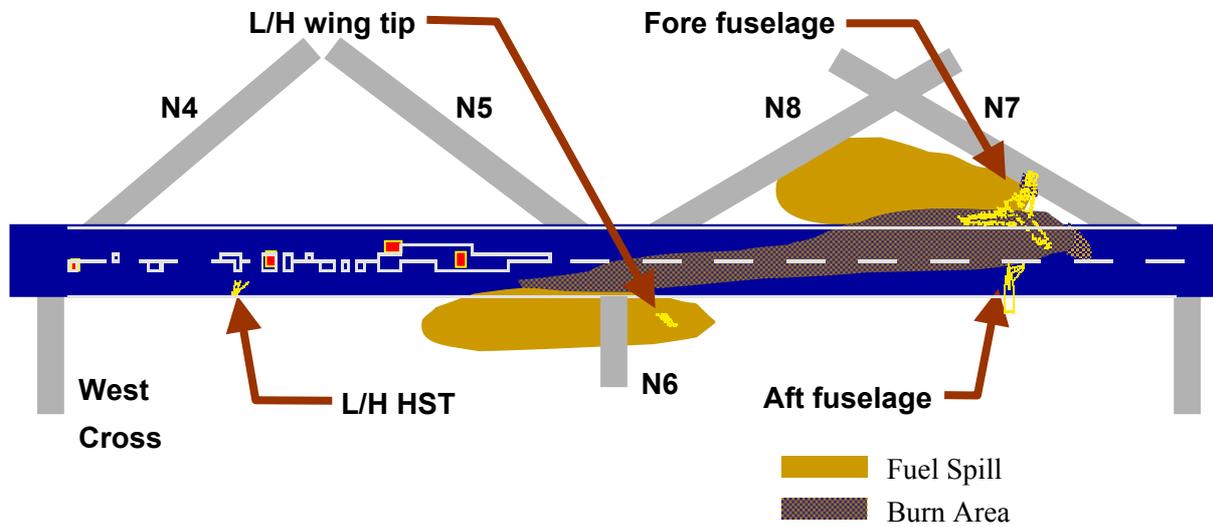
Figure 2.2-8 Structure failure sequence-8

8. When the #4 engine impacted the concrete pad, a counterclockwise force was applied to the forward fuselage section, rotating the aircraft to its final heading when it came to rest.

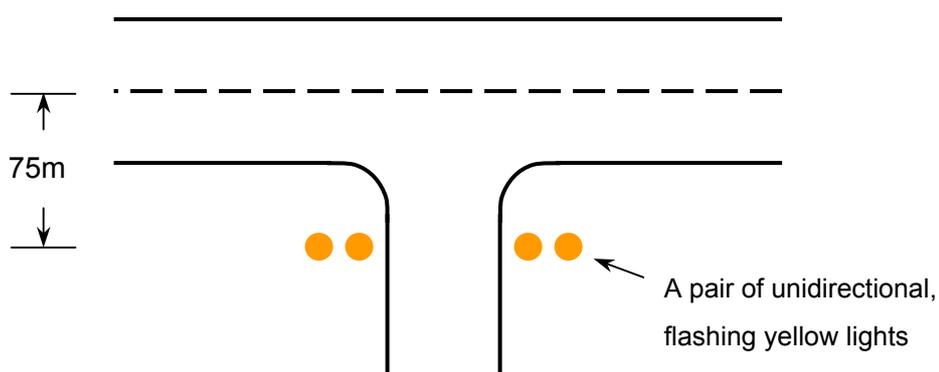
Figure 2.3-1 RGL of configuration A

ICAO Annex 14 (third edition-July 1999) vol. 1, paragraph 5.3.20.1, stated that a configuration A Runway Guard Light (Figure 2.3-1) shall be provided as a standard. FAA AC 120-57A paragraph 8b suggests: runway guard lights to be provided when operating below RVR 365 meters. AC 150/5340-28 also mentioned: RGL provides a distinctive warning to anyone approaching the runway holding position that they are about to enter an active runway. The CKS Airport did not install configuration A RGL. Therefore, it did not meet the ICAO standard.

If CKS Airport had installed RGL on both the left and right sides of Taxiway N1 as required by the ICAO standard, that is, 75 meters from the centerline of Runway 05L, the distance from that location to the centerline of Taxiway NP would be 249 meters and the distance to the intersection on Taxiway N1 that turns into Runway 05R would be about 175 meters. Since the RVR on the night of the accident was 450 meters, the crew could have had one indication that the CAT II Runway (05L) was still ahead of them. This will be discussed further in section 2.5.

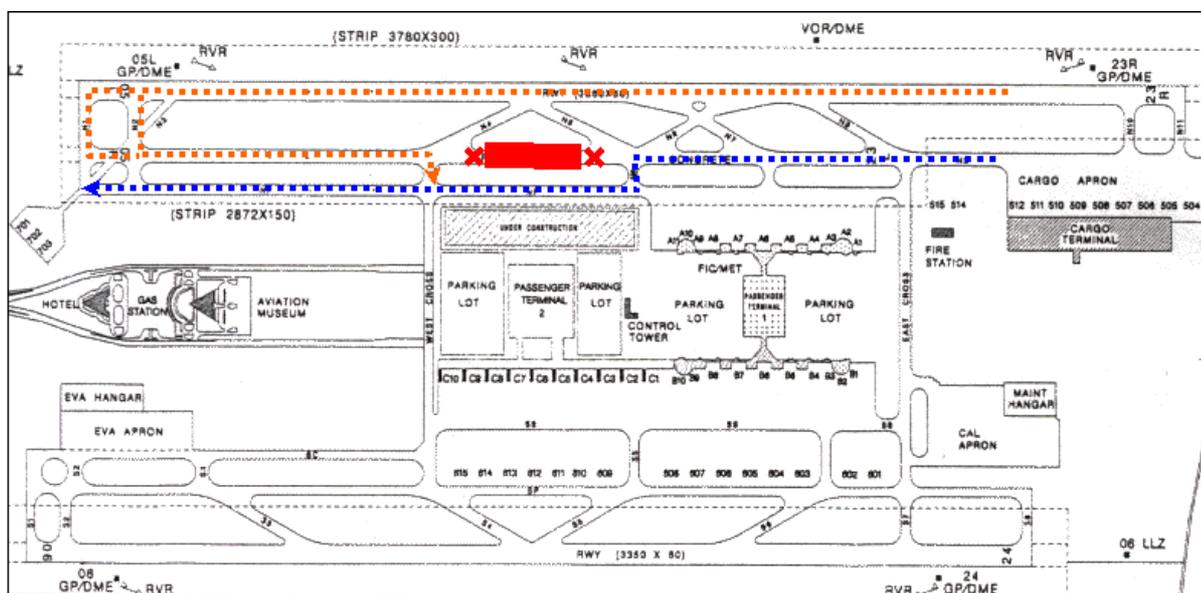
Figure 2.3-2 Taxi route during Runway 05R under construction

However, with regard to the construction area on Runway 05R, the Safety Council identified two safety deficiencies. First, according to ICAO Annex 14, vol. 1, paragraph 7.1.3 (Standard), there should have been closure markings adjacent to the construction site (Figure 2.3-2); however, there was no requirement to place runway closure markings near the threshold of Runway 05R. Secondly, according to ICAO Annex 14, vol. 1, paragraph 7.1.4, (Standard), the barriers placed at the construction site, should have been frangible. The concrete barriers did not meet the intent of ICAO SARPs. It should be stated that neither of these deficiencies was involved in the circumstances regarding the SQ006 accident.

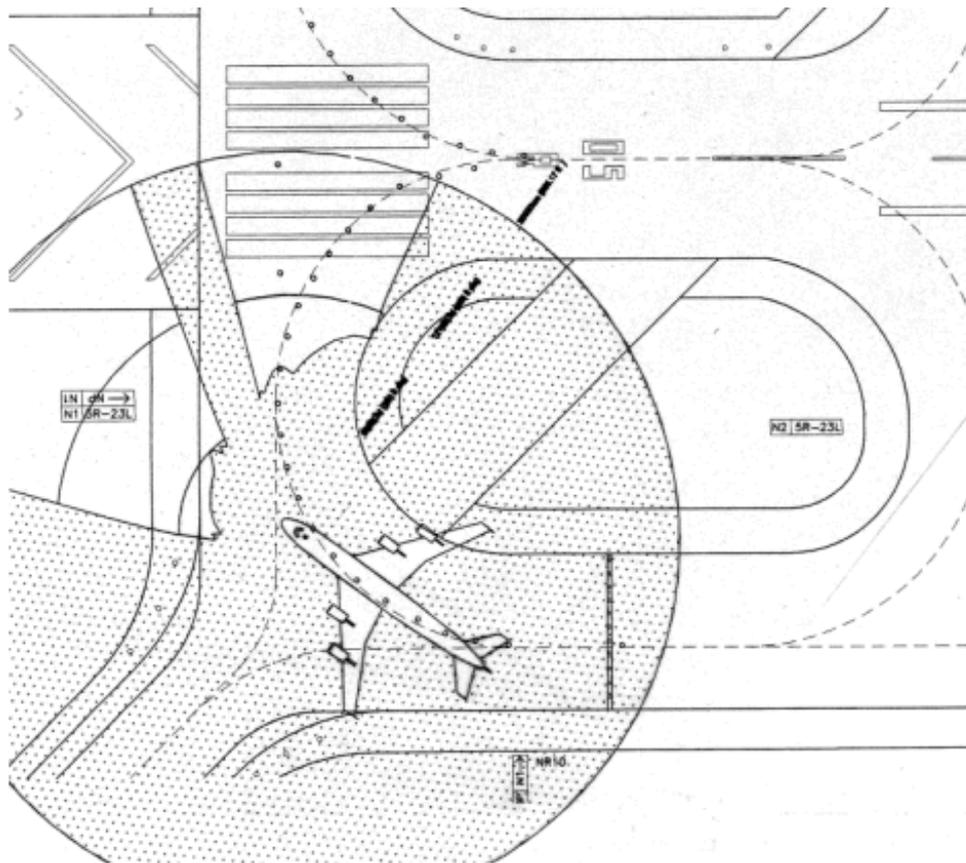
Figure 2.5-1 Captain's Field of View turning from Taxiway NP onto Taxiway N1 approaching the threshold of Runway 05R. (The circle around the aircraft represents a 100 meters radius from CM-1's eye reference point. The diagram is based on the pilot looking forward and not moving his head)

The field of view study showed that the pilots’ field of view outside the cockpit through the areas swept by the windscreen wipers was limited; however, the study found that the following items would have been visible from the cockpit at intervals throughout the turn from Taxiway NP through Taxiway N1 onto Runway 05R: the Taxiway N1 sign and Taxiway N1 centerline lights leading to Runway 05L; the Runway 05R sign; the Runway 05R threshold marking and designation; and the Runway 05L signage. In particular, the study indicated that the “N1/5R-23L” signage was visible from CM-1’s eye reference point through CM-1’s windshield when the aircraft was turning from Taxiway NP onto Taxiway N1 (Figure 2.5-1). The clear areas in the diagram present the visible areas available to CM-1 during taxi. CM-1 stated that he had his eyes directed outside of the cockpit during the turn from Taxiway NP onto the runway because he was taxiing the aircraft with reference to the taxiway lights during the turn.

In addition, the "N1/5R-23L" signage was internally illuminated. The distance between the signage and the cockpit was about 60 meters when the aircraft was turning. With a RVR of 450 meters, the signage would have been visible from the cockpit when the aircraft was turning from Taxiway NP onto Taxiway N1.

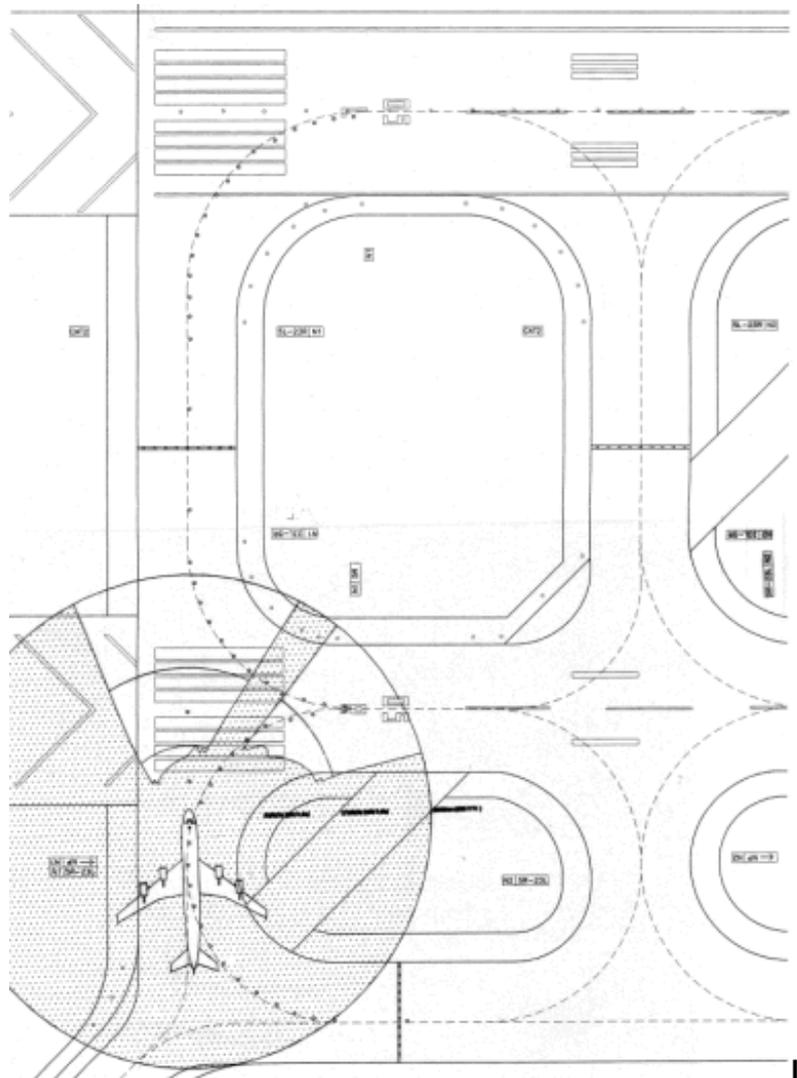
Figure 2.5-2 Captain's Field of View along Taxiway N1 approaching the thresholds of Runway 05R and 05L (RVR for Runway 05L was 450 meters. Taxiway N1 between Runway 05R and 05L was 214 meters. The diagram is based on the pilot looking forward and not moving his head)

When the aircraft taxied through Taxiway N1 and was just about to turn onto Runway 05R (Figure 2.5-2), "the piano keys" on Runway 05R and the Taxiway N1 centerline lights leading to Runway 05L would have been visible from CM-1's eye reference point through CM-1's windshield. The runway marking "05" and "R" would also have been visible from CM-1's eye reference point through CM-2's windshield. The distance between the cockpit and the Runway 05R marking, Taxiway N1 centerline lights leading to Runway 05L, and the Runway 05R "piano keys" were all within 120 meters.

Based on the above evidence and the taxi simulation data, the Safety Council concludes that the visibility at the time the crew turned from Taxiway NP and entered Runway 05R was sufficient for

them to see the markings and signage, if they had looked for them to help locate their position and to correctly navigate the aircraft to the correct runway.
