Accident on 24 March 2001 at Saint-Barthélemy (971) to the DHC-6-300 registered F-OGES operated by Caraïbes Air Transport

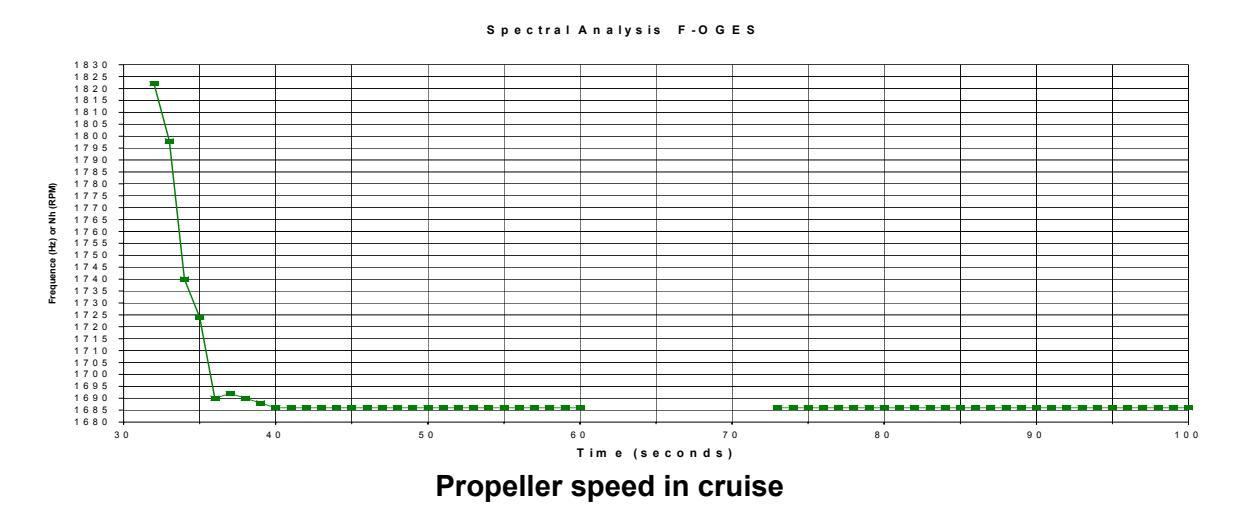
Spectral analysis of the soundtrack on take-off

<u>Cruise</u>: the sound signal indicates a slowing down of the propeller rotation speed from 1,825 to 1,690 RPM in five seconds, then stabilization at 1,685 RPM. This figure corresponds to the cruising speed specified by the manufacturer. Again, the absence of a double peak shows that the propellers were synchronized.

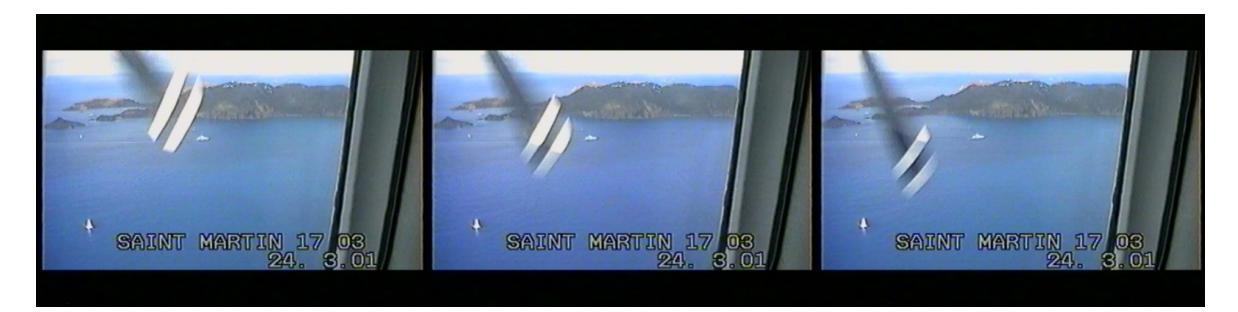
Analysis of the video tape where the left propeller is visible enabled the green curve to be drawn: there are twenty-five images per second; it is possible to determine on each the position of the blades and thus the number of passages per second. Three photos taken from the film are presented below to illustrate the calculation.

Overlaying the green and blue curves shows that the latter corresponds to the left propeller.

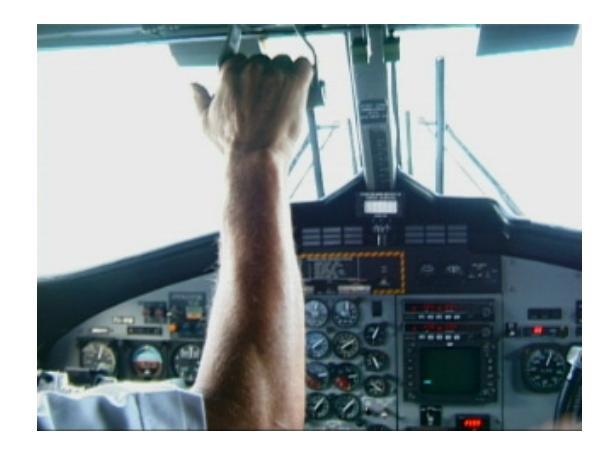
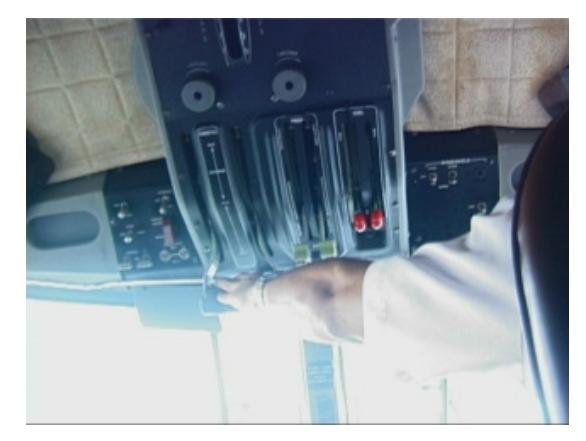
When the PF is seated in the left position, his right forearm is located in the extended vertical axis of the levers, a position which is favorable to symmetric handling. When the PF is seated in the right position, his left forearm is not vertical; he stretches slightly to the left and is thus not aligned with the axis of the levers, this "angle" being compensated by wrist movement.

During approaches to Saint-Martin Juliana, it was noted that certain pilots in the right position used short successive and separate movements on the engine n°1 lever, then on the engine n°2 lever, with the hand always remaining in contact with both levers.
