**In-Flight Separation of Vertical Stabilizer  
American Airlines Flight 587  
Airbus Industrie A300-605R, N14053  
Belle Harbor, New York  
November 12, 2001**

**NTSB/AAR-04/04**

**NTSB/AAR-04/04  
PB2004-910404  
Notation 7439B  
Adopted October 26, 2004**

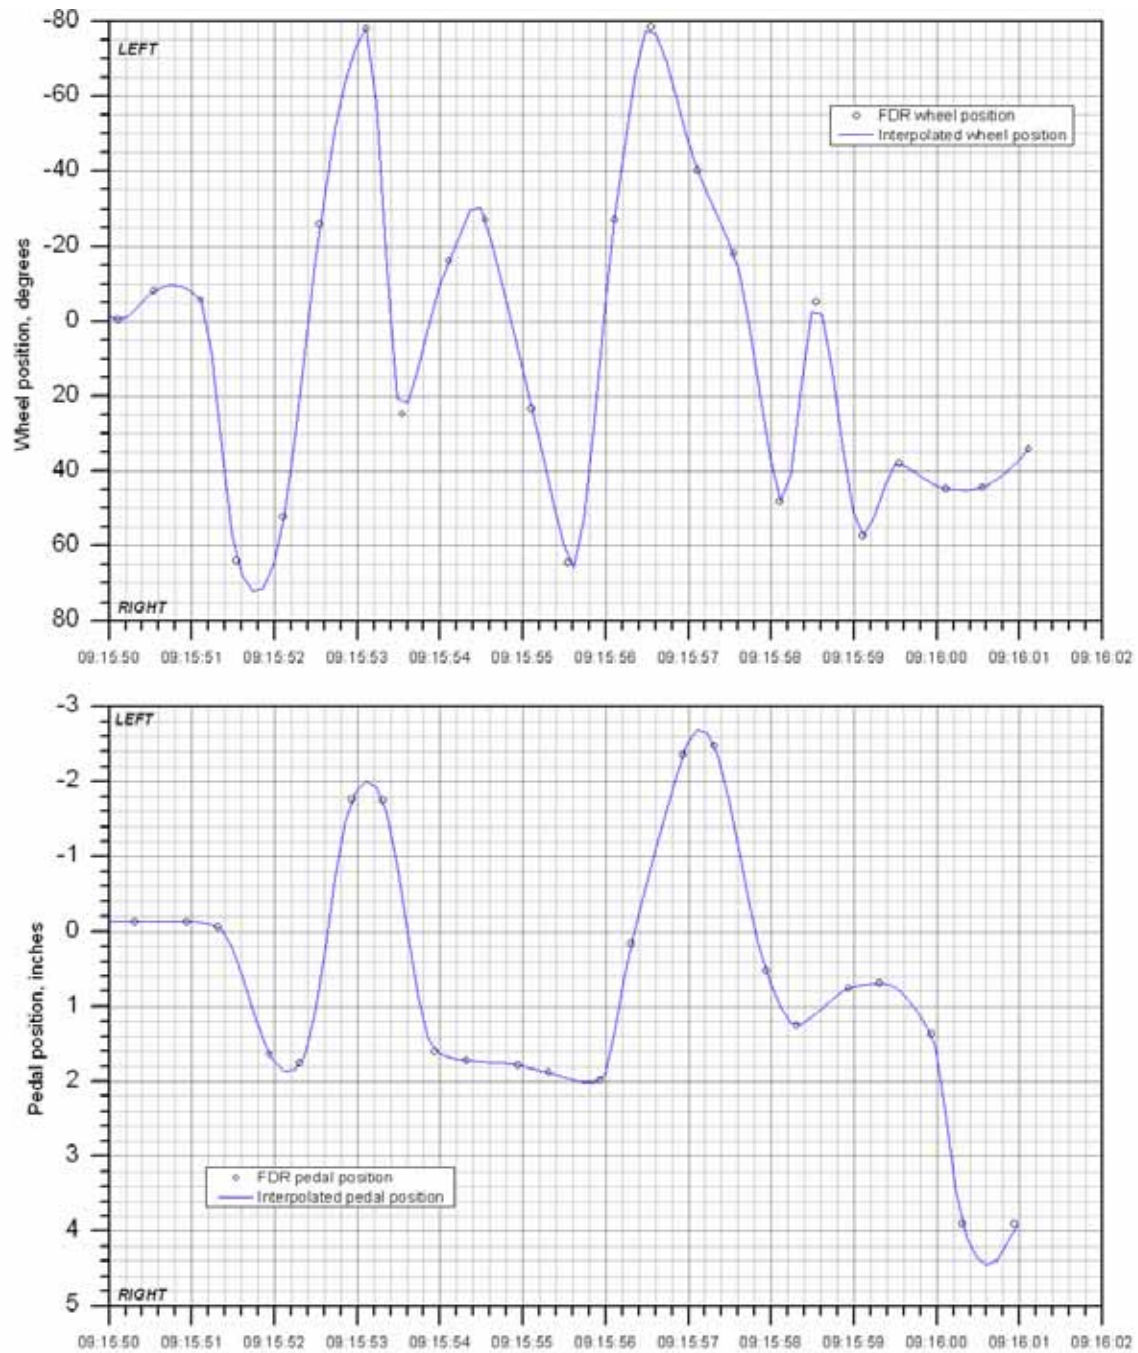
**Figure 1.** Control Wheel and Rudder Pedal Movements During the Second Wake Encounter

According to the FDR, the rudder pedals moved from 1.7 inches right to 1.7 inches left, 1.7 inches right, 2.0 inches right, 2.4 inches left, and 1.3 inches right between 0915:52 and 0915:58.5.<sup>18</sup> Also, the FDR showed that the control wheel moved 64° to the right at 0915:51.5, 78° (full) to the left at 0915:53.5, 64° to the right at 0915:55.5, and 78° to the left at 0915:56.5.<sup>19</sup> Figure 1 shows these cockpit control movements.

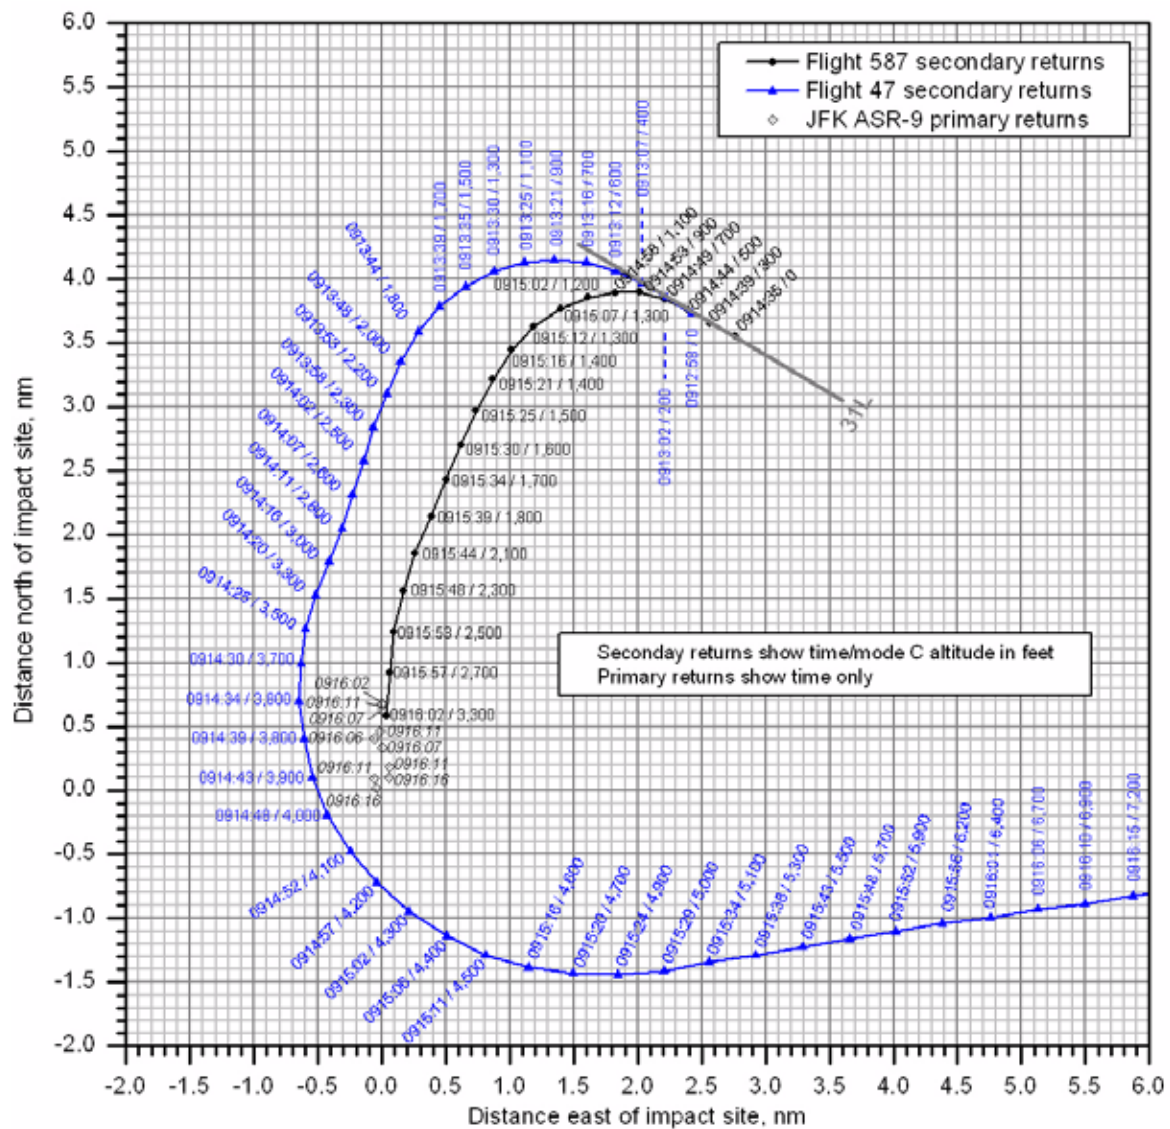
**Figure 2.** American Airlines Flight 587 and Japan Air Lines Flight 47 Flightpaths

Figures 2 and 3 show flight 587's radar track based on JFK Airport Surveillance Radar-9 (ASR-9) information. Figure 2 shows flight 587's flightpath, from takeoff to impact, in relation to the flightpath for Japan Air Lines flight 47, and figure 3 shows flight 587's flightpath overlaid on a topographical map, along with key events.

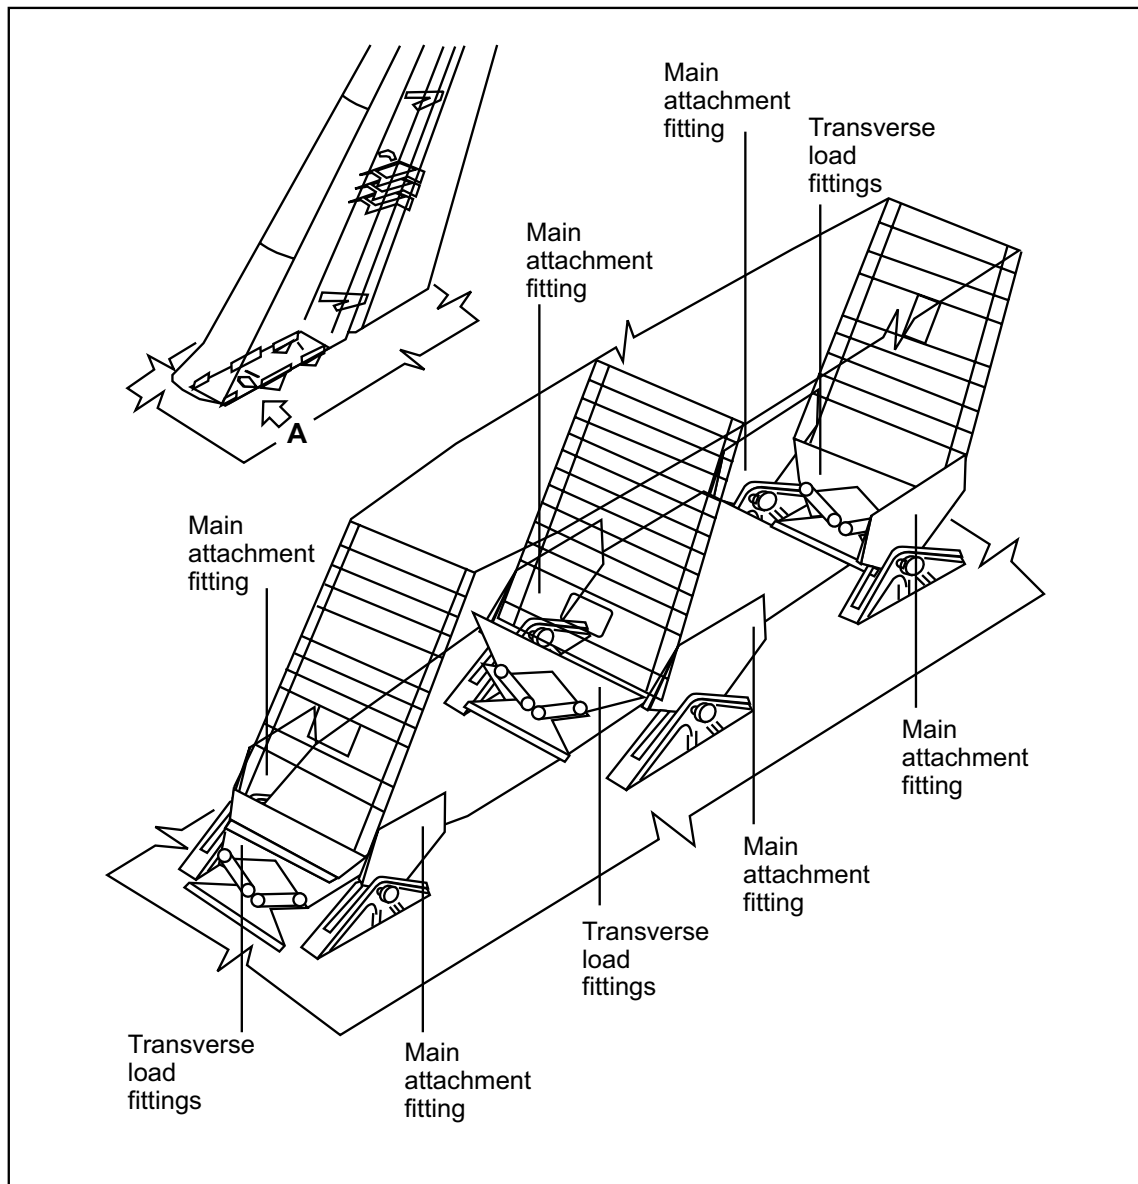
**Figure 4.** Vertical Stabilizer-to-Aft Fuselage Attachment Points

The vertical stabilizer is attached to the aft fuselage by three pairs of main attachment fittings and three pairs of transverse load fittings, as shown in figure 4. All of the fittings are made from a CFRP material. The main attachment fitting pairs, which are up to 1.6 to 2.5 inches thick, are located at the bottom of the front, center, and rear spars and are integrated in the skin panels. The transverse load fittings pairs, which are up to 0.5 inch thick, are integrated in the front, center, and rear spars. Each main attachment fitting (left forward, left center, left rear, right forward, right center, right rear) has its own assembly that consists of inboard and outboard fitting halves that are bonded to the skin panels during the curing process. The fitting assemblies and skin panels have lug portions,<sup>36</sup> which extend below rib 1. Figure 5 shows a main attachment lug in detail.

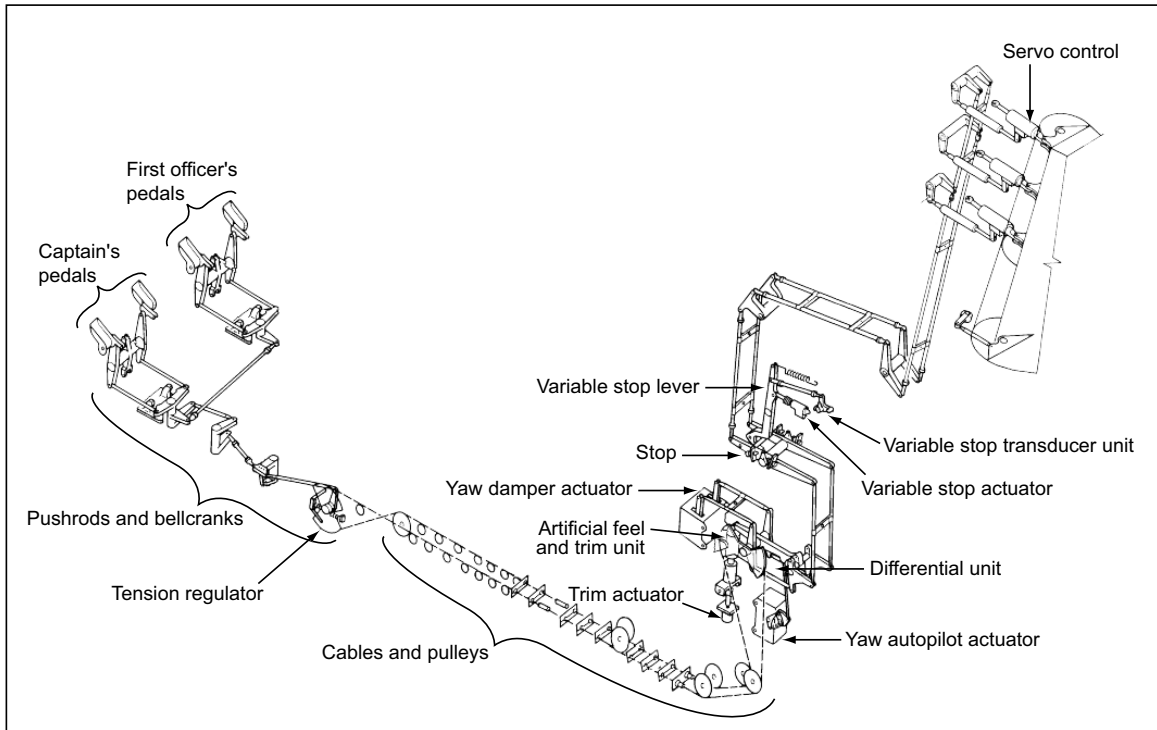
**Figure 6.** Rudder Control System

The rudder control system includes (1) the rudder pedals, the rudder trim actuator, the yaw damper actuator, and the yaw autopilot actuator, which command the rudder to move; (2) pushrods, bellcranks, a tension regulator, and cables (also referred to as linkages), which transmit rudder commands; (3) three servo controls (upper, middle, and lower), which operate the rudder; (4) a rudder travel limiter system, which provides a variable stop that limits rudder pedal travel with increasing airspeeds; and (5) a differential unit, which is a mechanical device that sends the rudder servo controls a command that is the sum of a pilot or an autopilot input and a yaw damper input. The maximum rudder deflection is 30° either left or right, the maximum rate of rudder movement (with no loads) is 60° ±5° per second, and the maximum rudder pedal displacement is 4 inches.<sup>38</sup> The rudder control system is shown in figure 6.

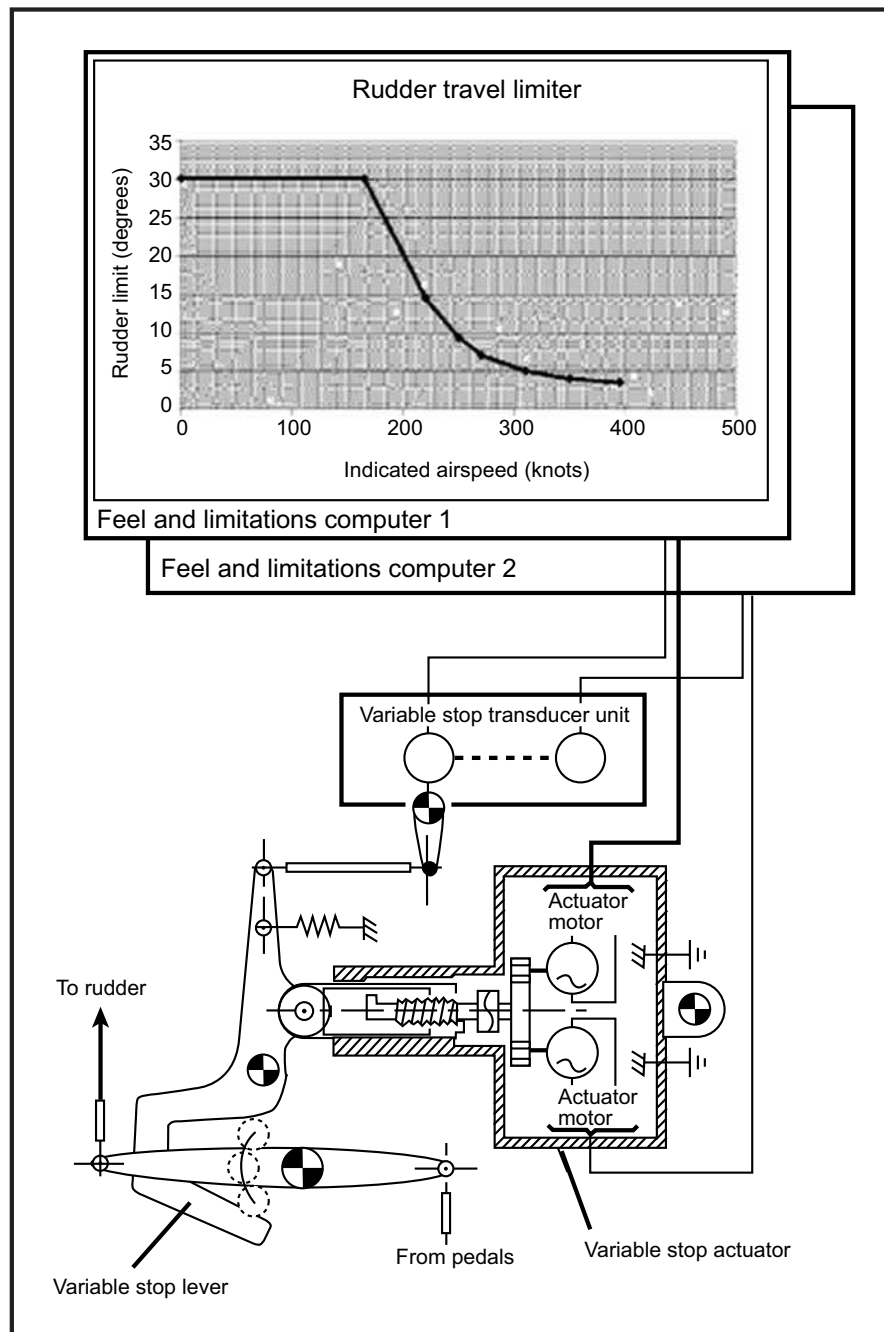
**Figure 7.** Rudder Travel Limiter System

The rudder travel limiter system is controlled by two feel and limitations computers. Each feel and limitations computer receives indicated airspeed data from two air data systems and uses the data from the system with the higher values to determine the appropriate rudder limit.<sup>43</sup> Feel and limitations computer number 1 is normally the active computer, and feel and limitations computer number 2 is normally the backup computer. Both feel and limitations computers are powered by a.c. electricity, but computer number 1 receives a.c. electrical power from the airplane's emergency bus. Each feel and limitations computer operates one of the motors of the variable stop actuator. Figure 7 shows the rudder travel limiter system along with the maximum rudder deflections shown in table 2.

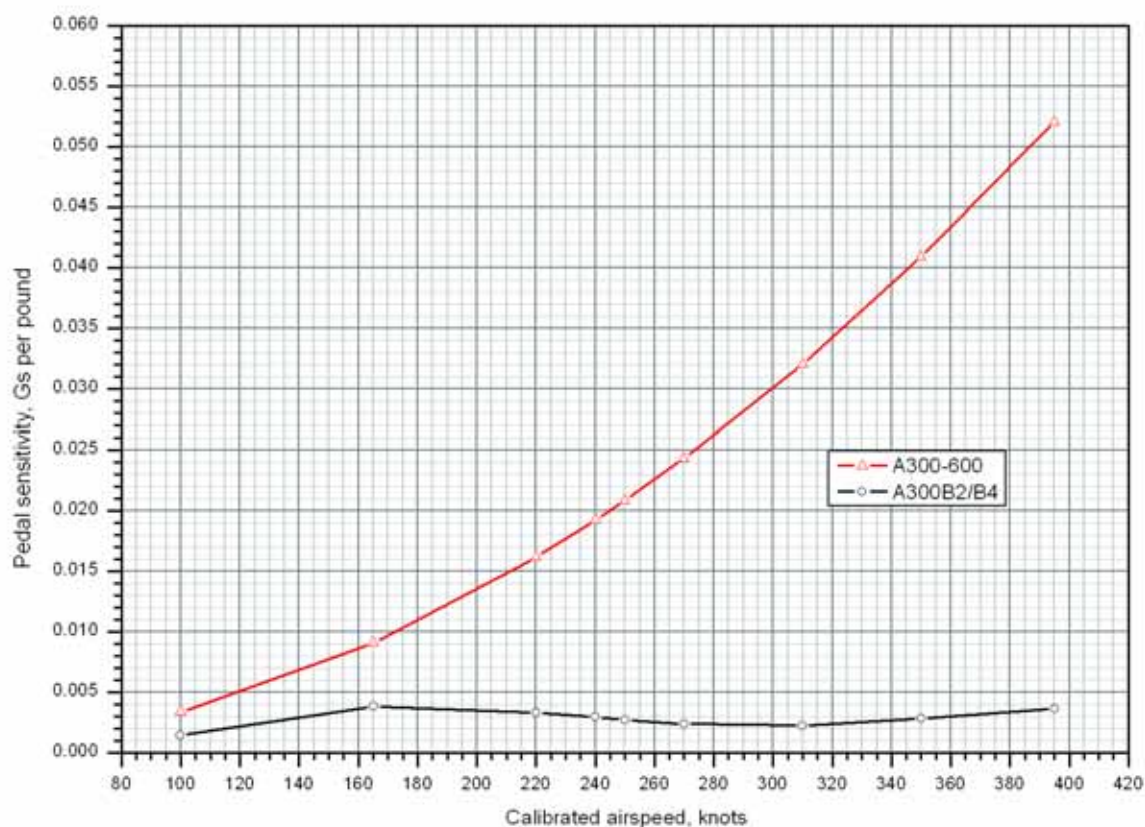
**Figure 8.** A300-600 and A300B2/B4 Rudder Pedal Sensitivities

systems (such as the A300-600), the rudder deflection per pedal deflection remains constant, so the sensitivity of the pedals increases with the square of the airspeed. These characteristics are illustrated in figure 8, which compares the A300-600 and A300B2/B4 rudder pedal sensitivities as a function of airspeed and shows that the A300-600 is twice as responsive to a pedal displacement at 250 knots KCAS than at 165 KCAS.

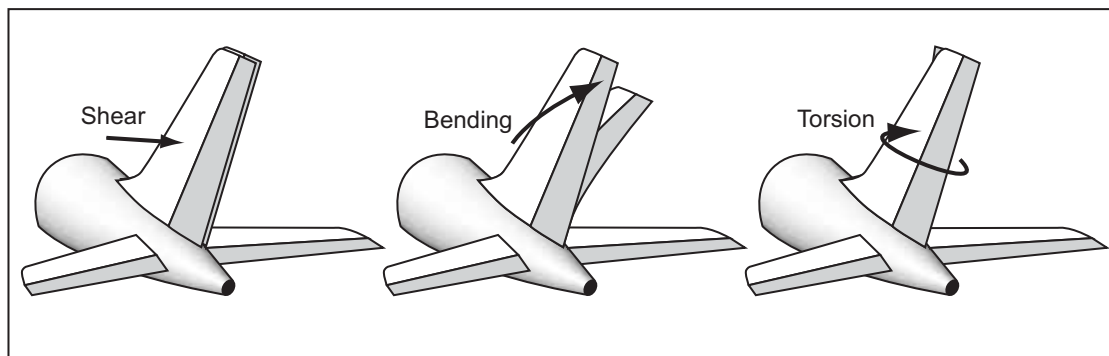
**Figure 9.** Shear, Bending, and Torsion

The external aerodynamic and mass inertial loadings on the vertical stabilizer can also be quantified as a net shear (a side load), a net bending (a moment about the longitudinal axis), and a net torsion (a moment about the vertical axis), as shown in figure 9. The correlated shear force diagram, which is used to define the limit and the ultimate load design envelopes, consists of one diagram plotting net shear versus net torsion and, as shown in figure 10, one diagram plotting net torsion versus net bending.<sup>58</sup>

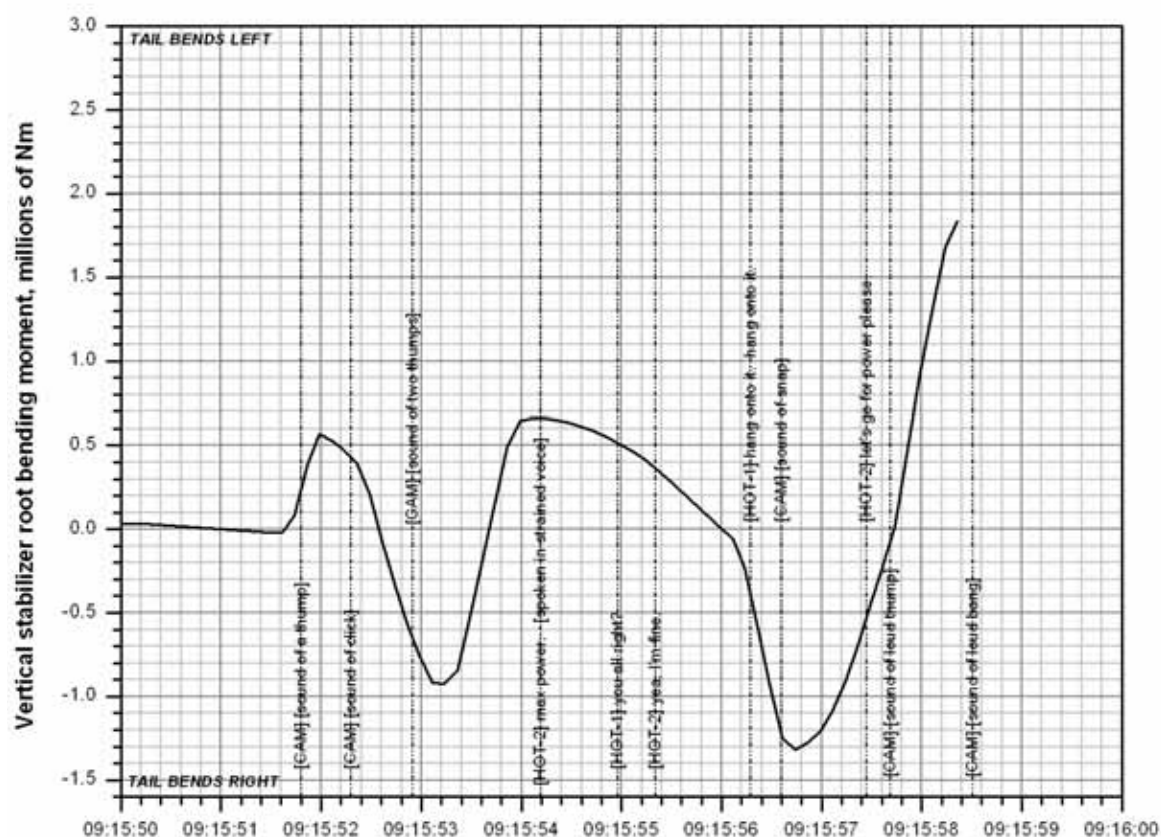
**Figure 13.** Bending Moment About the Root Chord in the Vertical Stabilizer Axis System

At any given altitude and airspeed, many parameters affect the loads on the vertical stabilizer;<sup>98</sup> the most significant of these parameters are sideslip angle and rudder angle. During the design of the A300-600, Airbus developed a model of the loads on the vertical stabilizer based on linearized wind tunnel data that described the effects of sideslip angle and rudder angle on the vertical stabilizer structural loads. With the use of this linear loads model, the Safety Board calculated the shear, bending, and torsion loads on the vertical stabilizer during the final seconds of flight 587's recorded FDR data (before the sound of the loud bang at 0915:58.5). Figure 13 shows the calculated bending moment about the root chord in the vertical stabilizer axis system.<sup>99</sup>

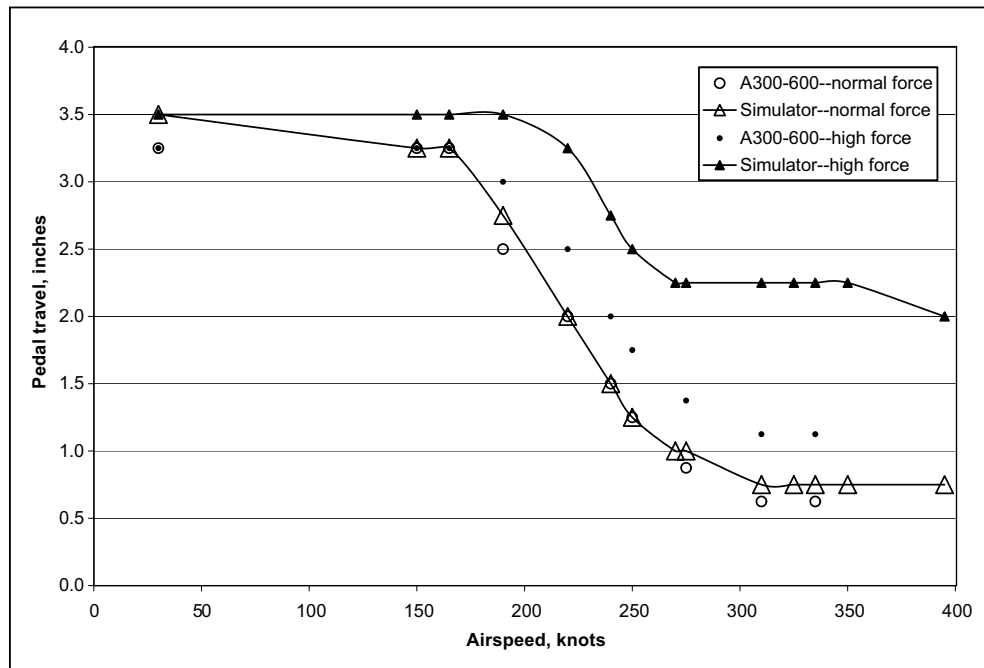
**Figure 18.** Rudder Pedal Motion With Normal and High Pilot Pedal Force in the A300-600 Airplane and the American Airlines A310/300 Training Simulator

From January 31 to February 2, 2002, Safety Board investigators performed tests on an American Airlines A300-600 airplane at American's maintenance facility in Tulsa. With the assistance of an American Airlines representative, the investigators measured rudder pedal limits at different airspeeds (30, 150, 165, 190, 220, 240, 250, 275, 310, and 335 knots), the travel of the control wheel, and the dimensions of the wheel. To measure the pedal limits, an investigator sat in the left cockpit seat and pushed the left pedal until the stop was contacted (normal force) while another investigator in the right cockpit seat recorded the actual pedal motion. The investigator in the left cockpit seat then pushed the left pedal as hard as he could (high force), and the actual pedal motion was again recorded.

Safety Board investigators repeated these tests on April 23, 2003, in the American Airlines A310/300 training simulator. With the assistance of two American Airlines representatives, the investigators assessed how the portrayal of rudder pedal characteristics in the simulator compared with those of the actual A300-600 airplane. The investigators found that the rudder pedal motion in the simulator and the airplane produced by normal and high pilot input forces resulted in different pedal displacements despite the pedal travel limits, as shown in figure 18. The differences were attributed to the software representation of the elastic cable stretch in the simulator, which was less stiff than the cable stretch on the A300-600 airplane.
