Investigation Report of the Aircraft Accident Investigation Bureau

to aircraft AVRO 146-RJ100, HB-IXM,

operated by Crossair under flight number CRX 3597,

on 24 November 2001

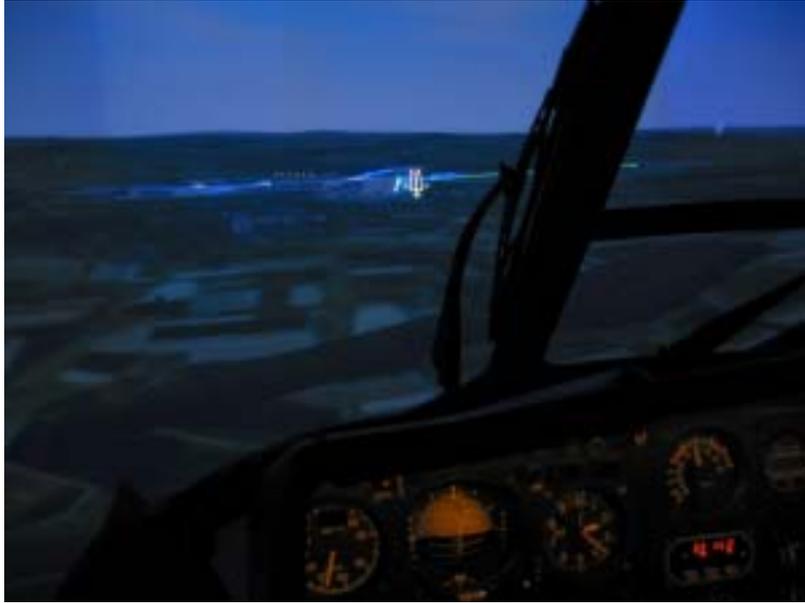
Runway 28 as seen from the Visual Descent Point (VDP) at 2390 ft AMSL by day with a visibility of more than 10 km

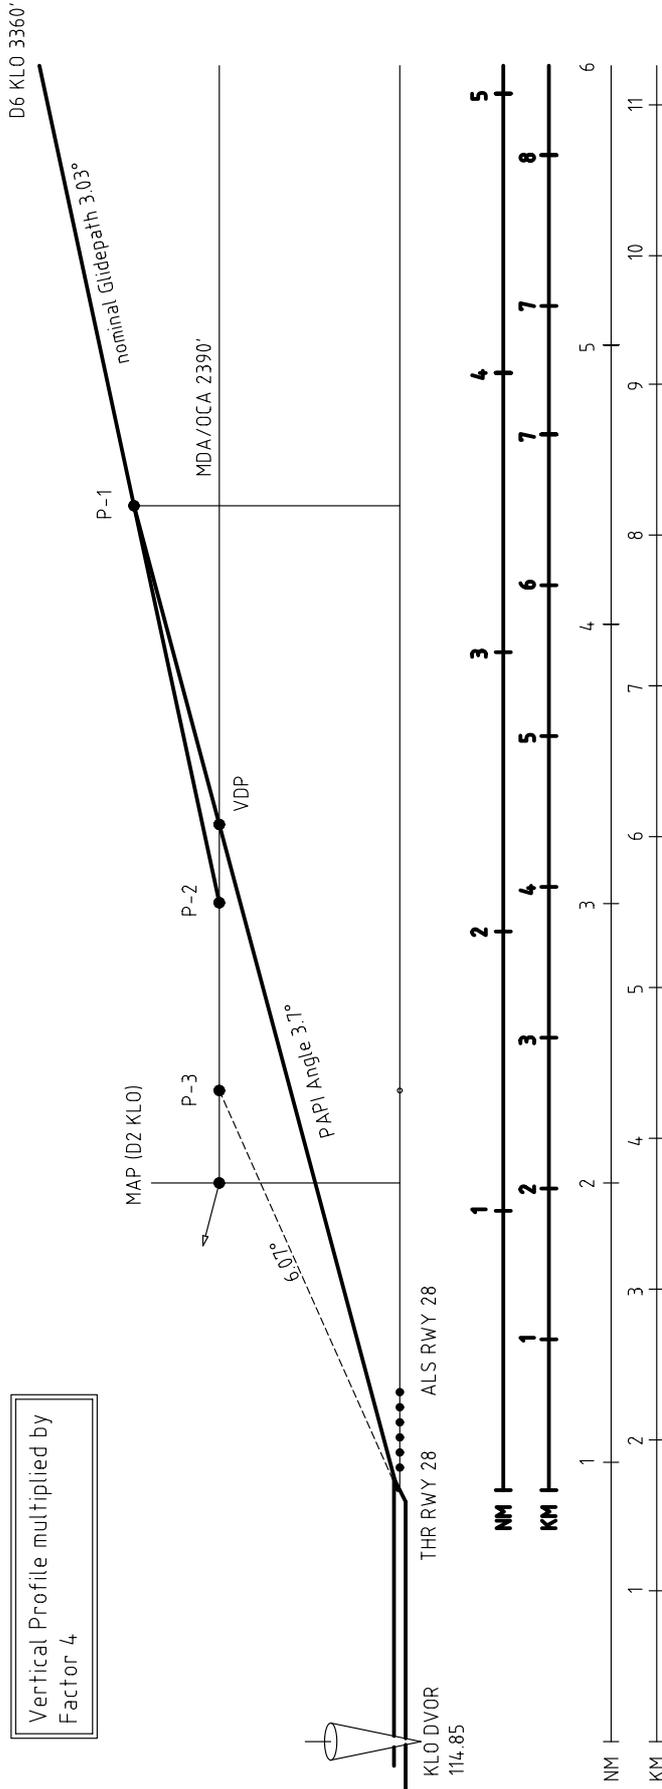
Appendix 11: Standard VOR/DME Approach - Illustration of the Final Segment

Point	above MDA	above PAPI	Dist. THR	Dist. ALS	Definition
P-1	14.0m/459ft	0m/0ft	6527m/3.5NM	5877m/3.2NM	Intersection of the nominal Glidpath (3.03°) and the PAPI Angle (3.7°)
VDP	0m/0ft	0m/0ft	4359m/2.4NM	3709m/2.1NM	Intersection of the PAPI Angle (3.7°) and the MDA/OCA (2390 ft)
P-2	0m/0ft	31m/102ft	3878m/2.1NM	3228m/1.8NM	Intersection of the nominal Glidpath (3.03°) and the MDA/OCA (2390 ft)
P-3	0m/0ft	110m/360ft	2650m/1.4NM	2000m/1.1NM	Point on the MDA/OCA (2390 ft) 2000m in front of the first approachlight along Rwy axis
MAP	0m/0ft	150m/492ft	2037m/1.1NM	1387m/0.8NM	Missed approach point
