Final Report No. 1874 by the Aircraft Accident Investigation Bureau

of the aircraft Beech Super King Air 300LW, D-ICBC

on 14 February 2002

on the Piz Sarsura (20 km NE of Samedan aerodrome),
Zernez municipality

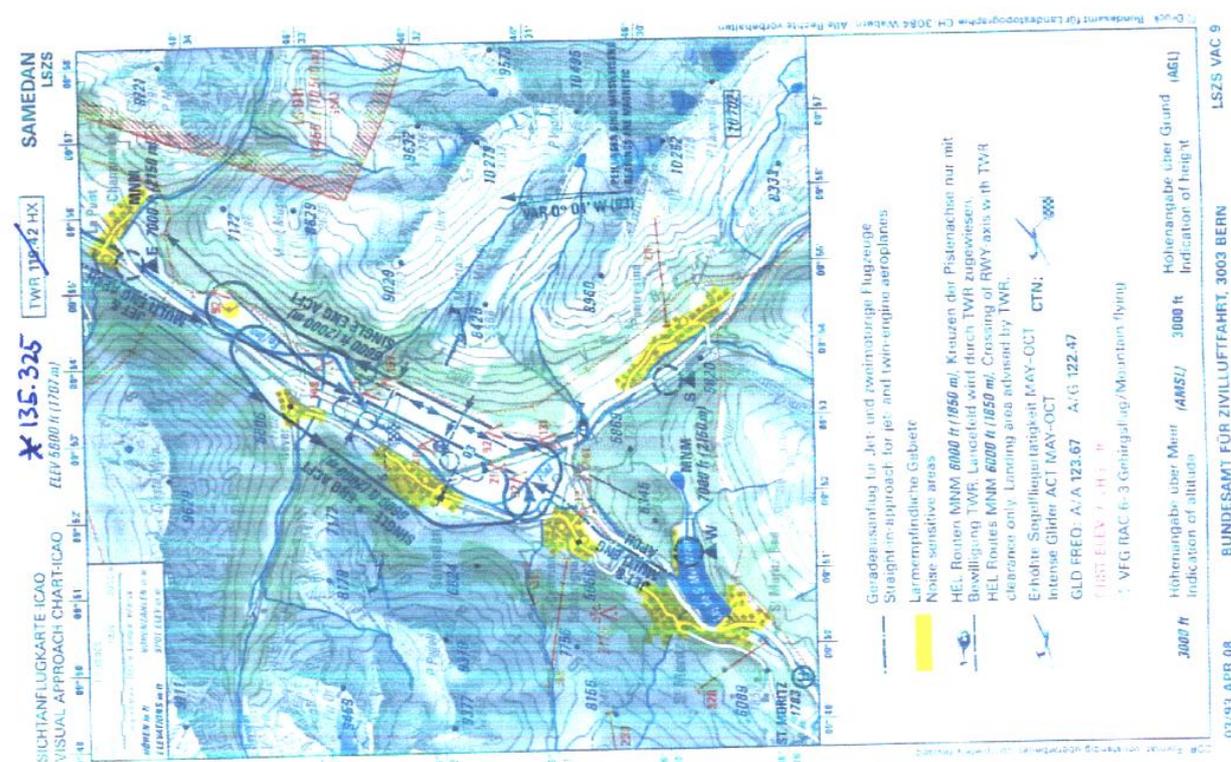
Ansicht Unfallstelle

In this context, it must be borne in mind that the visibility and weather conditions described by the witnesses presumably allowed a degree of visibility, but that because of the time of day and the precipitation this might have created a deceptive impression of a descent between two mountains. Subsequently the rising glacier, with a covering of fresh snow, might not have been recognised.
