AIRCRAFT ACCIDENT REPORT

**CONTROLLED FLIGHT INTO TERRAIN
AIR CHINA INTERNATIONAL FLIGHT 129
B767-200ER, B2552
MOUNTAIN DOTDAE, GIMHAE
APRIL 15, 2002**

**KOREA MINISTRY OF CONSTRUCTION AND TRANSPORTATION
KOREA AVIATION-ACCIDENT INVESTIGATION BOARD**

KAIB/AAR F0201
Adopted March 4, 2005

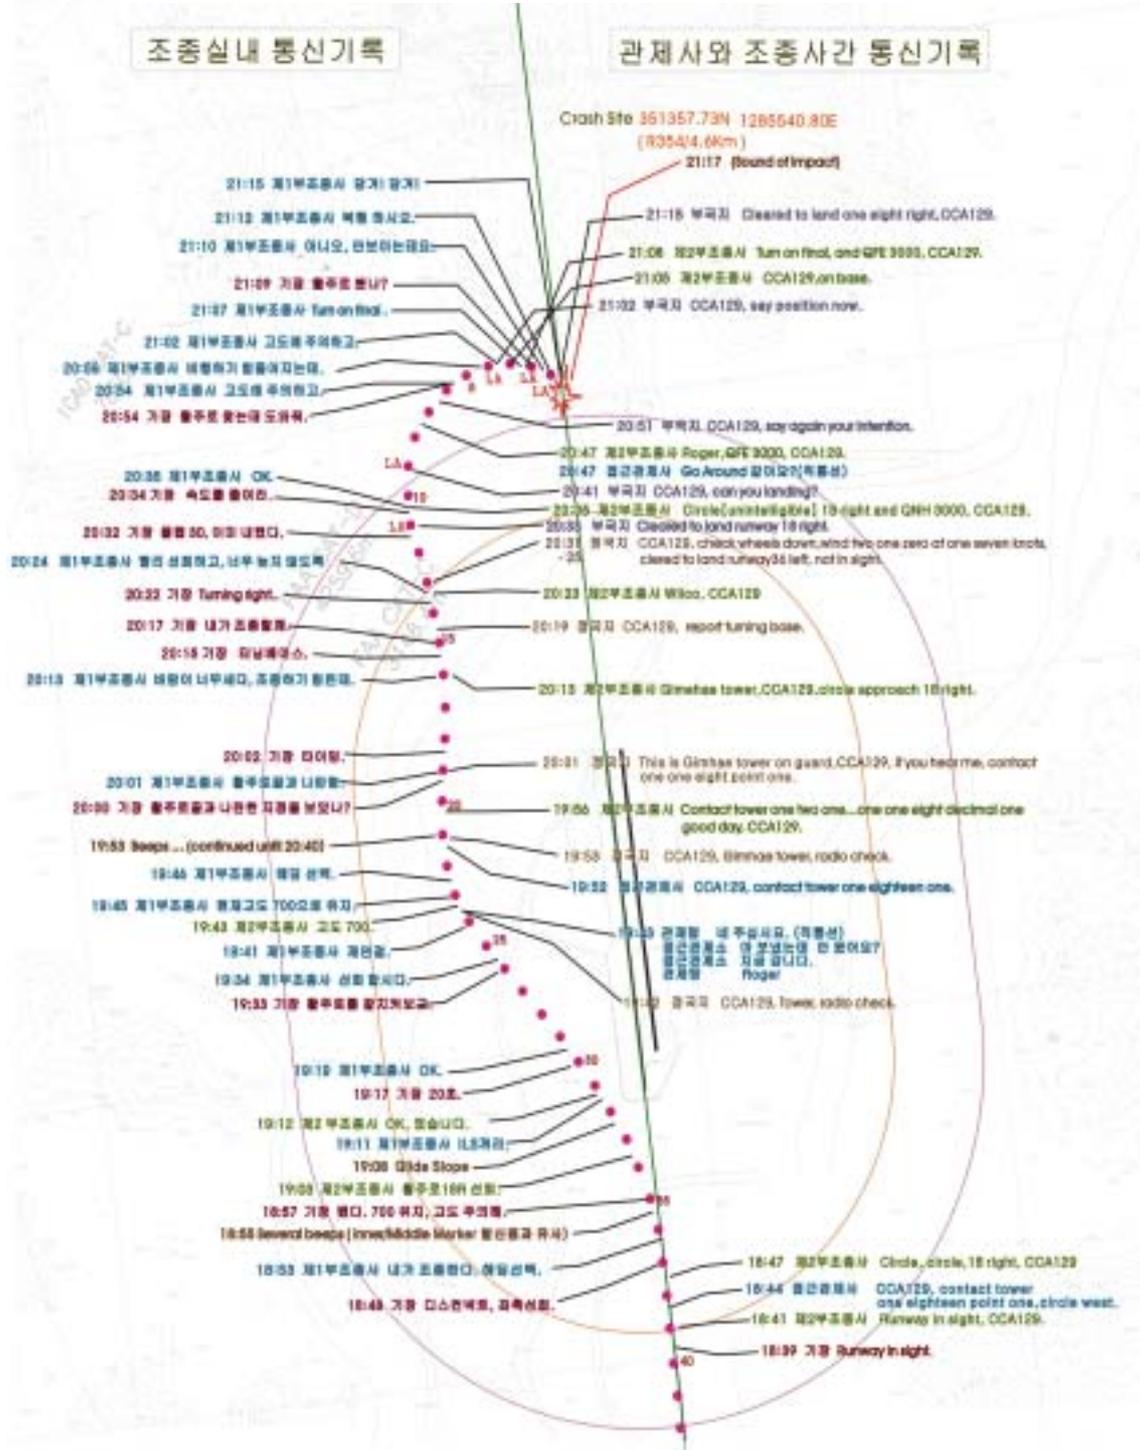
Figure 1-1 CVR & ATIS Transcripts Plotted along the Flight Track from the FDR Data (Korean Version)

Figure 1-1 (in Korean) and Figure 1-2 (in English) depict the flight track from the pertinent FDR data, with the communications of CVR and ATC tape recording transcripts, plotted on the chart, during the circling approach at Gimhae airport, until the time of accident.

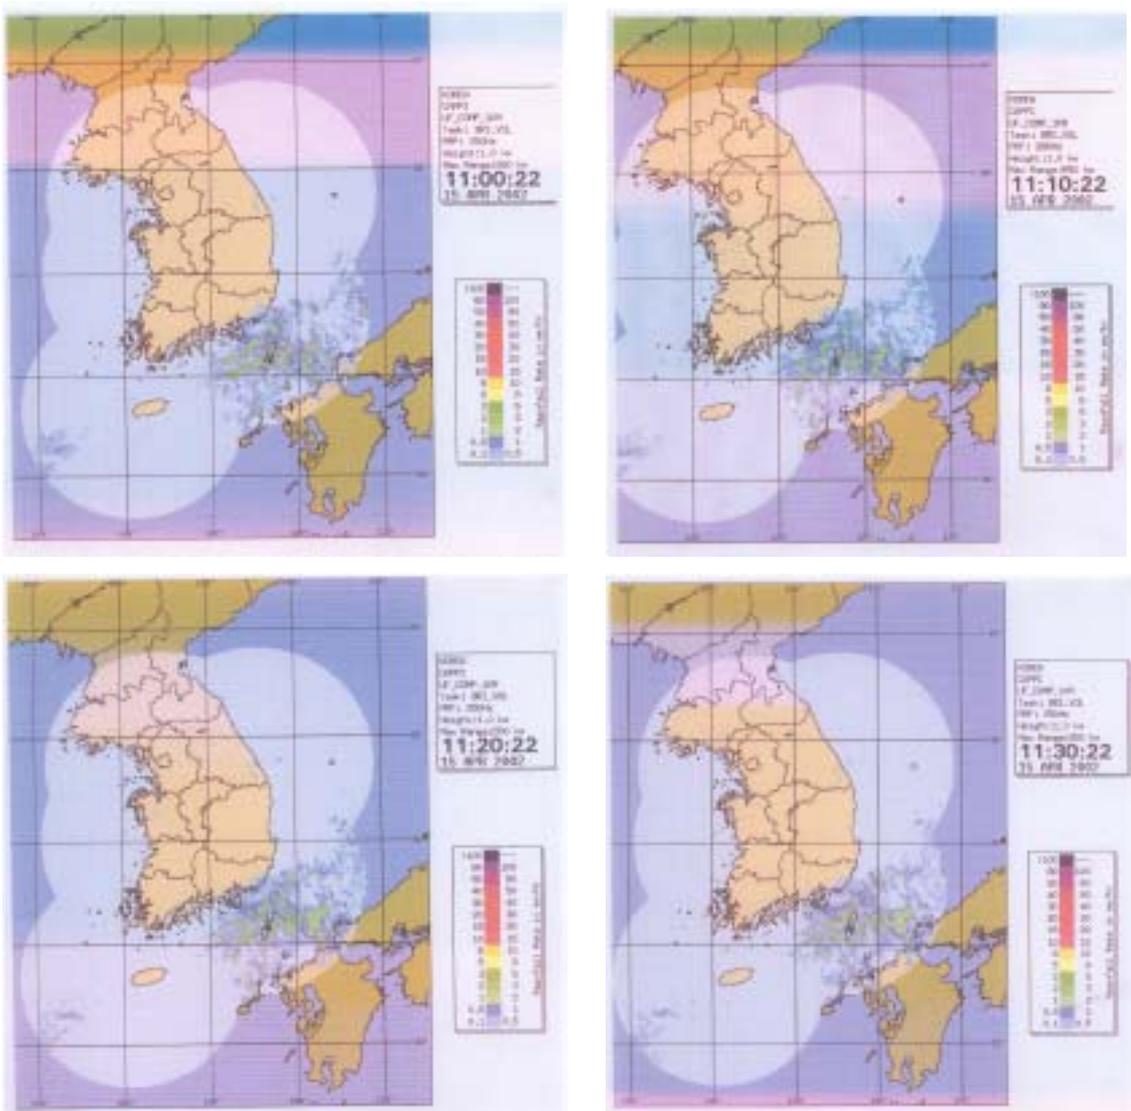
Figure 1-5 Radar Weather Data (11:00 ~ 11:30)

According to the upper air data at a height of 1 km, observed every 10 minutes between 09:00 and 12:00 on the day of the accident by the national weather radar network including the Korea Meteorological Administration weather radar installed on Mt. Gooduck located approximately 7-8 km southeast of Gimhae airport, about 09:00, there was a wide area of rain clouds of about 2 mm from the shores southwest of Gimhae airport to distant seas to the south and to the southeast as far as Japan, moving slowly to the east, so that at the time of the accident, about 11:20, rain clouds with less than 0.1 mm were remaining in the vicinity of the airport.

Figure 1-5 shows the radar weather data observed every 10 minutes between 11:00 and 11:30.

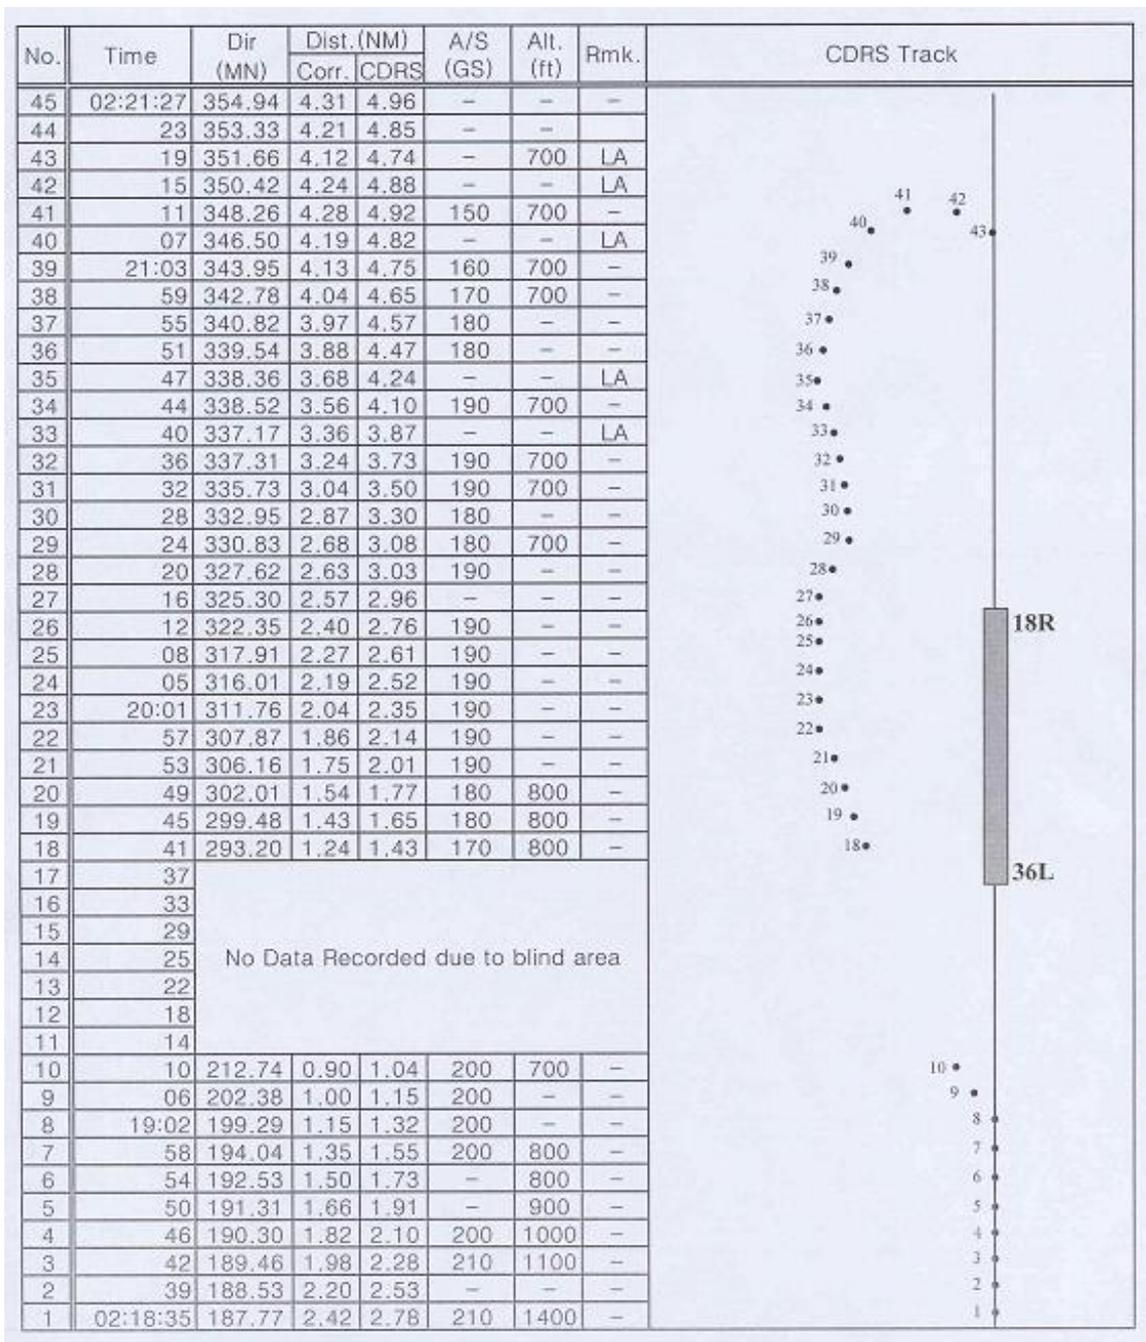
Figure 1-6 CDRS Data

Figures 1-6 and 1-7 illustrate respectively the radar track data and the circling approach area of flight 129 during the circling approach to runway 18R.

* Approximately 200 ~ 1,100 meters of difference existed from the final approach course to runway 36L to the crash point in the flight track on the drawing based on the CDRS data scaled one to 50,000, thus the CDRS data (distance) was multiplied by an invariable number 0.868976, and the revised the distance was calculated for the correction on the drawing. The flight track was composed on the basis of the revised data.

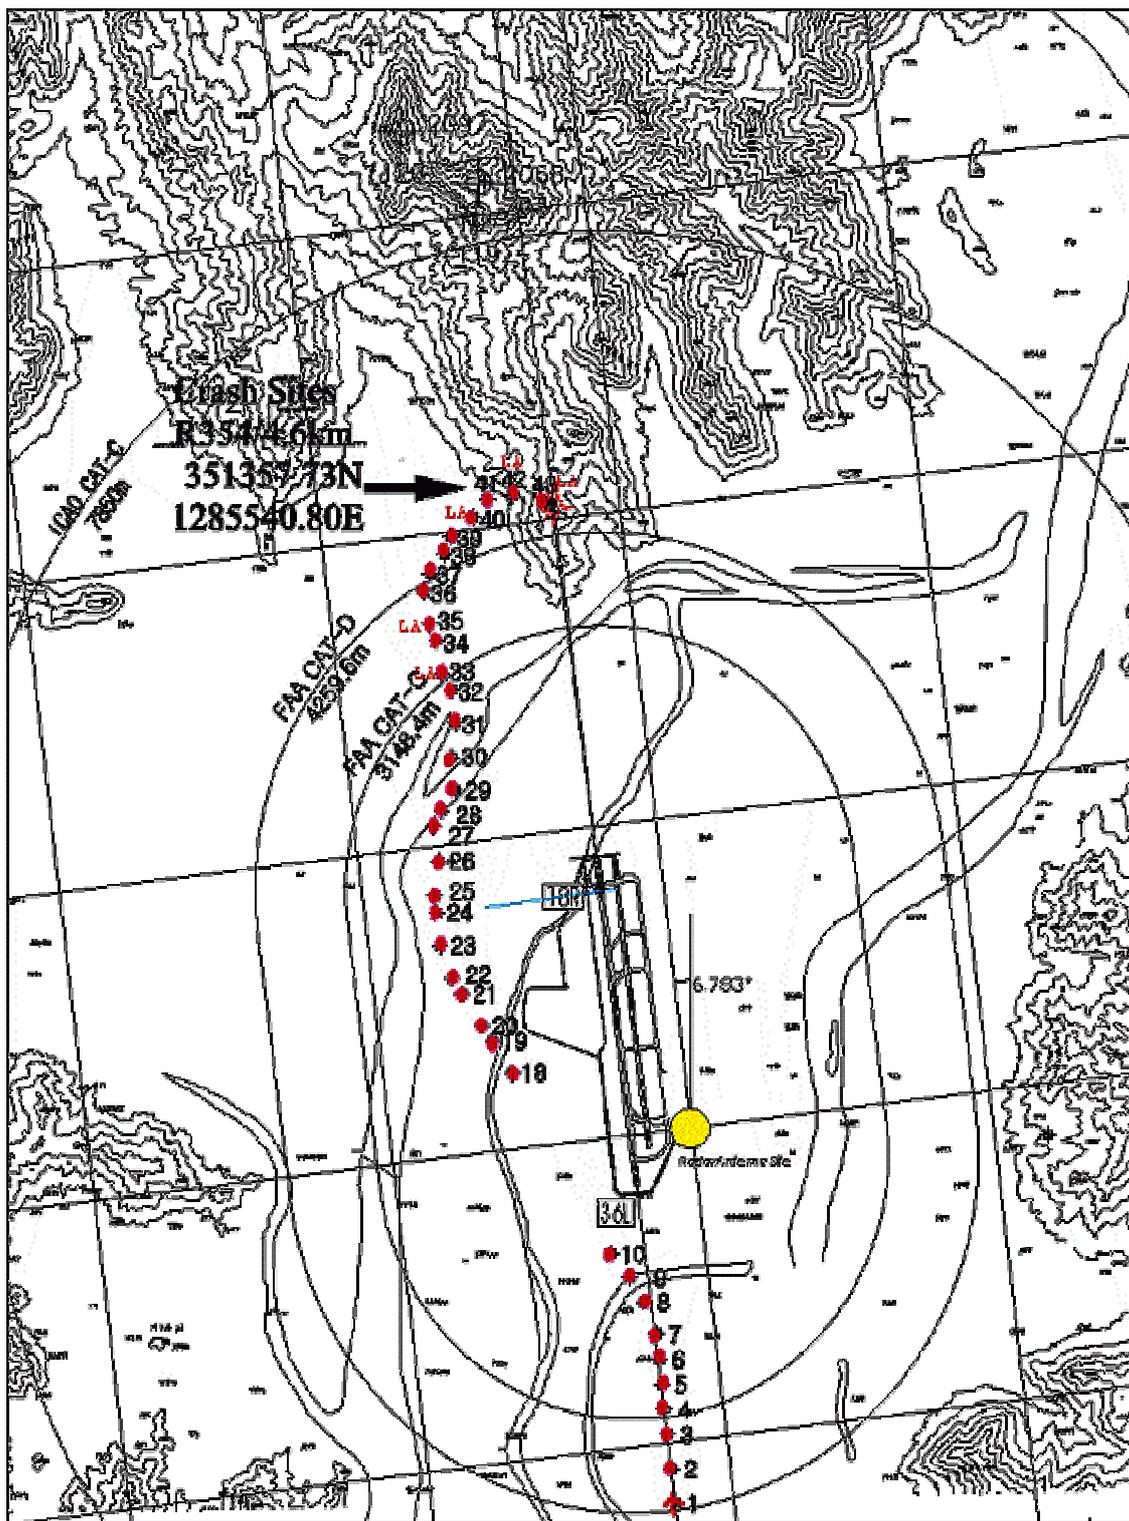
Figure 1-7 Circling Approach Radar Track of Flight 129 and Circling Approach Area

According to the statement⁵⁷ of the captain of flight 129, he observed the runway lights on the final approach course to runway 36L, however, he saw neither the runway lights on the downwind leg nor circling guidance lights during the circling approach. According to the record of the automatic aeronautical light switching system, and the testimony of the Gimhae tower duty chief in the public hearing, the runway, approach and circling guidance lights⁵⁸ of runway 18R were on at the time of the accident.

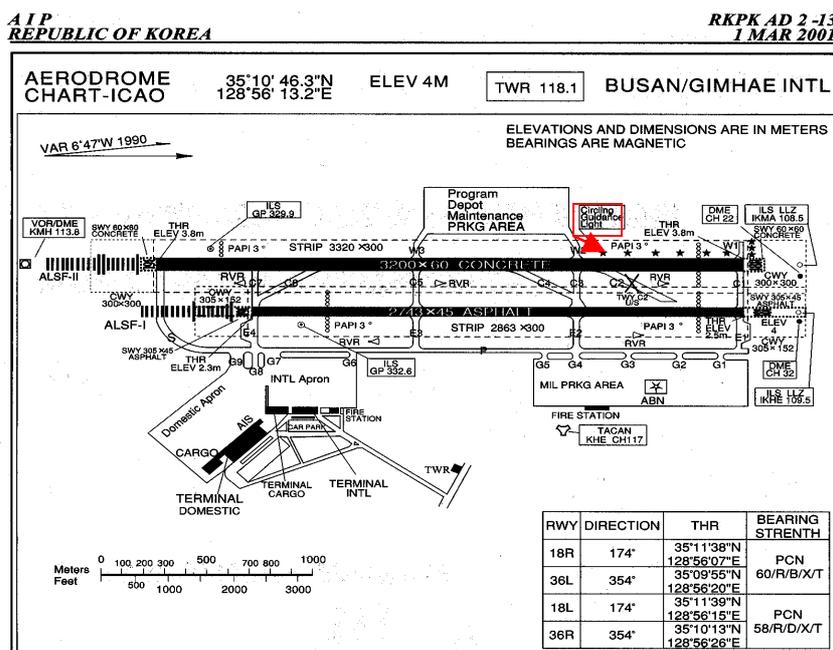
Figure 1-8 Circling Guidance Lights at Gimhae Airport

The automatic light switching and recording systems, used to calculate lighting fees, were installed in the lighting control room. The lighting times are automatically calculated by the clock installed in the system computer. The investigation revealed that the clock had been running about 19 minutes “fast,” and the clock was reset correctly by an engineer about 20:30 on April 18, 2002.

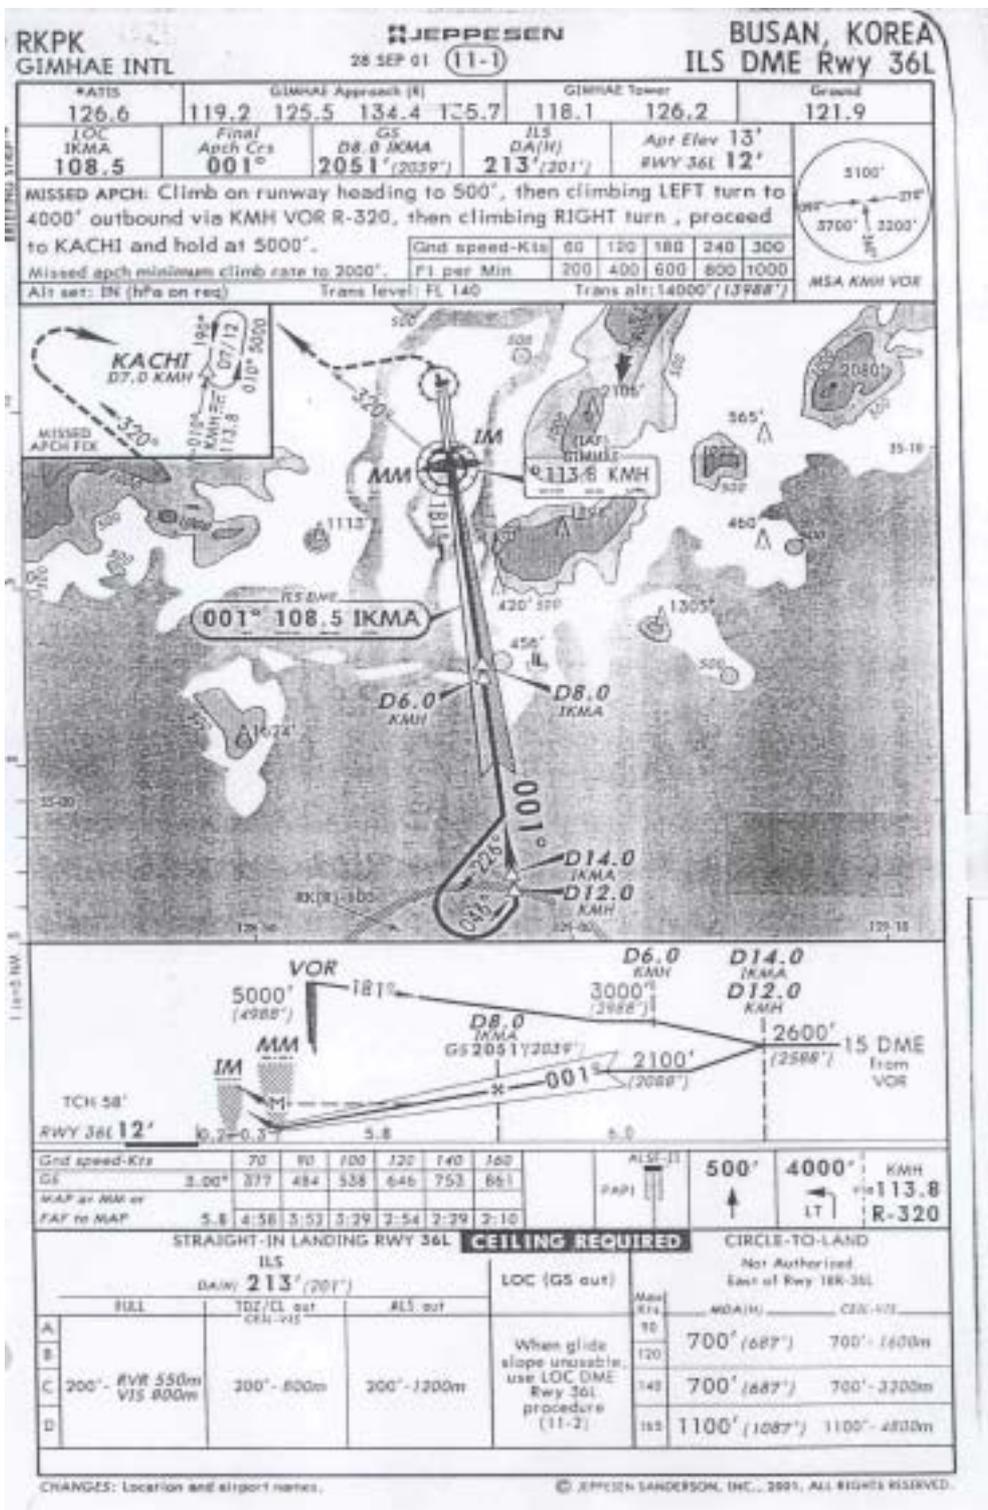
Figure 1-11A RWY 36L Instrument Approach Chart (Issued date: SEP 25, 01)

The instrument approach chart used⁶⁶ by the flight crew of flight 129 as shown on Figure 1-11A (ILS DME Rwy 36L, effective SEP 25, 01), displayed the plan view with contour lines and different shades of color to show heights of the terrain, and obstacle symbols marked with the elevations. The enlarged depiction of the missed approach holding precluded showing the obstacles to the north of the circling approach area. The Jeppesen chart of the Busan, Korea ILS DME or LOC DME Rwy 36L published Oct 25, 2002 was revised according to the amended ROK AIP. Jeppesen took the opportunity in this revision to improve the plan view depiction by changing the plan view scale to include a larger area, including the terrain and obstacles in the vicinity of the accident as shown on Figure 1-11B.

In the Jeppesen manual, there are two kinds of approach chart formats; one is for the procedures designed with ICAO criteria, the other with FAA TERPS criteria. At the time of accident, all the ROK approach procedures in Jeppesen chart whether they are designed with ICAO or FAA TERPS criteria, were identified as TERPS criteria. See Figure 1-11A of KAIB report.

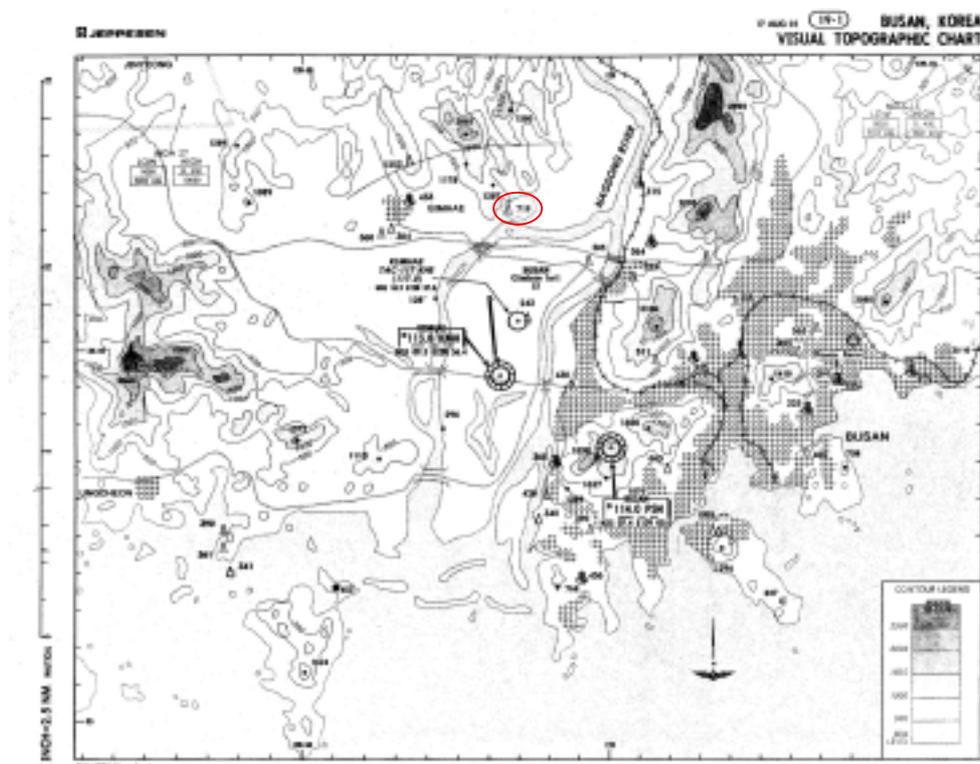
Figure 1-12 Visual Topographic Chart (Jeppesen RKP 19-1)

The Jeppesen manual, page 19-1 of Gimhae airport, a visual topographic chart as shown on Figure 1-12, did contain detailed obstacle and topographic information.

The position of key obstacle (719 feet), in the topographic chart of Jeppesen as shown on Figure 1-12 of KAIB report, which relating with the site where CA129 crashed, was about 2km deviated from the actual position by east, which had an adverse influence on pilot’ recognition of the terrain.

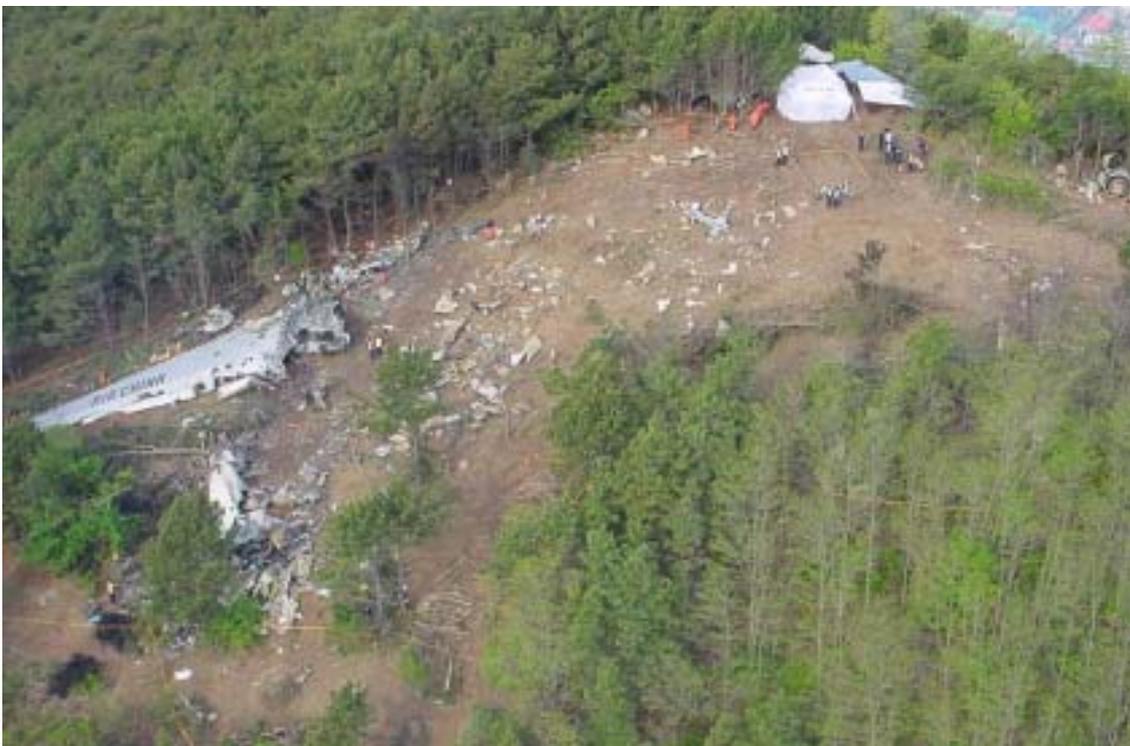
Figure 1-14 Photograph of the Accident Site

The investigation results on ground markings and the wreckage distribution pattern⁸² showed the initial contact with terrain of an elevation of 204m, where the right wing struck trees. As shown on the Figures 1-13 and 1-14, the wreckage was scattered in an area about 200 m long and 100 m wide.

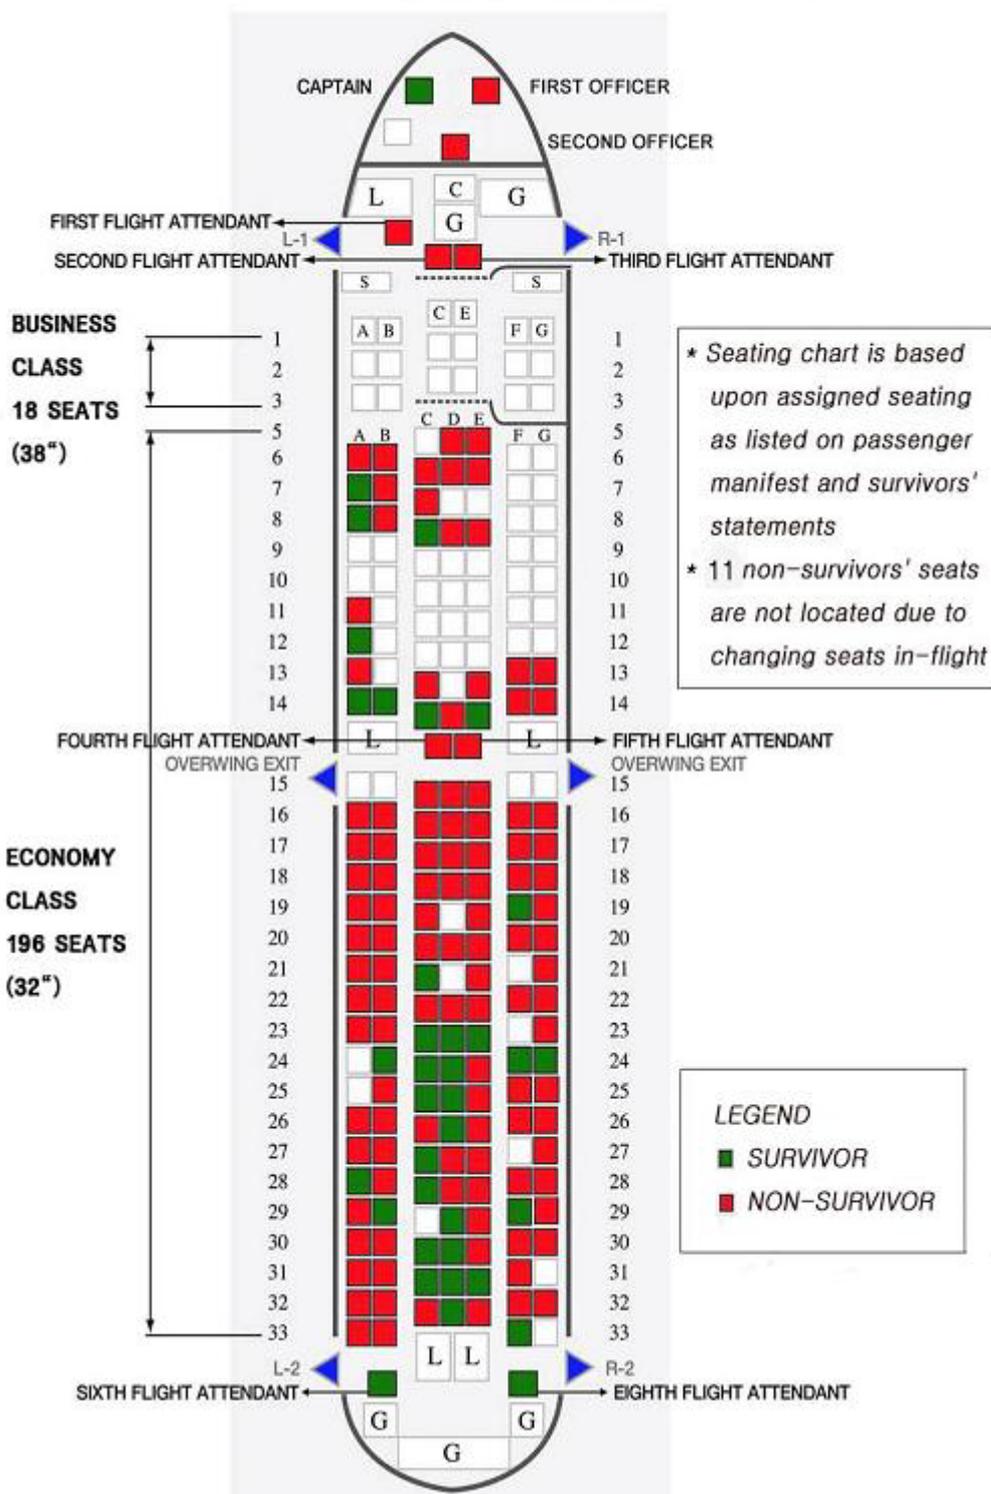
Figure 1-18 Seating Chart Showing the Location of the Occupants

Figure 1-18⁹³ shows that 8 of the 34 surviving passengers were seated in the economy class between rows 7 and 14, and out of these, 5 were seated on the left side and 3 in the middle seats. The seating for the other 26 surviving passengers was distributed from rows 19 to 33 in the back of the economy class, of which 3 were on the left side, 18 in the middle, and 5 on the right side.

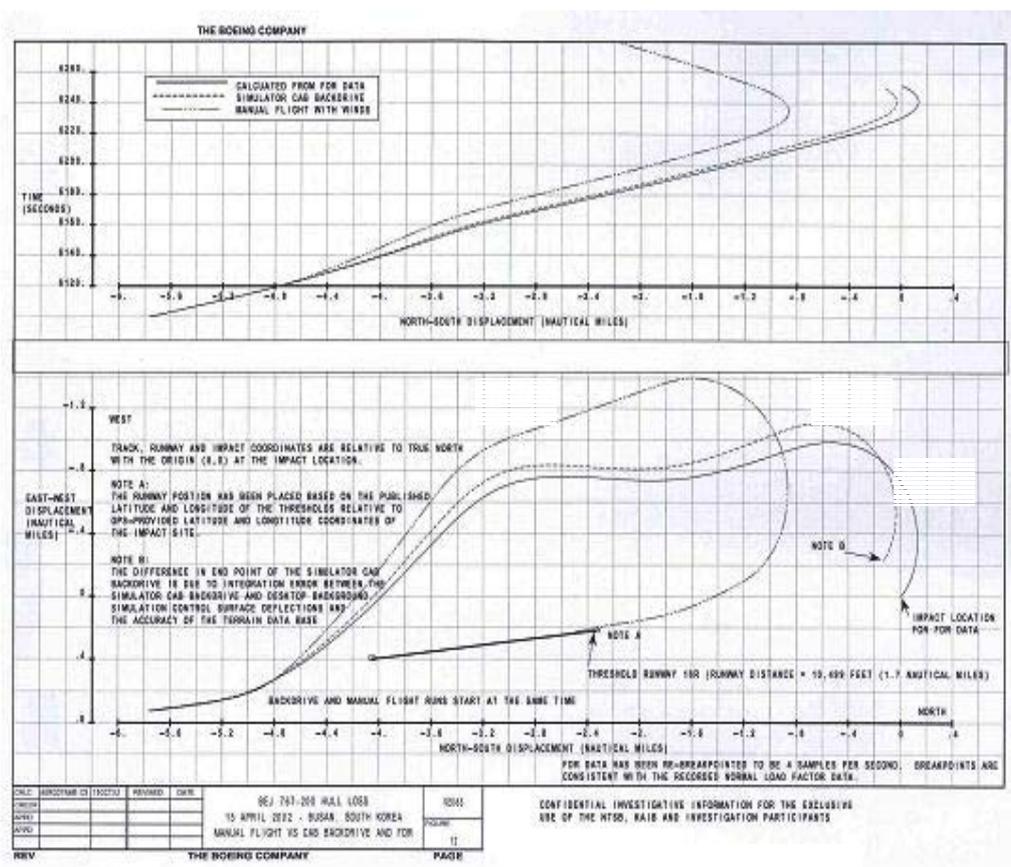
Figure 1-19 Flight Tracks from the Simulator Backdrive Session

The three tracks plotted on Figure 1-19 began from the same starting point, where: manual circling approach maneuvering track with wind corrected heading and 20 seconds time check; the backdrive cab track; and the FDR track are shown.

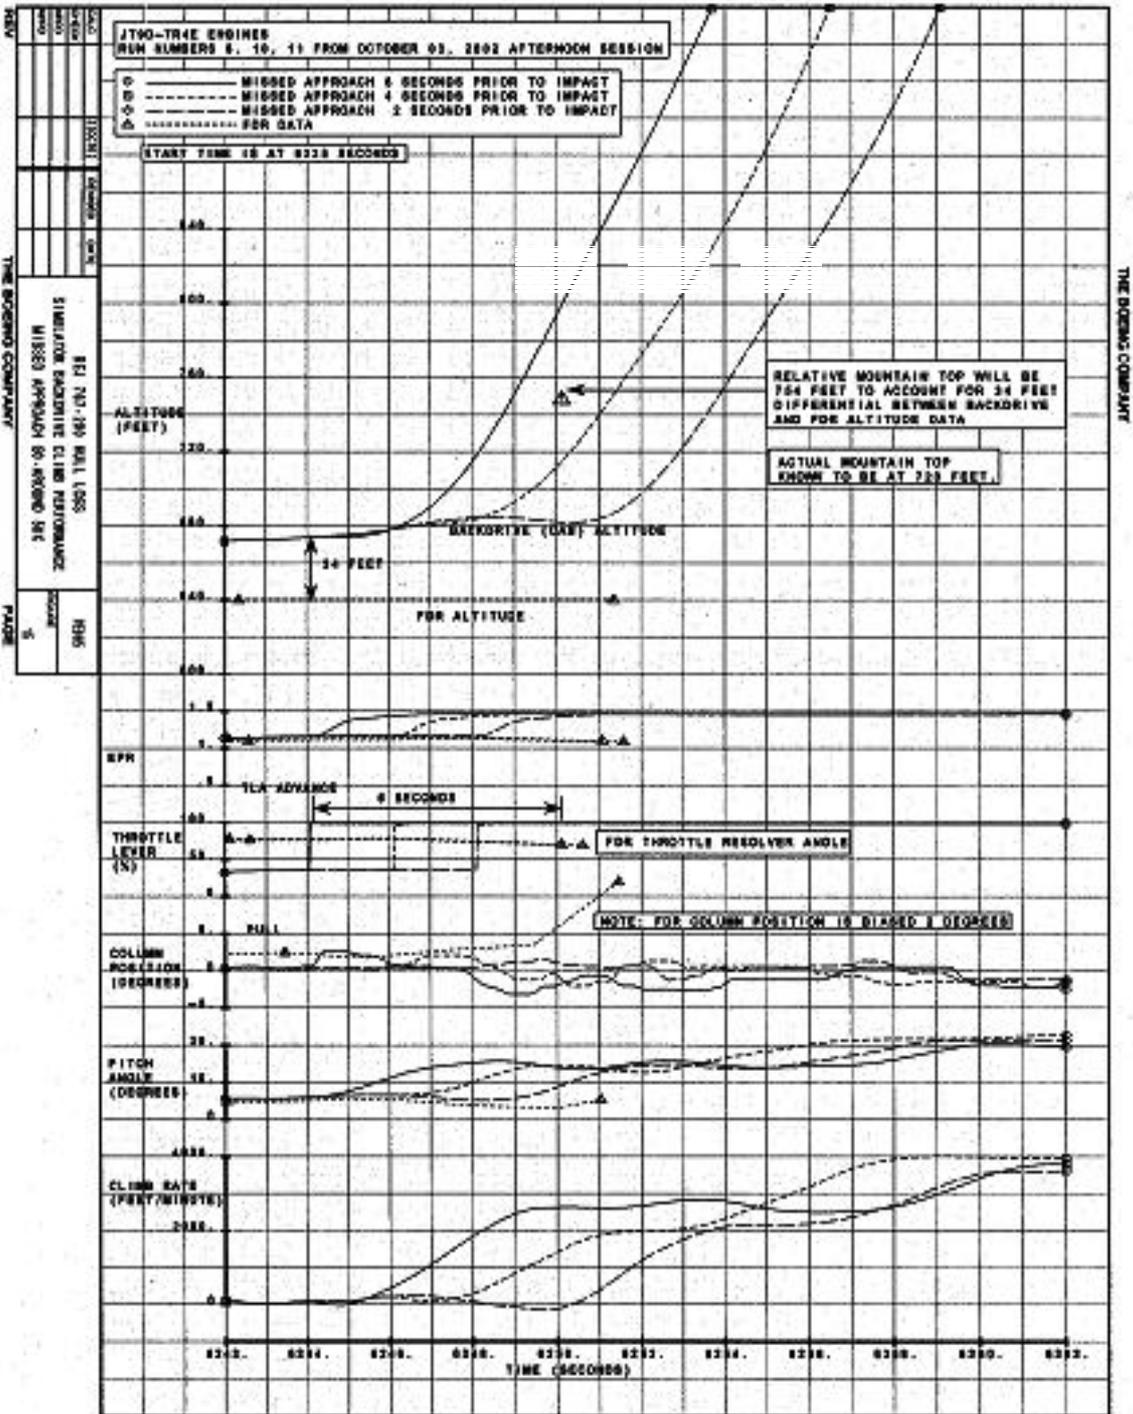
Figure 1-20 Climb Performance Data, Missed Approach Maneuver

Both go around and terrain avoidance maneuvers showed the aircraft clearing the mountain when either maneuver was performed 6 seconds prior to impact.

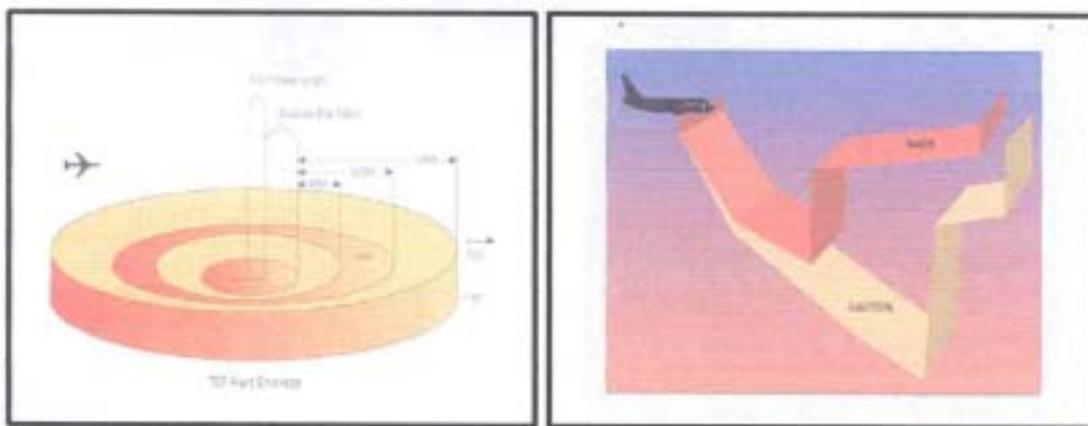
Figure 2-3: Terrain Clearance Floor Alert Envelope, Centered on the Runway

When an aircraft approaches an alert envelope, the EGPWS activates caution lights and generates an aural warning, “Too Low Terrain.” Both aural and visual warnings are generated 60 seconds prior to impact, and an aural “Pull Up” is generated 30 seconds before impact.

If the flight 129 aircraft had an EGPWS installed, it would have been a valuable tool to alert the flight crew about the approaching high terrain.
