Aviation Occurrence Report Volume I

ASC-AOR-05-02-001

IN-FLIGHT BREAKUP OVER THE TAIWAN STRAIT
NORTHEAST OF MAKUNG, PENGHU ISLAND
CHINA AIRLINES FLIGHT CI611
BOEING 747-200, B-18255
MAY 25, 2002

AVIATION SAFETY COUNCIL

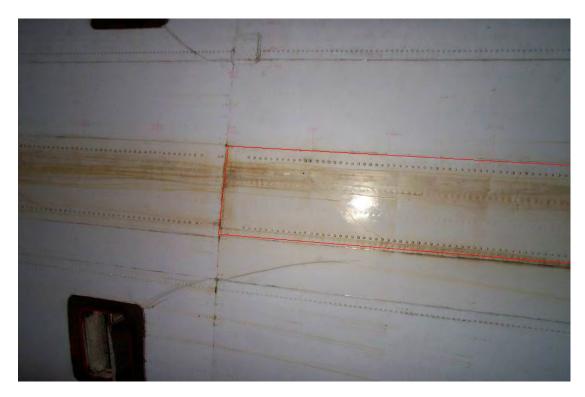
Figure 1.6-8 Aft of No.16 doubler (Picture taken on Nov 26,2001)

The B-18255 repair doubler mapping chart is shown in Figure 1.6-7. Photographs of number-16 doubler, the repair as the result of the 1980 tail strike, are shown in Figure 1.6-8 and 1.6-9. Number-16 doubler consists of two patches. The size of forward patch is 125 inches in length and 23 inches in width from STA 2060 to STA 2180. The aft patch is 60 inches in length and 23 inches in width from STA 2180 to STA 2240.

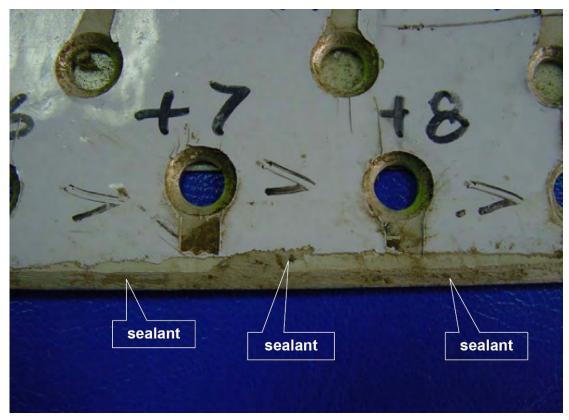
Figure 1.6-11 Paint removed from the doubler edge with sealant remaining

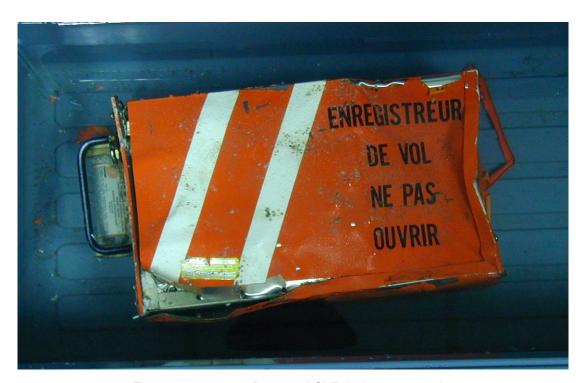
Figure 1.11-1 Damaged CVR in the water cooler

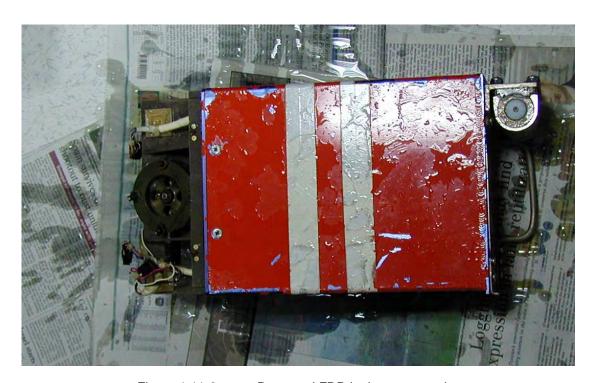
Figure 1.11-2 Damaged FDR in the water cooler

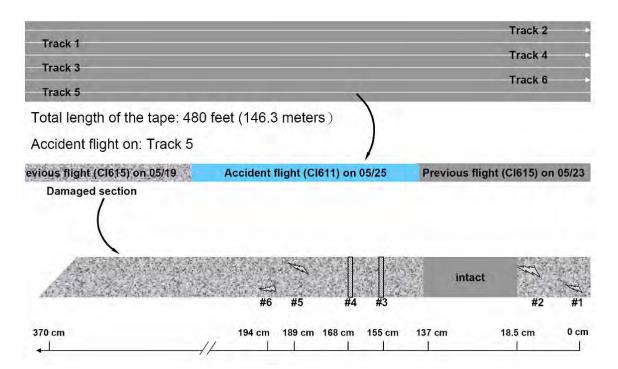
Upon arrival, the FDR enclosure was open immediately and the magnetic tape was found damaged. Pictures of the damaged FDR tape are shown in Figures 1.11-3 and 1.11-4. There are six crinkle marks on the tape.

Figure 1.11-4 Sketch of damaged tape locations and conditions

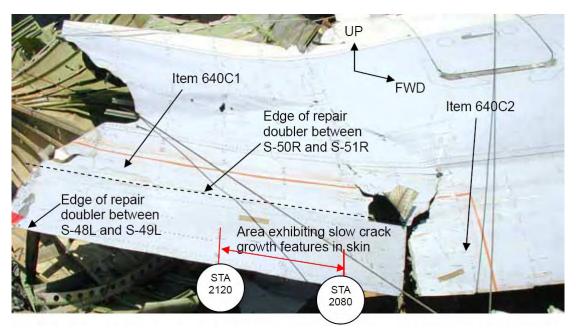
Figure 1.12-6 Item 640

Also included in item 640 is the bulk cargo door. The segment was recovered with the door closed and latched. The lower portion of the bulk cargo door seal protruded through the space between the door and the sill.

The forward portion of item 640 includes the aft portion of the aft cargo door cut out frame. There are deformations at the lower latch fitting attachment location.

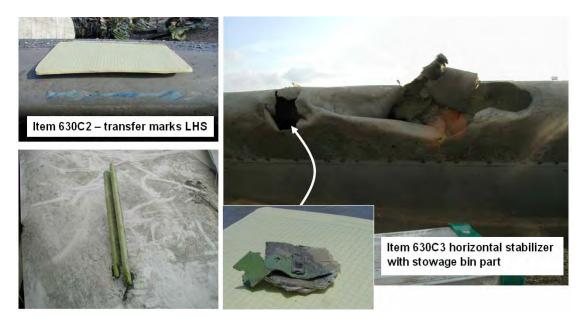
Figure 1.12-10 A small segment of fuselage stringer imbedded in the RHS elevator (left-down). A small fastener and shim were found inside the RHS leading edge (right).

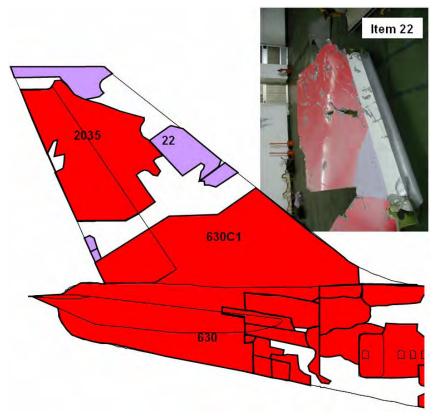
The lower portion of the fin (item 630C1), the upper portion of the fin (item 2035), and several of the floating pieces (item 22) show similar evidence of impact damage on the right side.

Figure 1.12-11 Vertical fin and item 22

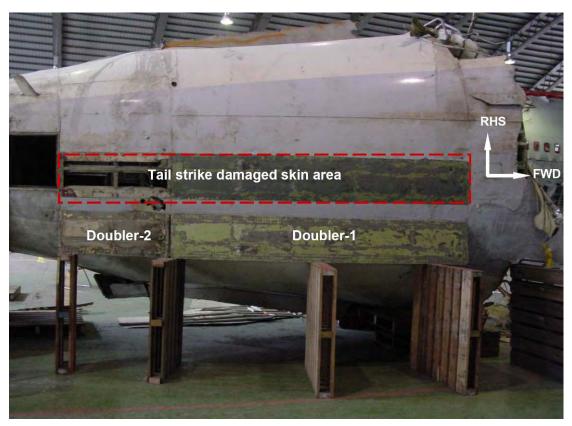
Figure 1.12-13 Doublers in section 48

The belly area of item 630 between STA 2484 to STA 2658 was examined, and two adjacent doublers were removed during wreckage examination as shown in Figure 1.12-13.

The B-18255 Aircraft Log Book stated the belly skin area between STA 2578 to STA 2638 had serious abrasion damage. Examination of the skin underneath the two doublers revealed that, skin underneath Doubler-1¹⁸ (STA 2484 to 2598) had damage consisting of fore to aft (longitudinal) scratching with the most severe scratching at the locations of skin stiffening members. The damaged area had not been cut out or removed (trimmed), however, blending was found over much of the repair surface. Skin beneath the Doubler-2 (STA 2598 to STA 2658) was cut out as shown in Figure 1.12-13.

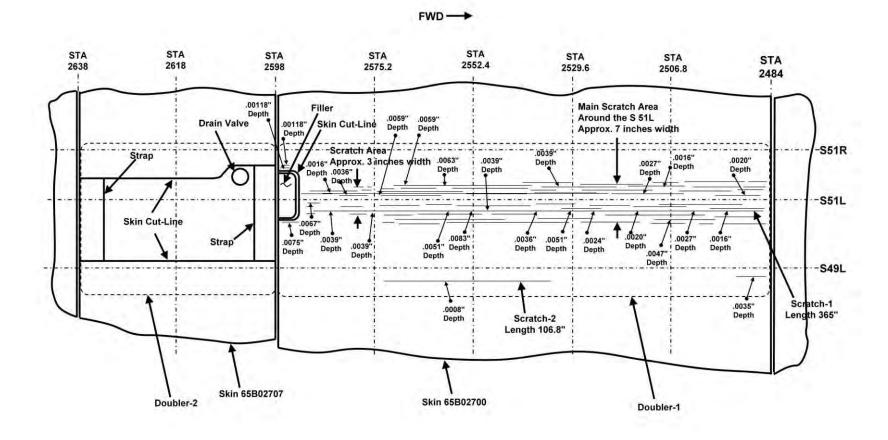
Figure 1.12-14 The schematic diagram of the doublers in Section 48

and starts from STA 2535 with the length of 42 inches. No evidence of crack was identified in this region. There are dents at STA 2567 and STA 2610, which was the result of wreckage handling.

It was noted that the former topcoat, enamel and primer (original painting before the skin repair) remained on the skin covered by Dubler-2.

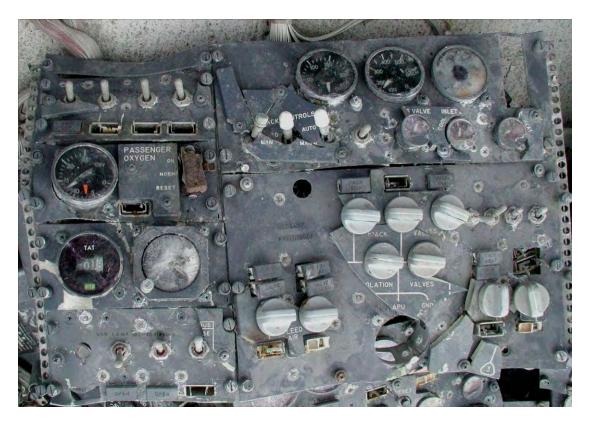
Figure 1.12-17 Flight engineer panel

Bleed Air switch was found in OPEN.

- MODE SELECT switch was found in MAN (manual) mode.
- The ALTITUDE tape was delaminated and partially missing.
- Both OUTFLOW VALVES indicator needles were found detached from their respective internal armature/wiper attachment mechanisms.

- The three PACK VALVES switches were found in the OFF position.
- Engine numbers 1 and 2 BLEED AIR switches were found in the OFF position.
- Engine numbers 3 and 4 BLEED AIR switches were found in the ON position.

- PASSENGERS OXYGEN needle at 700 psi. (which was disconnected from its driving rod either during or before disassembly).
- PASSENGER OXYGEN control switch was found in NORM position. Switch is functional.
- Switch guard breakaway wire is broken.
- Switch guard is damaged with portion missing.

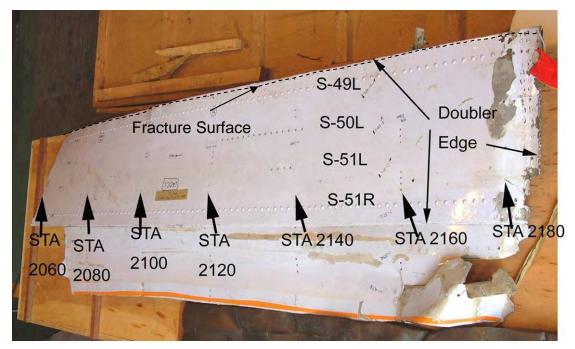
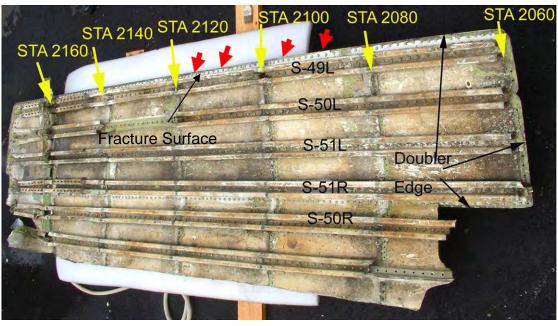
Figure 1.16-1 Exterior (up) and interior (down) of Item 640C1

Item 640C1 was a segment of Item 640 approximately from STA 2060 to 2180 and from S-49L to S-49R (Figure 1.16-1). A 23-inch wide, 125-inch long external repair doubler was attached to the skin by two rows of countersunk rivets around its periphery as well as by fasteners common to the stringer and shear tie locations. Universal head rivets were used at S-51R and S-49L while countersunk rivets were used at S-50L and S-51L.

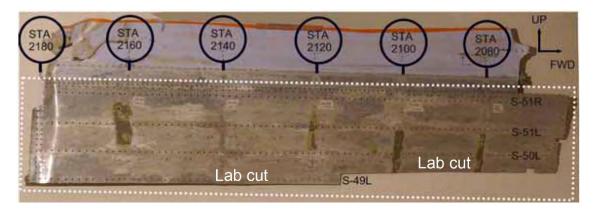
Figure 1.16-2 Faying surface with the repair doubler and protective finishes removed

After disassembling the doubler from the skin and removal of the protective finishes, scratching damage was noticed on the faying surface of the skin (Figure 1.16-2). This damage consists of primarily longitudinal scratching distributed in an area of 120 inches by 20 inches. The most severe scratching typically occurred at the skin stiffening members such as skin stringers and body frame shear ties. Evidence of an attempt to blend out these skin scratches, in the form of rework sanding marks, was noted over much of the repair surface. A close view of the skin area near STA 2080 is shown in Figure 1.16-3.

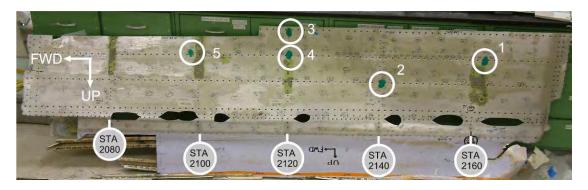
Figure 1.16-4 Locations chosen for scratch depth measurement

Five locations exhibiting major scratches on the repair faying surface of the skin as shown in Figure 1.16-4, were chosen for the examination of the scratch geometry and depth. The maximum scratch depth measured in each location is shown in Table 1.16-1.

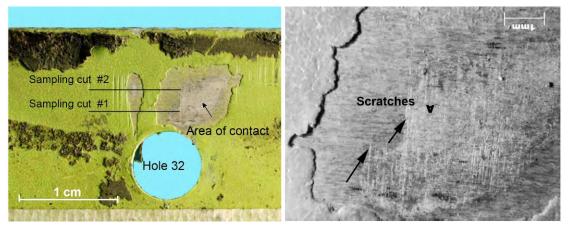
Figure 1.16-9 Area of contact near hole 32 showing the different colors (left) and scratches present (right)

- The fretting marks observed from STA 2061 (hole +16) to STA 2132 (hole 49) are associated with most of the rivet locations. The most significant fretting damage was present between holes 8 and 43.
- The fretting marks near hole 32 and an optically magnified photograph of the area of contact is shown in Figure 1.16-9. It shows that the area of contact exhibits many colors and some hoop-wise scratches (marked by arrows).
- Two cross-section locations were chosen to characterize the area of contact.
 Figures 1.16-10 and Figure 1.16-11 show the metallographic photographs
 through the area marked by data sampling cut #1 and data sampling cut #2
 respectively. It is observed that there was some material superimposed
 over the grooves of the scratches.

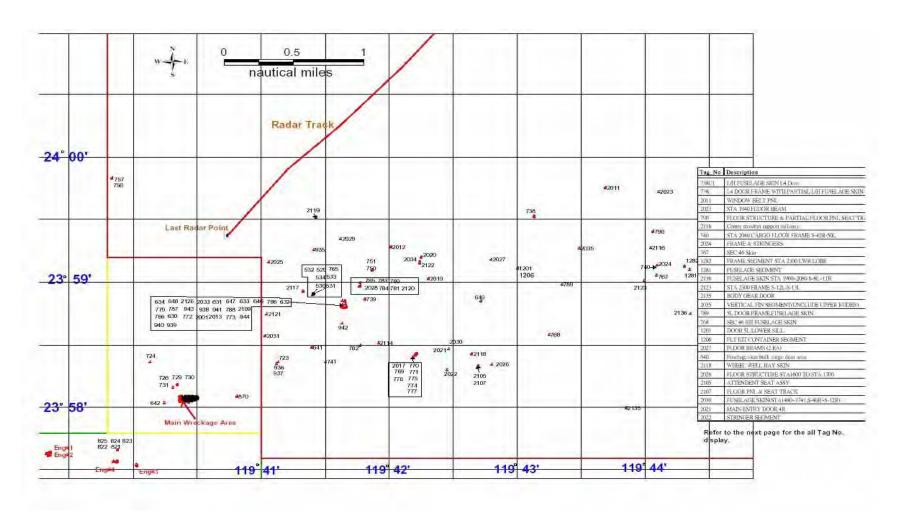
Figure 1.18-4 The wreckage distribution map

investigation lasted nearly 5 months, recovered approximately 1,500 pieces, and 175 bodies. After combining all the survey sources and the wreckage recovery locations, the wreckage map is shown in Figure 1.18-4. There are still 50 bodies and a major portion of the Section 46 uncovered.

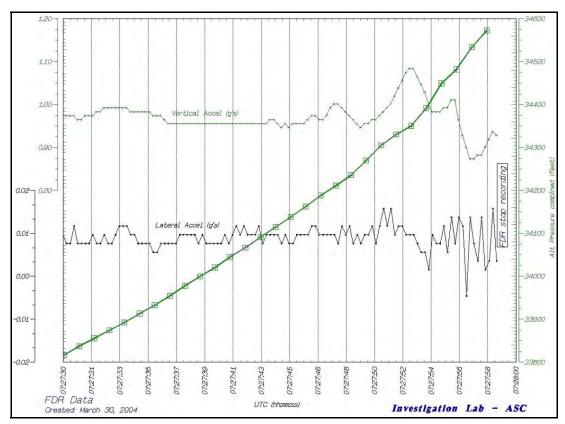
Figure 2.1-1 Cl611 vertical and lateral acceleration data (last 30 seconds)

By carefully examining the acceleration data from the FDR, one can observe that 10 seconds prior to the loss of power of the flight recorders, there was a slow increase in both the vertical acceleration and lateral acceleration, as shown in Figure 2.1-1. By comparing the lateral acceleration parameter of the previous two flights of B-18255, before approaching its cruising altitude of 35,000 ft, similar oscillatory behaviors were found, as shown in Figure 2.1-2. Comparison was also made of the vertical acceleration parameter of Cl611 and the two previous flights. A more pronounced increase in magnitude of the vertical acceleration was observed. These data led to the consideration that a preliminary breakup of the fuselage structure might have been in progress before the power loss of the FDR.

However, on Boeing 747 aircraft, the accelerometers are mounted along STA 1310, which is near the aircraft's center of gravity. These instruments measure accelerations of the aircraft associated with maneuvering, turbulence etc. They do not accurately measure the frequencies of vibrations that may pass through the fuselage. With the limited data available, the Safety Council could not determine what led to the slight increase in vertical acceleration prior to the break-up of the aircraft.

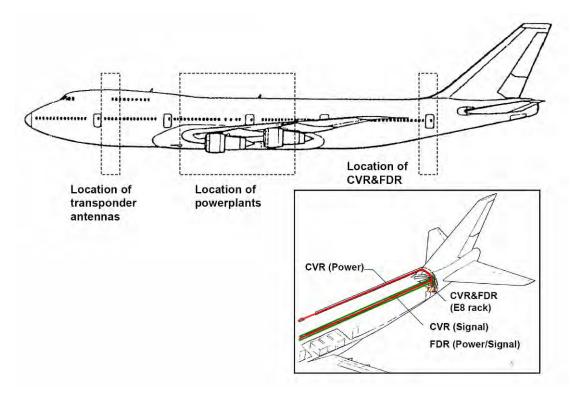
Figure 2.2-1 Locations of flight recorders, transponder antennas, and power plants

In addition, both recorders were located in the aft portion of the aircraft (above ceiling near to door 5L) and both transponder antennas were installed behind door 1 (Figure 2.2-1). The power of the CVR and FDR was interrupted simultaneously at 1527:59. However, the radar transponder continued to transmit for about 15 seconds longer. Therefore, the breakup should occur between the power plants and the recorders.

The Aviation Safety Council concludes that the loss of power to the CVR and FDR was the result of damage to electrical wires in the aft-pressurized fuselage area as the aircraft began to breakup. The forward portion of the aircraft continued to have power to the Mode-C transponder system for about an additional 15 seconds, before power to the transponder was interrupted.

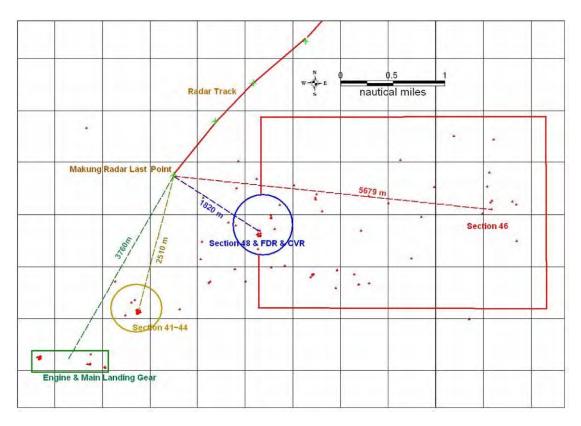
Figure 2.2-3 Relative location of the wreckage

Figure 2.2-3 shows the relative locations of the CI611 wreckage. The wreckage distribution pattern matches the four groups of aircraft wreckage detected by PSR.

The wreckage distribution data show that the distance between the tail (section 48 with lower portion of fin) and forward portion of fuselage (section 41-44) was 1.5 nautical miles. The distance between the tail and most eastbound wreckage (section 46), which was recovered under water, was 3 nautical miles.

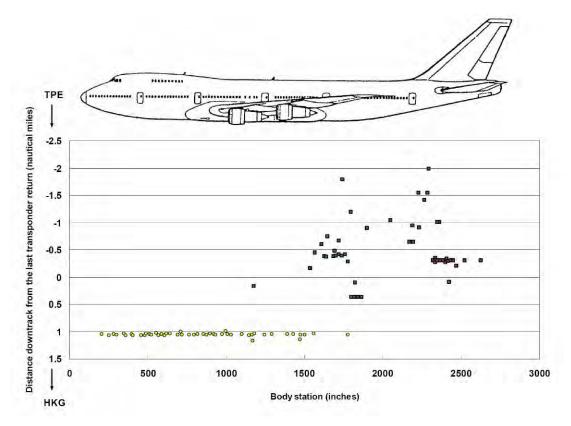
Figure 2.2-4 Wreckage distributions along the flight path

Hong Kong, which is shown in Figure 2.2-4. One can readily see that the wreckage pieces from the cockpit, engines, wings, all landing gears, and sections 41, 42, and 44 are distributed along a very concentrated segment while section 46, 48, and the tail empennage are spread widely.

The figure also shows a step jump from the forward portion of the aircraft to the aft sections. It shows that the fuselage section 46/48 structure aft of the aft wheel well bulkhead at STA 1480 was separated from the rest of the aircraft.

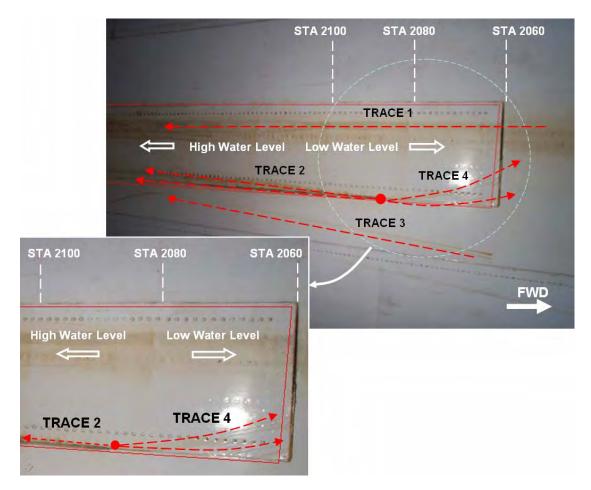
Figure 2.2-5 Comparison of Trace 1,2,3 (straight line) and 4 (curve)

The photograph was taken from underneath the aircraft looking up towards the fuselage. This area of the aircraft belly slopes upward towards the rear of the aircraft. When the aircraft is parked, the forward end of the doubler is closer to the ground then the aft end. There were several traces observed on the doubler and the skin around STA 2100. Traces 1, 2,and 3 are brown in color and straight toward the aft of the aircraft, suggesting that the traces were induced by the relative wind during flight. Trace 4 shows several curved lines of transparent condensate liquid that flowed from STA 2090 toward the forward (lower) end of the doubler, consistent with flow due to gravity when the aircraft was parked. The traces seen in the November 2001 photographs were not evident on the wreckage when it was recovered.

Traces 2 and 4 began at the same origin but went in different directions. It suggests that trace 2 occurred as the aircraft was in the air, but trace 4 occurred when the aircraft was on the ground. The darkness of the traces shows the accumulated time and quantity of the flow. The color of trace 2 is the darker, which suggests a larger quantity of flow escaped into the air stream in flight.

This phenomenon, discovered during the accident investigation upon examination of photographs of the 1980 repair doubler, showed that there was possibility hidden skin damage beneath the doubler in the vicinity of STA 2100, at the time when the photographs were taken.

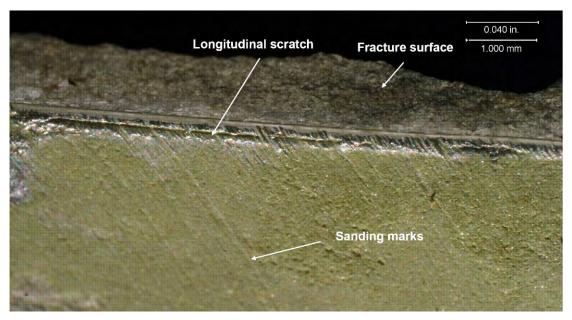
Figure 2.2-6 Fatigue crack originated from the scratch near hole 20

Photographs of the item 640 skin show that many longitudinal scratches (fore to aft) existed on the faying surface of the skin. An attempt to blend out of these scratches was also apparent from the rework sanding marks found on the repaired surfaces. Those scratches and sanding marks were consistent with the 1980 tail strike event of the accident aircraft.

The scratches caused discontinuity of the skin and stress concentration termed "stress risers." The laboratory observations showed that the main fatigue crack and most of the MSD aft and forward were initiated from the scratches that existed at or just beyond the peripheral row of fasteners common to the repair doubler. Figure 2.2-6 shows the longitudinal scratch on the faying surface of the skin near hole 20 where fatigue crack initiation occurred from multiple origins.

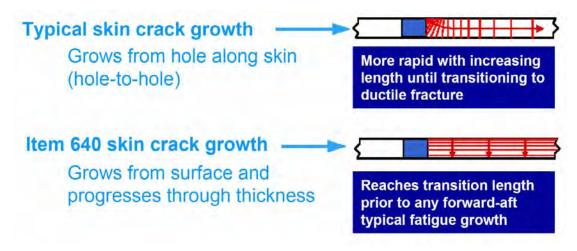
Figure 2.2-7 Cracking on Item 640 differs from typical fatigue crack

The fatigue crack pattern of Item 640 differs from traditional crack patterns. The standard cracking configuration assumes those cracks grow forward and/or aft

from hole to hole. But the crack configuration of Item 640 identified in the laboratories does not show any evidence of forward-aft striations within the flat-fracture fatigue areas. Instead, the crack growth pattern on Item 640 shows an increasing growth rate through thickness (Figure 2.2-7). This can be attributed to the cracks growing from many origins on the skin surface at the scratch locations and propagating inward. While the number of cycles required for the cracks to propagate through the skin thickness was determined as indicated in the BMT report, it was not possible to determine when in the aircraft history these particular cycles occurred. Thus, it was not possible to determine when the crack first penetrated the entire skin thickness.

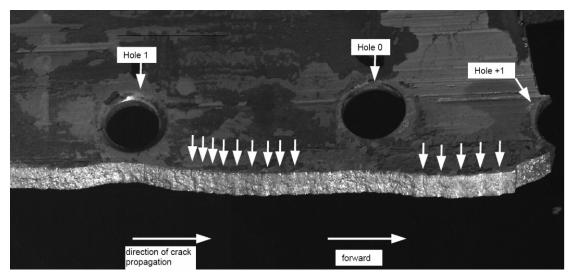
Figure 2.2-9 The regular spacing of cracking increments found on Item 640

The regular spacing of these marks as shown in Figure 2.2-9, is consistent with the application of constant magnitude stress cycles, or the pressurization cycles (once per flight cycle). These marks are more closely spaced near the flat-fracture fatigue area than away from the main fatigue area. These incremental crack growth indications were observed as far forward as approximately STA 2055 (outside the covert of the repair doubler) and as far aft as STA 2140 (hole 56).

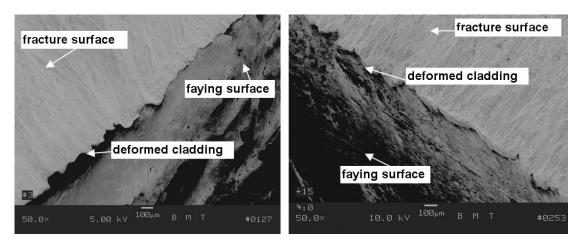
Figure 2.2-10 SEM photographs of the cladding near hole 3 (left) and +15 (right)

Cyclic rubbing of the fracture surface and associated compressive deformation of the cladding was observed along the faying surface shown in Figure 2.2-10 providing additional evidence of pre-existing crack. The cladding displayed compressive deformation due to cyclic crack closure as far forward as hole +17 and as far aft as hole 62. The remaining fracture aft of hole 62 displayed "necking", which is typical of continuous tensile loading to ultimate tensile separation (Figure 2.2-11).

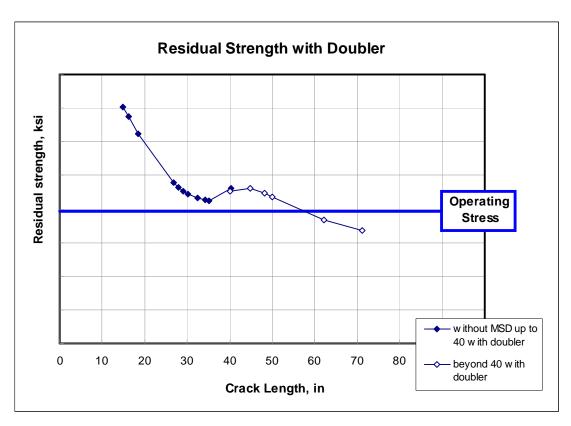
Figure 2.2-13 Residual strength of cracking

From the residual strength analysis discussed in section 2.5, when the crack was over 58 inches, the residual strength of the skin assembly would go below the operating stress (Figure 2.2-13), therefore caused the skin assembly beyond the capability limit under the application of normal operational loads.

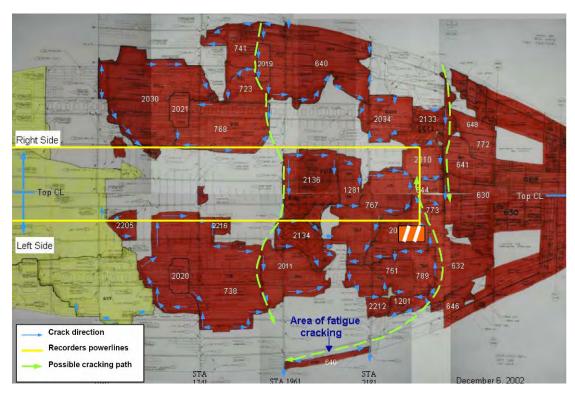
Figure 2.2-14 Directions of fracture propagation

Figure 2.2-14 shows the direction of the crack propagation on each piece of the wreckage in section 46. The methodology used to determine the direction of the cracking is described in Appendix 18. Once a portion of the structure failed, it could no longer sustain the integrity of the entire fuselage structure. The propagation pattern of the fracture is highly nonlinear and extremely dynamic. Without the recovery of all the wreckage pieces, it was nearly impossible to draw a conclusive break-up sequence of the aircraft. Therefore, the following observation only provides one possibility for the cracking to link together accordingly and formed a possible propagating sequence.

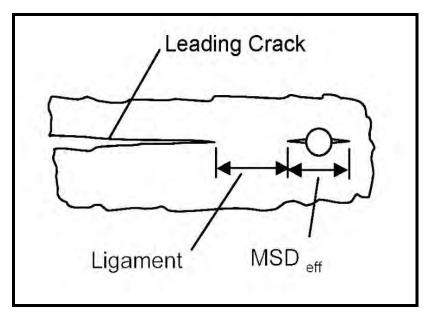
Figure 2.5-3 The relation between the leading crack and MSD

Phase one of the analysis was to determine the capability of the skin given the stable, flat-fracture, through-thickness fatigue crack as confirmed by the CSIST and BMT. It considered the main 15.1-inch long through thickness fatigue crack centered at STA 2100 frame as well as the MSD. MSD adjacent to the leading crack could further reduce the residual strength of the skin. The degree of reduction in its residual strength is dependent on the size of the MSD, and its proximity to the leading crack defined by the length of the ligament. A local ductile fracture could occur between the leading crack and the adjacent MSD once the reduced residual strength of the skin is lower than the applied stress (Figure 2.5-3).

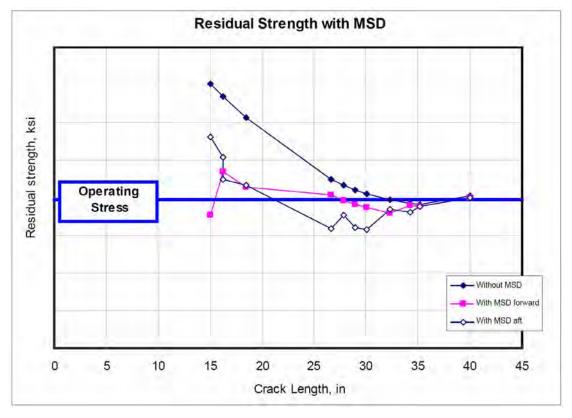
Figure 2.5-4 The residual strength of the crack length up to 40 inches

The reduction factors were calculated for the forward and afterward MSD adjacent to the leading crack. The leading crack would link to the MSD hence yield a relatively lower strength and then a new leading crack formed. The result of the final calculation was shown in Figure 2.5-4.

The upper curve of the Figure 2.5-4 shows the capability of the discontinued skin assembly without MSD. The lower two curves represent the residual strength capability of the skin assembly reduced by MSD effect within the two-bay region. These two curves indicated that the fatigue cracks identified in the two bay region should begin linking together as an overall crack length of 21 inches formed. For Item 640, once the crack grew to 35 inches, the MSD is no longer a factor in the residual strength capability, and then only the upper curve (without MSD) should be considered. Noted that at a two bay length (40 inches), the calculated residual strength capability and the operating stress are essentially equivalent.

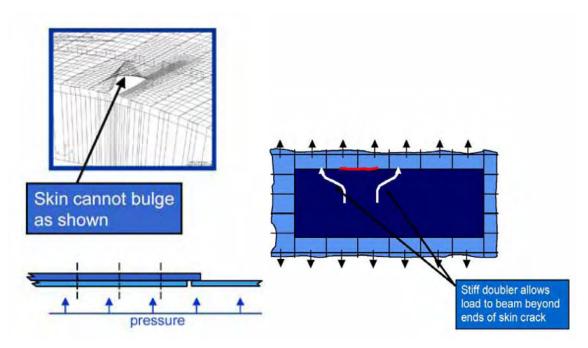
Figure 2.5-5 The influence of the repair doubler

The repair doubler could prevent the skin from bulging outward when the aircraft was pressurized as Figure 2.5-5 shows. It also allows increased load redistributing around the cracking area to increase the residual strength of the skin. The factor of the influence on the residual strength was determined by a non-linear finite element model developed for the case of Cl611. The model provides values that can be compared to and correlated with the established analysis in Section 2.5.2. Employing this model, with the effect by incorporating the repair doubler to determine the resulting increase in residual strength when the skin is not allowed to bulge, was evaluated. The upper curve in Figure 2.5-6 represents the calculated increase in residual strength with the effect of the repair doubler for up to a two-bay skin crack.

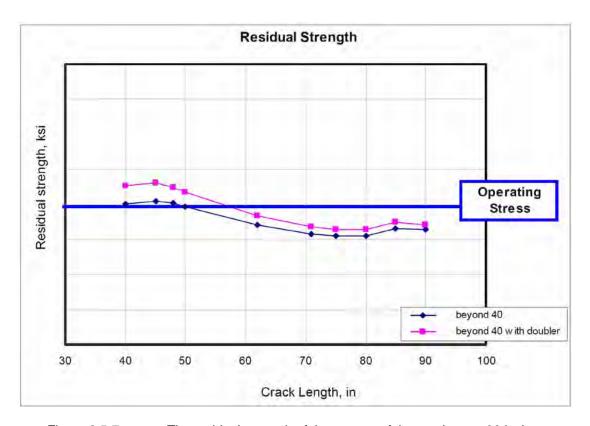
Figure 2.5-7 The residual strength of the extents of the crack up to 90 inches

The nonlinear FEM was also used to assist in determining the values for the residual strength beyond two bays (40 inches) of skin damage. Figure 2.5-7 represents a comprehensive residual strength analysis for the skin assembly, showing the calculated capability of the skin for cracks extending beyond 40 inches. This analysis includes both the basic residual strength for a cracked panel and the increased residual strength with the installation of the repair doubler. It can be seen that the influence of the repair doubler is less pronounced toward the extents of the pre-existing crack. This is primarily due to the inability of the repair doubler to sustain beam loads around the cracked area as the crack starts to approach the ends of the repair doubler.

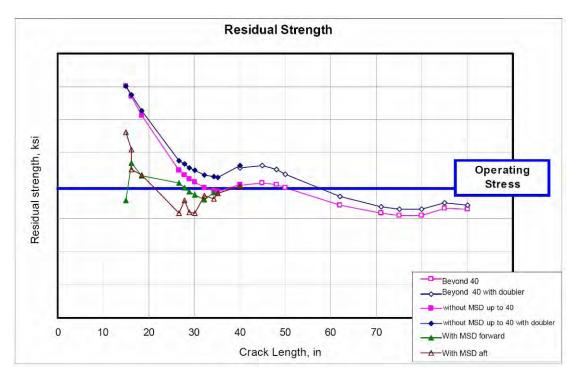
Figure 2.5-8 The combination of the two-stage residual strength analysis

A combination of all the above results is shown in Figure 2.5-8. It shows the MSD region, the residual strength without MSD, and the repair doubler effects for crack lengths ranging from 15 to 90 inches.

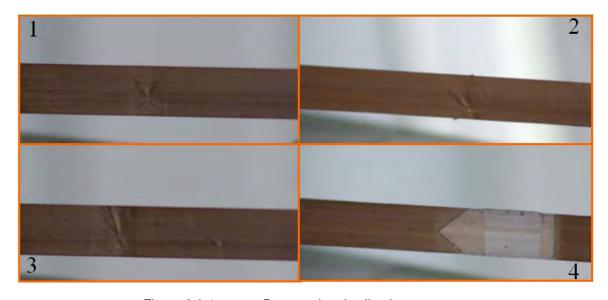
Figure 2.6-1 Damaged and spliced tape areas

Eight unidentified sounds were attributed to the tape damage and one with no signal was attributed to the tape splicing. Figure 2.6-1 frame #1 to #3 shows the typical tape damage and frame #4 shows the spliced area. Several sounds were identified as possible sounds from a toggle switch, or other switches. Because of high noise background, sounds from switches are difficult to be identified, such as momentary switch, switch movements, keyboard entries on the INS panel, switch on the audio selector panel, etc. Some unidentified sounds are likely the sound of crew motions but they might not be directly related to any operational action. Table 2.6-2 lists the unidentified sounds and their associated possible events.

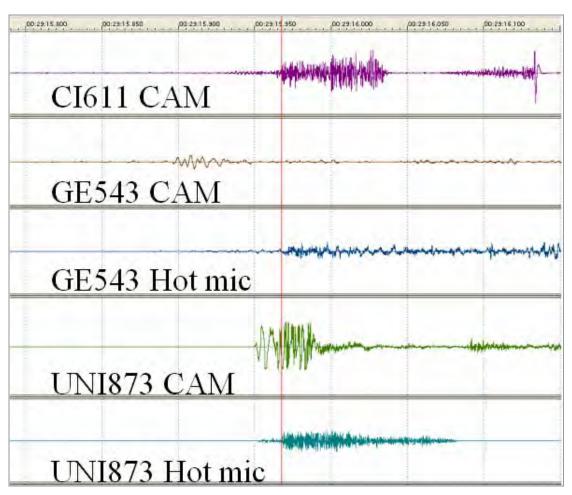
Figure 2.6-2 Comparison of the sound spectrum of three accidents

If the event sound propagated via air in cabin and cockpit, but without the fuselage attenuation, the event sound level would be recorded with significantly higher energy. For instance, the UNI Air 873 accident; an explosion took place on the left overhead luggage compartment of the forward fuselage of a MD-90 aircraft in the landing roll. The energy level of the event sound was very high on the CAM channel, because the explosion area is very close to the cockpit; the level of precursor is also high (Figure 2.6-2).

If the breakup is in the non-pressurized area, the fuselage structure will behave like a sound insulator that reduces the sound energy to the CAM. In this case the event sound level would be less than the precursor level. In the case of Cl611, the event sound level is much higher than the precursor sound level. Based on these analysis, the Safety Council concludes that the structure breakup area

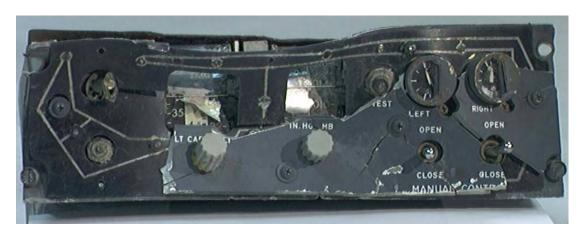
Figure 2.7-1 Cabin pressure control selector panel

Based on the examination, the Cabin Pressure Control Selector Panel (shown in Figure 2.7-1) is deformed, delaminated and fractured. The examination and test results show that the mode switch was in the "MAN" (manual) position.

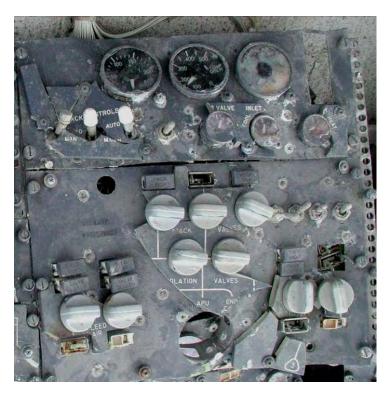
Figure 2.7-2 Air conditioning panel

Examination and test results of the air conditioning panel revealed that two of the three air conditioning "pack" valve selectors were found in the "Closed" position and another one was found in the near closed position. The normal operating procedures for CAL B747-200 specify that at least two pack valves be in the "open" position after engine start, and CM3 shall check the setting after takeoff and during climb. Also, CM3 is required to verify two packs "Open" after takeoff and during the initial climb. The CVR transcript reveals that CM3 verbally confirmed that two packs were "Open."

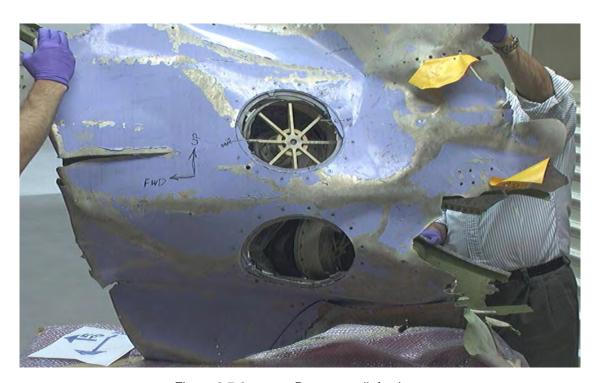
Two cabin pressurization relief valves are installed to relieve excessive pressure in the cabin. Both valves were recovered as shown in Figure 2.7-3. All flapper (blowout) doors (upper and lower for both valves) and some hinge pins are missing. The Lower Pressure Relief Valve was no longer attached to the structure. The structure between the upper and lower valves was buckled outward.

Figure 2.7-3 Pressure relief valves.

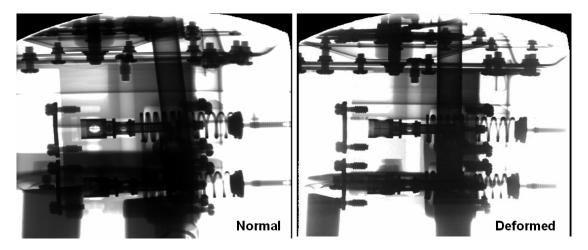
X-Ray on the upper relief valve control switch was conducted. The results show that the control sensor assemblies were deformed from their original setting as shown in Figure 2.7-6.

Figure 2.7-6 X-ray check results

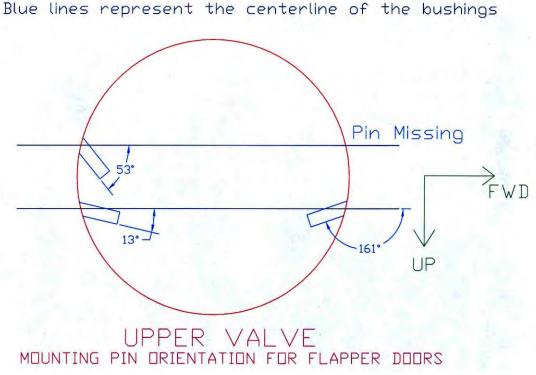
The measurement of pin angles was performed using a flat reference plane (outer skin of aircraft); using two imaginary reference lines running between the centerlines of the pin mounting holes (upper fwd to upper aft) & (lower fwd to lower aft). All angular measurements were based from these two imaginary lines as shown in Figure 2.7-7. Results of the measurements are:

Upper aft pin was approximate 13°; Upper fwd pin was approximate 161°; Lower aft pin was approximate 53°

Figure 2.7-7 Upper flapper doors pins measurement results

The wreckage examination results show that the upper pressure relief valves had been deformed inward, the flapper doors were missing and the three out of four existing shear pins were bent-in, but moveable. It could be that outside-in forces crushed the relief valve and damaged the flapper doors and the web gate. Those three pins of item 275 were still attached to the shear pins and are parallel to the relief valves housings (aircraft fuselage skin) that might indicate the valve doors was open before the water impact. However, based on the test results, the Safety Council could not conclude whether the door was open prior to the water impact.

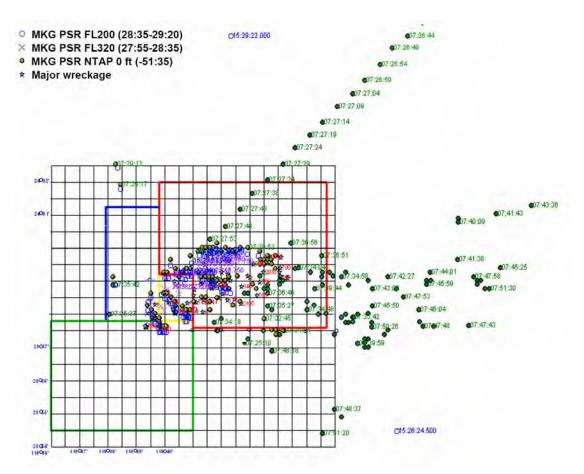
Before correction, there were no relevant PSR returns within 1,500 ft of the recovered positions of engines #1, #2, and the main wreckage field. Figure 2.9-3 shows the superposition of the PSR returns, SSR track from 1526:39 to 1528:14, and positions of major wreckage.

Figure 2.9-3 SSR track, PSR returns and position of major wreckages

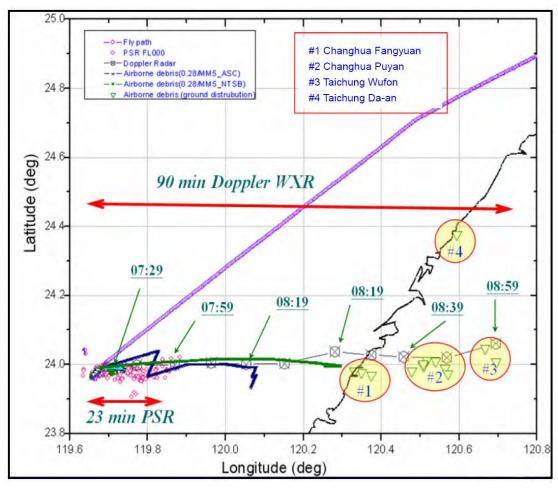
All the ballistic trajectories were consistent with the salvaged wreckage positions. The average distance error is less then 1,000 ft. Figure 2.9-7 (denoted as blue and green) shows the superposition of ballistic trajectories, SSR track, PSR returns, Doppler weather radar trajectory, and airborne debris distribution. Two

trajectories using different wind profiles with the same breakup initial condition (BC assumed to be 0.28). These trajectories indicated that airborne debris initiated descent at the altitude about 35,000 ft. Doppler radar trajectories and the recovered location of those light pieces of debris match with the computed ballistic trajectory.

Figure 2.9-7 2D ballistic trajectories, SSR, PSR returns, and airborne debris

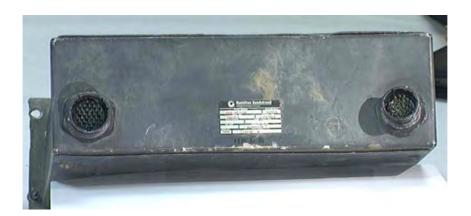
Figure 8: Flight Engineer's Cabin Pressure Control Selector Panel - (back view)

- J3 connector (right) misaligned due to deformation of rear chassis. Both connector (J3 and J4) pins are intact.
- Both connectors show contamination around multiple connector pins.

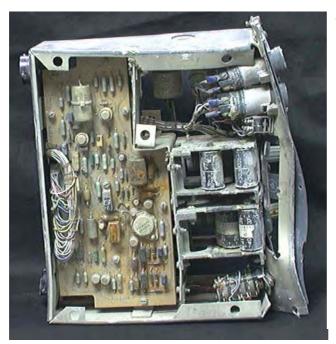
<u>Figure 9</u>: Flight Engineer's Cabin Pressure Control Selector Panel -(top view)

- Deformation of the face of the chassis.
- Broken spot welds and separation of face of chassis (lower right).
- Sedimentary deposits deposited throughout unit.
- Corrosion noted in multiple locations on multiple components.
- Slight deformation of rear chassis panel at the J3 plug (lower left).
 Flight ALTITUDE
- Flight ALTITUDE selection tape delaminated and partly missing.

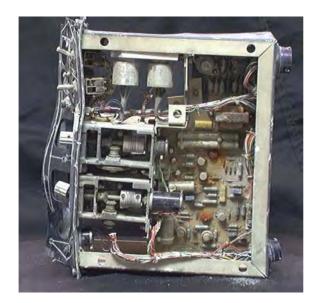
<u>Figure 11</u>: Flight Engineer's Cabin Pressure Control Selector Panel – (bottom view)

- Deformation of the face of the chassis.
- Sedimentary deposits deposited throughout unit.
- Corrosion noted in multiple locations on multiple components.

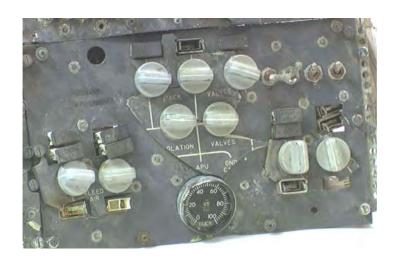
<u>Figure 23:</u> Detail overview of the M170 portion of the Flight Engineer's Panel.

- Panel is bent back on both sides of center area, then forward at left and right edges.
- Pack **RESET** button not attached to panel, hanging behind on wiring. Button assembly heavily corroded on all metal surfaces.

- Most of light plate is missing portions of the light plate remain captured under PACK VALVES and BLEED AIR knobs.
- Left and right (packs 1 and 3) **PACK TRIP** lights intact on front panel. Center light (pack 2) legend plate missing.

- PACK VALVES knobs intact and apparently in OFF position. Shaft of left switch (pack 1) found to be broken loose from switch assembly – shaft can be pulled straight out.

- Legend plates missing from both left side HIGH STAGE lights. Bulbs are missing from left (engine 1) assembly. Right bulb, and left bulb cover are intact on engine 2 assembly.

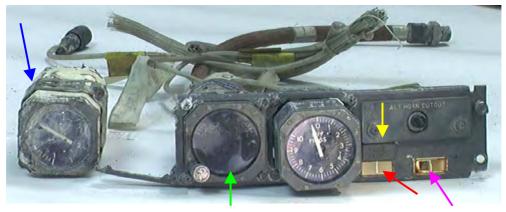
Figure 37: M188 panel. Note that the vertical speed indicator was detached from the module.

- Vertical Speed Indicator not attached to panel (blue arrow).
- Corrosion present on various surfaces with salt residue and sediment.
- AUTO FAIL legend plate is missing (purple arrow).
- PRESS RELIEF lower Indicator light cover is missing (red arrow).
- Panel frame is bent inward on left and broken at Vertical Speed Indicator frame.

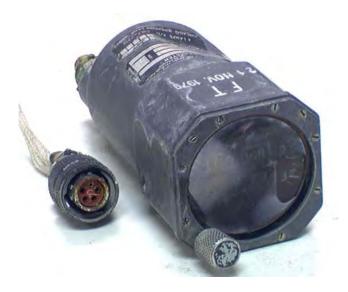
<u>Figure 42:</u> **CABIN ALT** Indicator (Ref. Figure 39, green arrow for location on module)

- 50% of face obscured by opaque discoloration inside of glass.
- BARO set knob bent upward.
- Dent in rear, top side of case.
- Dent on bottom side of case.
- Corrosion on sense line connection.
- Barrel Indicator reads approximately 13,000.
- Needle and barometric setting obscured by discoloration.
- Electrical connector appears undamaged.

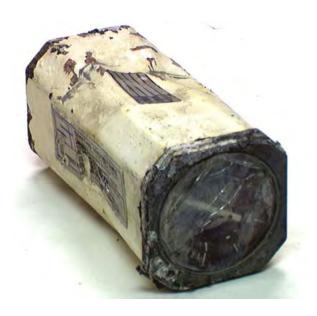
Figure 48: Cabin Vertical Speed Indicator

- Glass is broken.
- Numerous dents are on case.
- Needle is frozen at 500 FPM climb.

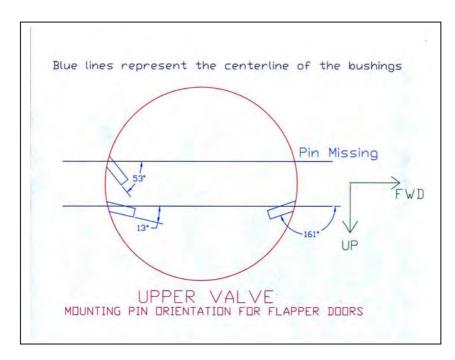
<u>Figure 96:</u> Upper Pressure Relief Valve, flapper valve doors, pin orientation.

- Performed <u>measurement</u> of pin angles using a flat reference plane (outer skin of aircraft); using two imaginary reference lines running between the centerlines of the pin mounting holes (upper fwd to upper aft) & (lower fwd to lower aft). All angular measurements were based from these two imaginary lines. (See: diagram. Upper Valve, flapper doors' pins, orientation, Figure 96).
- Results of measurements (approximation):
 Upper aft pin = 13°; Upper fwd pin = 161°; Lower aft pin = 53°

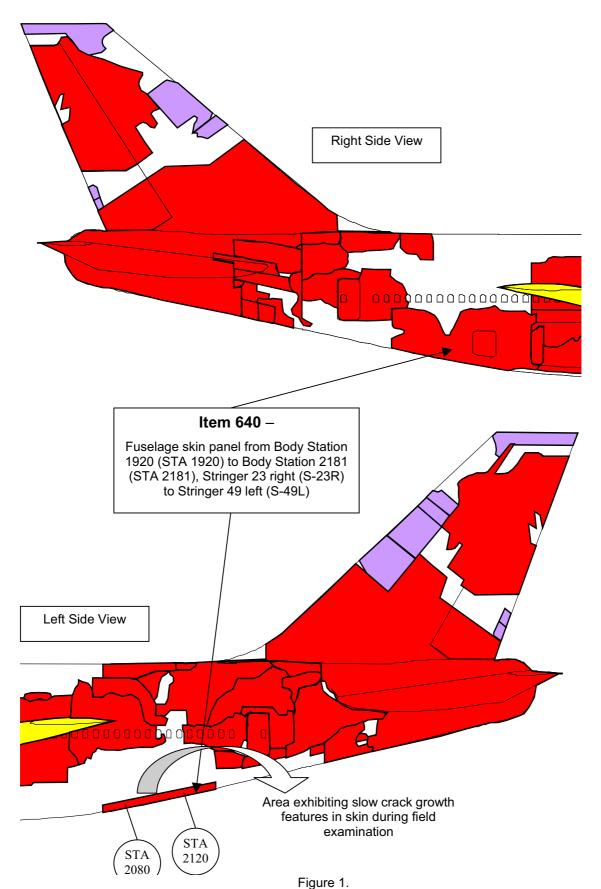
Partial wreckage recovery map for Cl611 showing the location of the item 640 skin panel and the area where slow crack growth features were found in the skin along S-49L during field examination.

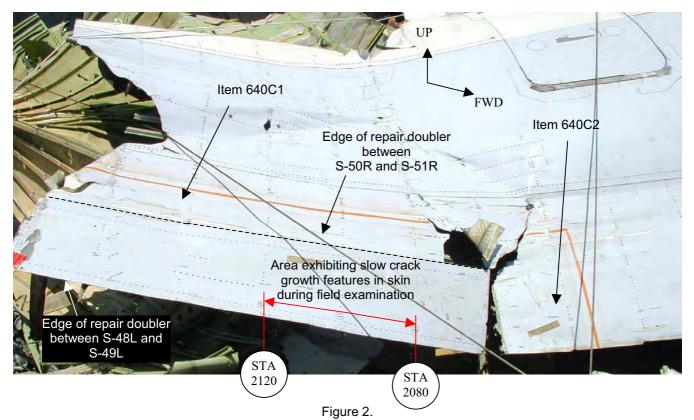
Item 640C1 and C2 Skin panel segments prior to removal from the parent item 640 wreckage in Makung, Taiwan.

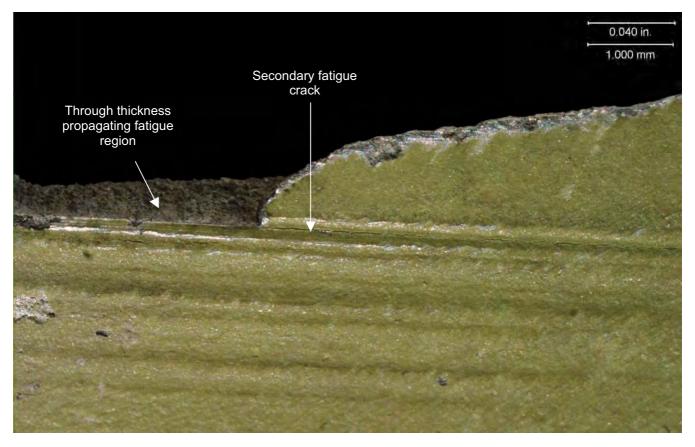
Figure 8.

Surface of skin faying with repair doubler between hole 29 and hole 30 showing the longitudinal scratches in relationship to this fatigue crack. Note the secondary crack extending out of this common scratch.

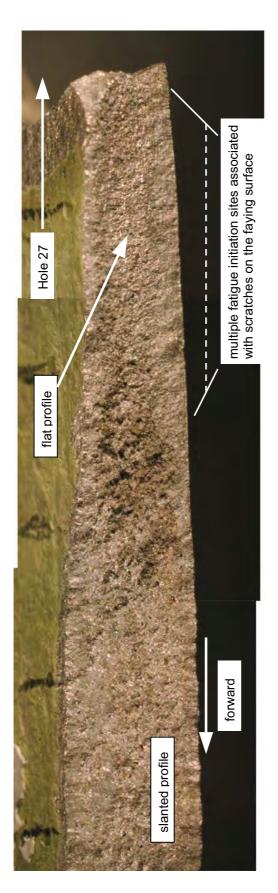
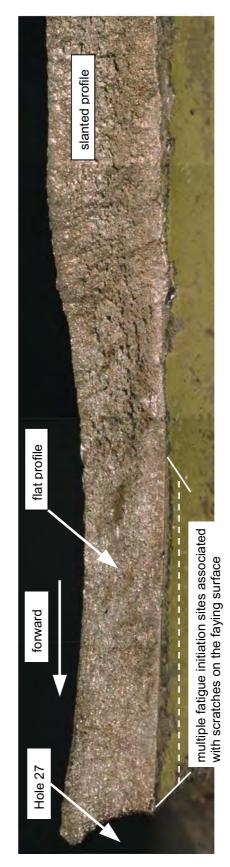
Figure 10, Photographs showing the transition regions from flat fracture profiles to slanted profiles at fastener Hole 27 in the forward direction (top) and the aft direction (bottom).

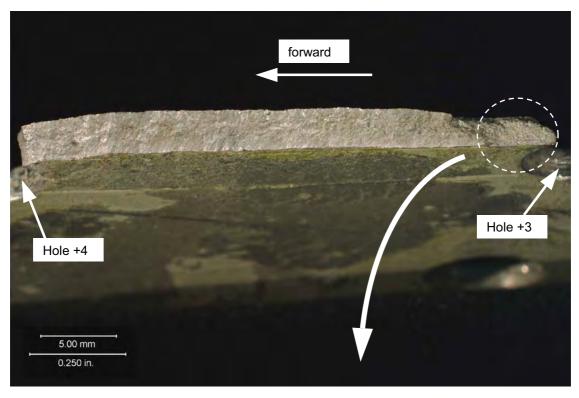
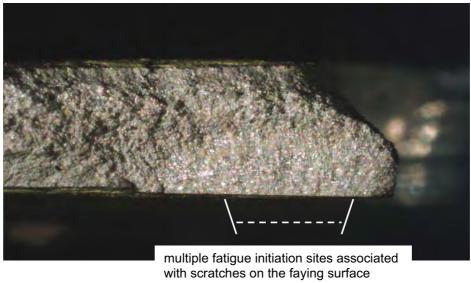
Figure 12, Photographs of the fracture segment extending from Hole +3 to +4 (top), and closer view of the flat profile fatigue region on the forward side of Hole +3 (bottom).

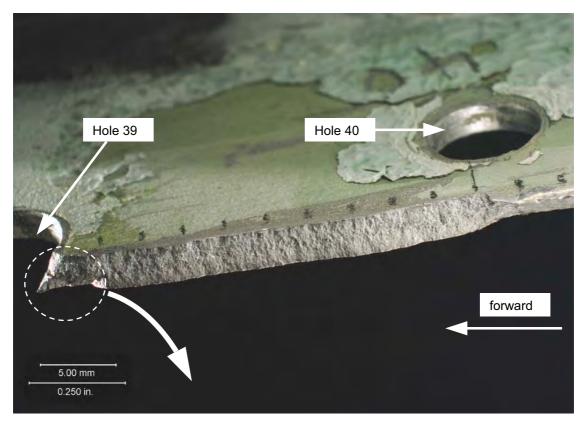
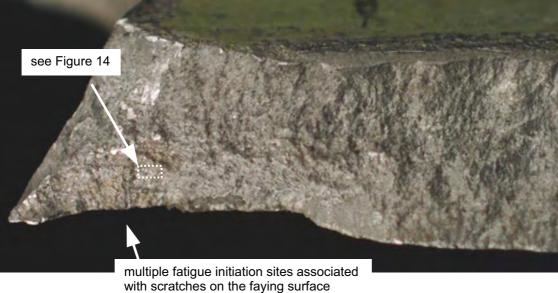
Figure 13, Photographs of the fracture segment extending from Hole 39 to 40 (top), and closer view of the flat profile fatigue region and short transition zone on the aft side of Hole 39 (bottom). SEM photographs showing a dramatic increase in striation spacing near the extent of the flat fracture thumbnail (indicated area) are shown below in Figure 14.

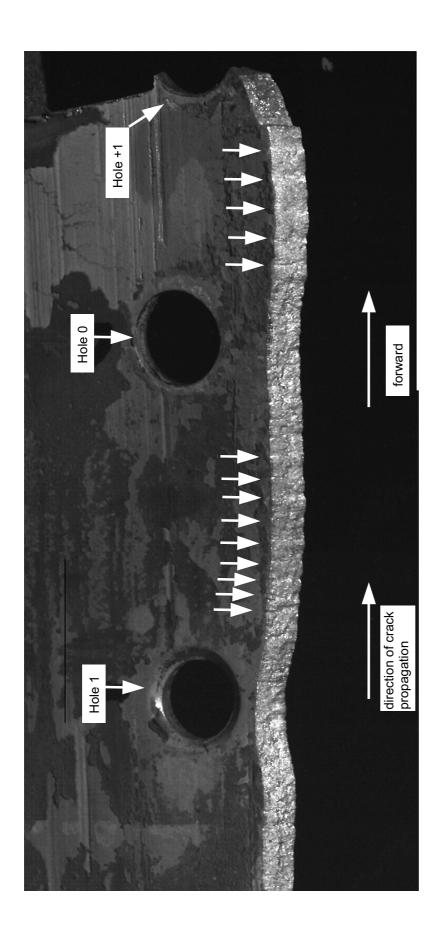
areas of Hole 4 shown in Figure 9. Note that the regular spacing generally increases as the distance increases from the main Figure 15, Photograph showing the incremental crack growth indications on the fracture segment from Hole 1 to Hole +1 with two groups of them identified with arrows. This area is just a few inches forward of the flat profile fatigue and transition rates in a forward direction here when these features were formed, rather than in a through-thickness direction as was cracking system at Holes 4 through 26. These features indicate that the dominant crack was growing at macroscopic the earlier fatigue initiation and propagation mechanism. This point is further exemplified in the following Figure 16.

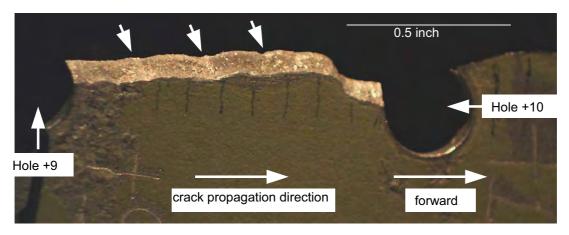
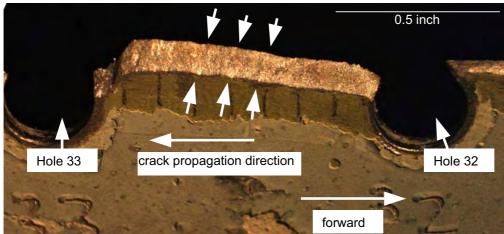
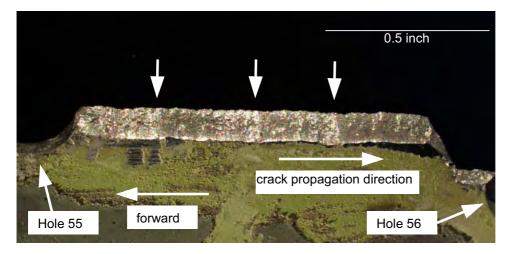
Figure 16, Photographs showing the incremental crack growth indications on the fracture segments between Holes +9 and +10 (top), Holes 32 and 33 (center), and Holes 55 and 56 (bottom).

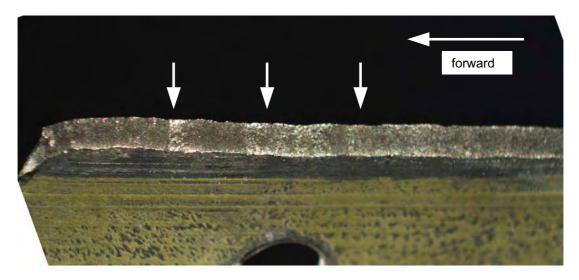
Figure 17, Photograph showing the incremental crack growth indications (arrows) on the fracture segment near Hole 7, which is between the two main fatigue cracking systems at Holes 4 and 5 and Holes 10 through 25.
