Aviation Occurrence Report Volume I

ASC-AOR-05-02-001

IN-FLIGHT BREAKUP OVER THE TAIWAN STRAIT
NORTHEAST OF MAKUNG, PENGHU ISLAND
CHINA AIRLINES FLIGHT CI611
BOEING 747-200, B-18255
MAY 25, 2002

AVIATION SAFETY COUNCIL

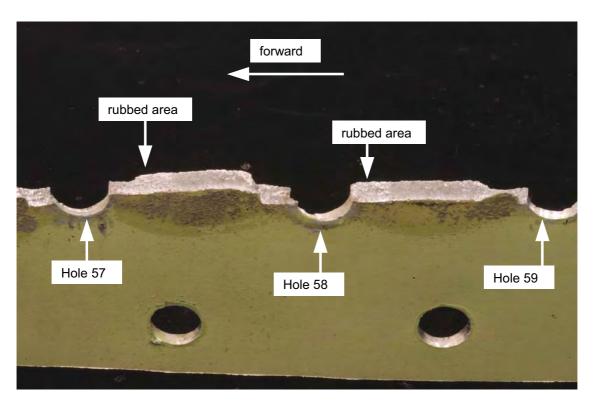
Cyclic rubbing of the fracture surface and associated compression deformation of the cladding was observed along the faying surface providing additional evidence of cracking that occurred prior to the accident flight. Figure 18 shows the visible appearance of the fracture surface near holes 57, 58, and 59. The damage that produced the scratches on the faying surface removed significant amounts of cladding. However, all areas where cladding remained forward and aft of the main fatigue cracking displayed compressive deformation due to crack closure as far forward as hole +17 and as far aft as hole 62. Figures 19 through 21 are SEM photographs showing the appearance of such aluminum cladding deformation. The remaining fracture aft of hole 62 displayed "necking", which is typical of continuous tensile loading to ultimate tensile separation (Figure 22). These observations suggest that cracking in the skin was continuous from approximately STA 2055 to 2146, or approximately 93 inches prior to the accident flight.

Figure 18, Photograph of the fracture surface at Holes 57, 58, and 59. The shiny areas are indicative of rubbing with the mating fracture surface and appeared consistently forward of this area, but were not present aftward beyond Hole 62.

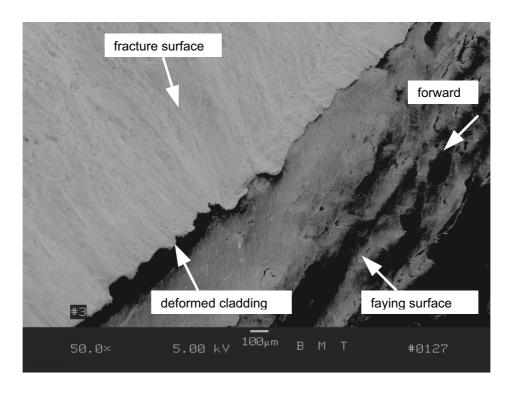
Figure 19, Scanning electron microscope photograph along the edge of the fracture common to the faying surface where the aluminum cladding remained near Hole 3. The fracture surface profile was slanted here. Another example further forward of this area is shown in Figure 20 below. Quasi-stable crack growth beyond these regions allowed cyclic crack closure, causing surface rubbing and compressive deformation of the cladding.

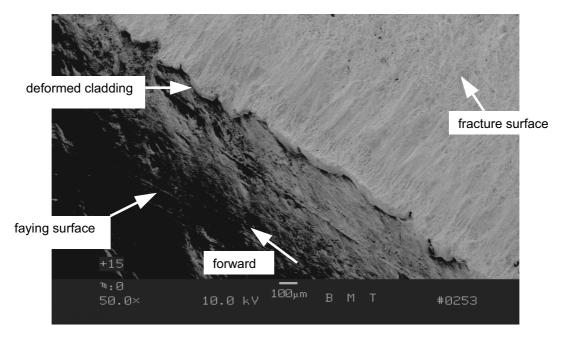
Figure 20, SEM photograph showing the compressive deformation of the cladding just forward of Hole +15.

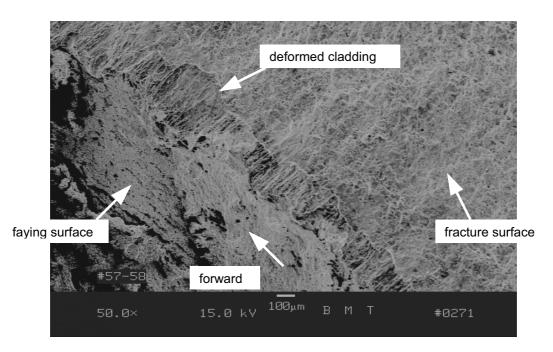
Figure 21, SEM photograph showing the compressive deformation of the cladding between Holes 57 and 58. Note that the degree of compressive damage is less severe than that observed closer to the main cracking system, Figure 19 for example. Fracture surfaces near the extreme extent of pre-existing cracking would have experienced few repetitive crack closures.

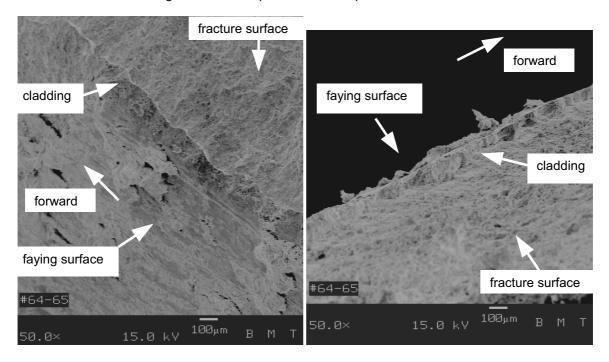
Figure 22, opposing angle SEM photographs of the fracture segment between Holes 64 and 65 showing the cladding on the faying surface retaining its upward profile from the necking process during ultimate tensile separation without subsequent crack closure.

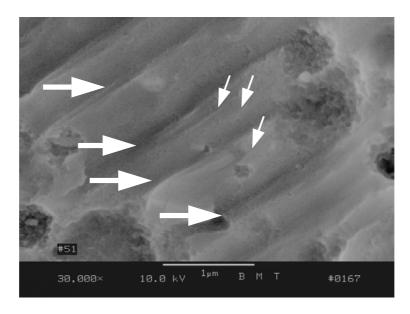
Although much of the fracture suffered from heavy corrosion, fatigue striations were resolved by SEM in many local areas of the fatigue cracking regions as described in Figures 5 and 6. Striation counting was performed at a number of locations along the flat profile fatigue regions of the fracture. Since the fracture surface was not continuous from a single fatigue initiation origin to the ultimate extent of stage II (striation producing) cracking, it was not possible to estimate a time of initiation. Instead, the nature of cracking on this detail provided numerous initiation sites along scratches on the faying surface, with subsequent propagation in the through-thickness direction. Because cyclic cabin pressure is the prevailing driving force for cracking at this detail, each striation is considered to represent the microscopic crack advancement during one flight cycle of the airplane. Thus, striation counting was performed in order to obtain an estimate of the number of flight cycles that contributed to the fatigue crack propagation through the material thickness. Reference 1 reported the observation of "major" and "minor" striations. The occurrence of striation-like features appearing between actual striations is not uncommon for fatigue cracks in similar structural details propagating at mature growth rates. These minor striation-like features are shown in Figure 23 and were ignored for striation counting purposes.

Figure 23, SEM photograph showing minor striation-like features (indicated with smaller arrows), which were also observed during examination at the Chung Shan Institute of Science and Technology. Such features are not uncommon and were ignored for striation counting purposes. The striations corresponding to flight cycles, and used for estimating growth rates are indicated with the large arrows.

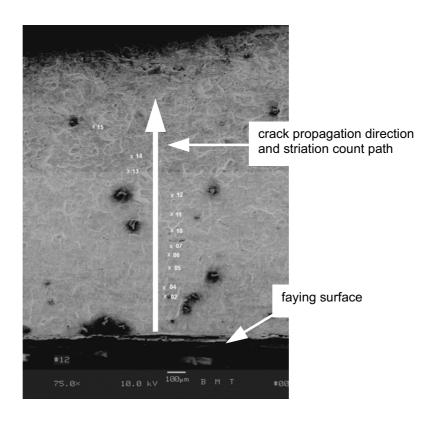
Figure 24, SEM photograph showing the locations through the skin thickness that were sampled for crack growth rate at Hole 12. The approach was repeated for other through-thickness areas

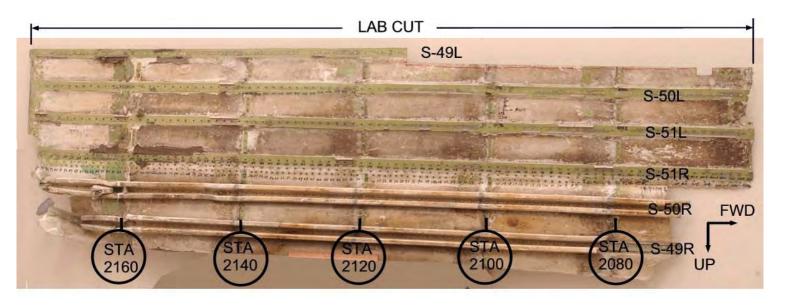
FIGURE 25. AS RECEIVED ITEM 640 CI SKIN INBOARD SURFACE- The S-49L fracture segment was removed at the CSIST during the initial examination.

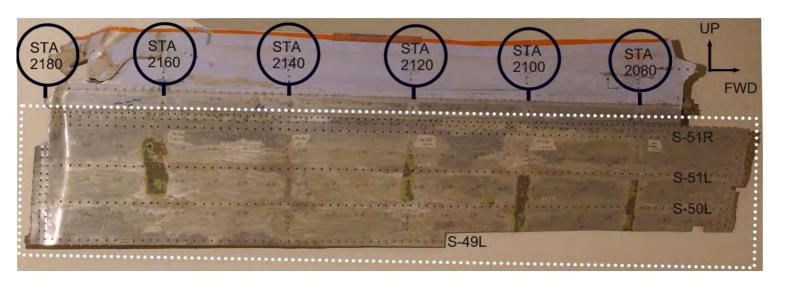
Photographs showing features of the as-received item 640 C1 skin inboard and outboard (repair faying surface) surfaces are shown in Figures 25 and 26 respectively. Protective finishes had previously been removed from much of the repair faying surface at the CSIST to enable examination of skin damage consistent with a tail strike event. Close-up photographs displaying the extent of damage consistent with a tail strike are shown in Figures 27 through 36. This damage consists primarily of fore to aft (longitudinal) scratching with the most severe scratching typically occurring at the location of skin stiffening members such as skin stringers and body frame shear ties. Figure 37 displays the location of the most severe skin damage. As noted in this photograph, the most severe damage consistent with a tail strike occurred on the left hand side of the airplane in the area covered by the repair doubler. Evidence of an attempt to blend out these skin scratches, in the form of rework sanding marks, was noted over much of the repair surface.

FIGURE 26. AS RECEIVED ITEM 640 C1 SKIN OUTBOARD SURFACE – The approximate location of the repair doubler is shown with dotted lines. Protective finishes were removed from the repair faying surface at the CSIST.

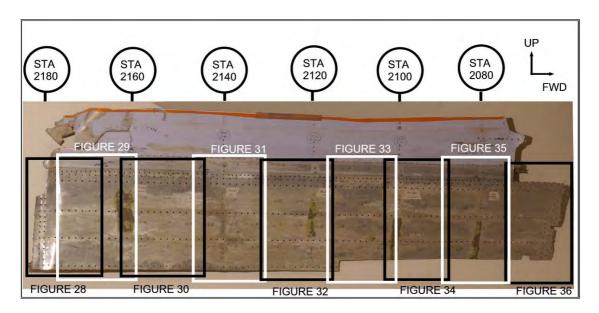
FIGURE 27. SCRATCH PHOTOGRAPH LEGEND – This illustration identifies the location of following photographs that document scratch features observed on the skin repair faying surface. Scratches are fore/aft in orientation and characteristic of a tail strike event.

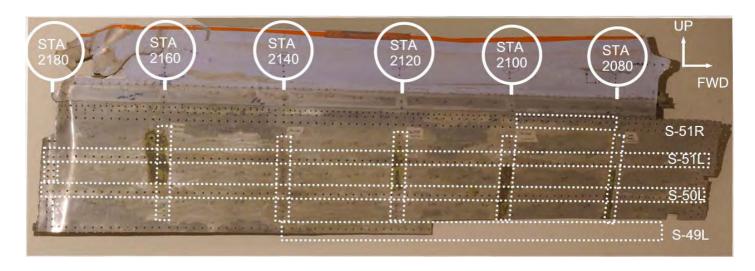
FIGURE 37. AREAS OF MOST SEVERE SKIN DAMAGE – Scratch severity was greatest in the left hand/forward area of the skin.

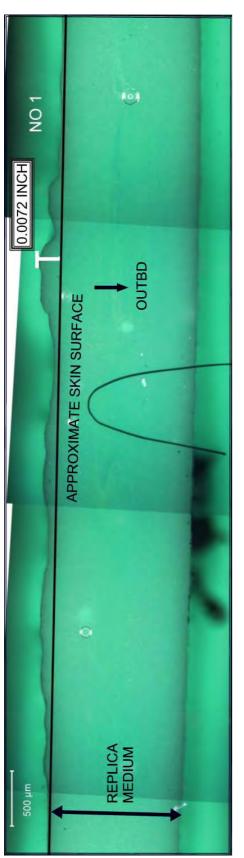
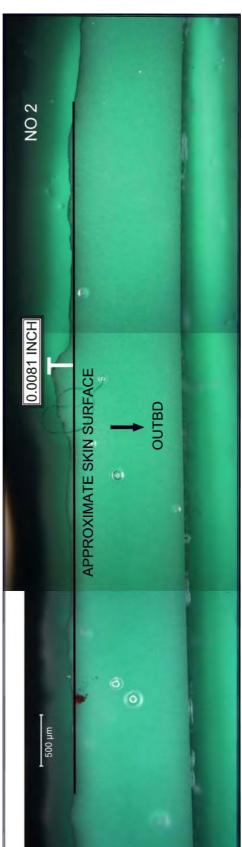
A surface replication medium was applied at five locations on the skin repair faying surface as shown in Figure 38 to examine scratch geometry and depth. The locations were chosen to display surface features typical to areas exhibiting major scratching. This medium creates a "positive" of the surface it is applied to, enabling direct feature measurement from the replica. The maximum scratch depth measured with this technique was 0.0096 inch. Composite photographs exhibiting scratch profiles at locations noted above are shown in Figures 39 and 40.

FIGURE 39. SCRATCH PROFILE COMPOSITE PHOTOGRAPHS – The replication medium creates a "positive" of the skin scratches. Scratch features of replica locations 1 and 2 are shown above.

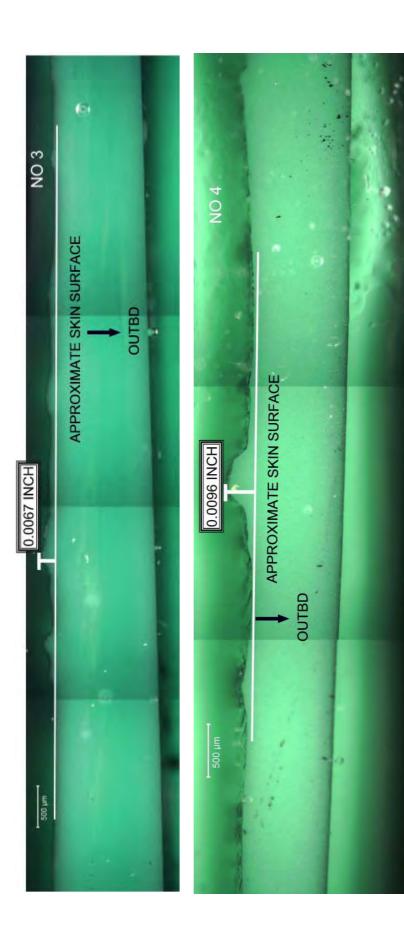
SCRATCH PROFILE COMPOSITE PHOTOGRAPHS – Shown above are replicas from locations 3,4, and 5. Location 4 presented the deepest scratch found using this technique. FIGURE 40.

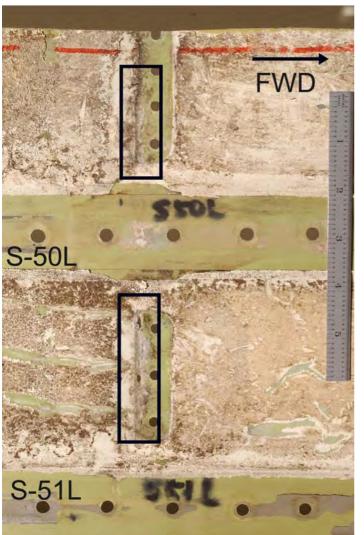
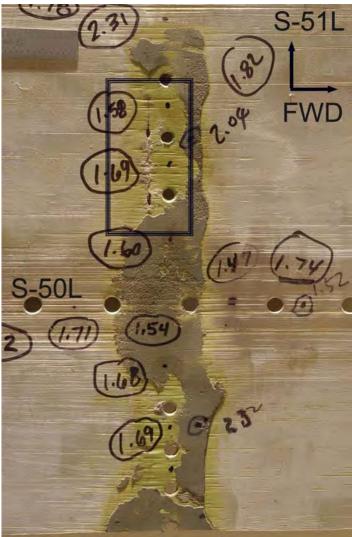
Corrosion was noted at several shear tie locations on the skin inboard surface sometimes penetrating completely through the skin thickness. General features of this damage and the general condition of the skin indicate that the corrosion most probably existed at the time of the accident, and was not a result of salt water immersion after the event. Photographs displaying these corrosion features are shown in Figures 47 through 49. Table VIII records visual observations of these features.

Figure 47. SKIN CORROSION FEATURES AT STA 2080 - Areas of corrosion are identified with rectangles above. Corrosion penetrated completely through the skin thickness at the shear tie located between S-50L and S-51L.

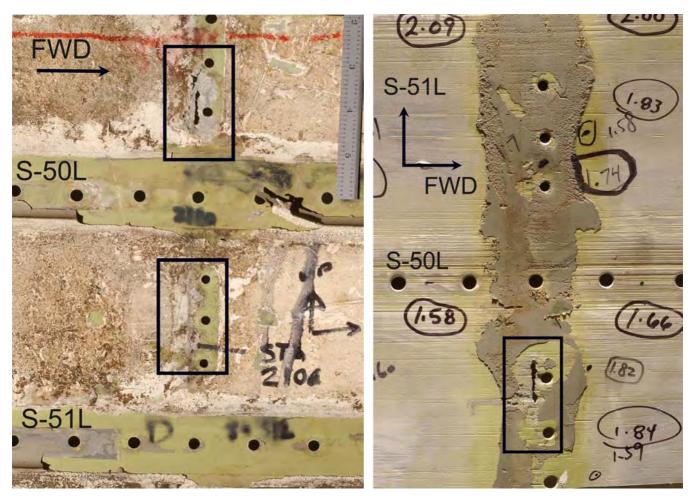
Figure 48. SKIN CORROSION FEATURES AT STA 2100 - Areas of corrosion are highlighted with rectangles. Corrosion penetrated completely through the skin thickness between S-49L and S-50L.

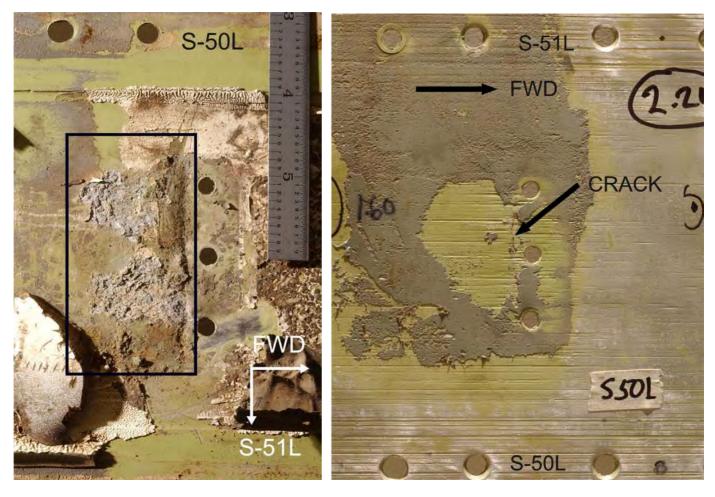
Figure 49. CORROSION FEATURES AT STA 2160, INBOARD SURFACE - The area of corrosion is identified with a rectangle above. A crack noted on the skin faying surface may have been the result of exfoliation corrosion penetrating from the skin inboard surface.

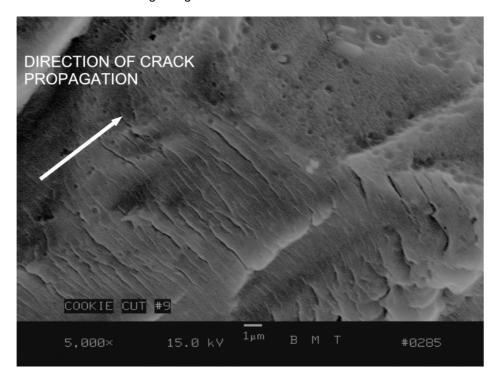
Figure 56. COOKIE CUT #9 FATIGUE CRACK FEATURES - Cracking initiated from the single origin noted above.

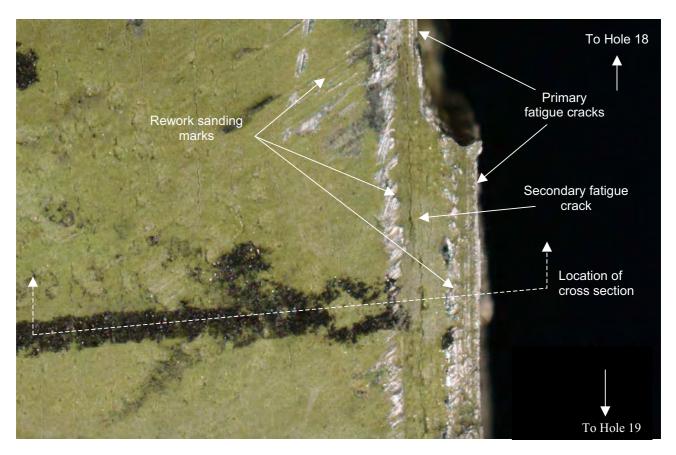
Figure 61.Location of cross section taken to characterize the scratch depth and geometry in the main fatigue region between holes 18 and 19.

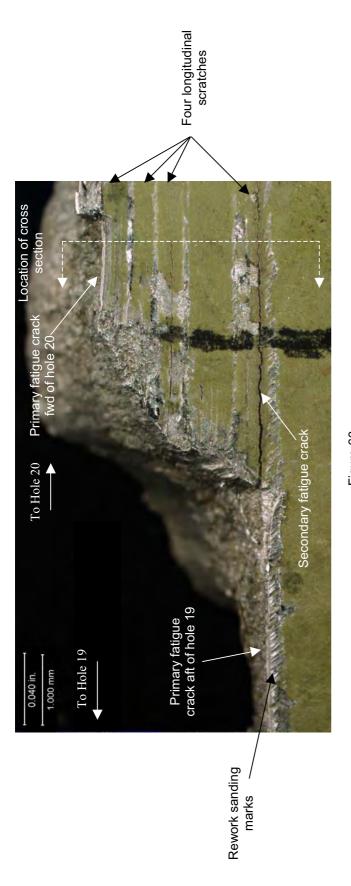
Figure 63. Location of cross section taken to characterize the scratch depth and in the main fatigue region between holes 19 and 20.

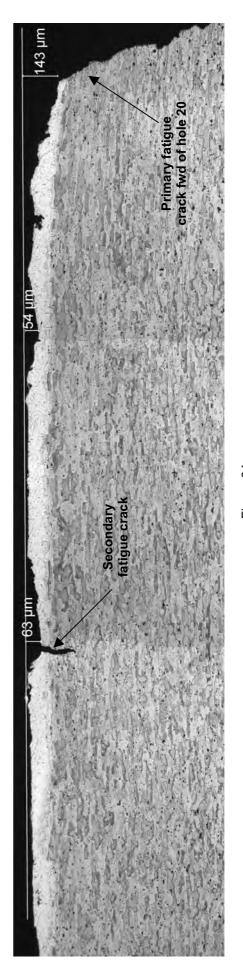
Metallographic montage through the area indicated in Figure 63 above. The line shown was projected back to an area of undisturbed clad material to determine the depth of the scratches at the primary and secondary fatigue cracks present in this area. Figure 64.

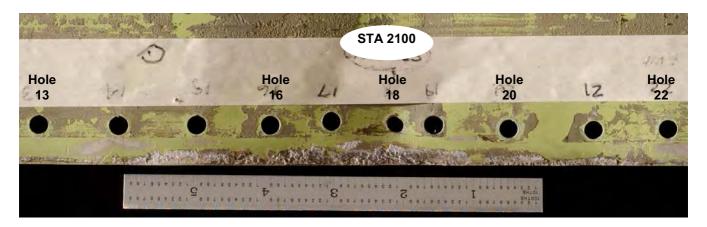
Figure 65. Faying surface of doubler with skin showing the light colored deposit present from hole 14 to 22.

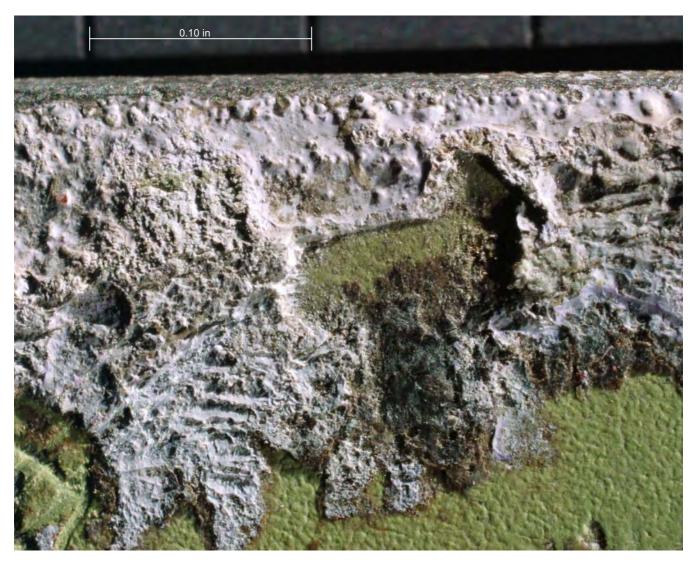
Figure 66.

Higher magnification image of light colored deposit on faying surface of doubler in the vicinity of hole 15. Note the smooth bubbled appearance of the deposit adjacent to the edge of the doubler indicative of paint flow into the joint.

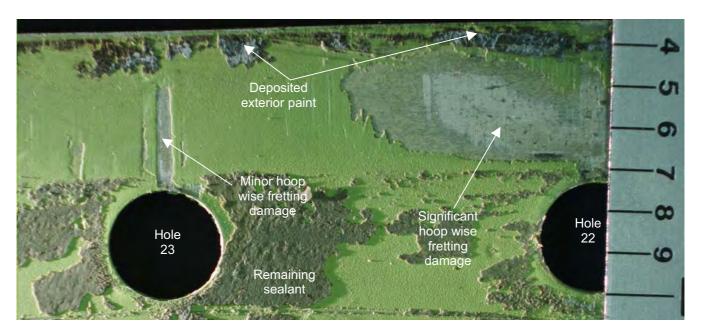
Figure 69.

Faying surface of the doubler showing an example of minor fretting at the 12:00 clock position of hole 23 and significant fretting at the 10:00 to 12:00 clock position of hole 22. Note the presence of deposited paint near the edge of the doubler.

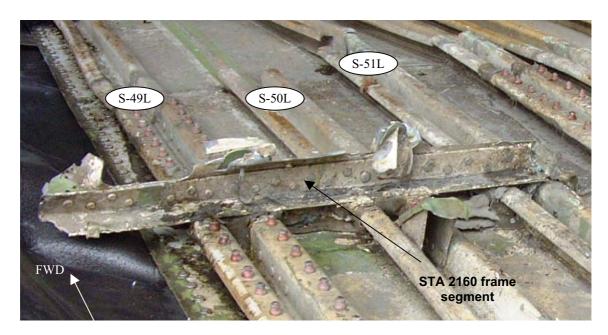
Figure 70. Condition of the STA 2160 frame segment prior to disassembly from the Item 640C1 skin panel at the CSIST.

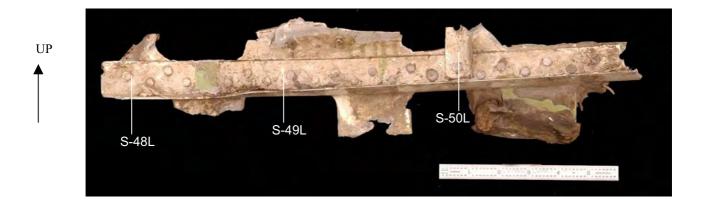
Figure 71.

As received condition of the STA 2160 frame segment submitted for examination. The aft surface is shown in this view.

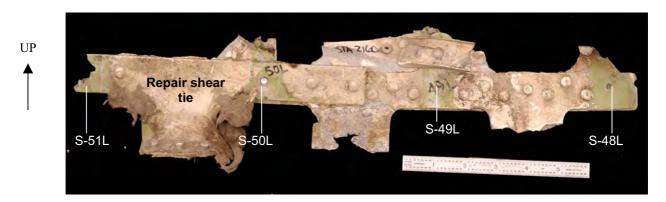
Figure 72.As received condition of the STA 2160 frame segment submitted for examination. The forward surface is shown in this view.

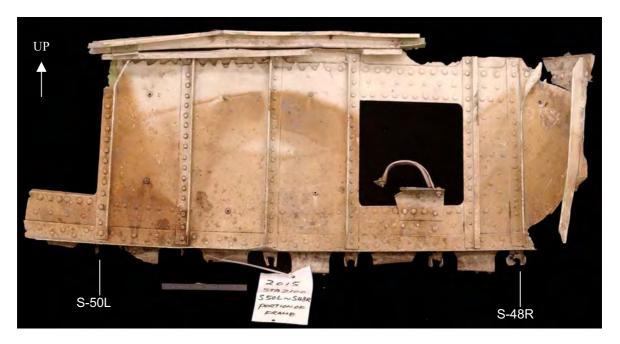
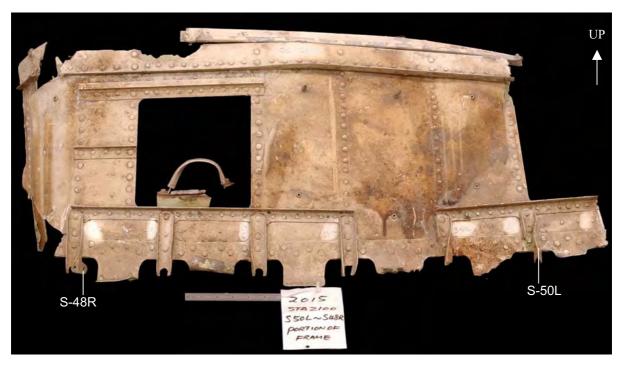
The overall condition of this frame segment as received by BMT is presented in Figures 75 and 76.

The fracture to the S-49L end of this frame segment was common to the failsafe chord, shear tie, web and intermediate chord. Visual and low power optical examination of these fracture surfaces revealed slanted fracture profiles with fracture morphologies consistent with ductile separation. No evidence of pre-existing damage (slow crack growth or corrosion) was observed. The fractured end common to S-49L exhibited deformation of the shear tie member in the forward direction and deformation of the web at the intermediate chord location in the aft direction (refer to Figure 77). In addition, the hole in the shear tie at the fracture location was elongated in the upward direction. No evidence of compressed or buckled members at this area was noted.

Figure 75. As received condition of the STA 2100 frame segment submitted for examination. The aft surface is shown in this view.

Figure 76. As received condition of the STA 2100 frame segment submitted for examination. The forward surface is shown in this view.

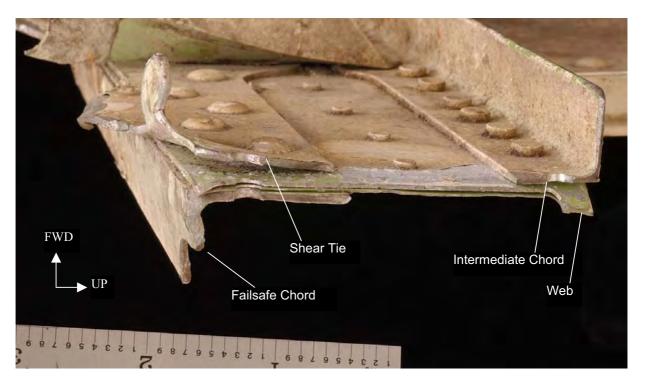
Figure 77. Fracture at S-49L of the STA 2100 frame segment showing deformation in shear tie and web.

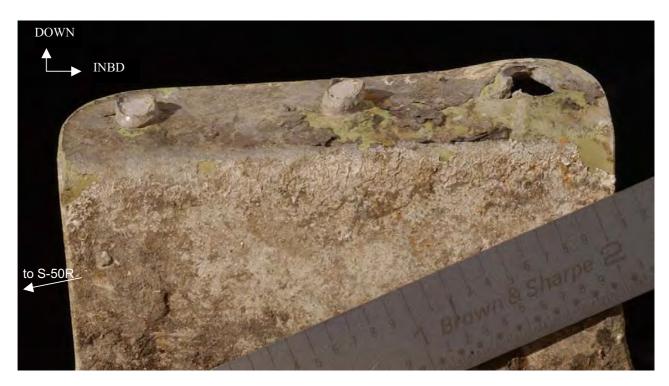
Figure 78.

Shear tie between S-51R and S-50R of the STA 2100 frame segment showing downward deformation in skin flange and pull through of the fastener hole at the inboard most fastener hole.

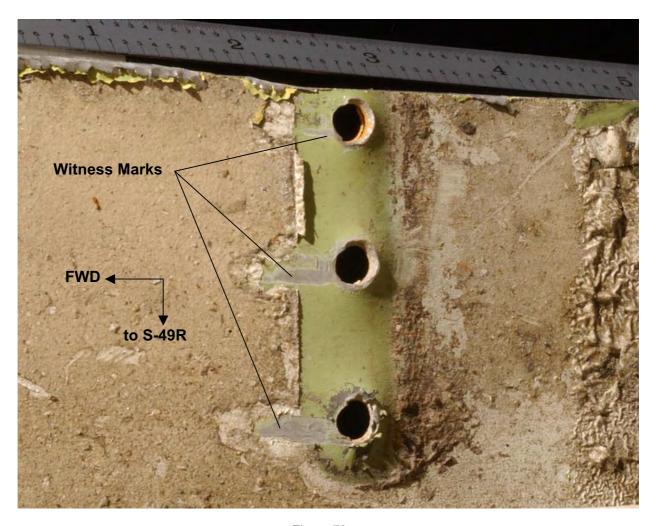
Figure 79. Witness marks and deformation in skin at shear tie fastener holes common to S-49R /S-48R at STA 2100.

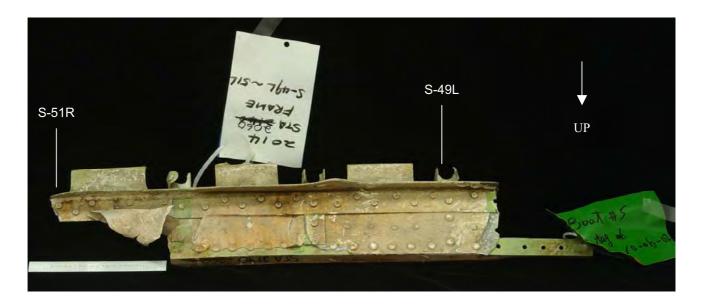
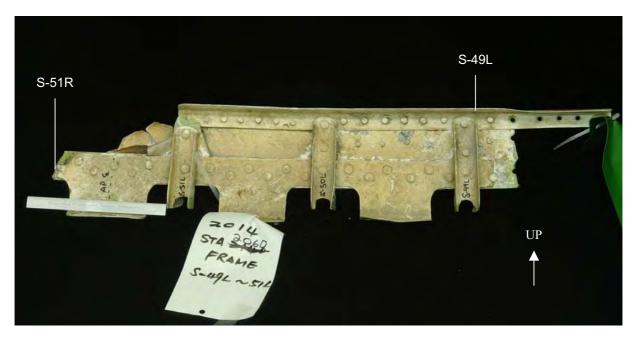
The as-received condition of this frame segment is shown in Figures 80 and 81. This frame segment contained three stringer clips, two shear ties, the failsafe chord, the intermediate chord and a portion of the web.

Figure 80. As received condition of the STA 2060 frame segment. The aft surface is shown in this view.

Figure 81. As received condition of the STA 2060 frame segment. The forward surface is shown in this view.

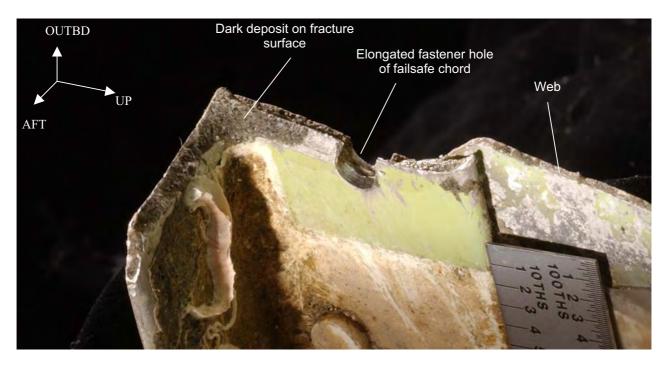
The fracture at S-49L was common with the failsafe chord and web. The shear tie at this location fractured through one fastener hole inboard of this location. Visual examination of the fracture surface of the failsafe chord revealed a slanted fracture profile, however, a heavy, dark deposit in a localized area of the fracture precluded complete examination (see Figure 82). Attempts to remove this deposit using

Figure 82. Fracture surface of failsafe chord and web common to S-49L of the STA 2060 frame segment.

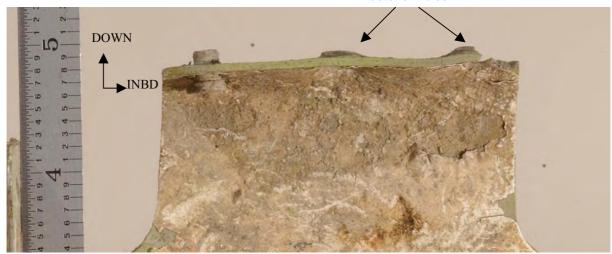
Figure 83.
Shear tie between S-51L and S-50L of the STA 2060 frame segment showing deformation of skin flange fastener holes in the downward direction.

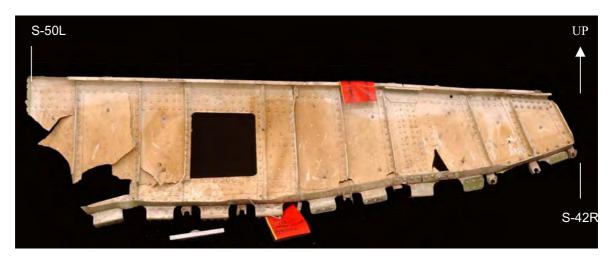
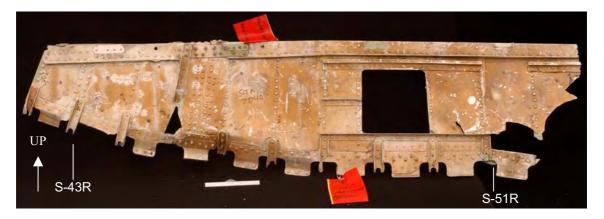
Figure 84 and 85 provide overall views of the aft and forward faces of this frame segment submitted for examination.

The failsafe chord, web, and shear tie all were fractured at S-51L. At S-42R the fracture was common with the failsafe chord and web. Examination of these fracture surfaces with the use of visual and low power optical techniques revealed slanted fracture profiles with no evidence of any pre-existing corrosion or slow crack growth regions. The overall fracture morphologies were consistent with ductile separation. At S-51R, the failsafe chord was fractured at the free flange radius with deformation consistent with compression buckling (see Figure 86). All of the inner chord fractures exhibited slanted fracture profiles with fracture morphologies consistent with ductile separation as well.

Figure 84. As received condition of the STA 2040 frame segment submitted for examination. The aft surface is shown.

Figure 85. As received condition of the STA 2040 frame segment submitted for examination. The forward surface is shown in this view.

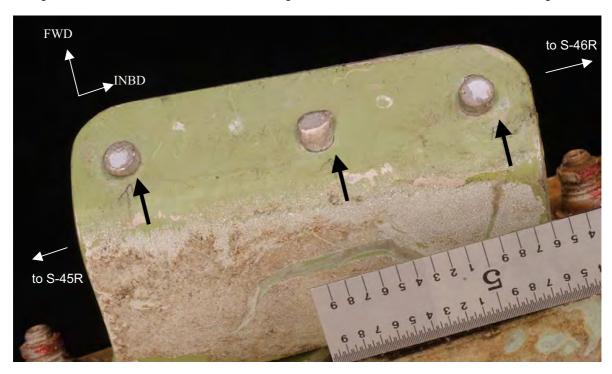
All of the shear ties on this frame segment with the exception of the two at the far right side (between S-42R and S-44R) exhibited no fractures. The extruded "T" shear tie between S-42R and S-43R was fractured through the forward skin flange while the sheet metal shear tie between S-43R and S-44R was fractured through the free flange. Visual and low power optical examination of these fracture surfaces revealed slanted fracture profiles with fracture morphologies typical of ductile separation. The remainder of the shear ties on this frame experienced skin flange rivet fractures. These rivet fractures were examined to help determine the direction of loading during separation from the skin. The skin flange rivets present on the three shear ties between S-45R and S-48R exhibited evidence of loading in the forward to forward/inboard direction (see Figure 87) while the four shear ties between S-48R and S-51L exhibited evidence of loading in the aft/outboard direction (note the direction of loading for the shear ties between S-51R and S-51L was identical to the other three shear ties) (see Figure 88). All these shear ties exhibited no deformation except for the location between S-45R and S-46R which exhibited forward deformation.

Figure 87.Skin flange rivet fractures at shear tie between S-45R and S-46R of the STA 2040 frame. Black arrows indicate the direction of loading.

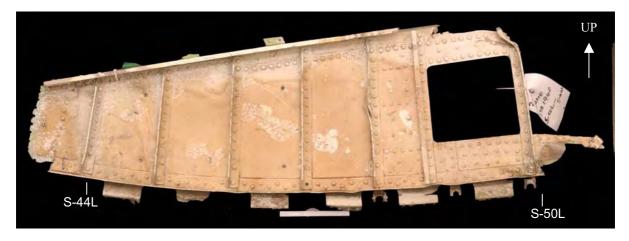
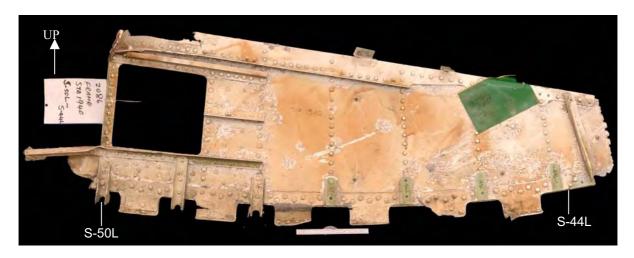
The as-received condition of this frame segment is shown in Figures 89 and 90. This frame segment contained two repairs of shear tie locations and one repair to the web. The shear ties were repaired between S-50L and S-49L with the use of a doubler (see Figure 91) and between S-46L and S-44L with the use of a replacement shear tie/doubler combination (see Figure 92). The web was repaired with the use of a doubler placed on the aft side under the cut-out between S-50L and S-49L (see Figure 93).

Figure 89. As received condition of the STA 1940 frame segment submitted for examination. The aft surface is shown in this view.

Figure 90.
As received condition of STA 1940 frame segment submitted for examination.
The forward surface is shown in this view.

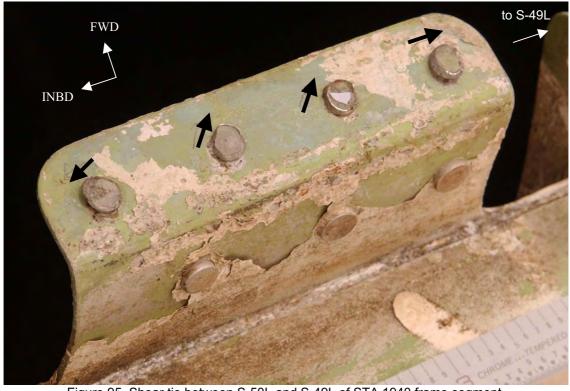
Figure 95. Shear tie between S-50L and S-49L of STA 1940 frame segment.

Black arrows indicate the direction of loading.

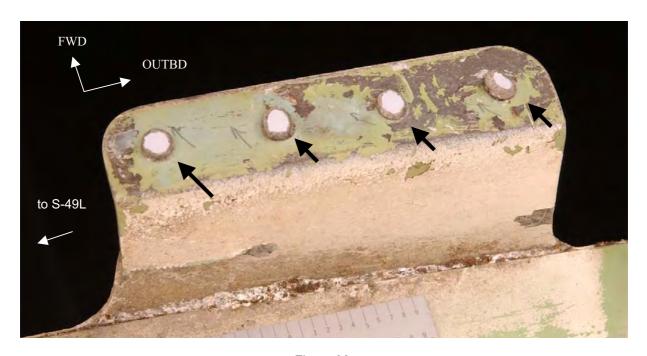
Figure 96.
Shear tie between S-49L and S-48L of STA 1940 frame segment.
Black arrows indicate the direction of loading.

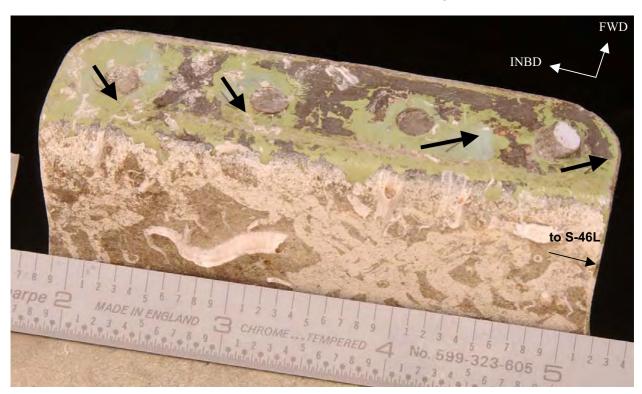
The shear ties present on this frame segment were examined for evidence of separation direction from the skin. This frame segment exhibited fractured shear ties at two locations: between S-45L and S-44L and between S-45L and S-46L. The repair shear tie between S-45L and S-44L was fractured through the inboard most hole by what appeared to be a bearing type fracture. The deformation was observed at this location in the outboard direction. The remaining skin flange attachment rivets were fractured in an outboard direction as well (see Figure 94). The shear tie between S-46L and S-45L was fractured through the free flange of the production shear tie and therefore no separation direction observations were made. Visual and low power optical examination of this fracture surface revealed a slanted profile with a morphology consistent with ductile separation. The remaining shear ties were not fractured but exhibited either fractured skin flange attachment rivets or deformation. These skin flange attachment rivets were examined using visual and low power optical techniques to determine if any evidence of loading direction was present. On the shear tie between S-50L and S-49L three of the skin flange attachment rivets were fractured in the forward to outboard direction while the inboard most rivet exhibited evidence of an inboard direction of loading (see Figure 95). All the skin flange attachment rivets of the shear tie between S-49L and S-48L showed signs of fracture in the forward to inboard direction (see Figure 96). The skin flange attachment rivets for the shear tie between S-48L and S-47L were not fractured but the shear tie exhibited general deformation in the aft direction. On the shear tie between S-47L and S-46L the two outboard most skin flange attachment rivets were fractured in the forward to outboard direction while the two inboard most rivets exhibited evidence of an aft to outboard direction of loading (see Figure 97).

Figure 97.
Shear tie between S-47L and S-46L of STA 1940 frame segment.
Black arrows indicate the direction of loading.

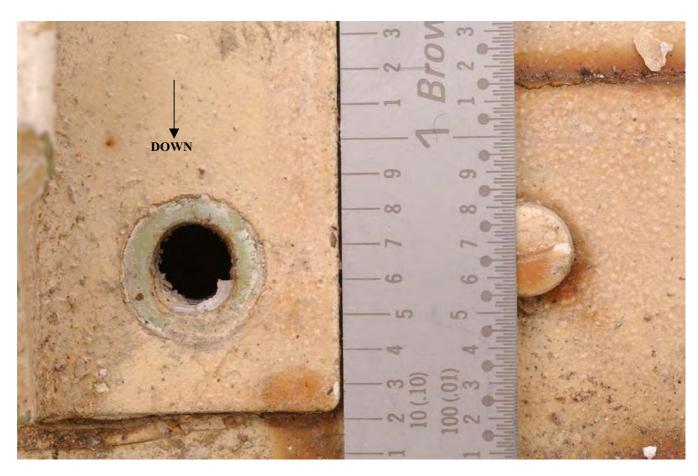
Between S-47L and S-44L the stringer clips were missing from this frame segment. The rivet fractures and or hole deformation at these locations were examined to determine if any evidence of separation direction was present. At all of these stringer clip locations the rivets were fractured and remained in the shear tie except at the lower attachment hole at S-47L which was missing the rivet. All of the fractured rivets that could be viewed (some of the fractures existed at the web/shear tie interface) exhibited signs of loading in the downward direction. The lower attachment hole at S-47 exhibited elongation in the downward direction as well (see Figure 98).

Figure 98.
FWD view of STA 1940 frame segment showing downward deformation of the lower attachment hole of shear tie at S-47L clip.

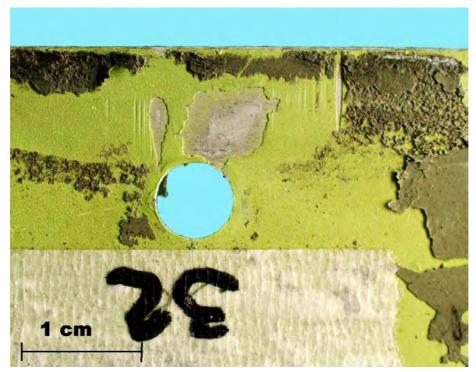
- (1) The surface markings near hole 32 are presented in Figure 1, and an optically magnified photograph of the subject area is shown in Figure 2. Figure 1 shows that the surface markings at the suspected area of contact exhibit many colors. Figure 2 shows that some hoop-wise scratches (marked by arrows) were visible on the surface of the suspected area of contact.
- (2) Figure 3 is an SEM photograph at point A in figure 2, indicating that the grooves of the scratches were covered by some material(s).
- (3) Two cross section locations were chosen to characterize the surface markings. Figures 5 and 6 are the metallographic photographs through the area marked by the data sampling cut #1 and data sampling cut #2 respectively, shown in Figure 4, showing that there was some material superimposed over the grooves of the scratches.

Figure 1, Surface markings adjacent to hole 32, showing the different colors on the metal surface.

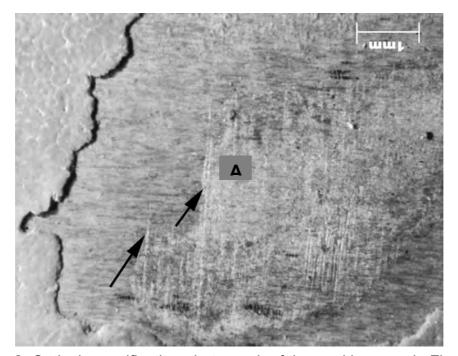
Figure 2, Optical magnification photograph of the marking area in Figure 1.

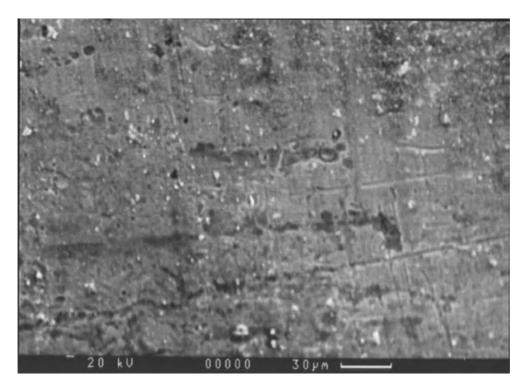
Figure 3, SEM photograph at point A in figure 2, indicating that the grooves of some of the scratches were covered by some material.

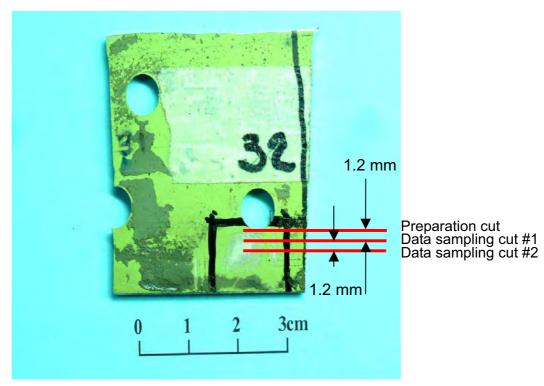
Figure 4, Cross section locations - taken to characterize the surface marking contours.

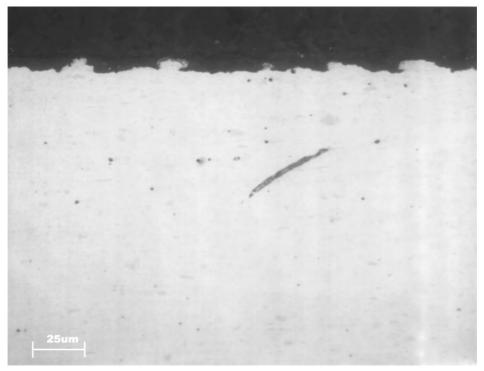
Figure 5, Metallographic photo through the area marked by the data sampling cut #1 in Figure 4.

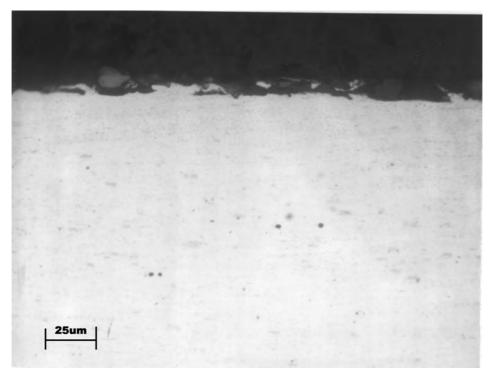
Figure 6, Metallographic photo through the area marked by the data sampling cut #2 in Figure 4.

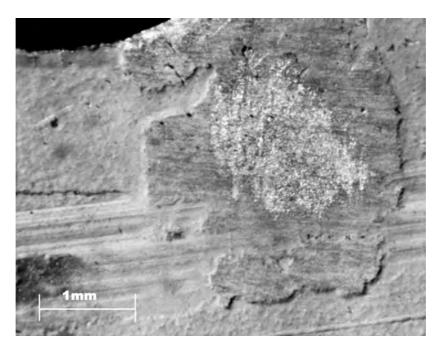
Marking areas of interest adjacent to holes 11, 49 and +16 are shown in Figure 7, 8, 9, respectively; all showing scrape/scratch marks on the surface.

Figure 7 Surface area adjacent to hole 11.

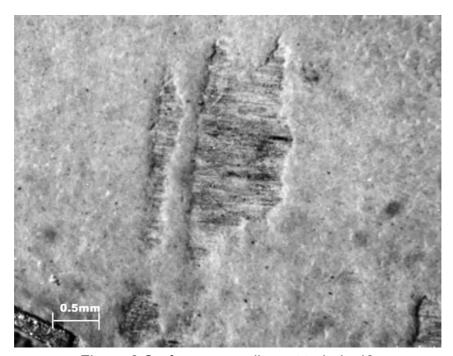
Figure 8 Surface area adjacent to hole 49

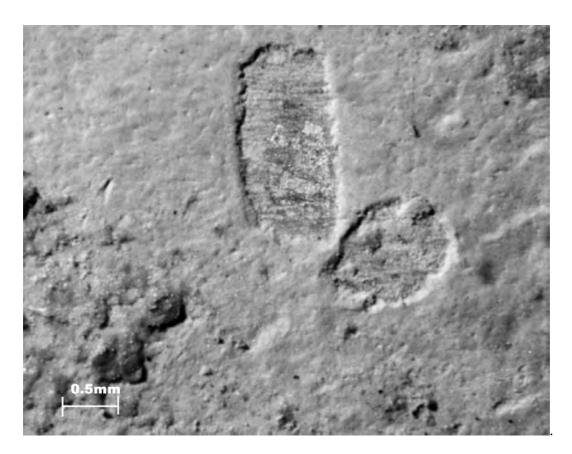
Figure 9 Surface area adjacent to hole +16
