Accident
on 25 December 2003
at Cotonou Cadjèhoun
aerodrome (Benin)
to the Boeing 727-223
registered 3X-GDO
operated by UTA
(Union des Transports Africains)

REPORT TRANSLATION
3x-o031225a

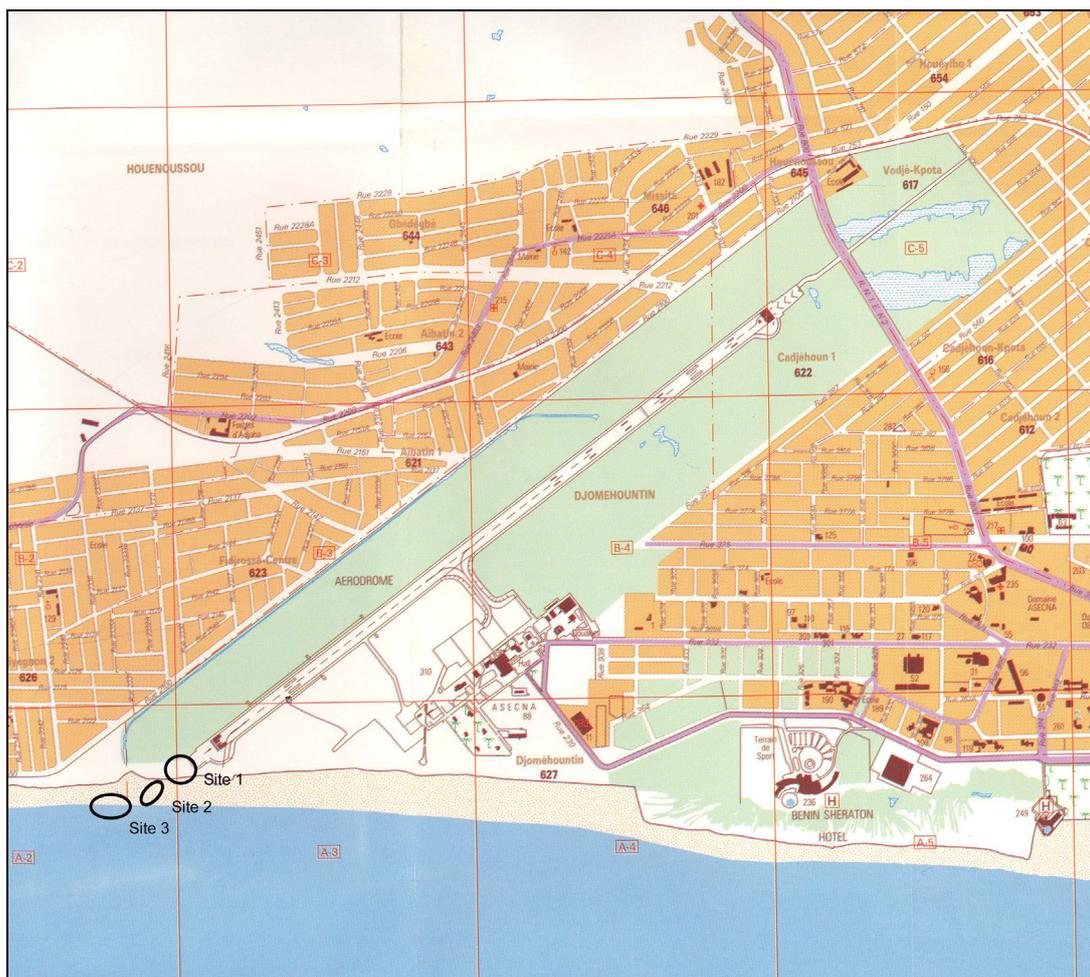
The airplane struck a technical building after the end of the runway (site 1), crashed onto the beach (site 2) and ended up in the ocean (site 3).

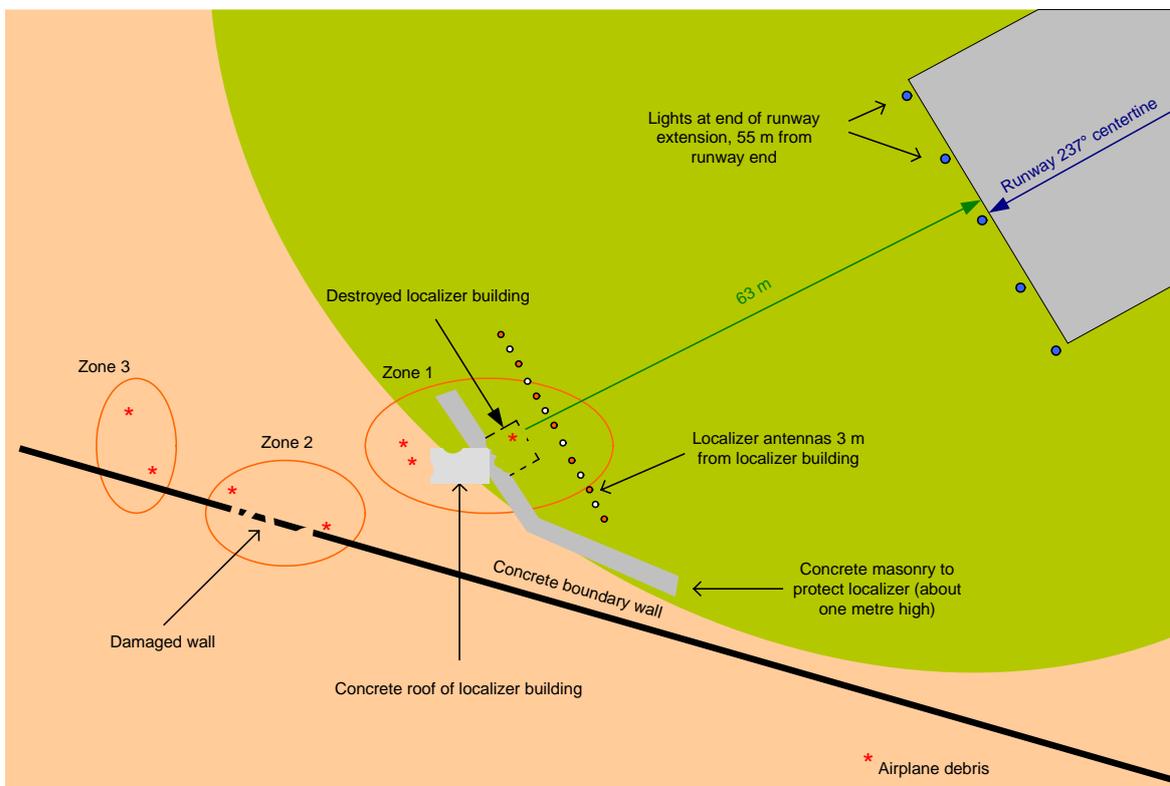
The illustration of site 1 (below) shows the distribution of the airplane debris in three distinct zones, with a total area of about 1,550 m².

The airplane damaged the localizer antennas, which were about a hundred and fifteen meters from the end of the runway, then destroyed the reinforced concrete building housing the electronic equipment bays.

On the east wall of the building, at a height of two meters ten, marks were found from a burst tire from the left main landing gear.

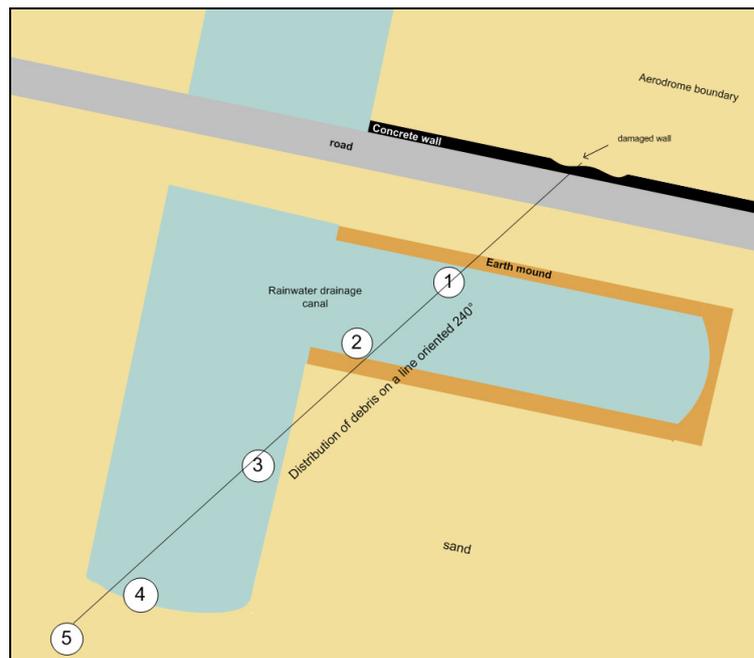
The plan of site 2 shows the position of the parts found in the rain drainage channel that crossed it. The heavy parts, numbered ① to ⑤ indicate the airplane's path after it passed over the aerodrome boundary wall.

The cylinder, the drag strut, the pivot link, parts of the side strut, the lock crank and the right ① main landing gear support beam ① were found in the canal, a hundred and fifty meters from the boundary.

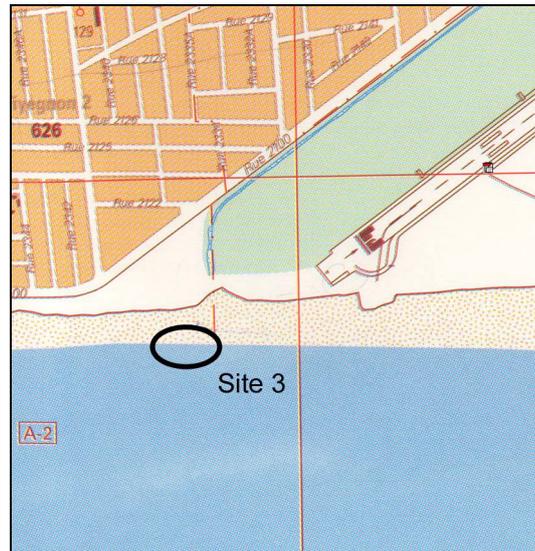
The main parts of the airplane were found in the ocean, in an area where the depth of water varied between three and ten meters. The waves that were breaking about fifty meters out kept the wreckage close to the shoreline.

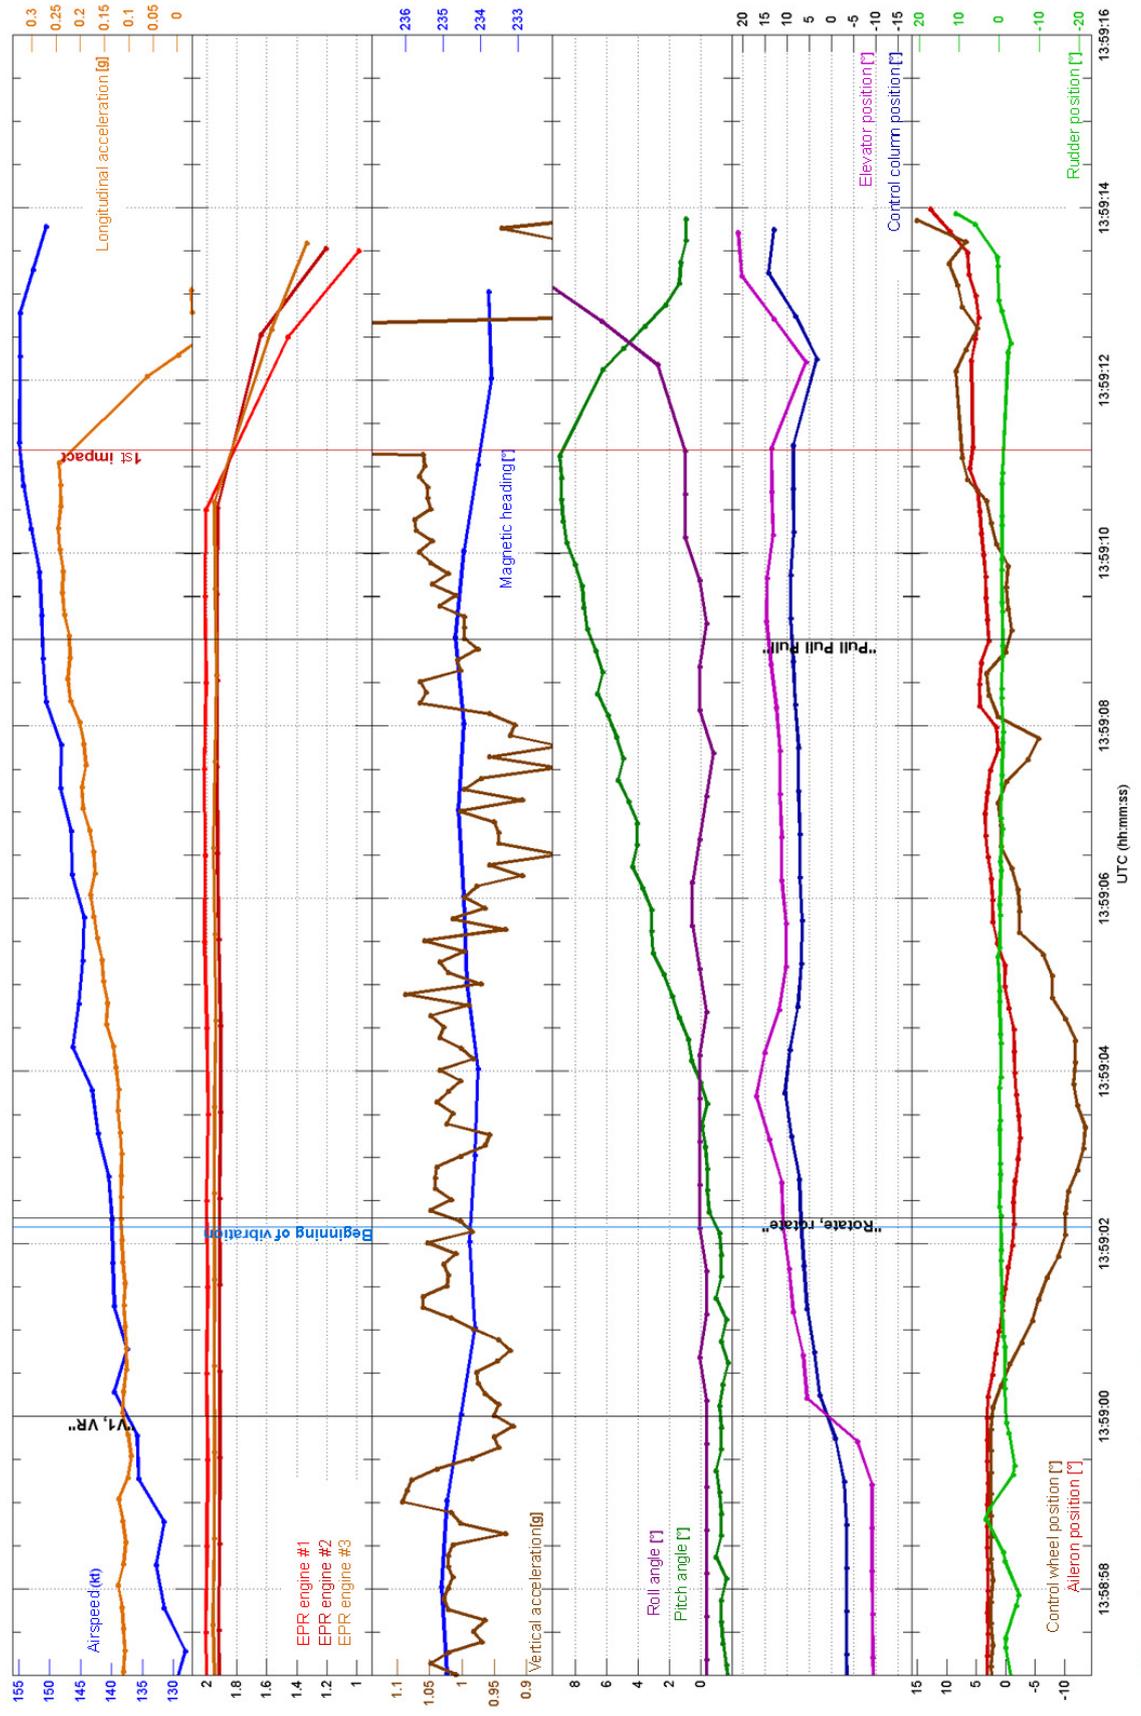
Takeoff in Cotonou, flight of the accident

The graphs obtained from the recorded parameters (see appendix) show that, when the stick was pulled back, the elevator was immediately set in pitch-up position, but that the airplane's response time was very slow compared to the usual time, the nose lifting off late while the acceleration was continuing. Such a situation at the beginning of the climb-out indicates either a limitation in the elevator's operation or an airplane with a center of gravity that is too far forward.
