Investigation report

B 2/2005 L

Aircraft accident at Helsinki–Vantaa airport on 31 January, 2005

SE-KYH

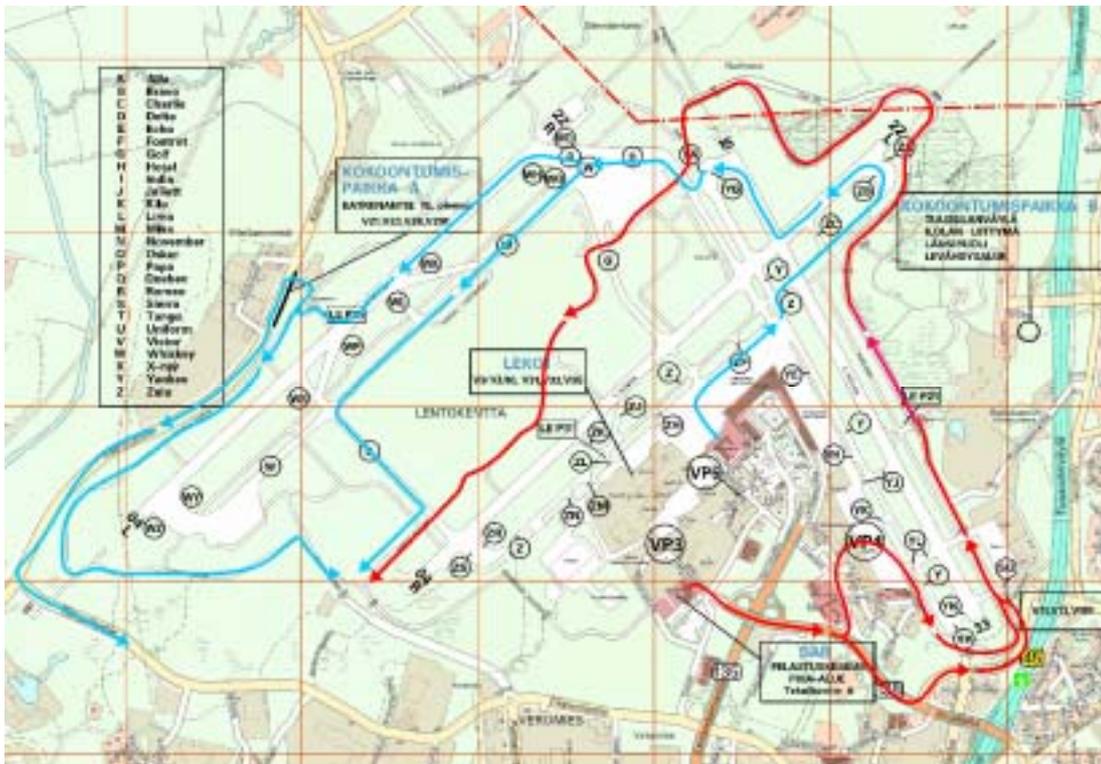
In the following figure the colour red represents the route taken by the municipal rescue service and the colour blue the airport rescue service, respectively.

Figure 5. Rescue service routes
(Source: City of Vantaa, survey department)
