# **AIRCRAFT ACCIDENT REPORT**

**Western Air Limited  
Fairchild Aircraft (SA-227)  
C6-REX  
Nassau New Providence Bahamas  
May 6, 2005**

**Report A0516317**

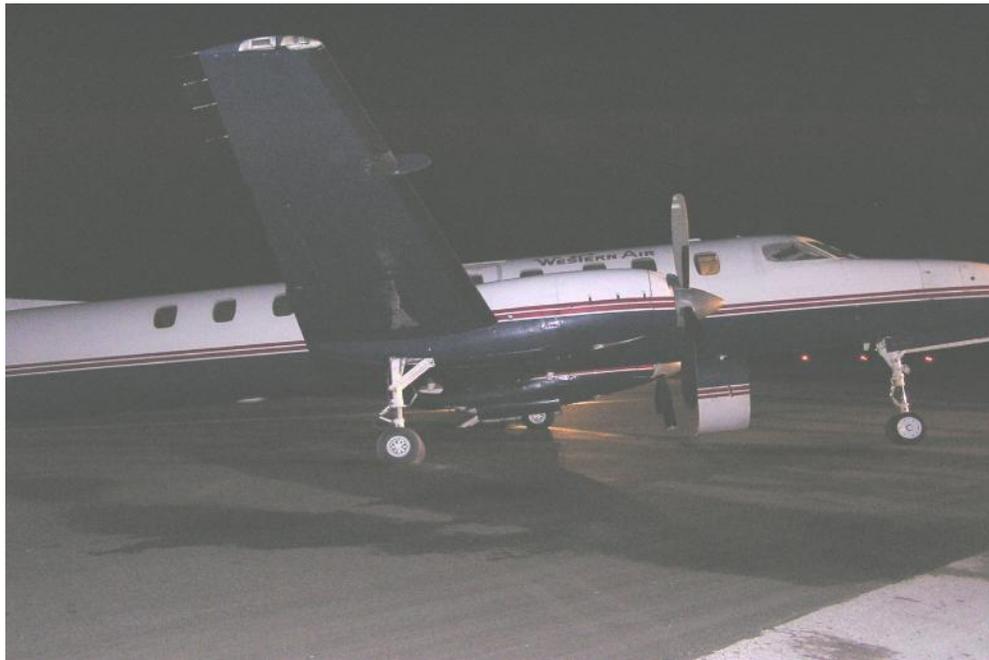
The aircraft came to rest upright. The underside of the left wingtip, the left propeller, the bottom of the left aft engine nacelle, and the left main gear, bore the main impact of the collapse. The right main gear tires also sustain damage. The fuselage remained intact. The cockpit and empennage were intact. The horizontal stabilizer and elevators had no visible impact or post impact damage. The vertical fin and rudder had no visible impact or post impact damage. There was no post impact fire.

Both engines were intact in the nacelles. Damage to the left engine could not be determined without more detailed inspection and analysis. The left propeller was extensively damaged from the impact. The right propeller did not appear to have sustained any impact damage.
