AIRCRAFT ACCIDENT REPORT

FINAL REPORT FUEL EXHAUSTION

**Flamingo Air Charter
Britten Norman (BN2-A) Islander
C6-ASA
Moss Town, Exuma Bahamas
16 May, 2005**

Report A0516517

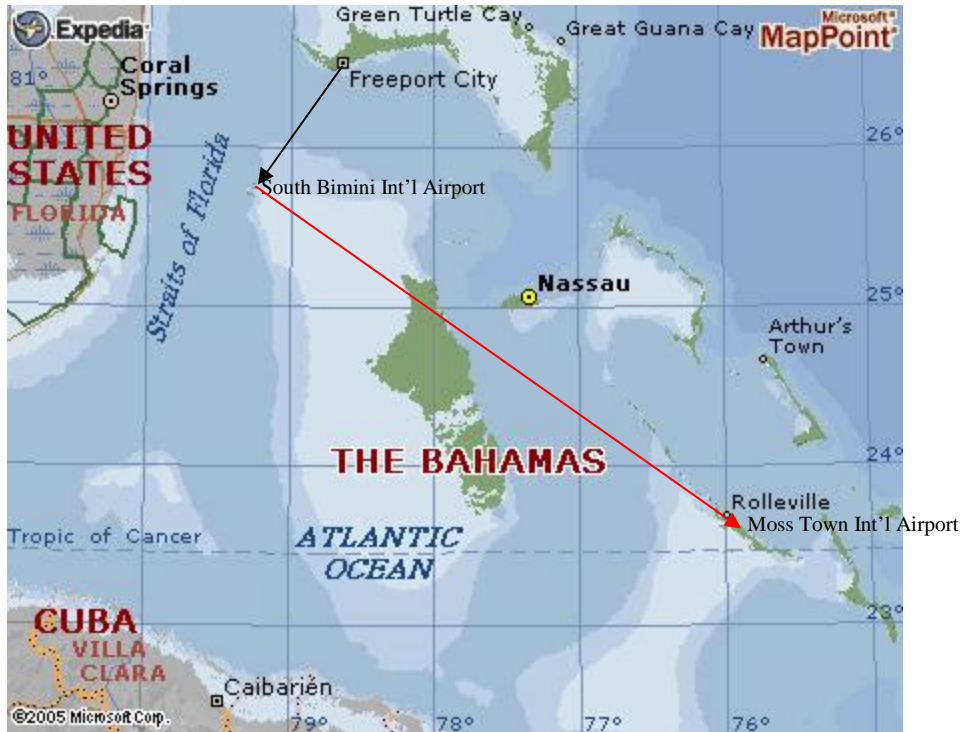
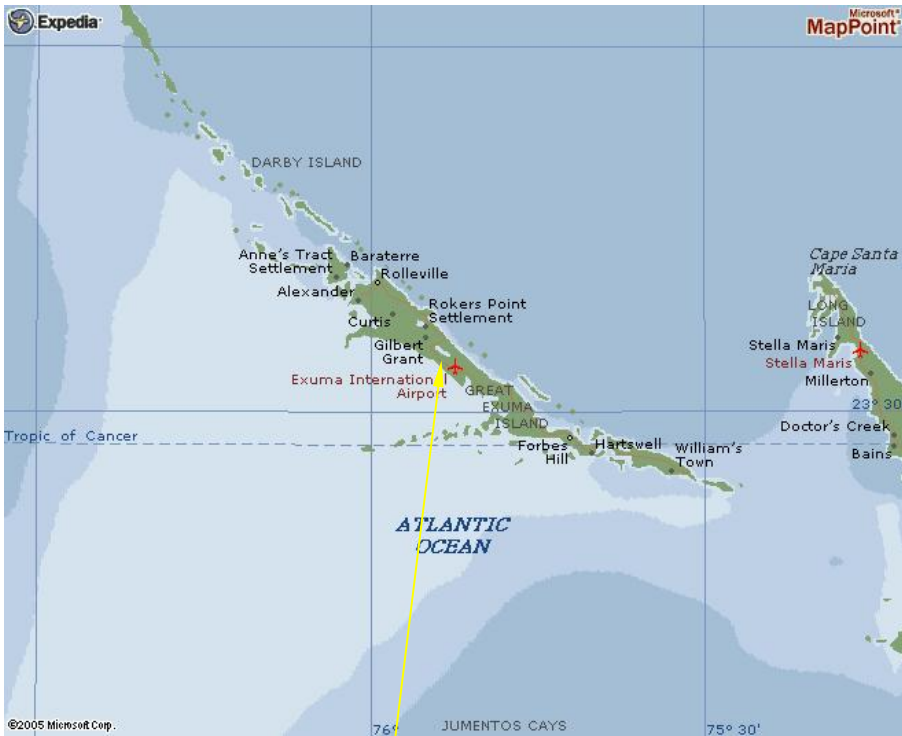
This is a map of the Exuma Islands, Bahamas showing the appropriate crash position of Aircraft C6-ASA. Aircraft C6-ASA crashed appropriate three [3] miles short of runway 12 at Moss Town International Airport, Moss Town, Exuma, Bahamas.
