DEPARTMENT OF AIR ACCIDENT INVESTIGATION

ACCIDENT REPORT

COLLISION 5Y-SFE & S9-BAS

CAV/ACC/BAS/SFE/05

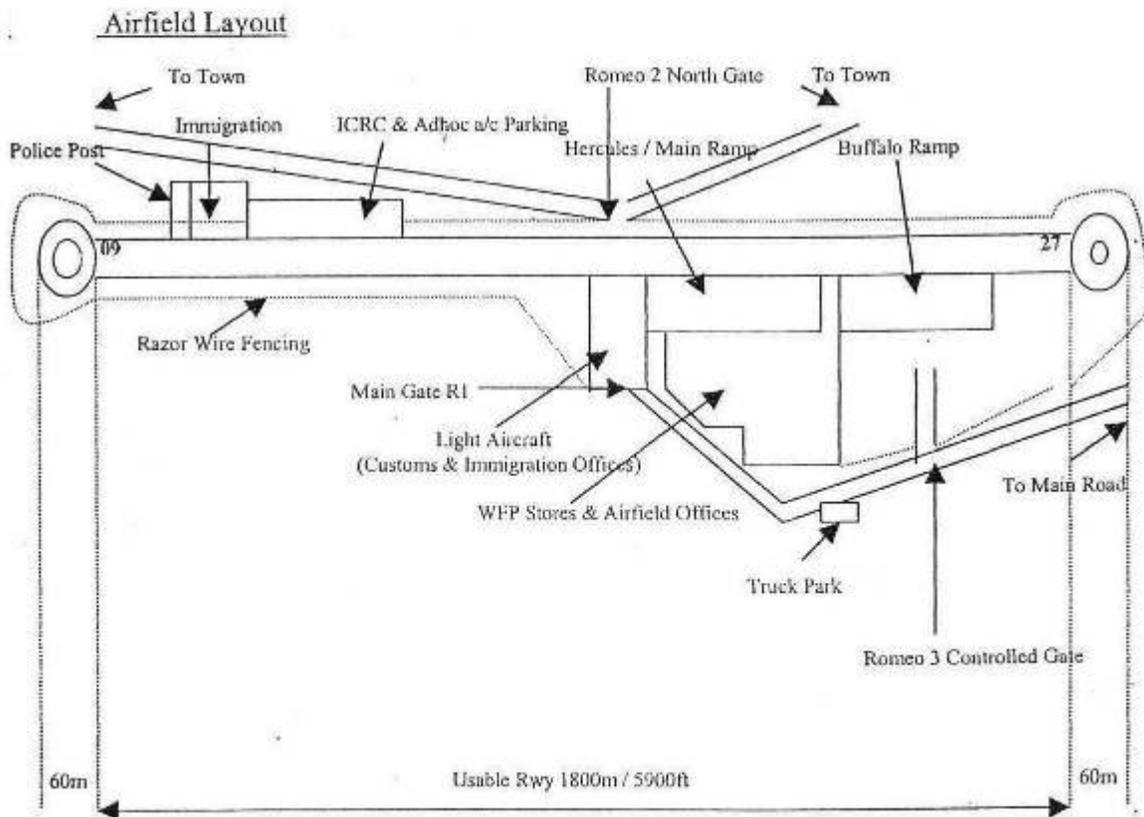
Lokichoggio Airport elevation is 2100 feet. It has one useable tarmac runway, 09/27, which is 1800 meters long and 25 meters wide. It also has a Control Tower and standard aerodrome equipment. The airport's geographical location is: Runway 09 position: N 04° 12.15' E 034° 20.24'; Runway 27 position: N 04° 12.13' E 034° 21.22'. Both crashed aircraft came to rest on the airfield at geographical location: N 04° 12.246' E 034° 20.847'.

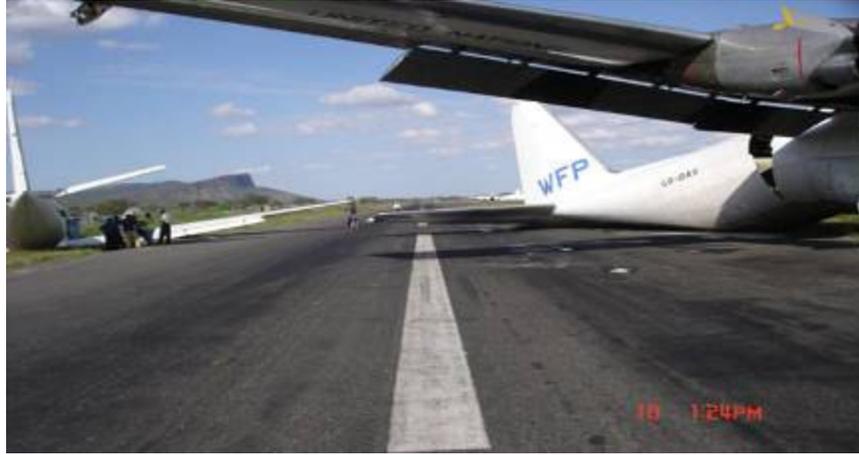
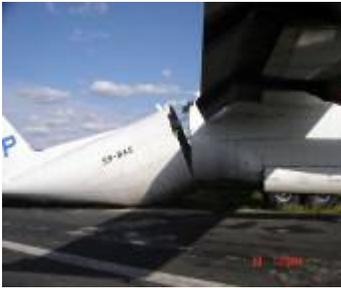
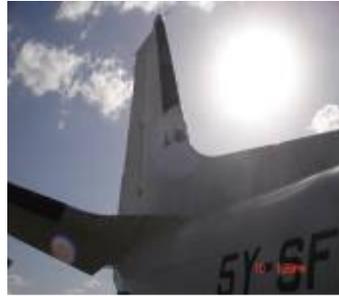
The lower fuselage was badly damaged by the impact and sliding on the bitumen. The propeller blades were bent back and slightly twisted showing that the engines were under power on landing. The bottom leading edge of the fin had a dent where it was struck by the right wing tip of the Hercules. After the accident, the landing gear selector was observed to be in the "UP" position.

The HS 748 Landing Gear Selector in the UP position
